PROPERTY CONDITION ASSESSMENT

SUMMARY REPORT

1096 Merritt St, Altamonte Springs, FL 32701

July 31, 2019

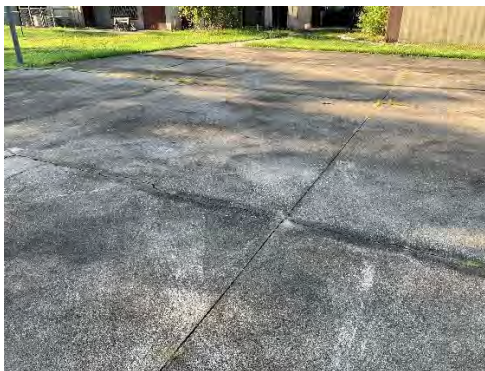
Fig. 4.9.1.A Basketball Court Condition

The basketball court is a concrete court. All markings have faded. The court has numerous cracks through the slab, spalling and differential settlement at several cracks possibly due to water infiltration.

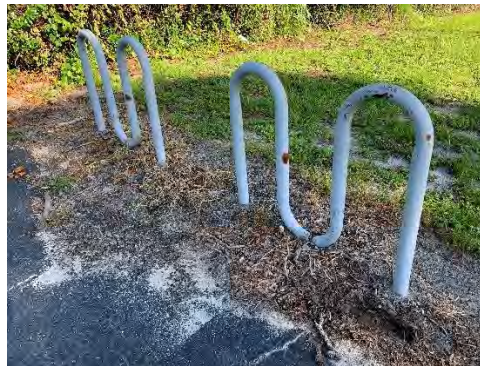
Fig. 4.8.1.C Bike Racks

Two two-capacity bicycle racks are located adjacent to parking and without a concrete slab or pedestrian sidewalk to the main building. The finish on the bike racks has deteriorated and the back racks are rusting.

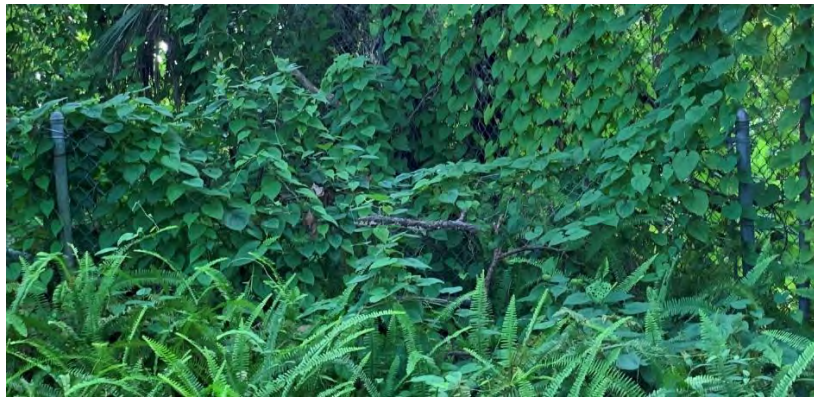
Fig. 4.9.6 Fence Impacted by Debris

The fence located along the south property line and right of way of Merritt Street, is a black wrought iron type fence with wing roll gates. The fence is rusting with significant corrosion at horizontal member connections. The fence along the west, north and east property lines is chain link of various heights. The chain link fence is overgrown with vegetation. Along the north side of the stormwater management pond, the fence height is compromised by fallen plant material on the fence fabric. There are various fence enclosures throughout the site around condensing units and for other unknown purposes.

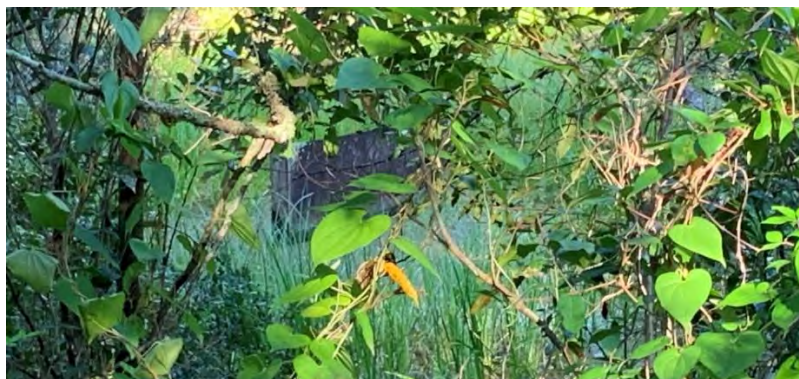
Fig. 4.9.7.A – Partial Baffle Remaining

The St. Johns River Water Management District issued a permit (49802-1, formerly 42-117-0445NG) in 1989 and a permit modification (49802-2, formerly 42-117-0445NGM) in 1994. The 1989 permit was issued for a new discharge facility consisting of dry detention with underdrain system to treat the runoff from new vehicular use areas. The 1994 permit modification was to modify the 1989 system to provide treatment by utilization of a wet detention system. The 1994 permit modified the 1989 design by expanding the pond limits and depth and construction of new courtyard storm sewer system. Visual confirmation of the existence of Inlet #3, Inlet #4, Inlet #6, Inlet #7 and Inlet #8 associated with permit modification 49802-2 is documented in the photographs. Structures Mitered End #1, M.H. #2 and M.H. #5 were not observed. The fiberglass baffle associated with the 49802-2 modification is in very poor condition and does not extend as documented in the permit files. The control structure from the wet detention pond to Lake Mobile was not found due to overgrown vegetation. The entire stormwater management pond is overgrown. Storm event staging and system ability to function during a storm event was not observed.

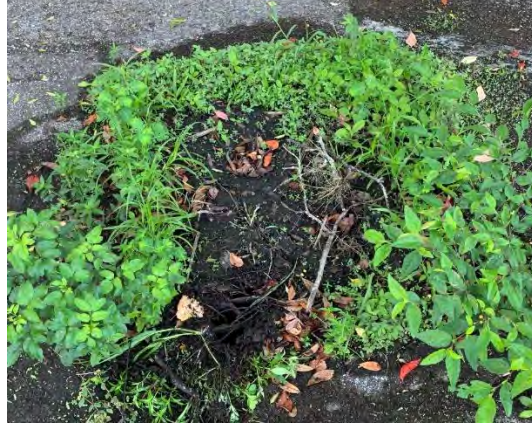
Fig. 4.9.7.B – Sedimentation Clogging Grate Inlet

inlet grates or are connected to storm sewer. The predominate method of discharge is to grade. Evidence of standing water and flooding over sidewalks was noted. Evidence of erosion was also found around the courtyard and inside of inlets. The erosion and transportation of suspended material is anticipated with the exiting roof runoff discharge to grade. Permanent stormwater pollution prevention methods are missing or are in a state of disrepair.

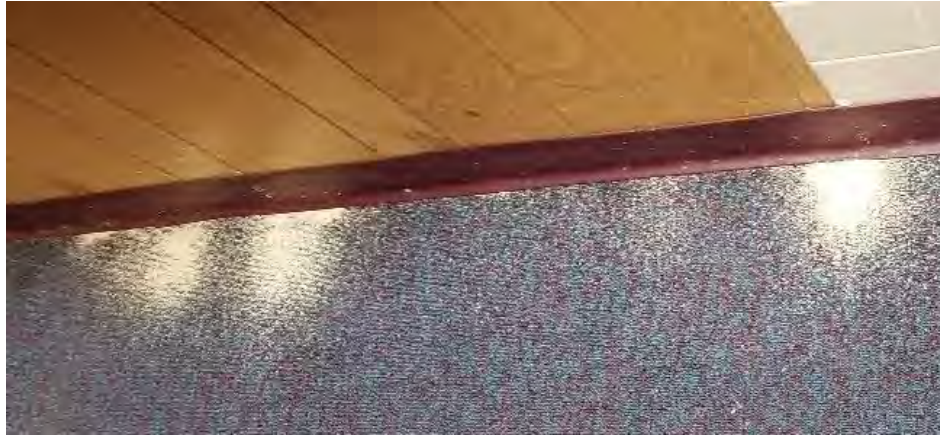
Fig. 4.10.3 Building 5 Potential insect damage

Building 5, 9, 10 and 11 have a stick-built wood framed roof. Much of the Building 5 roof structure was covered by wood paneling, but exposed areas of framing exhibited signs of water staining, rot and insect damage. Building 9's roof structure was not visible as it had a hard ceiling. Building's 10 and 11 roof framing appeared to be in good shape.

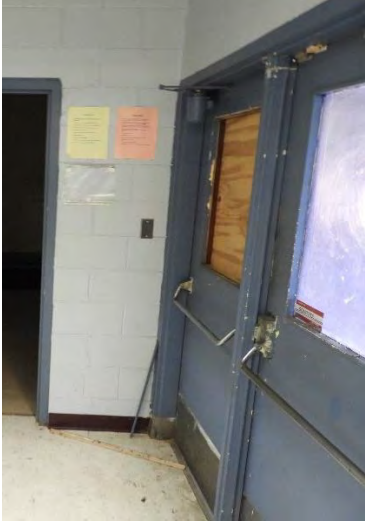
3. Missing glass panels were observed in locations at Buildings 1, 3 and 6. (*Refer to photos #5 EXTERIOR DOOR-1, #36 EXTERIOR DOOR-2 and #61 EXTERIOR DOOR-3*).
4. Significant damage to doors and Buildings 6, 7, and 12. (*Refer to photos #61 EXTERIOR DOOR-3, #73 EXTERIOR DOOR-4, and #94 EXTERIOR DOOR-5*).
5. Door is detached from structure at Building 10. (*Refer to photo #85 BUILDING 10 - DOOR*).

<p>REPORT SECTION: DOORS</p> <p>PHOTO: EXTERIOR DOOR – 1</p> <p>PHOTO DESCRIPTION: MISSING GLASS PANEL AT BUILDING 1</p>
<p>6.</p>

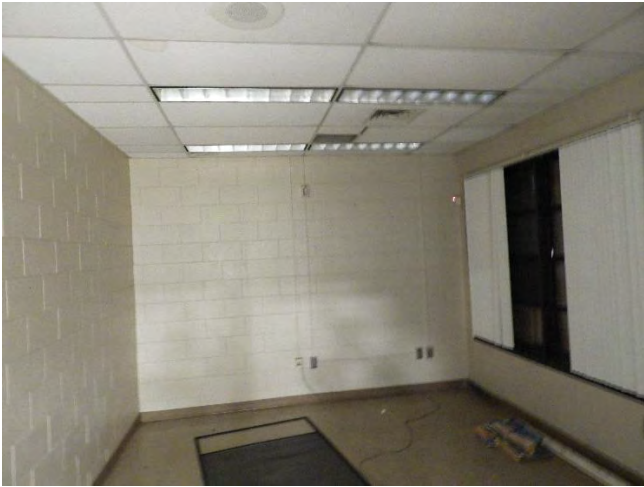
<p>REPORT SECTION: WINDOWS</p> <p>PHOTO: WINDOW IN LOUNGE</p> <p>PHOTO DESCRIPTION: MISSING SCREEN AT WINDOW</p>

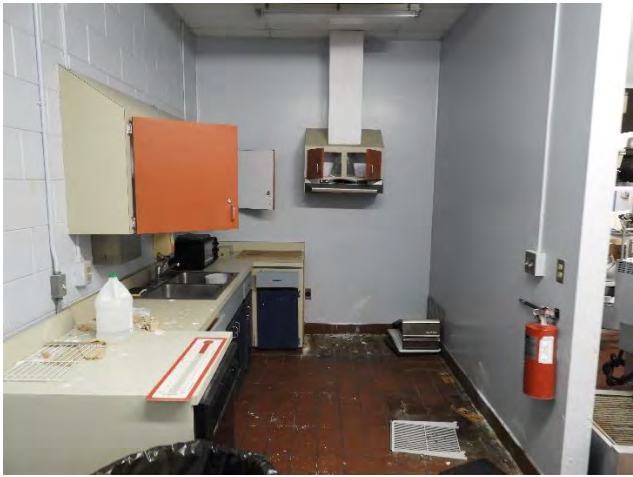
<p>REPORT SECTION: INTERIOR FINISH</p> <p>PHOTO: KITCHEN 2</p> <p>PHOTO DESCRIPTION: FLOOR STAINING IN KITCHEN AREA</p>
<p>9.</p>

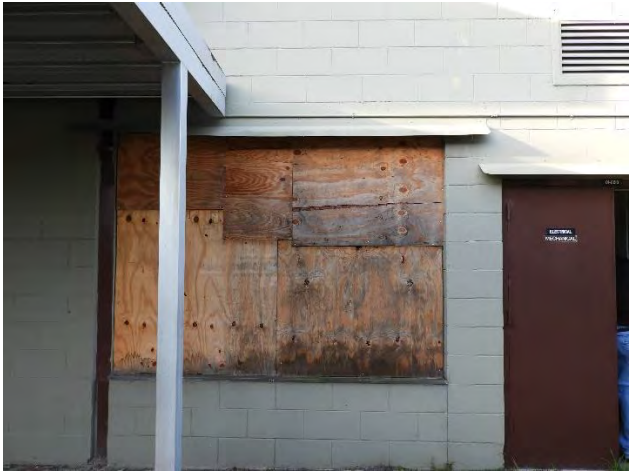
1. Missing glass was observed at multiple locations, the missing glass was replaced with plywood. (*Refer to photos #13 WINDOW-1 & #108 WINDOW-2*).

<p>REPORT SECTION: WINDOW</p> <p>PHOTO: WINDOW-1</p> <p>PHOTO DESCRIPTION: MISSING WINDOW NEAR ELECTRICAL/MECHANICAL ROOM</p>
<p>14.</p>

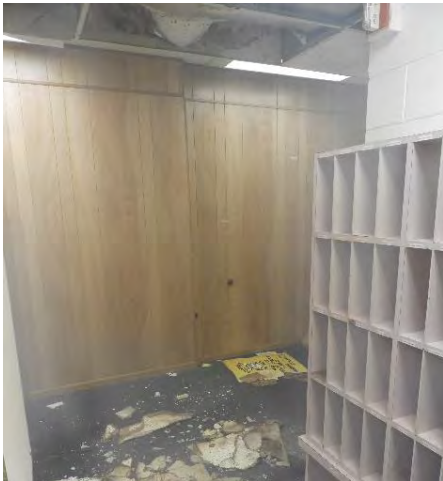
<p>REPORT SECTION: INTERIOR FINISH</p> <p>PHOTO: ACT – BUILDING 2</p> <p>PHOTO DESCRIPTION: DAMAGED CEILING TILE</p>
22.

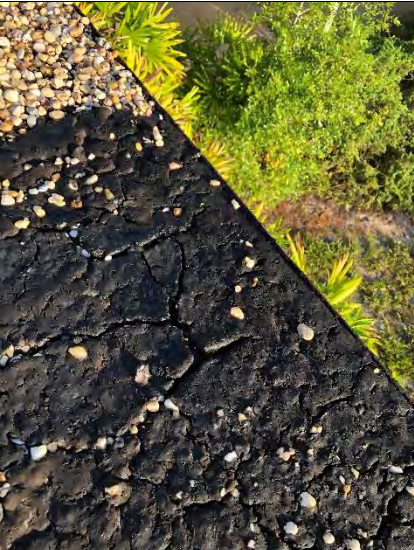
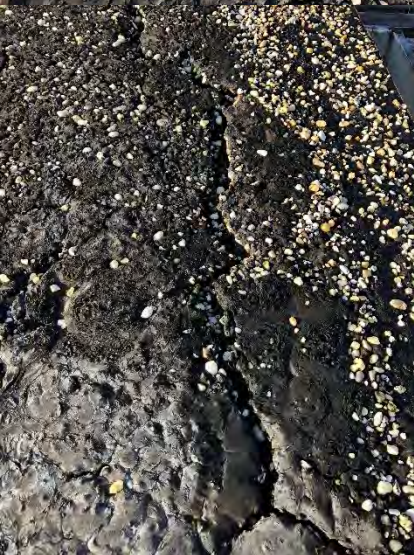
<p>REPORT SECTION: ROOF</p> <p>PHOTO: ROOF – BUILDING 2 PHOTO DESCRIPTION: CRACKED MEMBRANE</p>
28.

<p>REPORT SECTION: ROOF</p> <p>PHOTO: ROOF – BUILDING 2 PHOTO DESCRIPTION: CRACKED MEMBRANE</p>

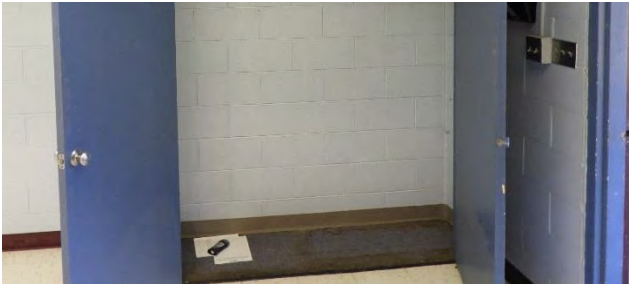
REPORT SECTION: INTERIOR FINISH PHOTO: CLOSET 1 PHOTO DESCRIPTION: CARPET STAINING

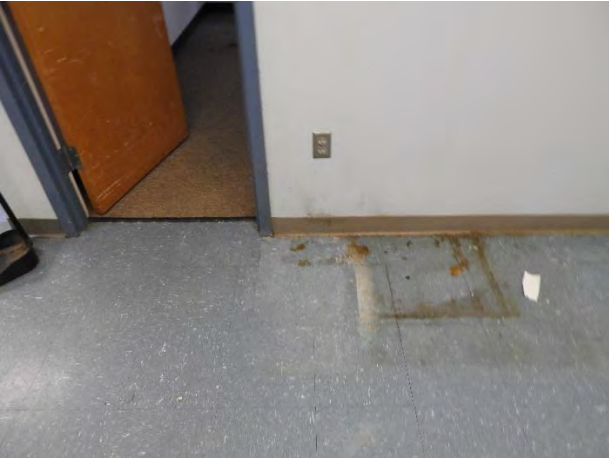
A photograph of a grey concrete floor with several yellowish-brown stains. A wooden door is partially visible on the left side of the frame. The wall is light-colored with a single electrical outlet.	<p>REPORT SECTION: INTERIOR FINISH</p> <p>PHOTO: VCT STAINS – BUILDING 3</p> <p>PHOTO DESCRIPTION: STAINING AT VCT IN KITCHEN AREA</p>
<p>34.</p>

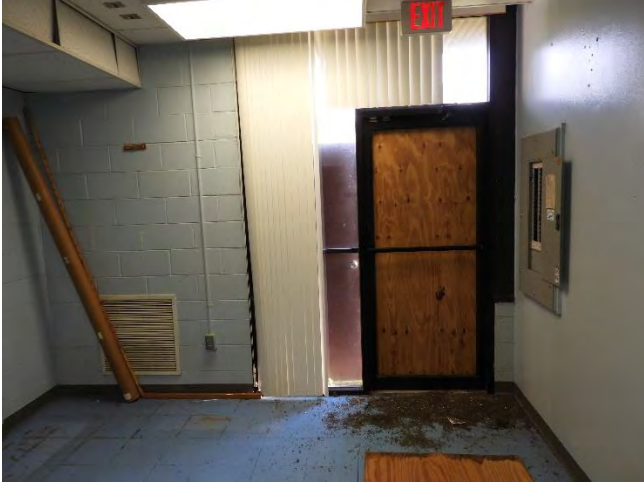
<p>REPORT SECTION: DOORS</p> <p>PHOTO: EXTERIOR DOOR - 2</p> <p>PHOTO DESCRIPTION: MISSING GLASS AT BACK EXTERIOR DOOR</p>
<p>37.</p>

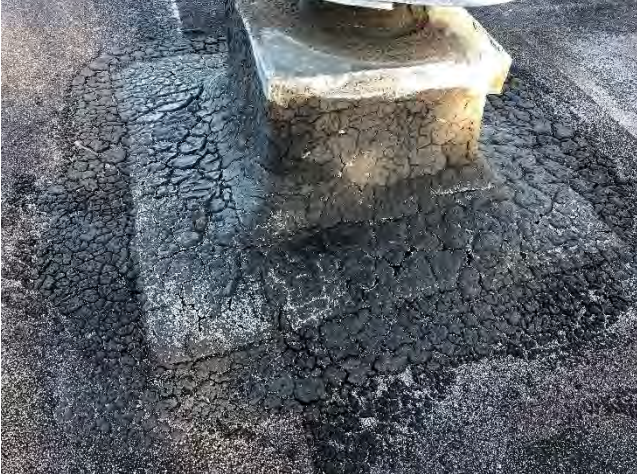
A close-up photograph of a roof membrane. The membrane is dark and shows significant cracking and peeling, particularly around a concrete base. The texture is rough and uneven.	<p>REPORT SECTION: ROOF</p> <p>PHOTO: ROOF – BUILDING 4</p> <p>PHOTO DESCRIPTION: “GATOR-BACKING” ROOF MEMBRANE</p>

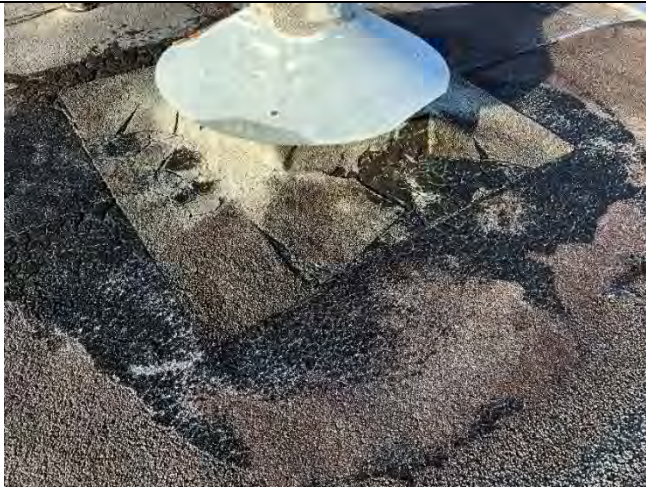
<p>REPORT SECTION: DOORS</p> <p>PHOTO: ROOF - BUILDING 4</p> <p>PHOTO DESCRIPTION: MEMBRANE DETERIORATION</p>
<p>51.</p>

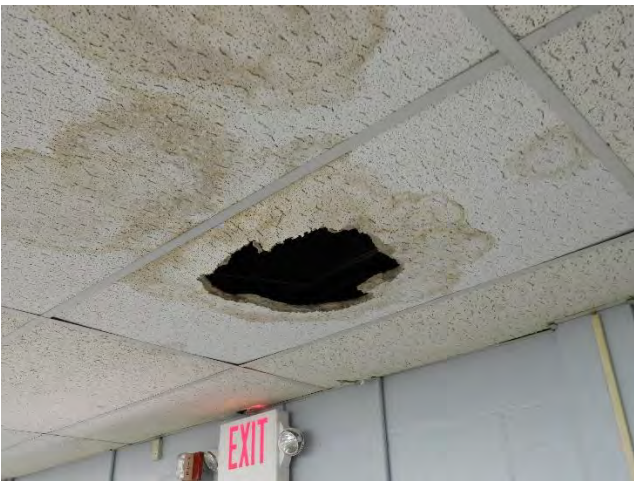
A photograph of a ceiling in a bathroom. A square ceiling tile is missing, revealing a dark, irregular hole. The surrounding ceiling tiles are light-colored and show signs of water damage, with yellowish-brown stains. In the background, a white door is visible with a red 'EXIT' sign mounted on it.	<p>REPORT SECTION: INTERIOR FINISH</p> <p>PHOTO: ACT – BUILDING 5</p> <p>PHOTO DESCRIPTION: DAMAGED ACT</p>

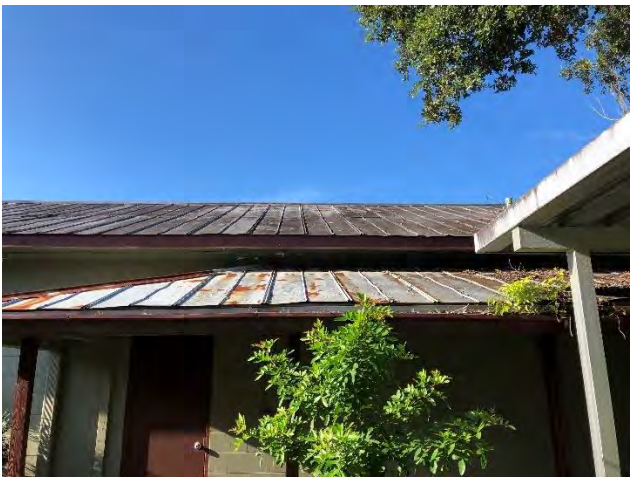
A photograph showing a portion of the roof of Building 5. The roof panels are made of metal and show significant rust and discoloration. A concrete overhang is visible on the right side, and some green foliage is growing near the base of the building.	<p>REPORT SECTION: ROOF</p> <p>PHOTO: BUILDING 5 - ROOF</p> <p>PHOTO DESCRIPTION: PORTION OF BUILDING 5 ROOF - RUSTED PANELS</p>

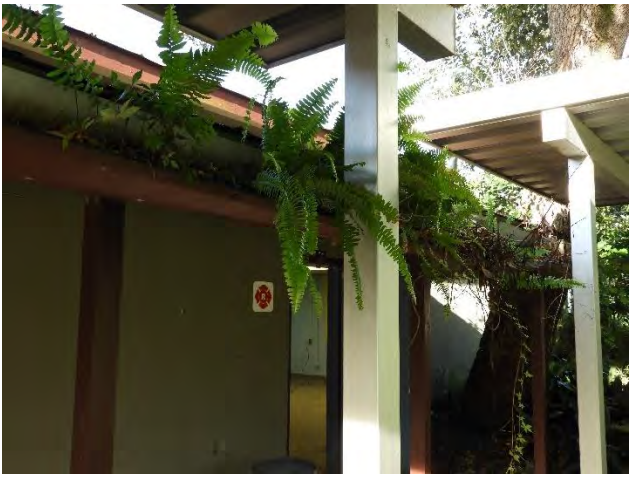
A photograph showing a damaged gutter on the exterior of Building 5. The gutter is overflowing with green ferns and other vegetation. The building has a concrete overhang and a white pillar is visible in the foreground.	<p>REPORT SECTION: ROOF</p> <p>PHOTO: BUILDING 5 - GUTTER</p> <p>PHOTO DESCRIPTION: DAMAGED GUTTER</p>

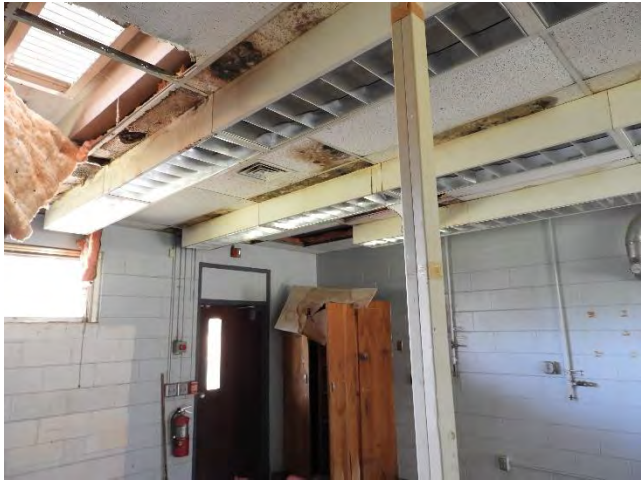
<p>REPORT SECTION: INTERIOR FINISH</p> <p>PHOTO: ACT - BULDING 6, 2</p> <p>PHOTO DESCRIPTION: ACT DAMAGE IN CLASSROOMS</p>
<p>67.</p>

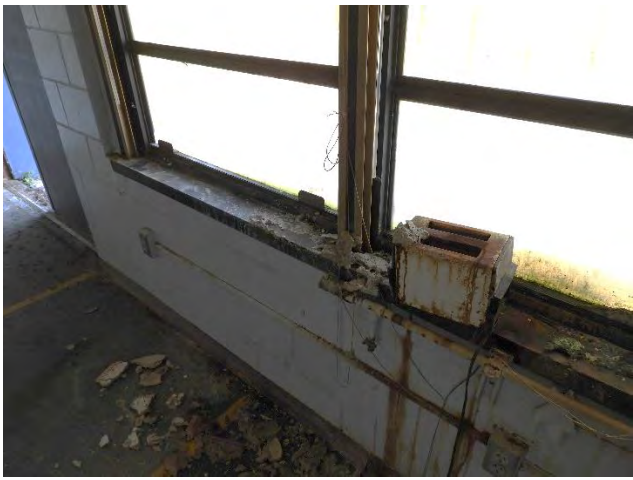
2. Significant damage at one of the window frames in Building 5 (*Refer to photo #54 WINDOW-BUILDING 5*).
3. Windows at Building 6 have significant signs of water damage (*Refer to #67 WINDOW-BUILDING 6*).

<p>REPORT SECTION: WINDOW</p> <p>PHOTO: WINDOW – BUILDING 6</p> <p>PHOTO DESCRIPTION: WINDOW FRAME RUST AND STAINING</p>
<p>68.</p>

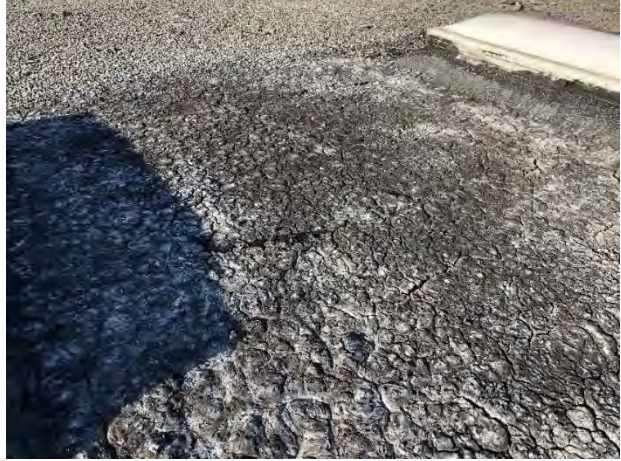
Building 6 has a shallow precast double-tee roof structure which also cantilevers to serve as the canopy cover on the south side of the building. The roof structure itself appears to be in good condition, however the roofing has failed which is allowing water through the roof joints which is damaging the finish on the underside of the canopy area and the MEP and architectural elements supported by the roof on the interior of the building (*Refer to photos #68-71 BUILDING 6 – ROOF 1 – 4*).

A close-up photograph of a dark, textured membrane on a roof. The membrane is heavily cracked and appears to be peeling or delaminating in several areas. A concrete curb is visible in the upper right corner.	<p>REPORT SECTION: ROOF</p> <p>PHOTO: BUILDING 6 – ROOF 3</p> <p>PHOTO DESCRIPTION: “GATOR-BACKING” MEMBRANE</p>

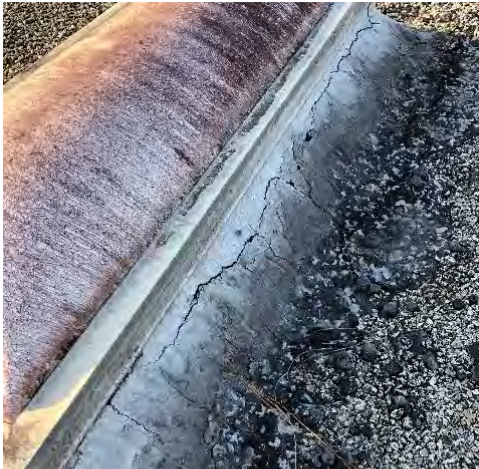
A close-up photograph of a roof edge. A concrete curb is visible, and the membrane around it is severely cracked and deteriorated. The membrane appears to be a dark, textured material, possibly a flashing membrane.	<p>REPORT SECTION: ROOF</p> <p>PHOTO: BUILDING 6 – ROOF 4</p> <p>PHOTO DESCRIPTION: CRACKED FLASHING MEMBRANE, DETERIORATED SKYLIGHT</p>

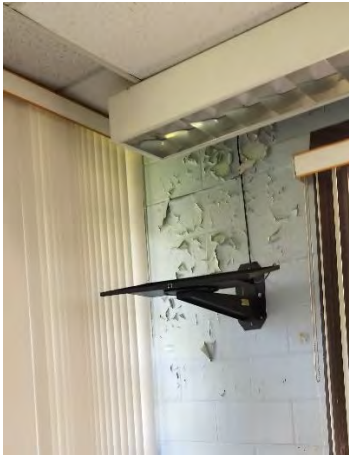
<p>REPORT SECTION: INTERIOR FINISH</p> <p>PHOTO: CMU PAINT – BUILDING 7</p> <p>PHOTO DESCRIPTION: PAINT PEELING FROM CMU WALL</p>
75.

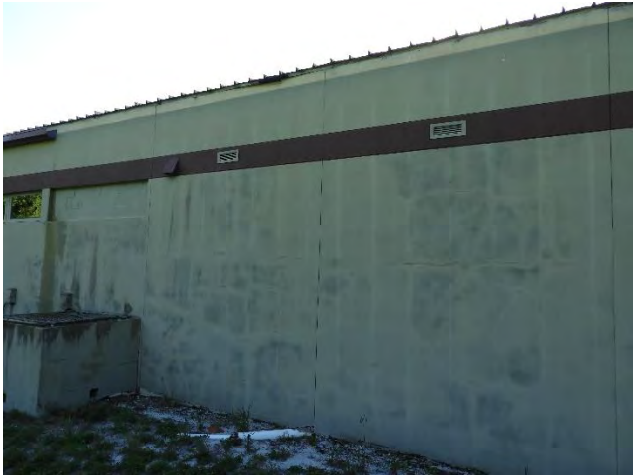
A photograph of the exterior wall of Building 14. The wall is a light green color with a dark brown horizontal band near the roofline. There are visible vertical cracks in the wall, particularly near the bottom left corner. The roofline is visible at the top, and some snow is on the ground in the foreground.	<p>REPORT SECTION: EXTERIOR</p> <p>PHOTO: PARTIAL BACK ELEVATION – BUILDING 14</p> <p>PHOTO DESCRIPTION: CRACKING AT BACK EXTERIOR WALL</p>

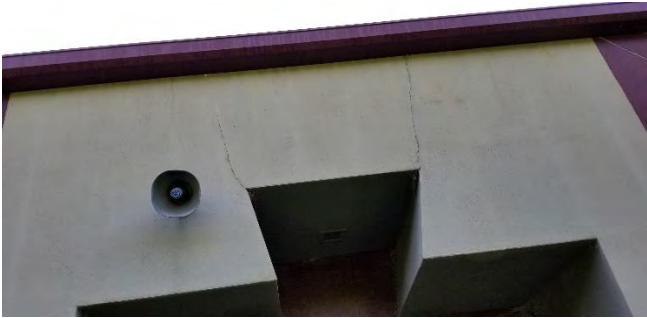
Walls at Buildings 13 and 14 are masonry block walls with a metal furring, insulation, and stucco finish. These walls are in fair condition. Moisture on the stucco finish was starting to telegraph the location of the metal furring. In addition, building 14 showed signs of potential moisture intrusion behind the stucco finish at locations where cracks in the stucco finish was observed (*Refer to photos #105 BACK ENTRYWAY – BUILDING 14 and # 104 PARTIAL BACK ELEVATION – BUILDING 14*).

A photograph of the back entryway of Building 14. The wall is a light beige color. There is a dark doorway in the center. To the left of the doorway is a circular vent. The corners of the entryway show signs of cracking and wear. The roofline is visible at the top.	<p>REPORT SECTION: EXTERIOR</p> <p>PHOTO: BACK ENTRYWAY – BUILDING 14</p> <p>PHOTO DESCRIPTION: CARCKING AT CORNERS OF ENTRYWAY</p>

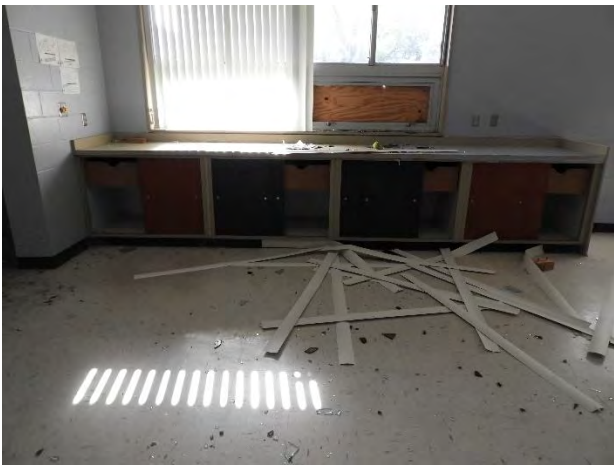
<p>REPORT SECTION: WINDOW</p> <p>PHOTO: WINDOW 2</p> <p>PHOTO DESCRIPTION: BROKEN GLASS WINDOW</p>
109.

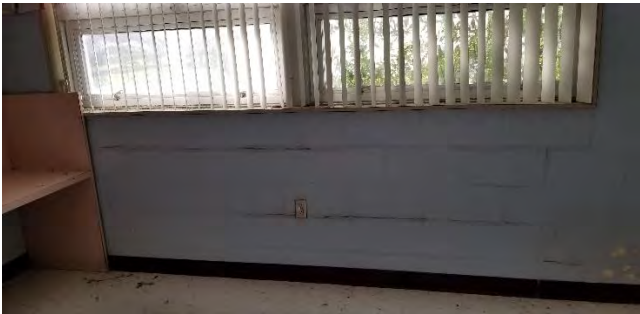
<p>REPORT SECTION: WALLS</p> <p>PHOTO: CMU – BUILDING 14</p> <p>PHOTO DESCRIPTION: CRACKING OF MORTAR JOINTS</p>

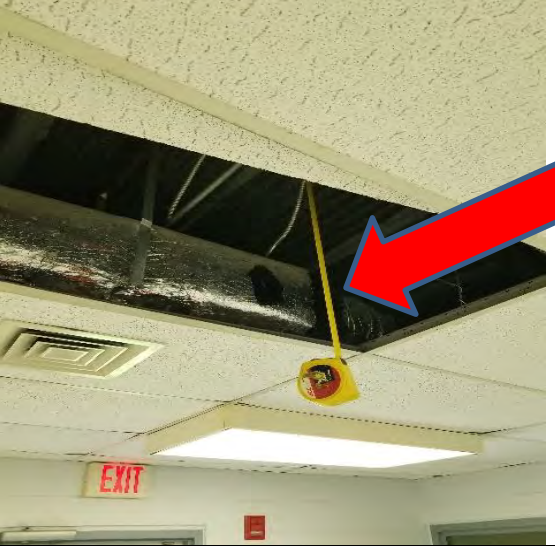
<p>REPORT SECTION: 4.5.2</p> <p>PHOTO: M17</p> <p>PHOTO DESCRIPTION: Building#4; Black mastic duct insulation sealer. Consideration should be given to having this mastic tested for hazardous materials.</p>
385.
