Greetings Buttonwood Residents,

Please find the latest bioassessment report for your waterbody below. Key highlights of this update include:

On **March 8<sup>th</sup>, 2016**, SCLMP personnel, Thomas Calhoun and Joey Cordell, surveyed the aquatic plants in **Buttonwood Pond**.

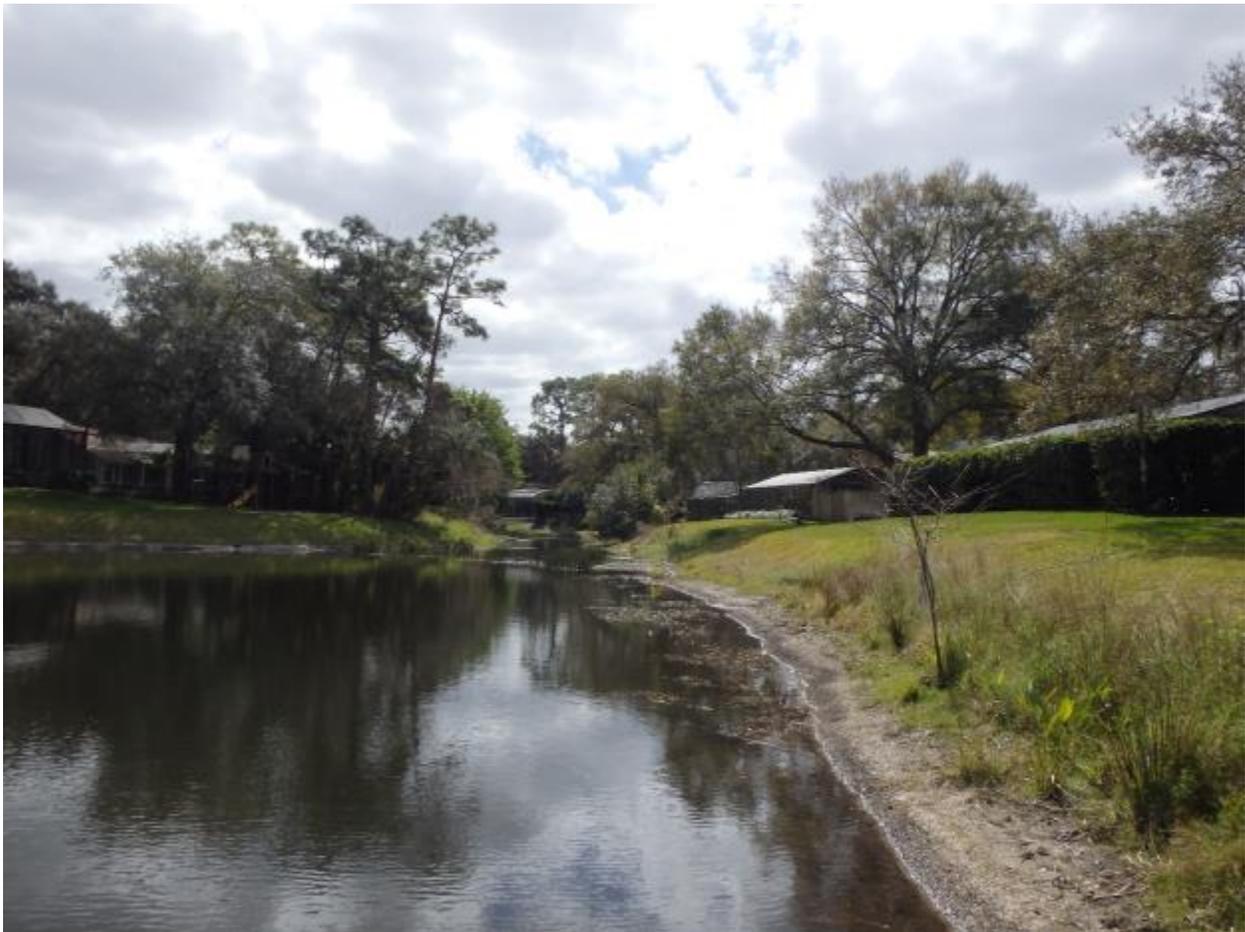
**Photo: Restoration site.**

At time of inspection the water level was very low.

In the restoration zone, the pickerelweed and duck potato have died due to the low water level. These species will be replanted lower on the shoreline.

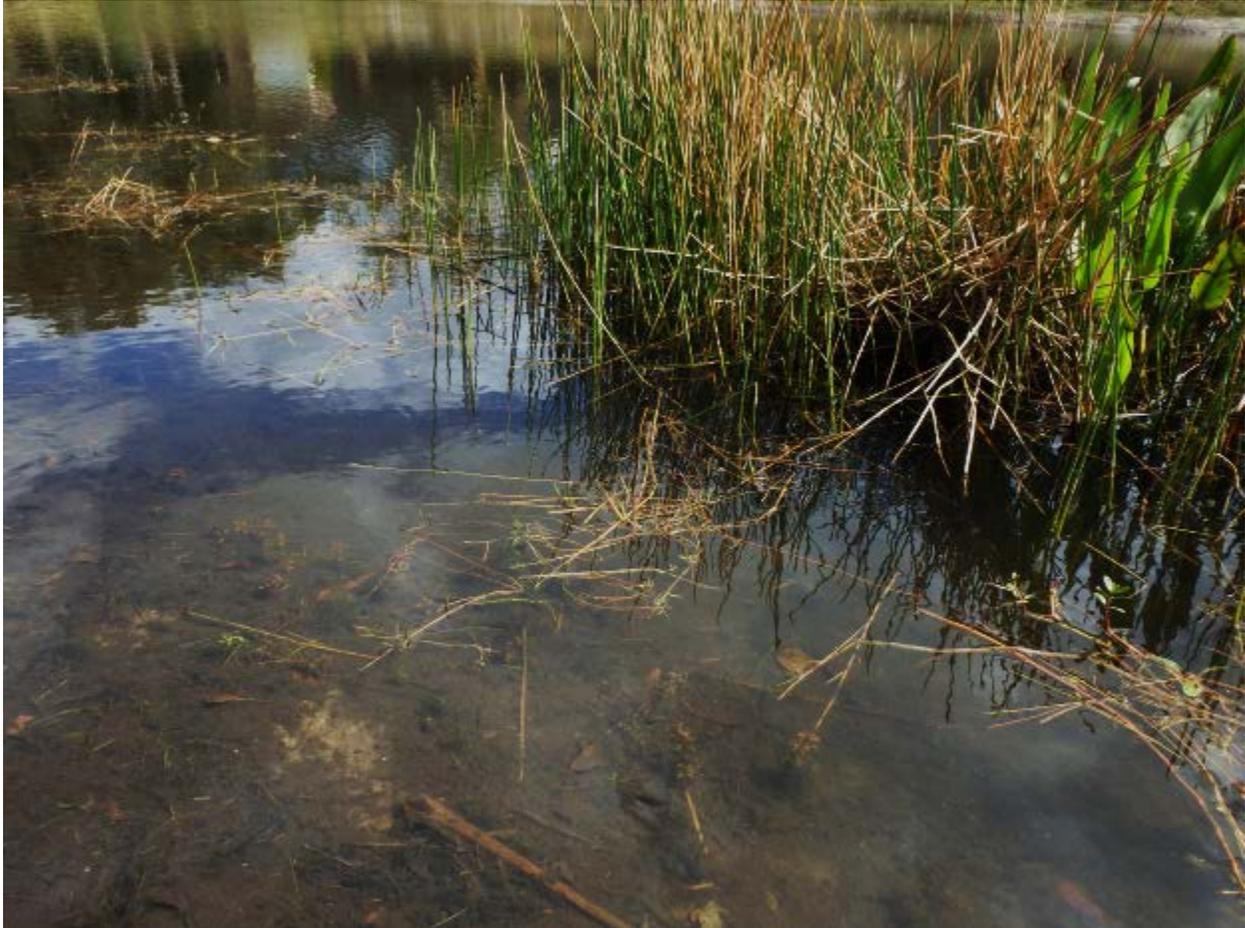
**Photo: Submersed Red Ludwigia.**

Submersed aquatic vegetation (SAV) observed during the inspection included: red ludwigia, roadgrass, and baby's tears. All species were found in shallow water.

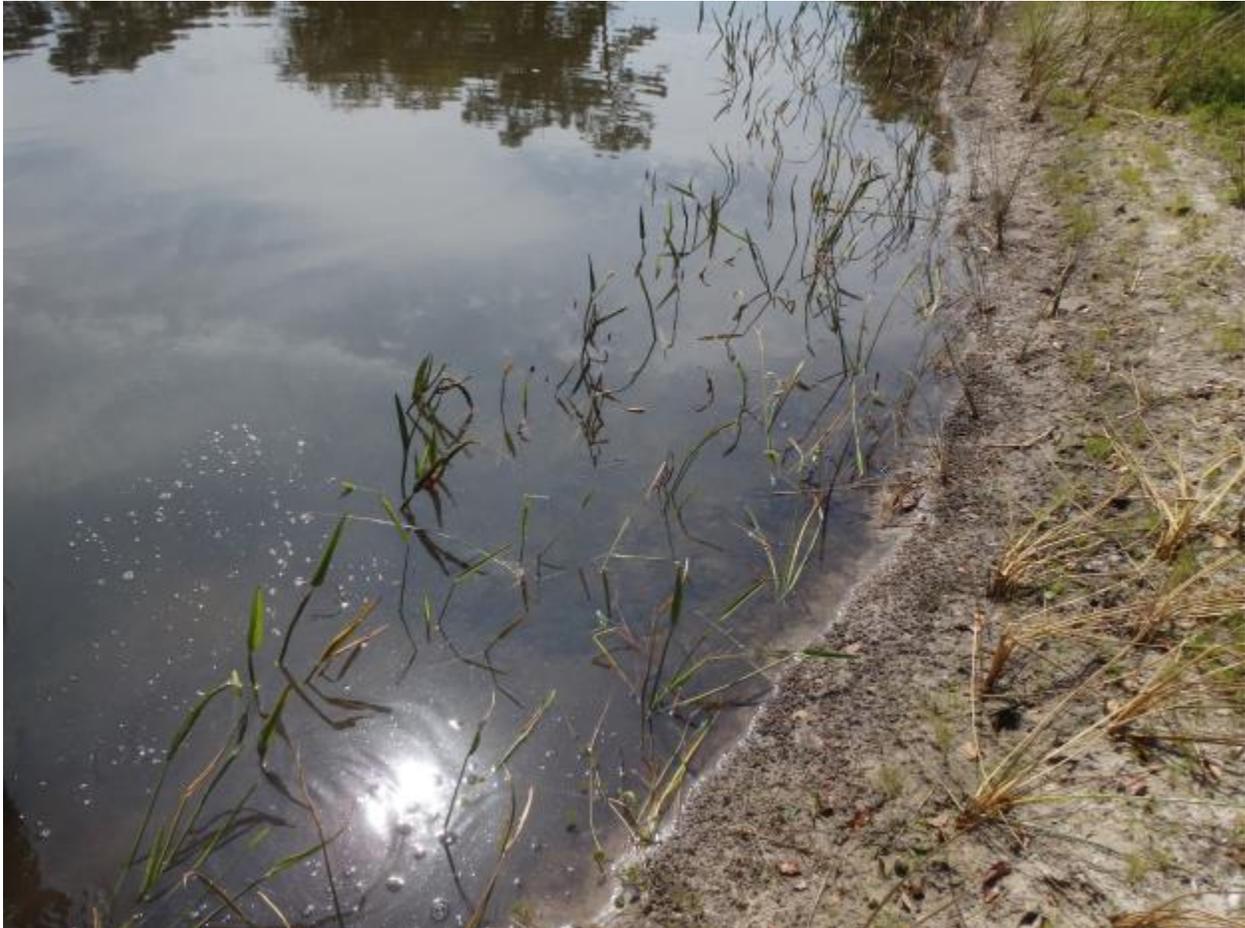
**Photo: Restoration site.**

The restoration zone was replanted in early April with duck potato, pickerelweed, soft rush, canna, and cord grass. The goal of this replanting was to identify which species will establish best in Buttonwood Pond.

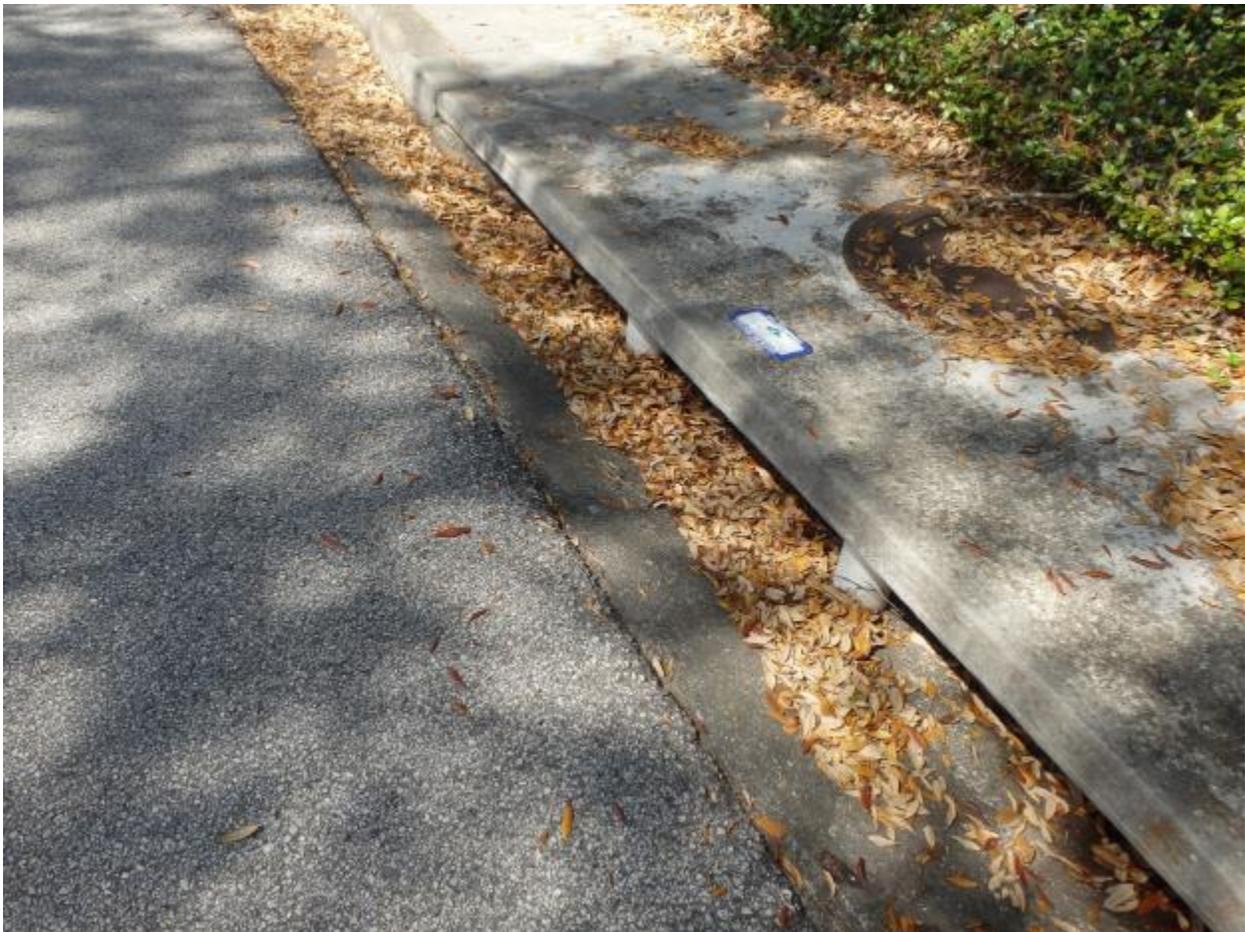
**Photo: Leaves in stormdrain.**

Leaf debris contains high levels of phosphorous that can negatively impact your waterbody. Consider increasing street sweeping services during times of peak leaf fall to ensure that this debris does not enter waterways.

- 2 Consider increasing street sweeping services during times of peak leaf fall to ensure that this debris does not enter waterways. Leaf debris contains high levels of phosphorous that can negatively impact your waterbody.

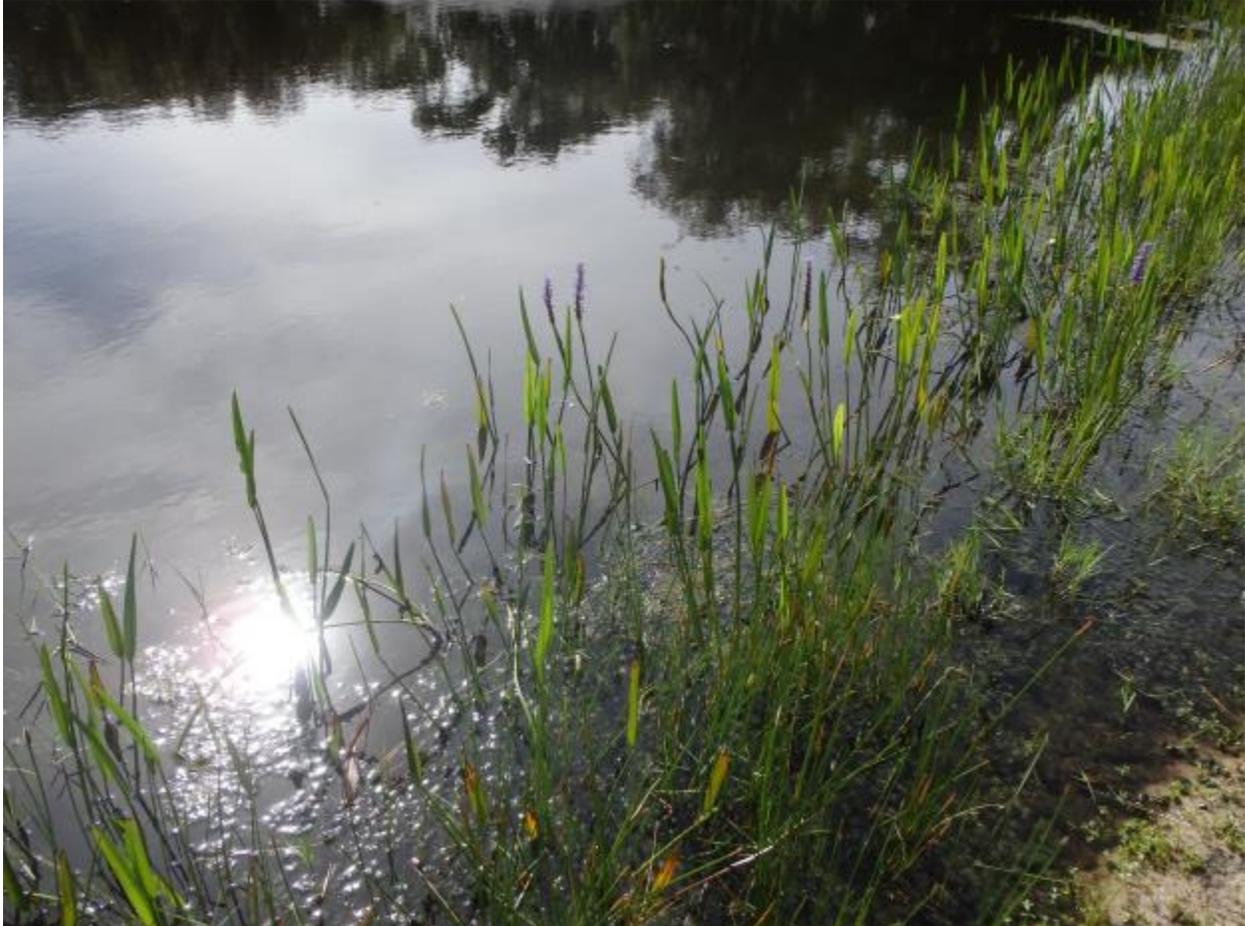
**Photo: Pickerelweed at the restoration site.**

In the restoration zone, pickerelweed and fire flag had established very well. Establishing emergent shoreline vegetation is beneficial to the pond by providing a buffer from yard runoff, protecting shorelines from erosion, and providing habitat for aquatic species.

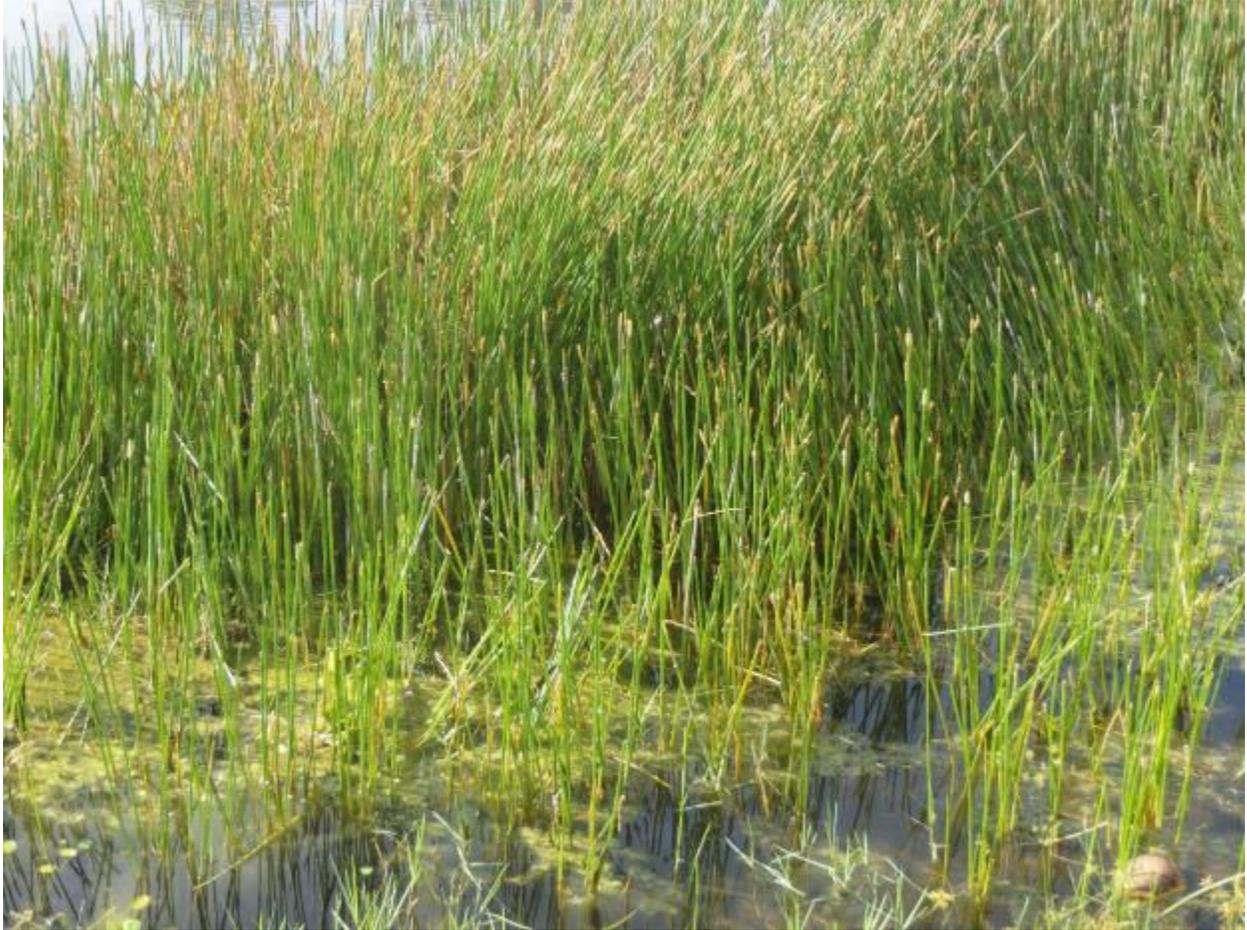
**Photo: Native spike rush.**

Native emergent vegetation found during the survey included: spikerush, soft rush, pickerelweed, duck potato, fire flag, and cordgrass. All native vegetation was found to be very healthy. Spike rush had expanded since the previous survey.

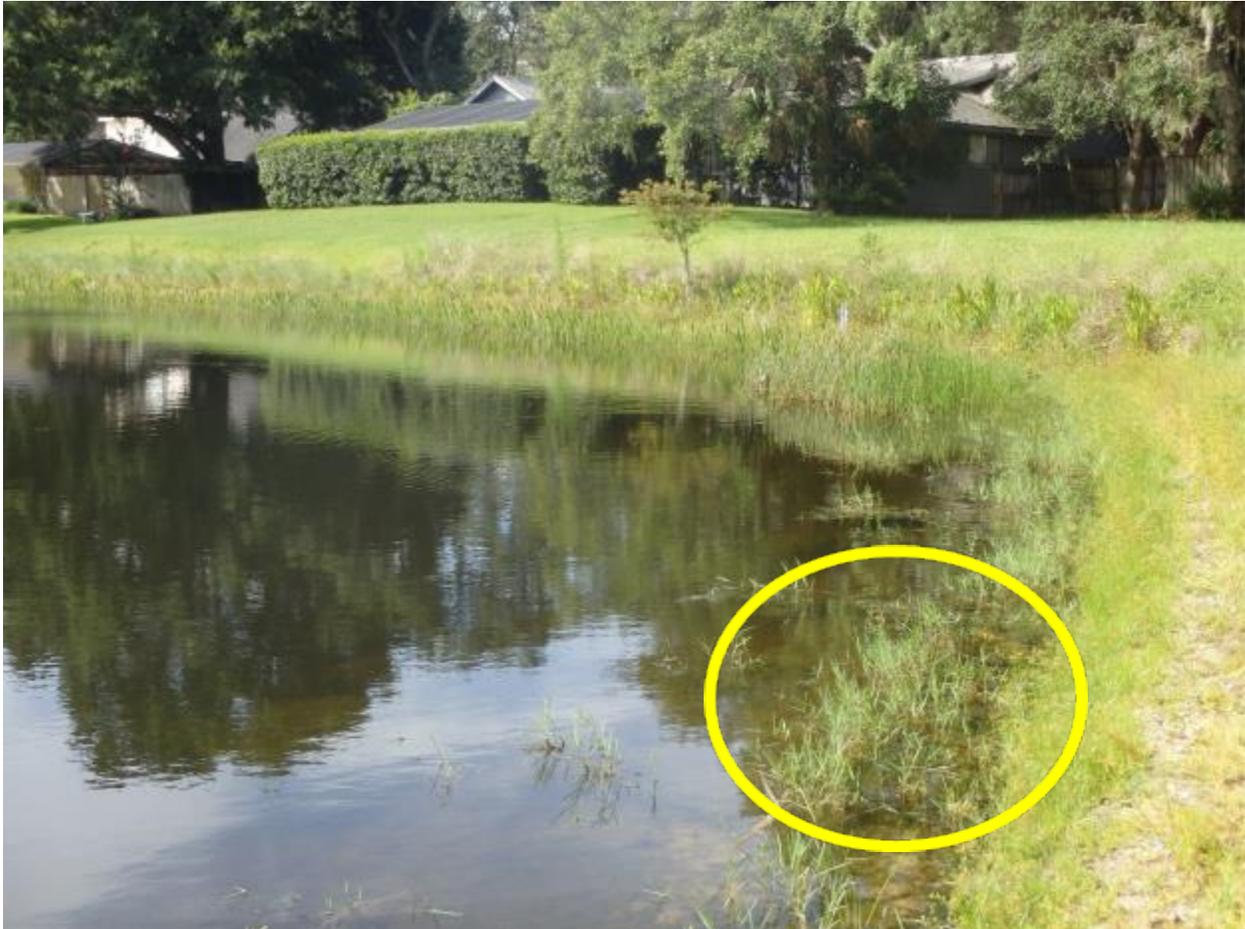
**Photo: Invasive torpedo grass.**

Invasive emergent vegetation included: alligator weed, and torpedo grass. The amount of torpedo grass was less than in the previous inspection.
