Greetings Horseshoe Lake North residents!

On **May 18th, 2016**, Seminole County Lake Management Program (SCLMP) personnel, Joey Cordell and Thomas Calhoun, surveyed the aquatic plants in **Horseshoe Lake North**.

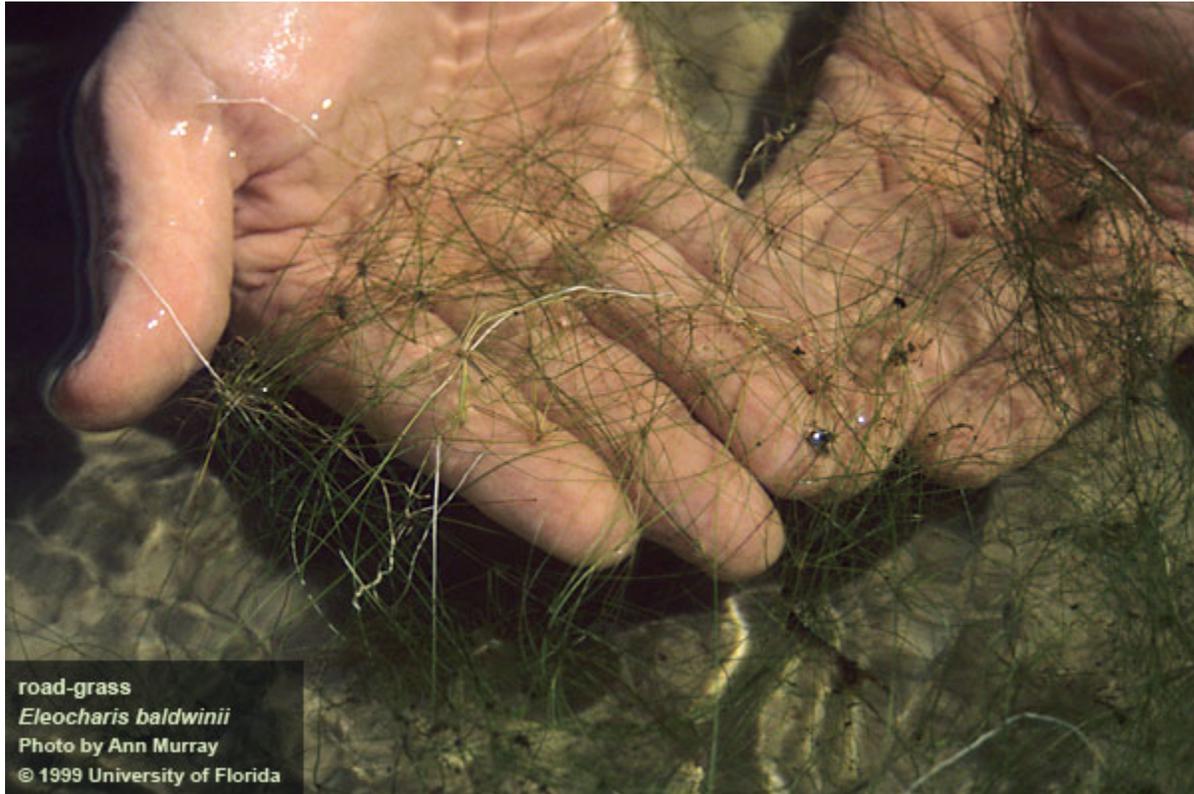
Native SAV found included: roadgrass to a depth of 2 feet.

Photo: Example of roadgrass.

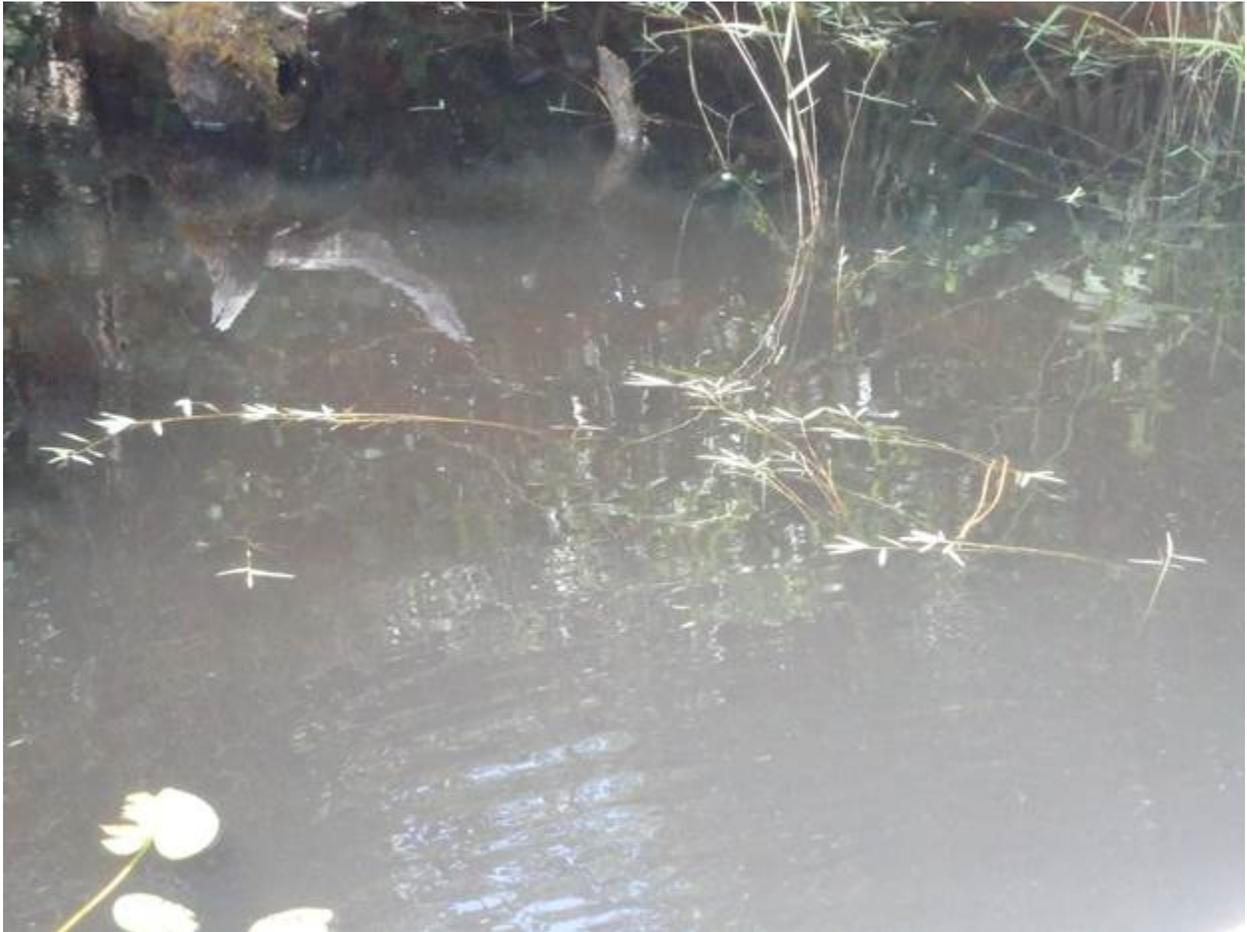
Native emergent vegetation including: buttonbush, sawgrass, southern water grass, spatterdock, maidencane, cup-scale grass, pickerelweed, duck potato, bulrush, fire flag, climbing aster and canna lily.

Photo: Native southern water grass.

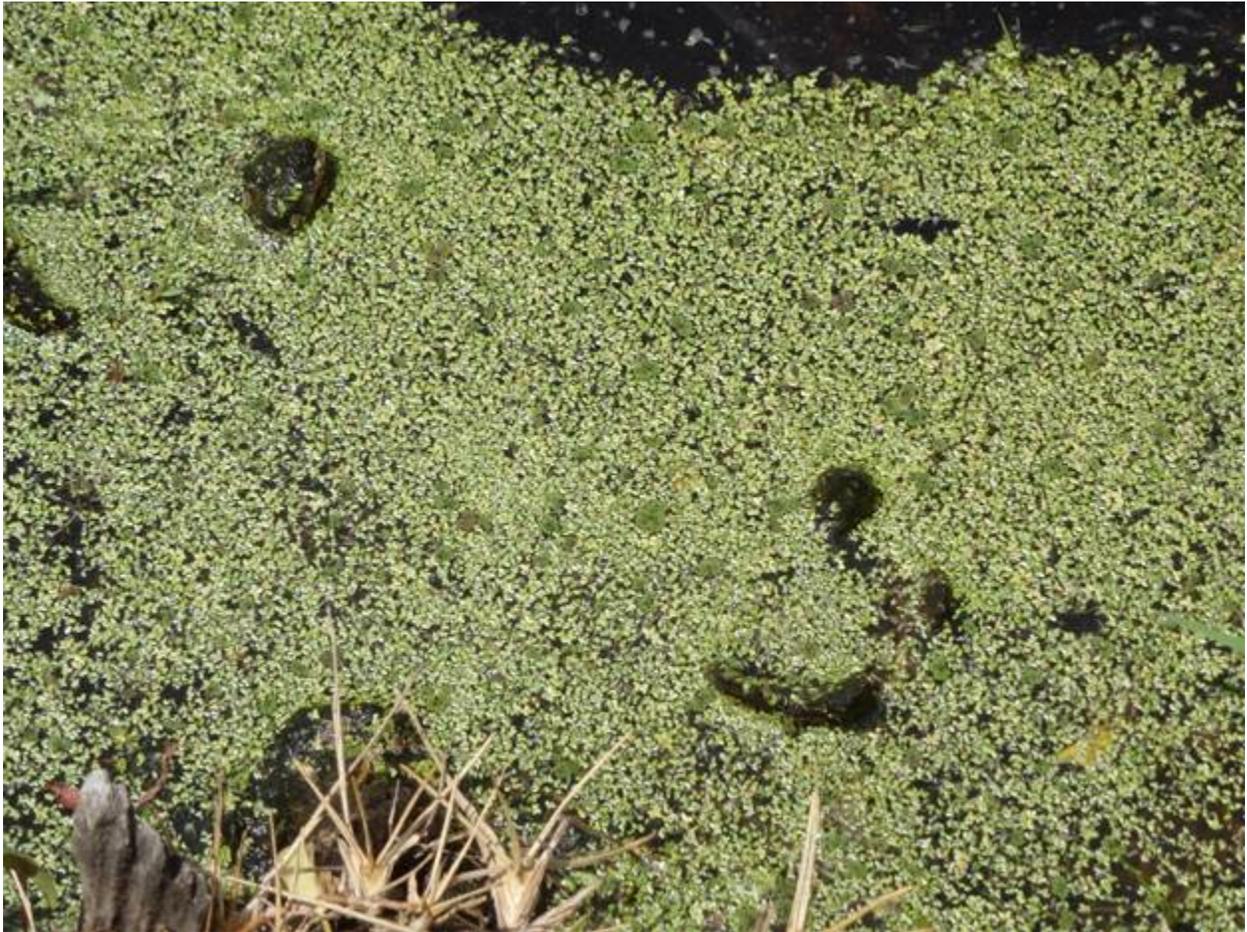
The canal was also inspected and was in great condition.

Photo: Duckweed and salvinia found in the canal.

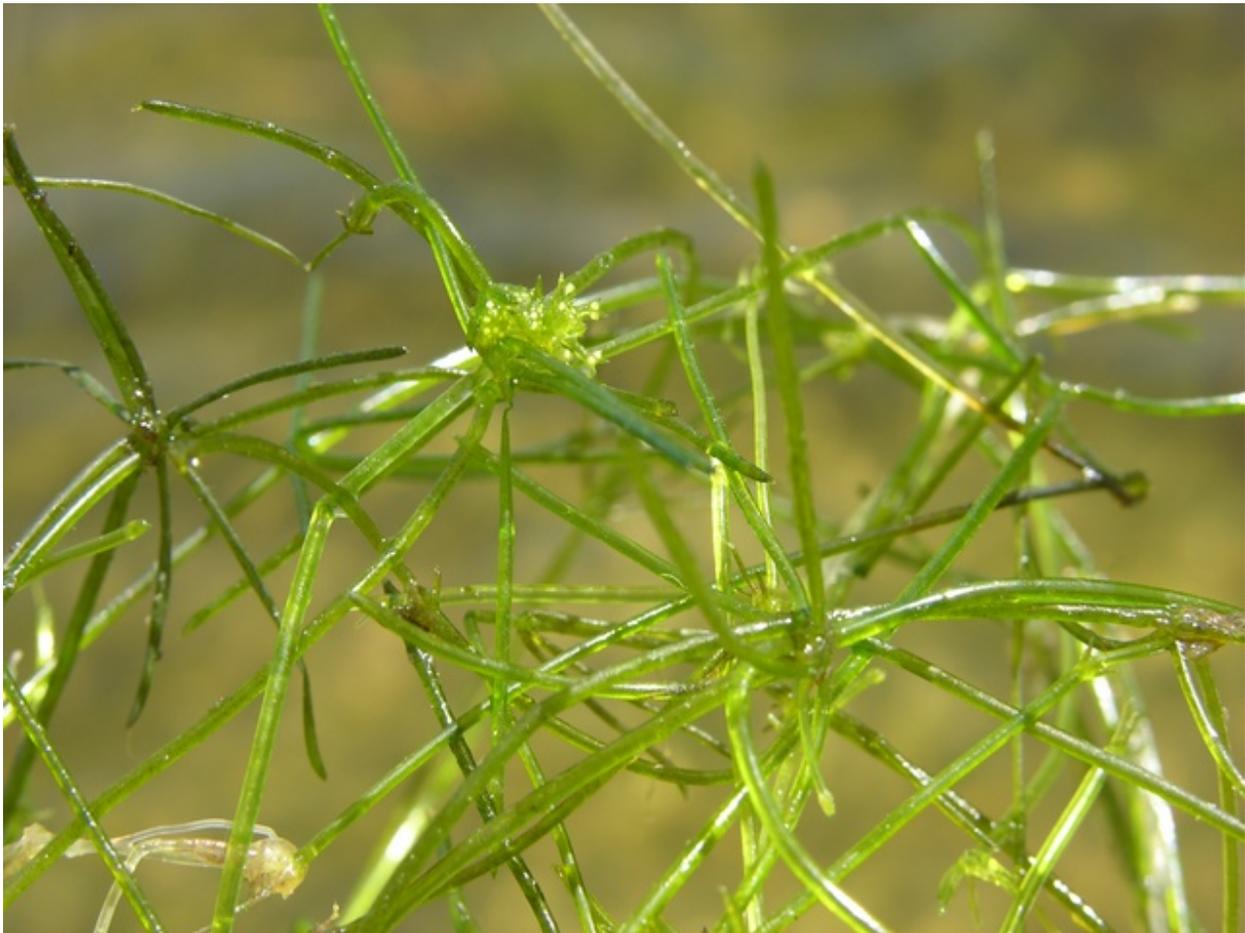
Native SAV found included: roadgrass and stonewort. Both species were found in low quantities.

Photo: Example of stonewort.

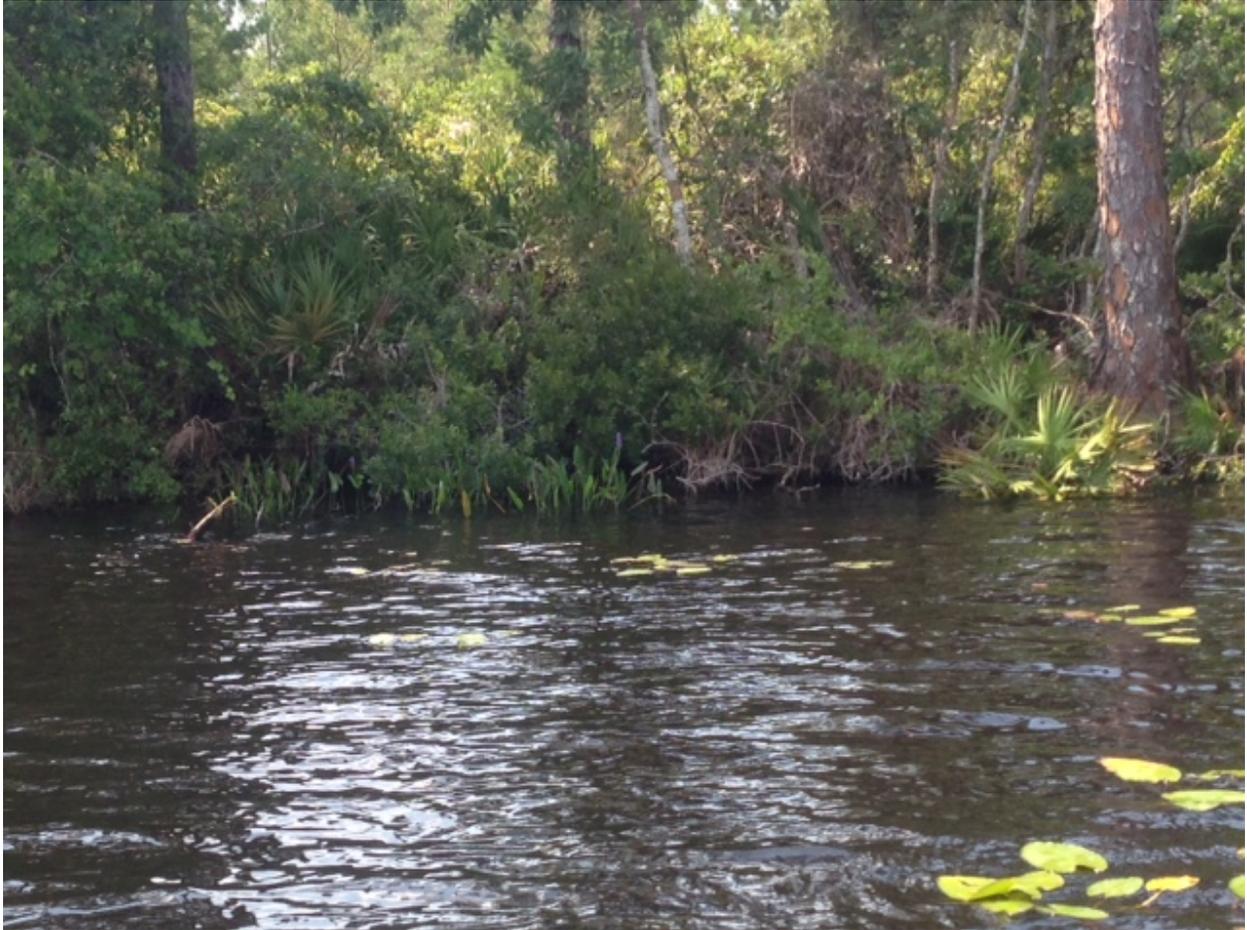
Photo: Pickerelweed.

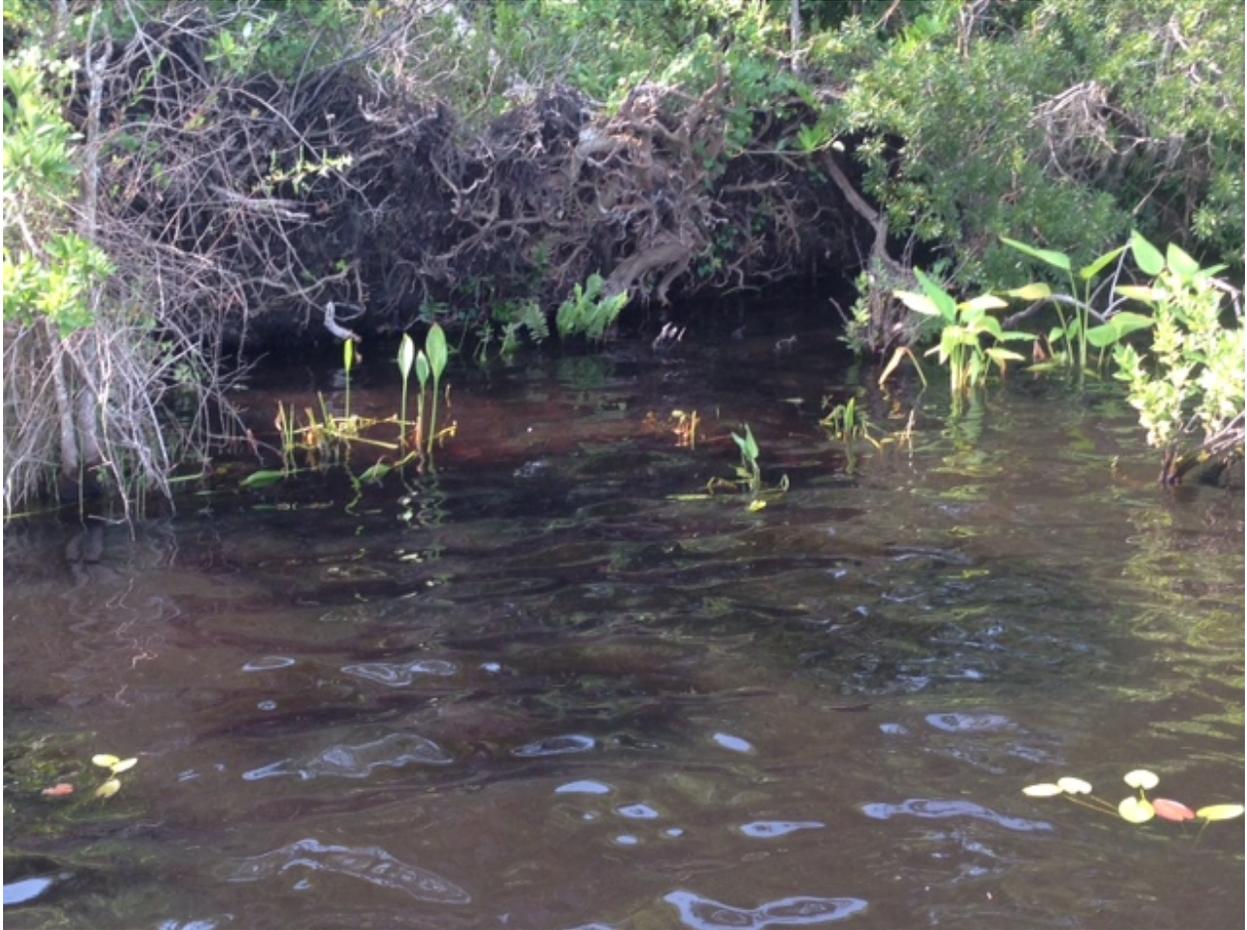
On June 6th, lake residents and volunteers came out to help Seminole County's SERV program plant native vegetation along the shoreline of North Horseshoe Lake. Those species planted included: duck potato, pickerelweed, sawgrass, arrow head, canna, and fire flag. Having a healthy population of shoreline vegetation filters runoff pollutants, protects against erosion, and provides habitat for the wildlife.

Photo: SERV planting site.

not survive from the previous planting session, the planting of native species should continue until successful establishment is achieved. SCLMP recommends planting in new locations that are shallower and have more sunlight.

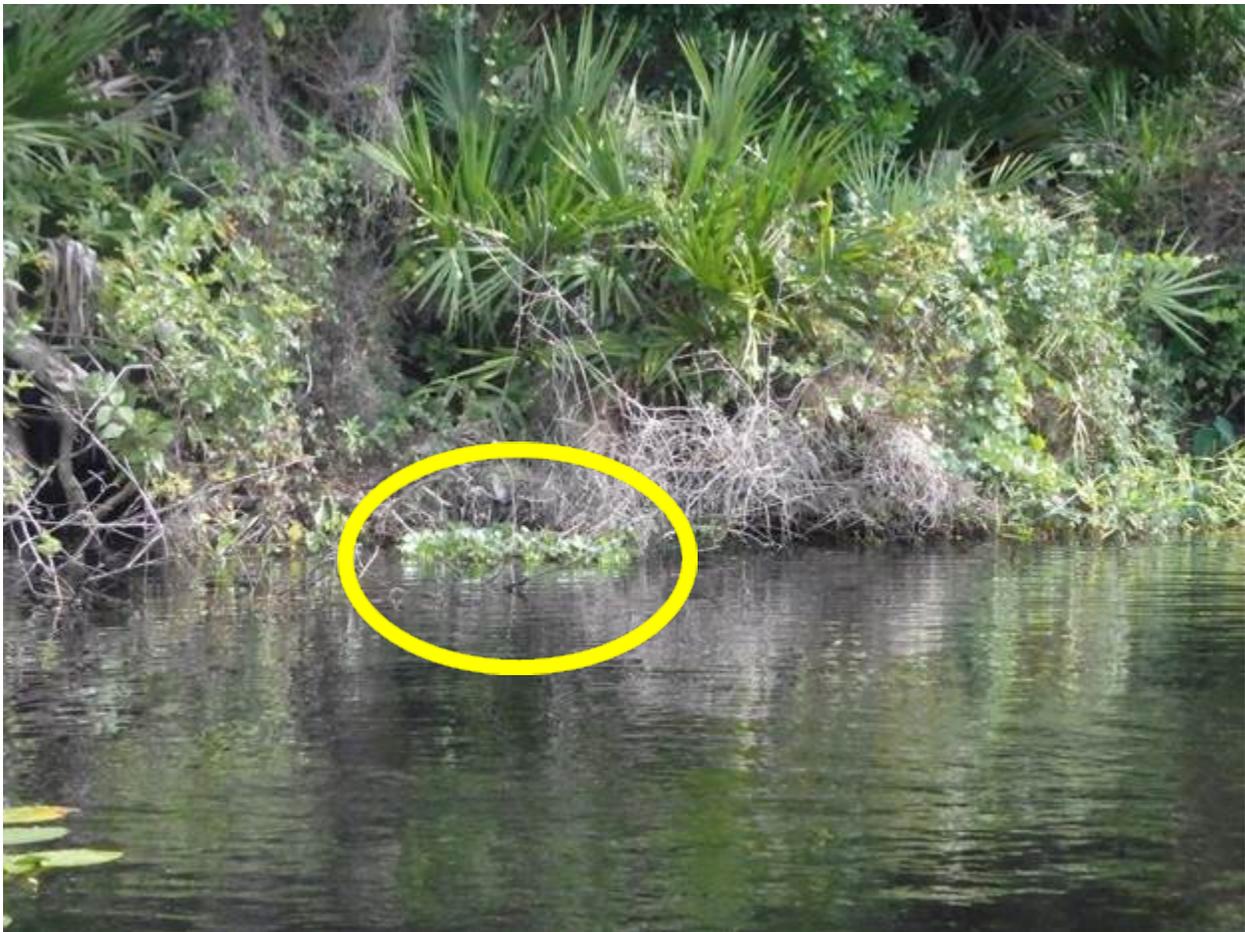
Invasive emergent species included: alligator weed, wild taro, primrose willow, bur-head sedge and torpedo grass. Torpedo grass and alligator weed were noted as increasing since the last inspection. Small patches of water hyacinth were observed in several areas around the lake.

Photo: Pocket of Water Hyacinth.

Routine herbicide treatments will resume at the end of July. This treatment will focus on small pockets of water hyacinth, alligator weed, torpedo grass and the canal area.

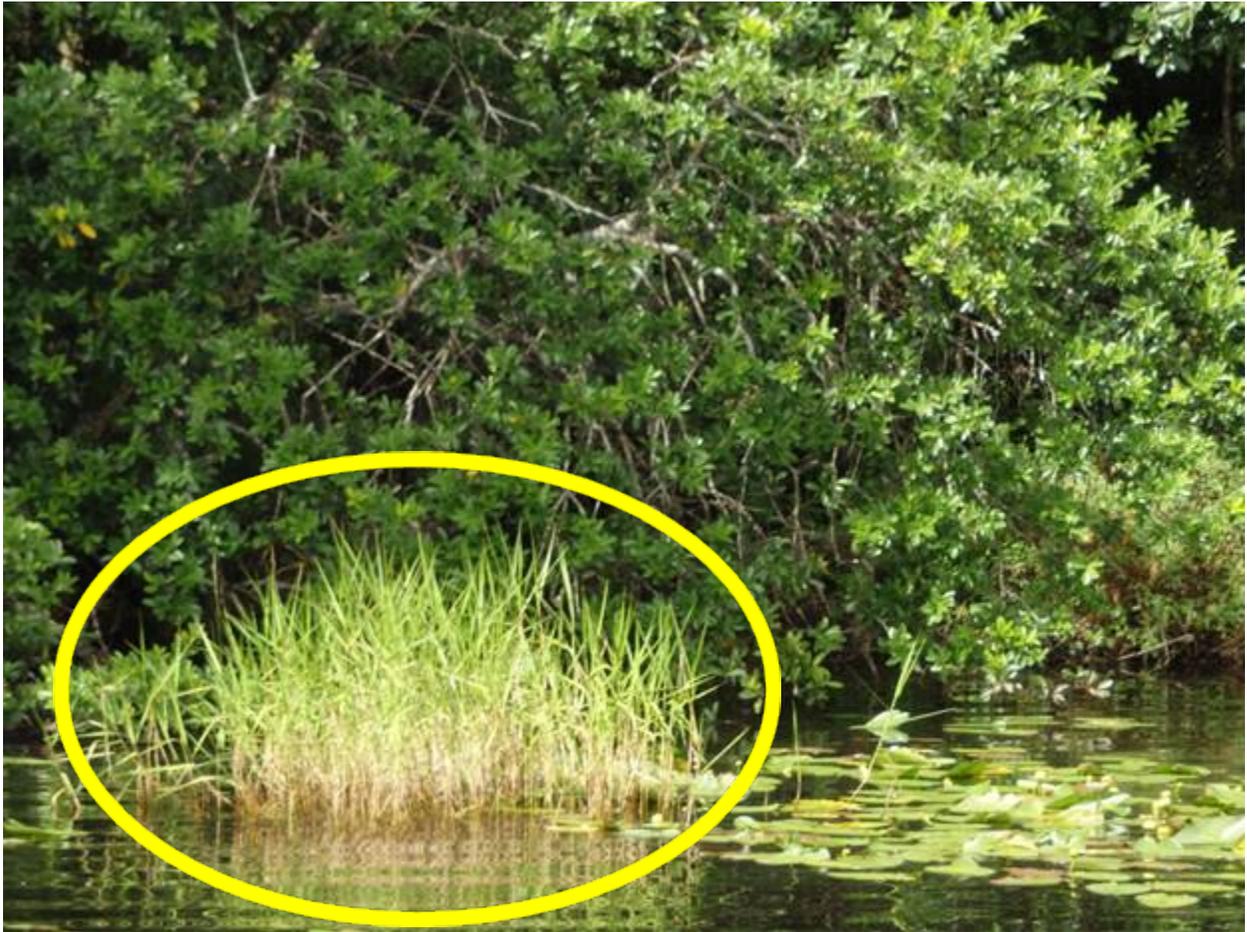
Photo: Maidencane.

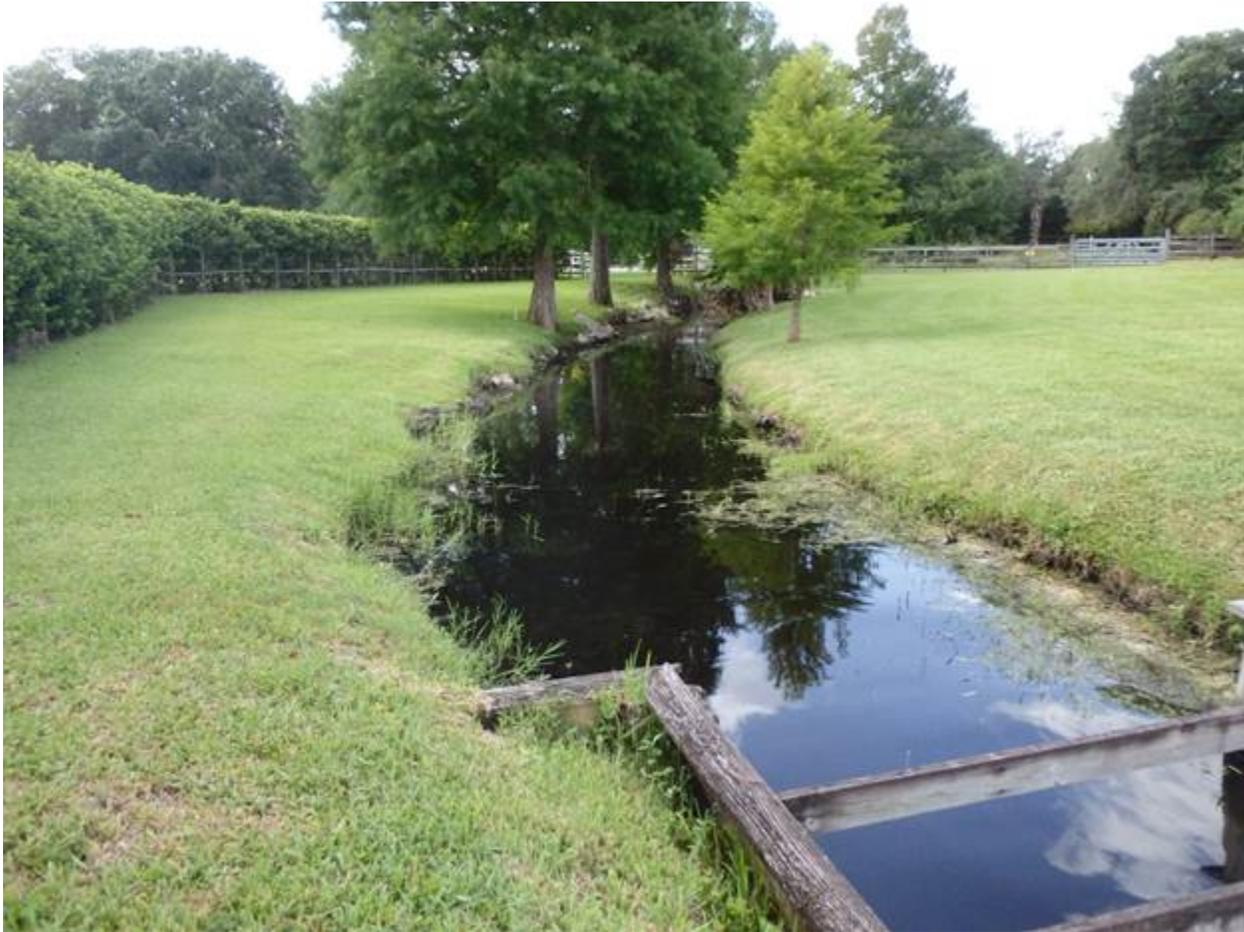
The canal was also inspected and found in good condition. A small amount of alligator weed and torpedo grass was found at the mouth of the canal. One sprig of hydrilla was found next to the culvert at the end of the canal.

Photo: Canal.
