**LAKE OF THE WOODS**  
**BIOASSESSMENT/INSPECTION REPORT**  
**December 2014 and March 2015**

On **March 3<sup>rd</sup>, 2015**, Seminole County Lake Management Program (SCLMP) staff, Thomas Calhoun and Gloria Eby, surveyed the aquatic plants in **Lake of the Woods**.

On **December 1<sup>st</sup>, 2014**, Seminole County Lake Management Program (SCLMP) staff, Thomas Calhoun and Joey Cordell, surveyed the aquatic plants in **Lake of the Woods**.

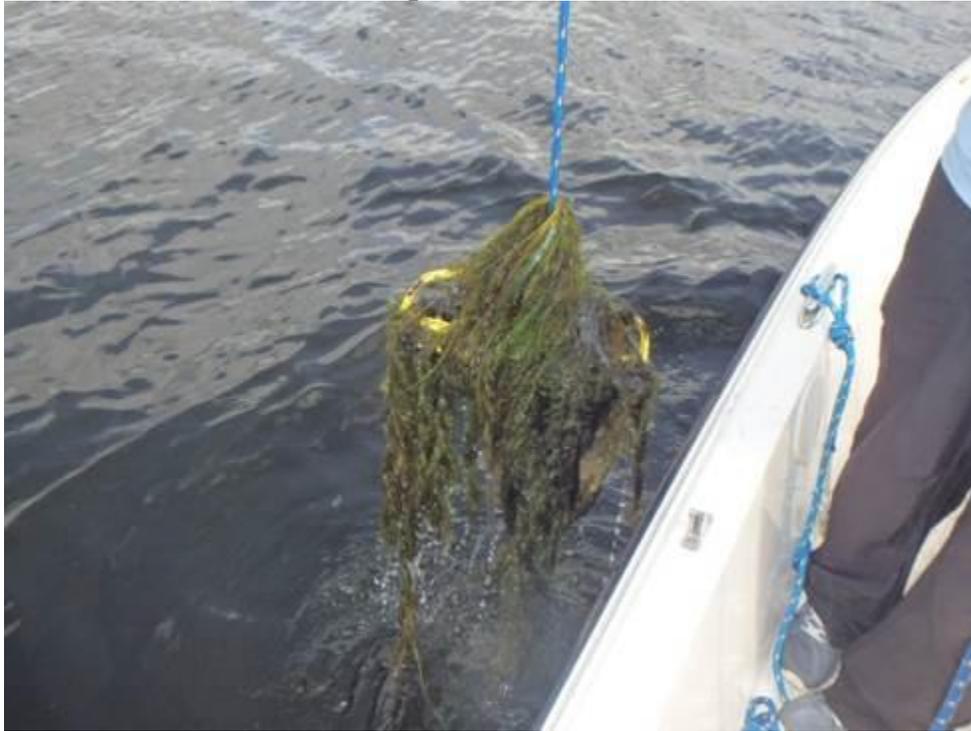
Native SAV was very healthy and was expanding around the lake. Native species found during the inspection included coontail to 9 ft, southern naiad to 3 ft, and eelgrass to 8 ft. Eelgrass blooms were abundant, and in some places appeared like an algae bloom was occurring. The beneficial native coontail has expanded significantly since the previous inspection.

**Photo: Coontail found to a depth of 9 feet.**

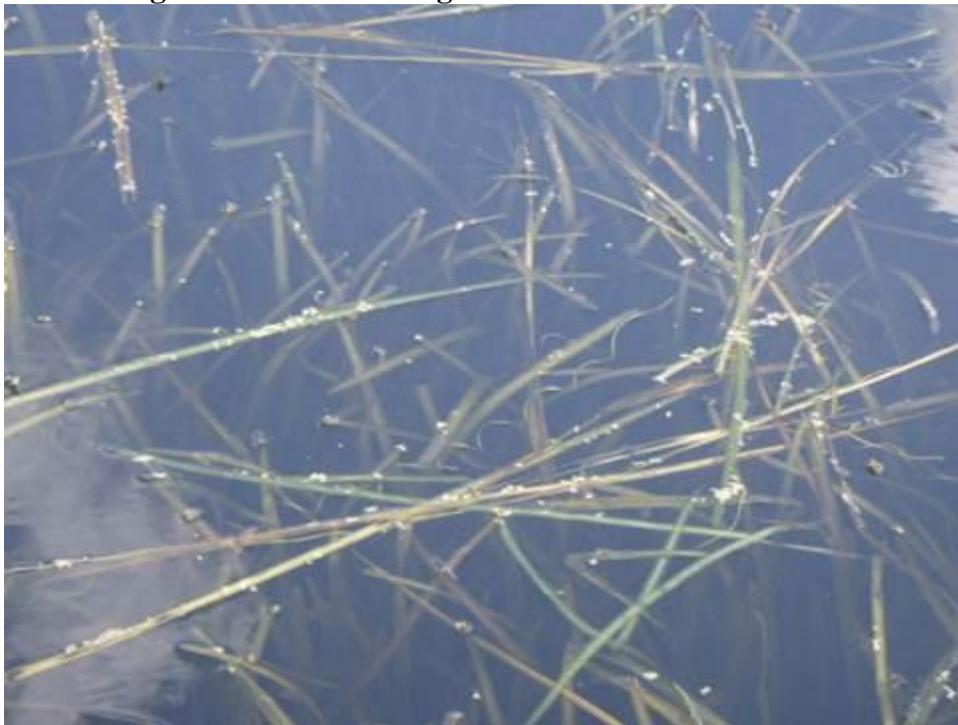
**Photo: Eelgrass blooms reaching the surface.**

We found many boat docks with restricted access due to topped out eelgrass. As previously mentioned, if SAV is blocking access to your boat dock you can apply for an aquatic plant removal permit through the Florida Wildlife Conservation Commission

<http://www.myfwc.com/license/aquatic-plants> or contact FWC regional biologist Kris Campbell at [Kristine.Campbell@MyFWC.com](mailto:Kristine.Campbell@MyFWC.com) or 321-246-0682 to obtain your free permit.

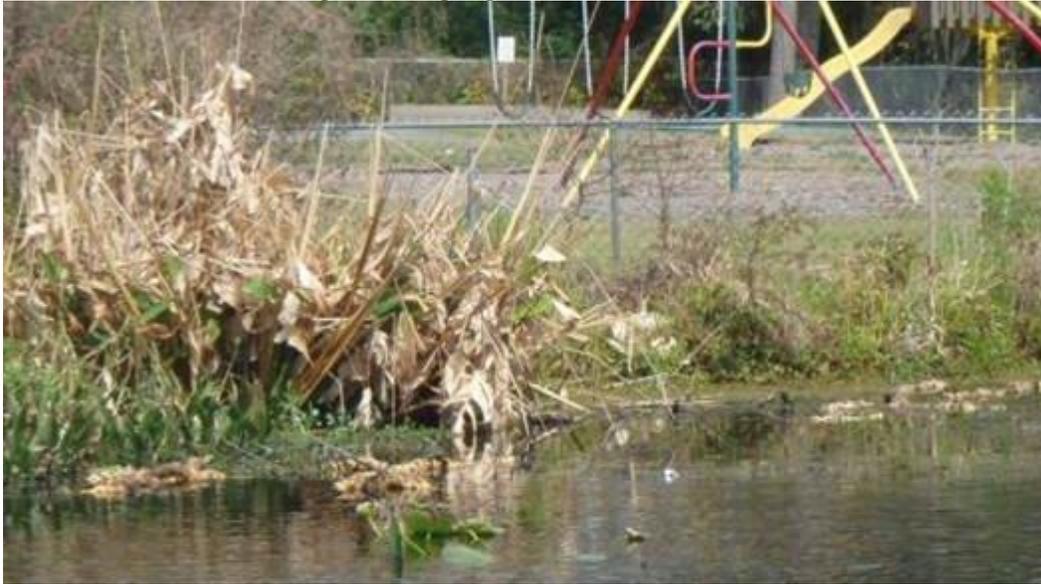
Some of the native emergent vegetation including pickerelweed and fire flag was still showing signs of winter die back. It is expected that these species will recover and continue to expand along with duck potato, canna, and maidencane in the coming months. Invasive emergent vegetation observed included: alligatorweed, dwarf papyrus, elephant ear, and torpedo grass. The northern canal was treated for lily pads and was found clear of vegetation. Torpedo grass remains to be minimal throughout the lake.

**Photo: Stand of fire flag showing signs of winter die back.**

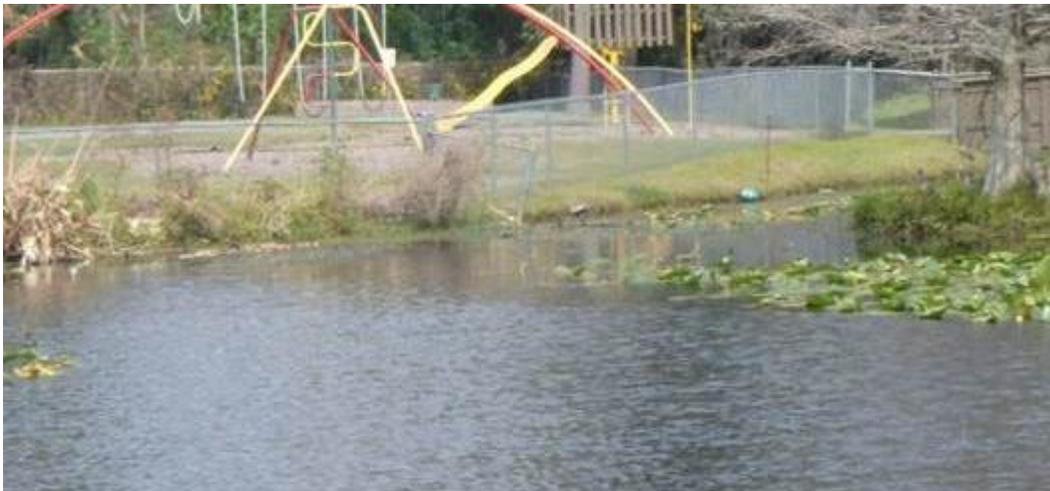
**Photo: Treated canal on northern shoreline.**

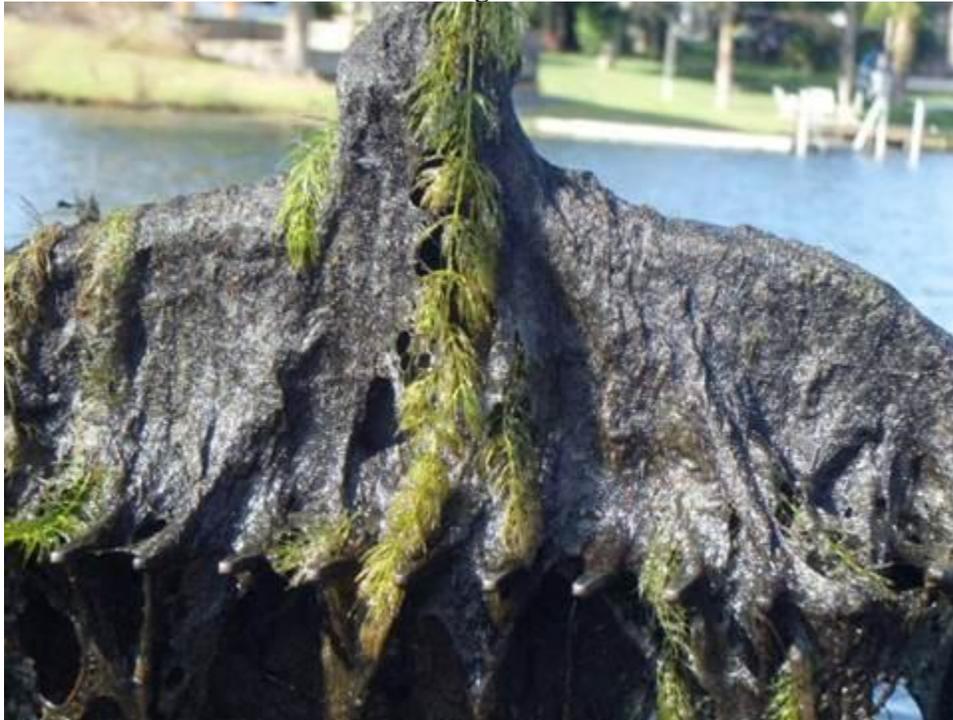
Native SAV was very healthy and was expanding around the lake. This beneficial vegetation continues to compete for space with hydrilla. Native species found during the inspection included coontail to 9 ft, southern naiad to 1 ft, and eelgrass to 8 ft. Algae was present, intermixed with the native coontail. We found many boat docks with restricted access due to topped out eelgrass. As previously mentioned, if SAV is blocking access to your boat dock you can apply for an aquatic plant removal permit through the Florida Wildlife Conservation Commission <http://www.myfwc.com/license/aquatic-plants> or contact FWC regional biologist Kris Campbell at [Kristine.Campbell@MyFWC.com](mailto:Kristine.Campbell@MyFWC.com) or 321-246-0682 to obtain your free permit.

**Photo: Coontail and filamentous algae.**

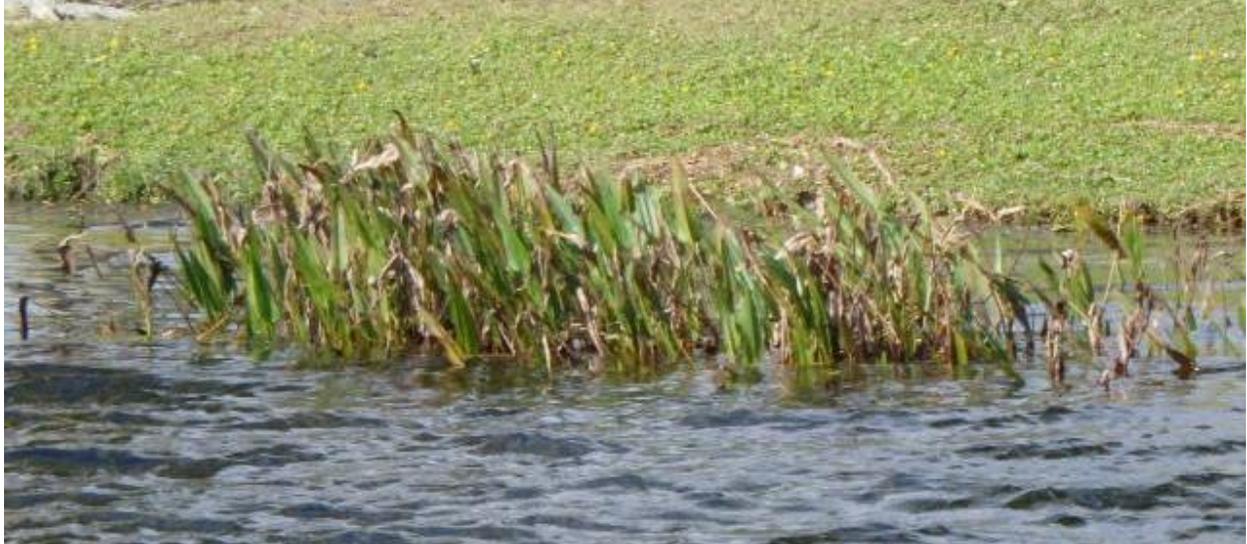
Native emergent vegetation observed during the survey included: canna, pennywort, yellow cow lily, fragrant water lily, maidencane, pickerelweed, duck potato, Carolina willow, bulrush, fireflag, blue flag iris, and creeping aster. Many native plants can experience a “winter die back” when affected by the colder weather and limited sunlight. Maidencane and pickerelweed both

showed a reduction due to the season. Invasive emergent vegetation observed included: alligatorweed, elephant ear, umbrella grass, primrose, cattail, papyrus, and torpedo grass.

**Photo: Pickerelweed with winter impact.**

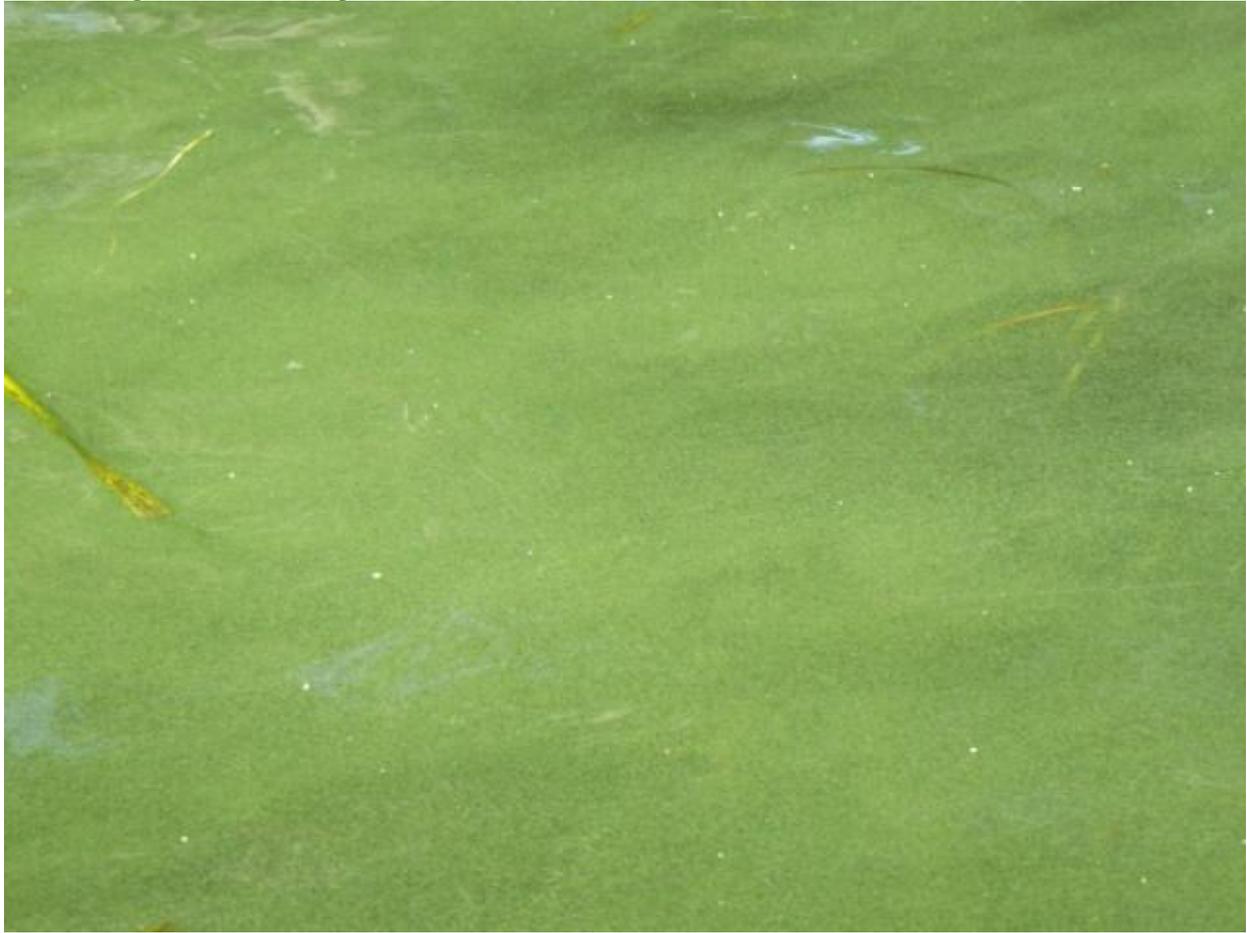
A blue-green algae bloom was observed along the southwest shoreline of the lake. Large algae blooms can deplete the lake's dissolved oxygen levels, which can cause a fish kill. Algae blooms are caused by high levels of phosphorus. The most common sources for excess phosphorus are fertilizer runoff and yard clippings. To help prevent algae blooms, residents can reduce overall fertilizer use, only use phosphorus-free slow release nitrogen fertilizer brands when fertilizers are needed, and prevent yard clippings from falling in the lake.

**Photo: Algae bloom along west shore.**

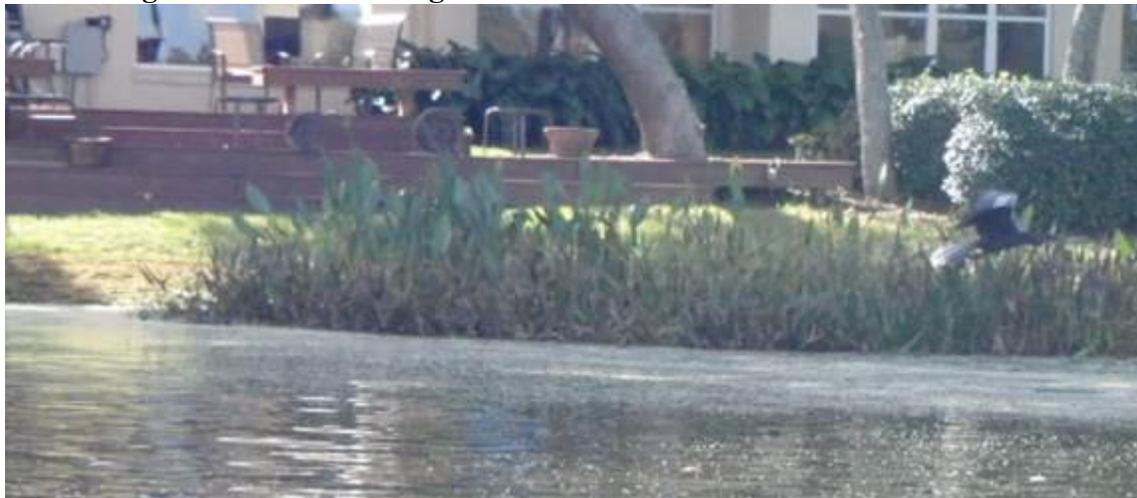
**Photo: Eelgrass blooms reaching the lake's surface.**
