LAKE OF THE WOODS
BIOASSESSMENT/INSPECTION REPORT
March through May 2015

Bioassessment

On **March 3rd, 2015**, Seminole County Lake Management Program (SCLMP) staff, Thomas Calhoun and Gloria Eby, surveyed the aquatic plants in **Lake of the Woods**.

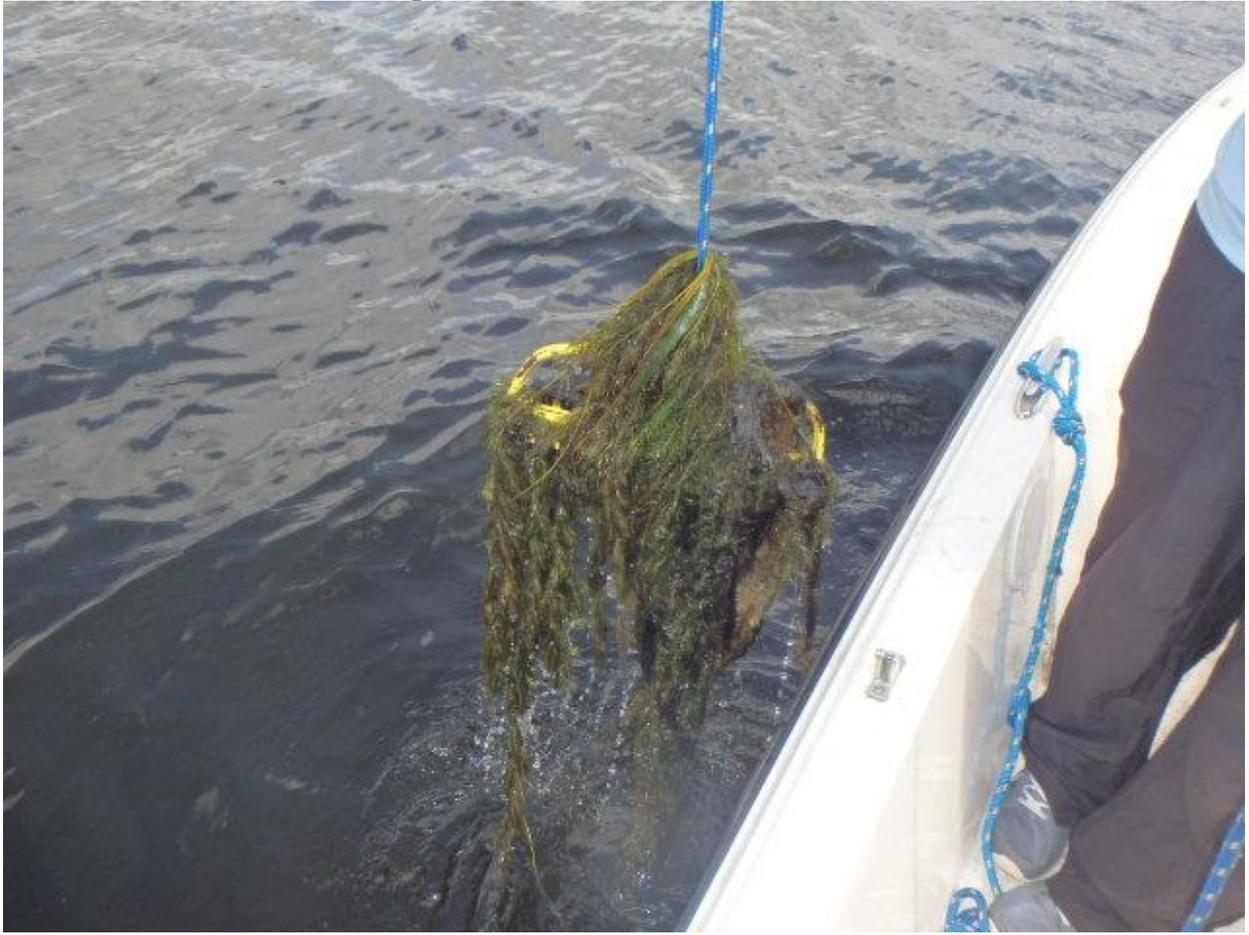
Native SAV was very healthy and was expanding around the lake. Native species found during the inspection included coontail to 9 ft, southern naiad to 3 ft, and eelgrass to 8 ft. Eelgrass blooms were abundant and in some places looked like an algae bloom. The beneficial native coontail has expanded significantly since the previous inspection.

Photo: Coontail found to a depth of 9 feet.

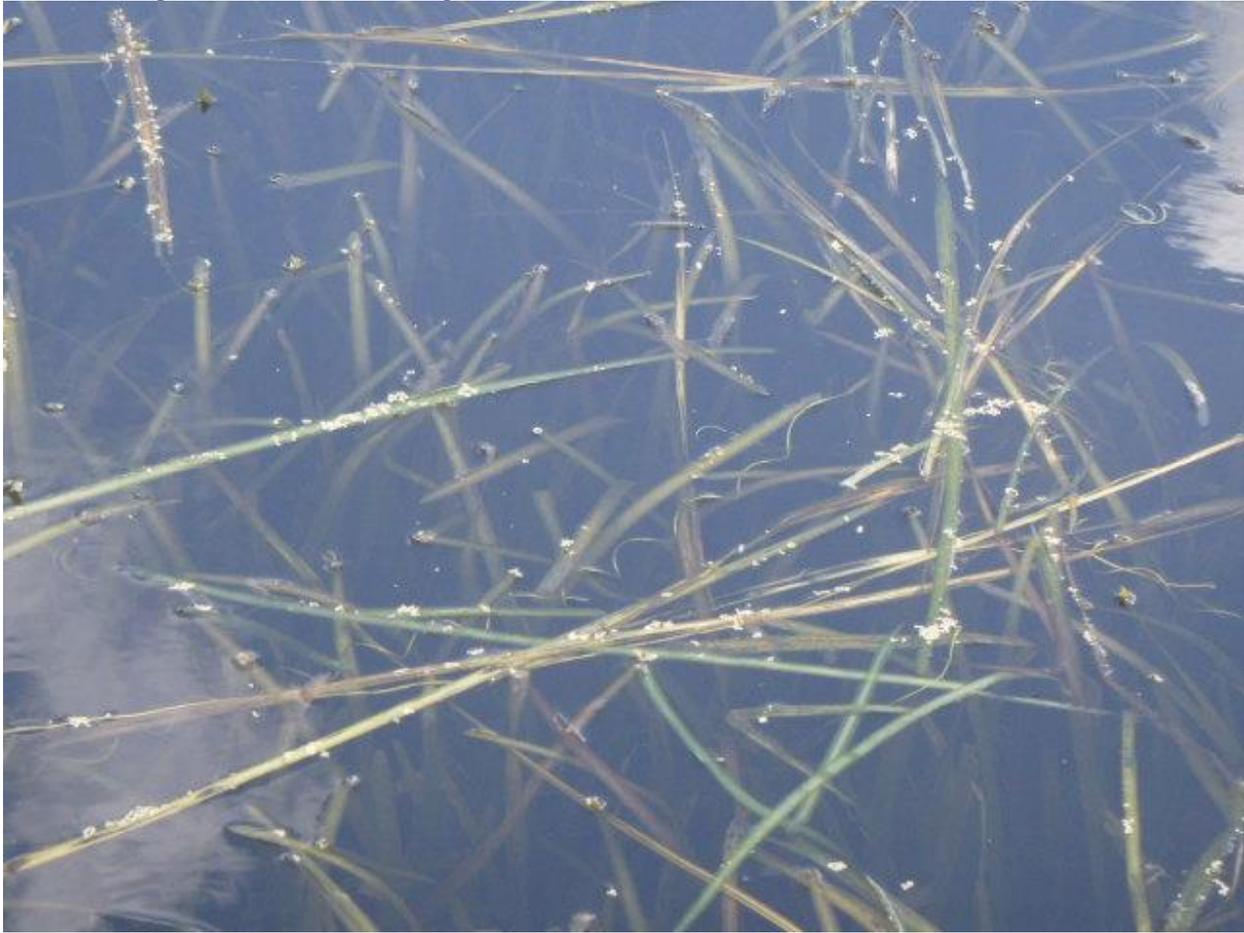
Photo: Eelgrass blooms reaching the surface.

We found many boat docks with restricted access due to topped out eelgrass. As previously mentioned, if SAV is blocking access to your boat dock you can apply for an aquatic plant removal permit through the Florida Wildlife Conservation Commission <http://www.myfwc.com/license/aquatic-plants>. Or contact FWC regional biologist Kristine.Campbell@MyFWC.com at 407-858-6170 to obtain your free permit.

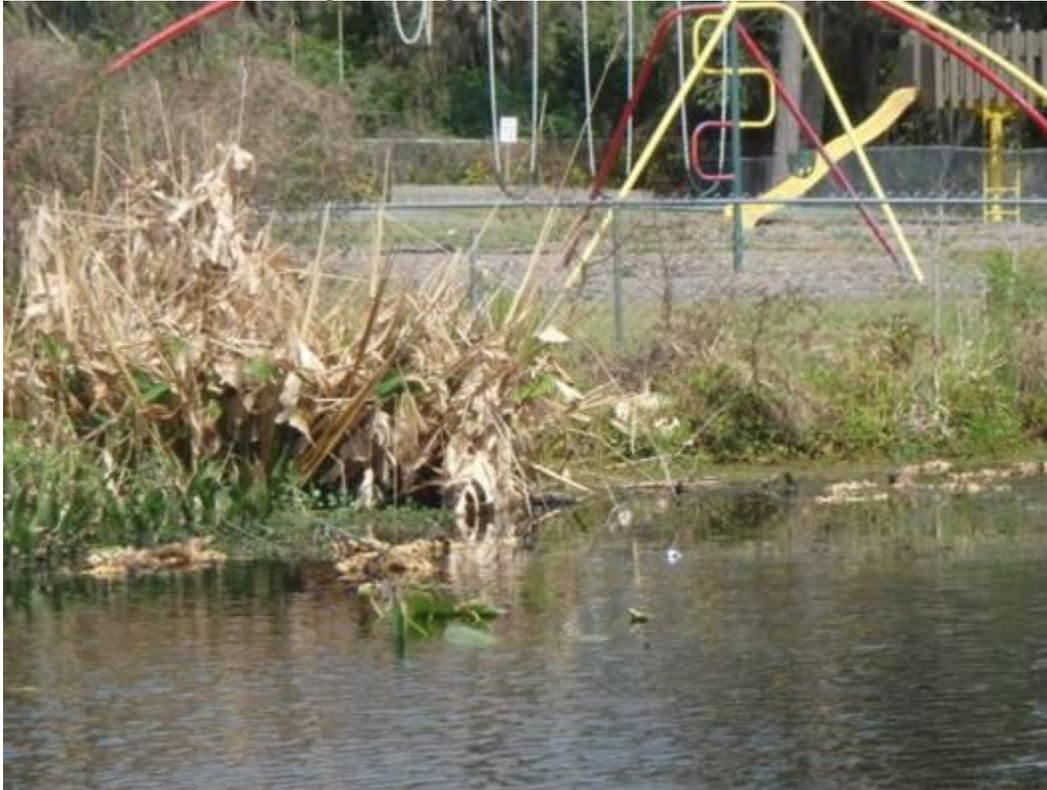
Some of the native emergent vegetation including pickerelweed and fire flag was still showing signs of winter die back. It is expected that these species will recover and continue to expand along with duck potato, canna and maidencane in the coming months. Invasive emergent vegetation observed included: alligator weed, dwarf papyrus elephant ear and torpedo grass. The northern canal was treated for lily pads and was found clear of vegetation. Torpedo grass remains to be minimal within the lake.

Photo: Stand of fire flag showing signs of winter die back.

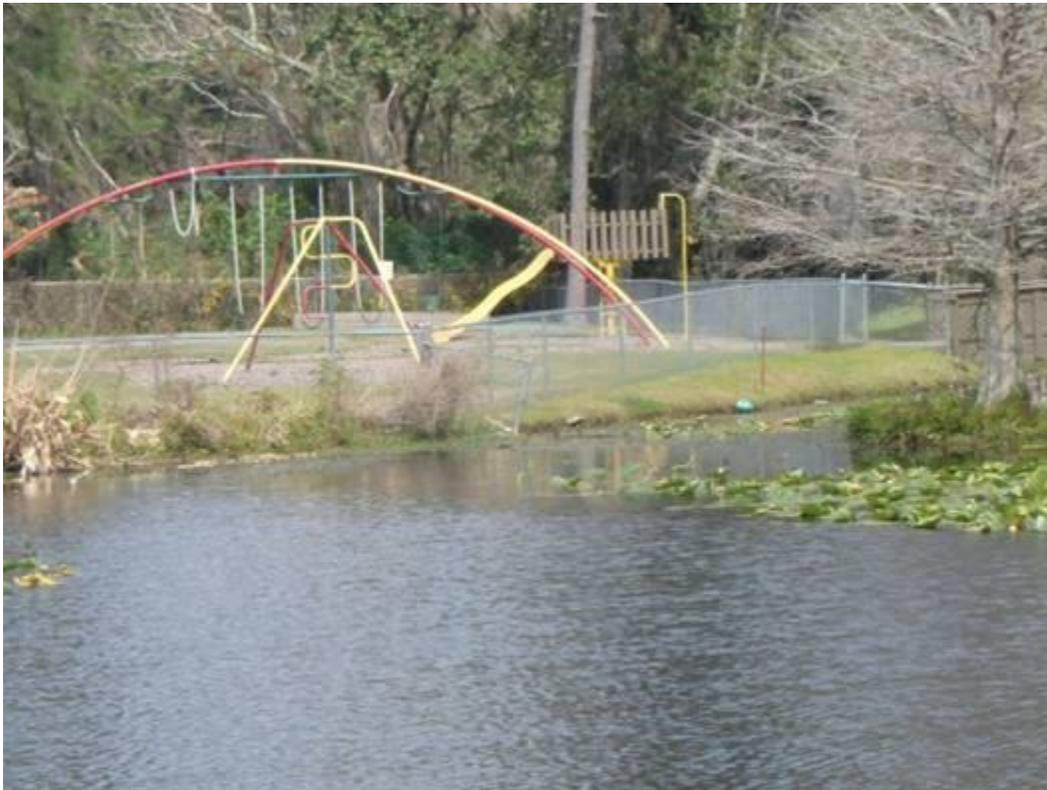
Photo: Treated canal on northern shoreline.

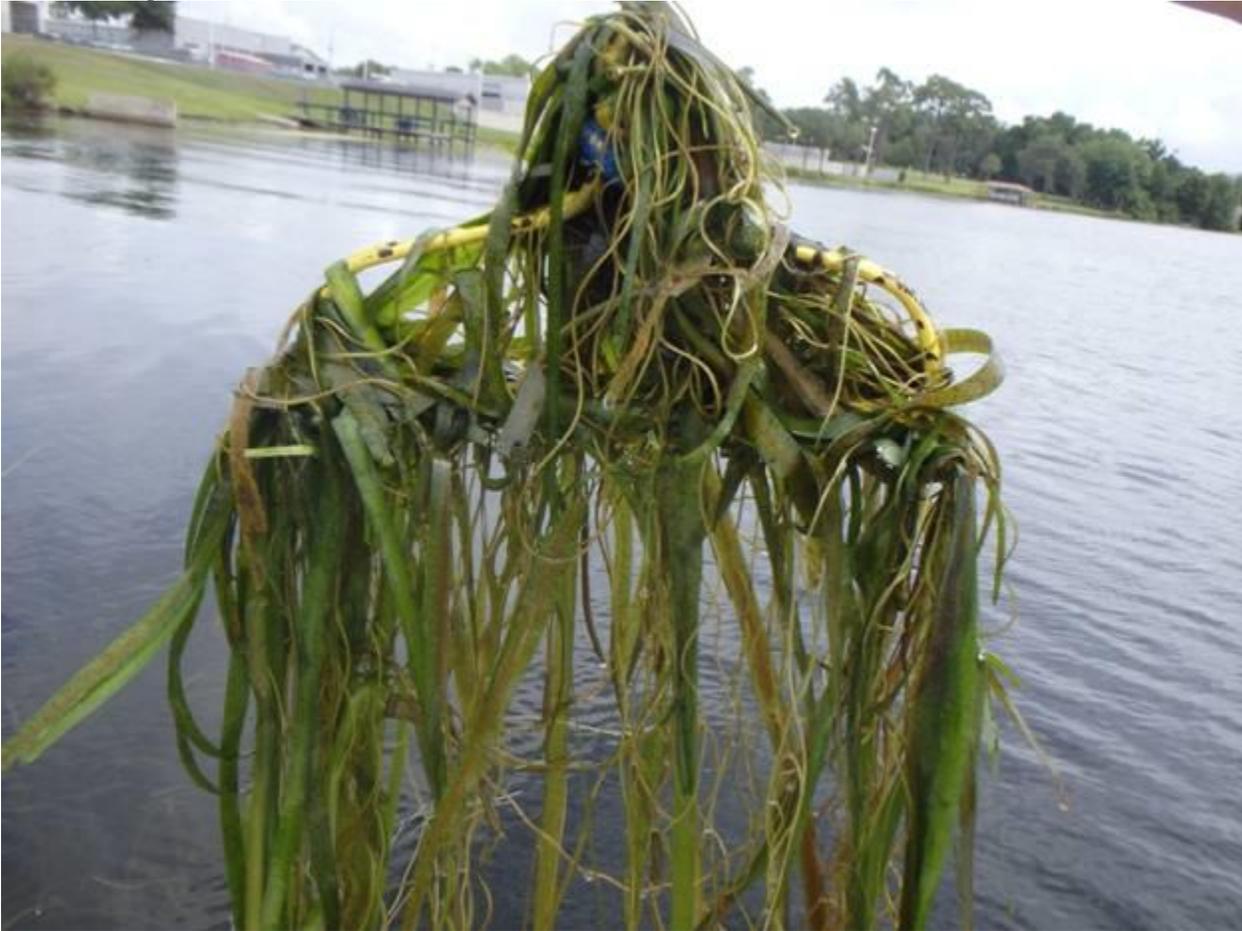
Native SAV was very healthy and was expanding around the lake. This beneficial vegetation continues to compete for space with hydrilla. Native submersed species found during the inspection included bladderwort, southern naiad to 3 ft, coontail to 8 ft, and eelgrass to 8 ft. Eelgrass was the dominant SAV species observed. We found many boat docks with restricted access due to topped out eelgrass. As previously mentioned, if SAV is blocking access to your boat dock you can apply for an aquatic plant removal permit through the Florida Wildlife Conservation Commission <http://www.myfwc.com/license/aquatic-plants>. Or contact FWC regional biologist, Kristine Campbell, at 407-858-6170 to obtain your free permit.

Photo: Eelgrass

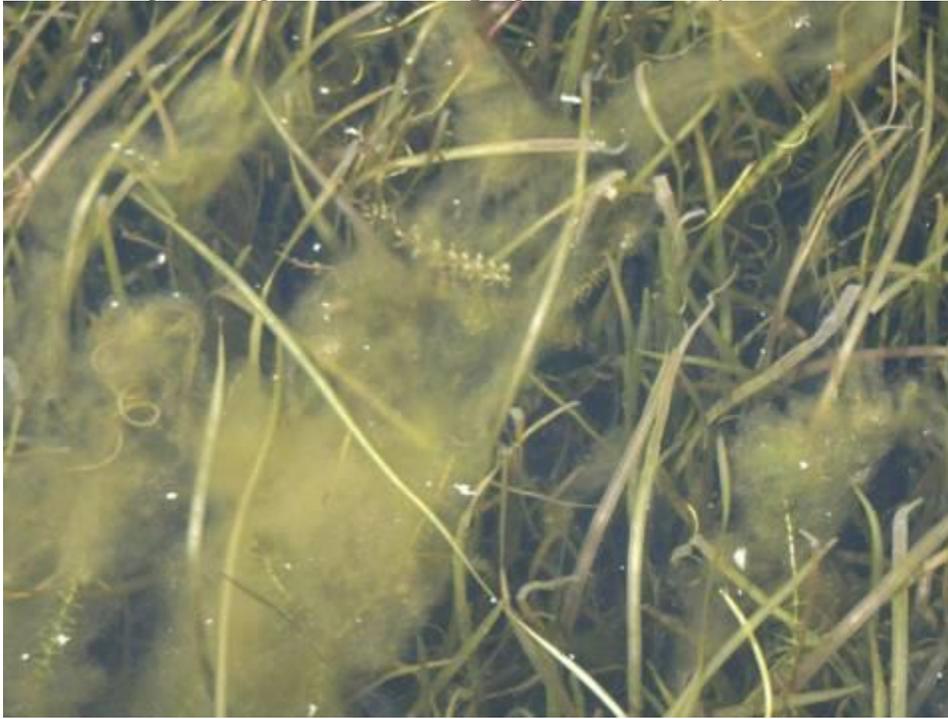
A few sprigs of hydrilla were found during the inspection near the boat ramp and dock. This species will continue to be closely monitored to see if further treatment is needed.

Photo: Eelgrass, algae, and a few sprigs of invasive hydrilla

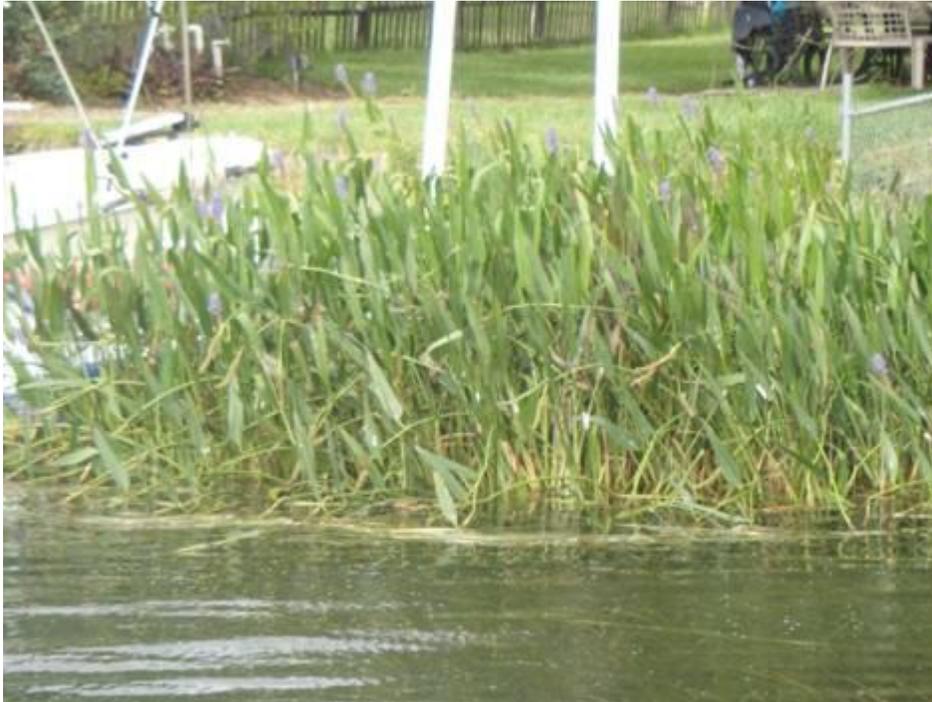
Photo: Pickerelweed (Native)

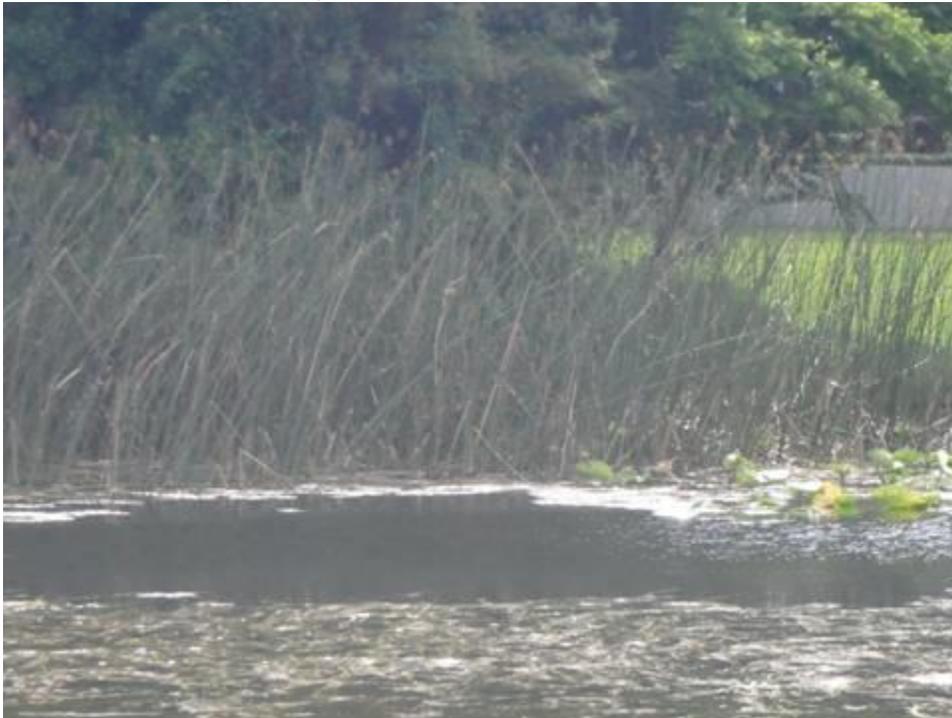
Photo: Bulrush (Native)

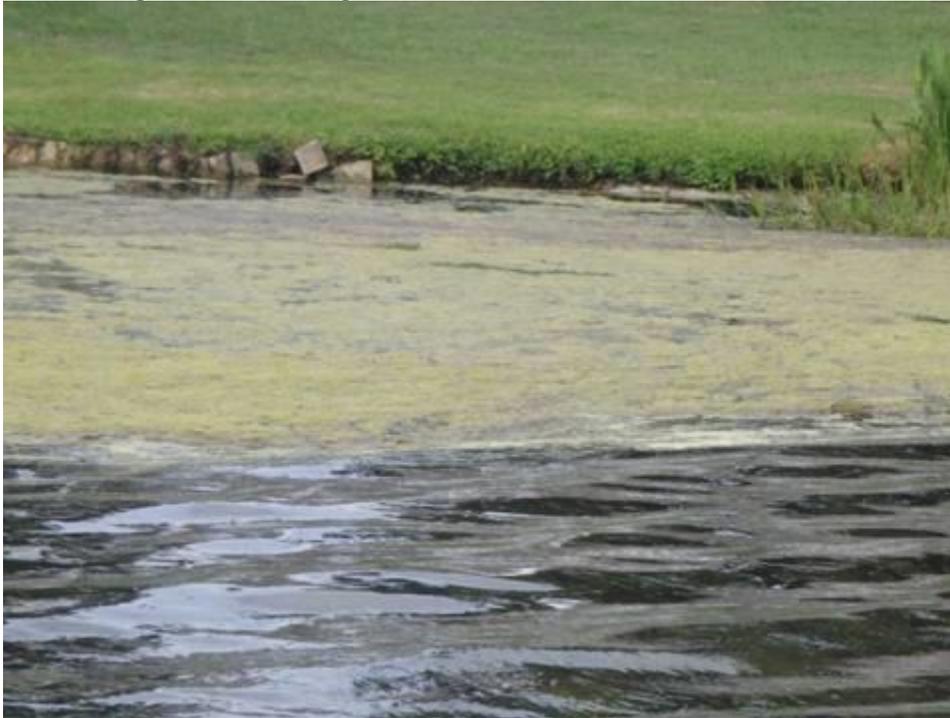
A substrate algae bloom was observed along the western shoreline of the lake. Large algae blooms will deplete the lake's dissolved oxygen levels, which can kill fish. Algae blooms are

caused by high levels of phosphates. The most common sources for excess phosphates are fertilizer runoff and yard clippings. To help prevent algae blooms, residents can reduce overall fertilizer use, only use phosphorus-free slow release nitrogen fertilizer brands when fertilizers are needed, and prevent yard clippings from falling in the lake.

Photo: Algae bloom along western shoreline.
