LAKE MILLS LAKE BIOASSESSMENTS

DECEMBER 2014 through MAY 2015

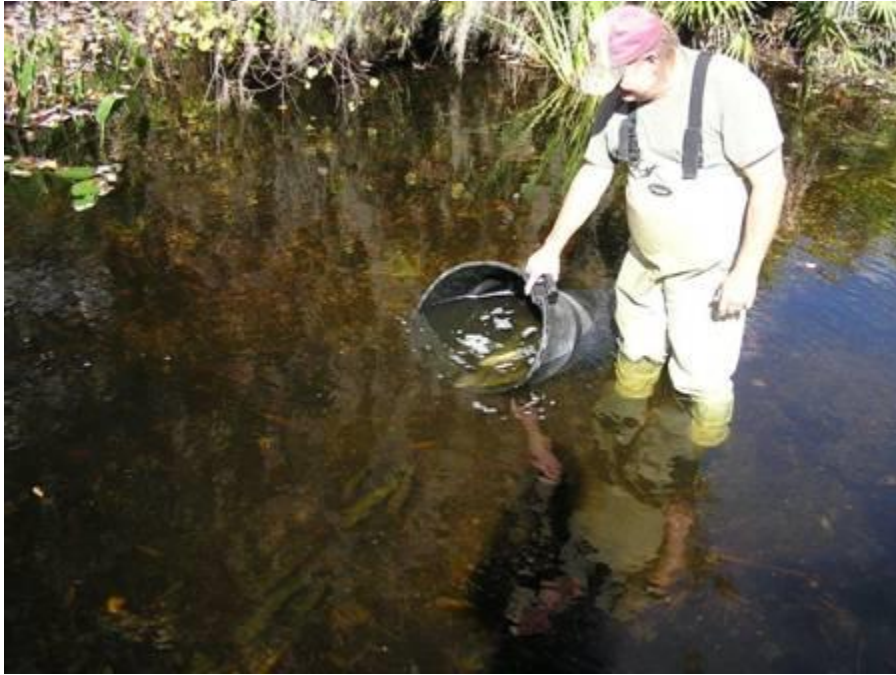
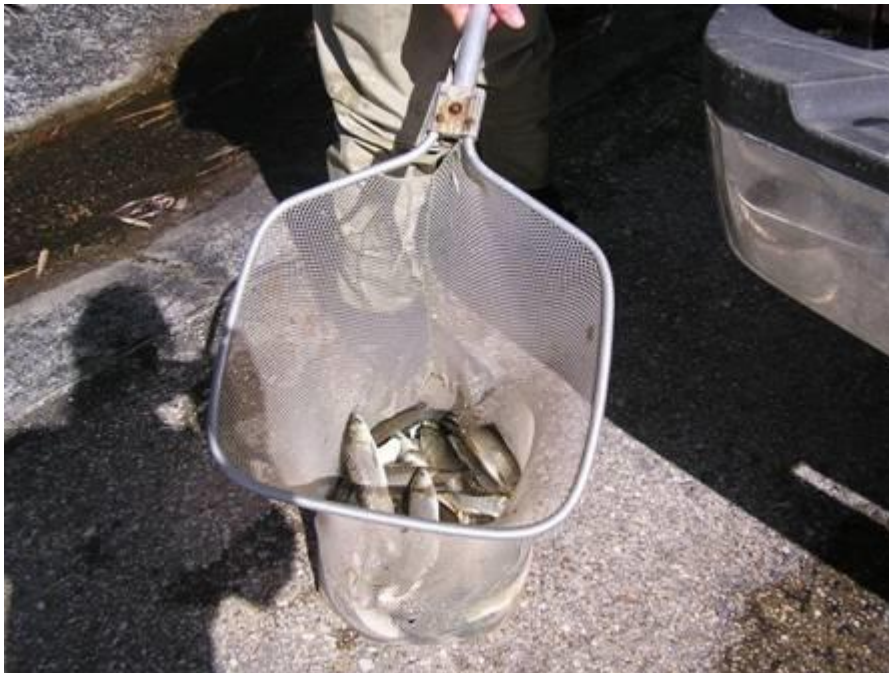
Additionally, due to the increase in hydrilla presence, an additional 243 triploid (sterile) grass carp fish were stocked into Lake Mills. This equated to a one fish per acre stocking rate.

Photos: Stocking 243 grass carp fish into Lake Mills.

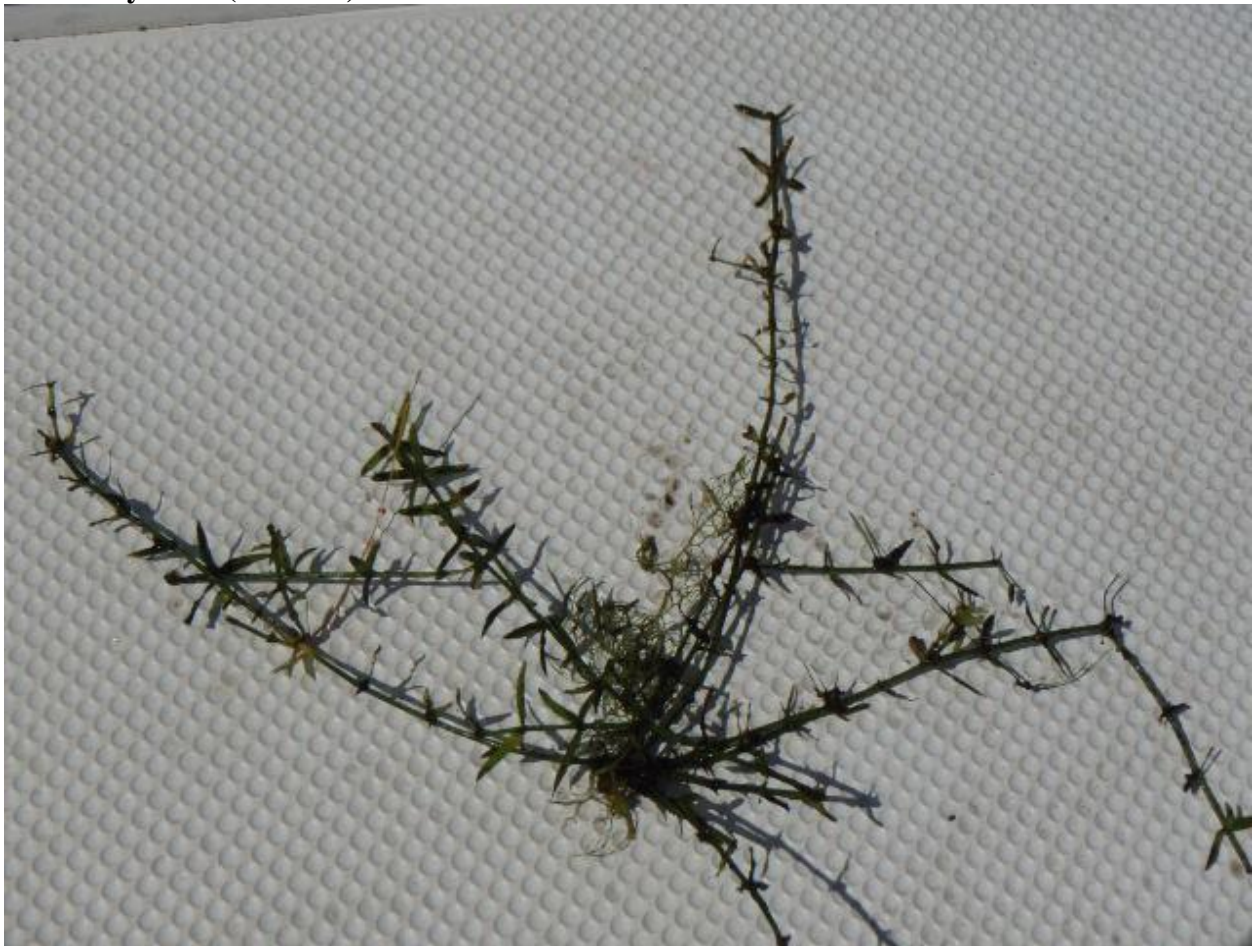
Hydrilla was observed in all the eastern coves, from the Mills Creek cove up to the northern point, as well as the southern west canal. December's treatment has reduced the presence of hydrilla, though not to the expected extent. Some treated hydrilla was found with evidence of new growth. This could be an indicator that the hydrilla will survive. However, there was also indication that recently introduced grass carp are consuming hydrilla. We will continue to closely monitor the hydrilla population.

Photo: Hydrilla (invasive)

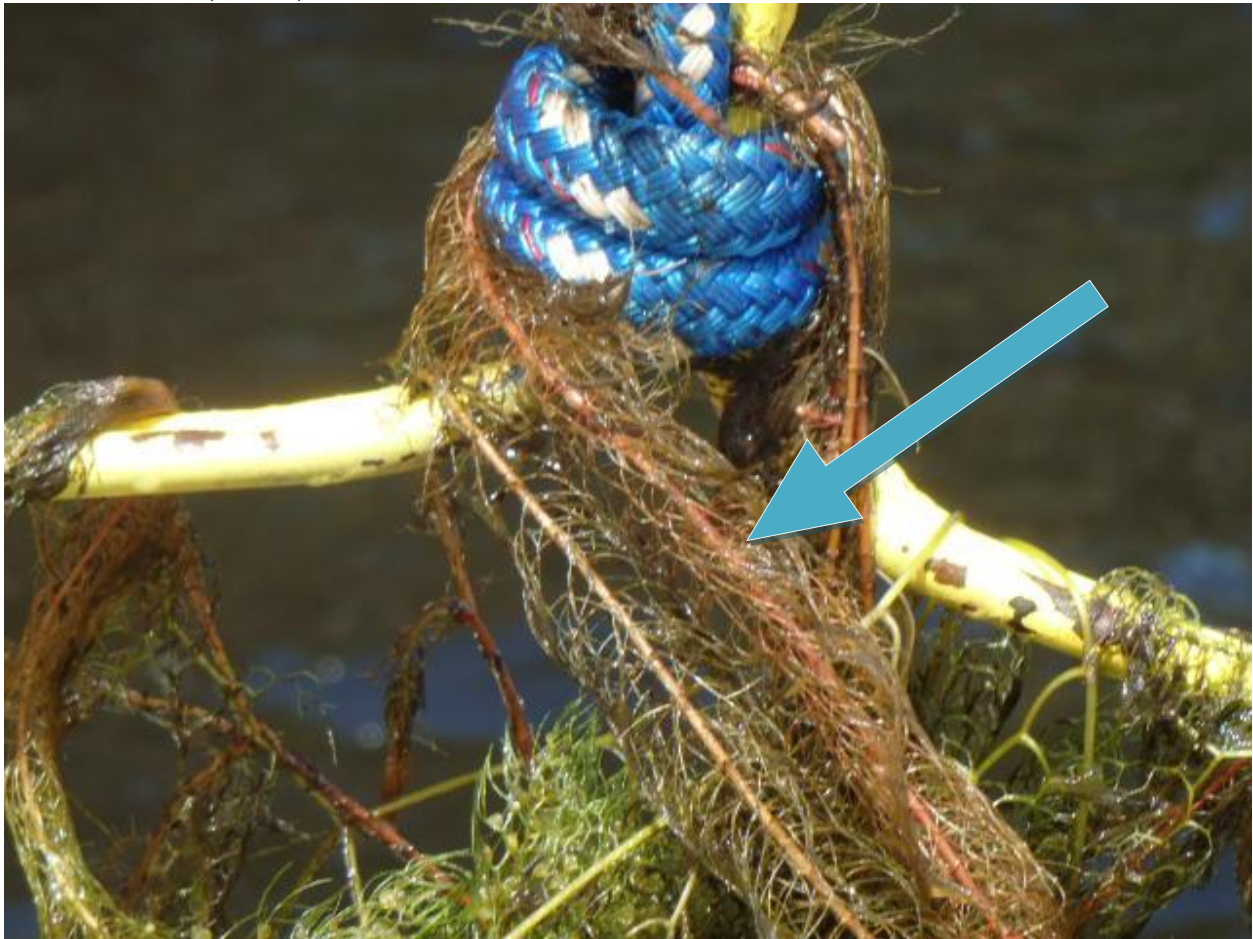
Eight species of native SAV were observed during the inspection. These species included: lemon bacopa to a depth of 5 feet, coontail to 8 feet, eelgrass to 3 feet, southern naiad to 6 feet, roadgrass to 6 feet, baby's tear to 8 feet, milfoil to 6 feet, and bladderwort to 6 feet. There has been a reduction in lemon bacopa since the previous assessment.

Photo: Milfoil (native)

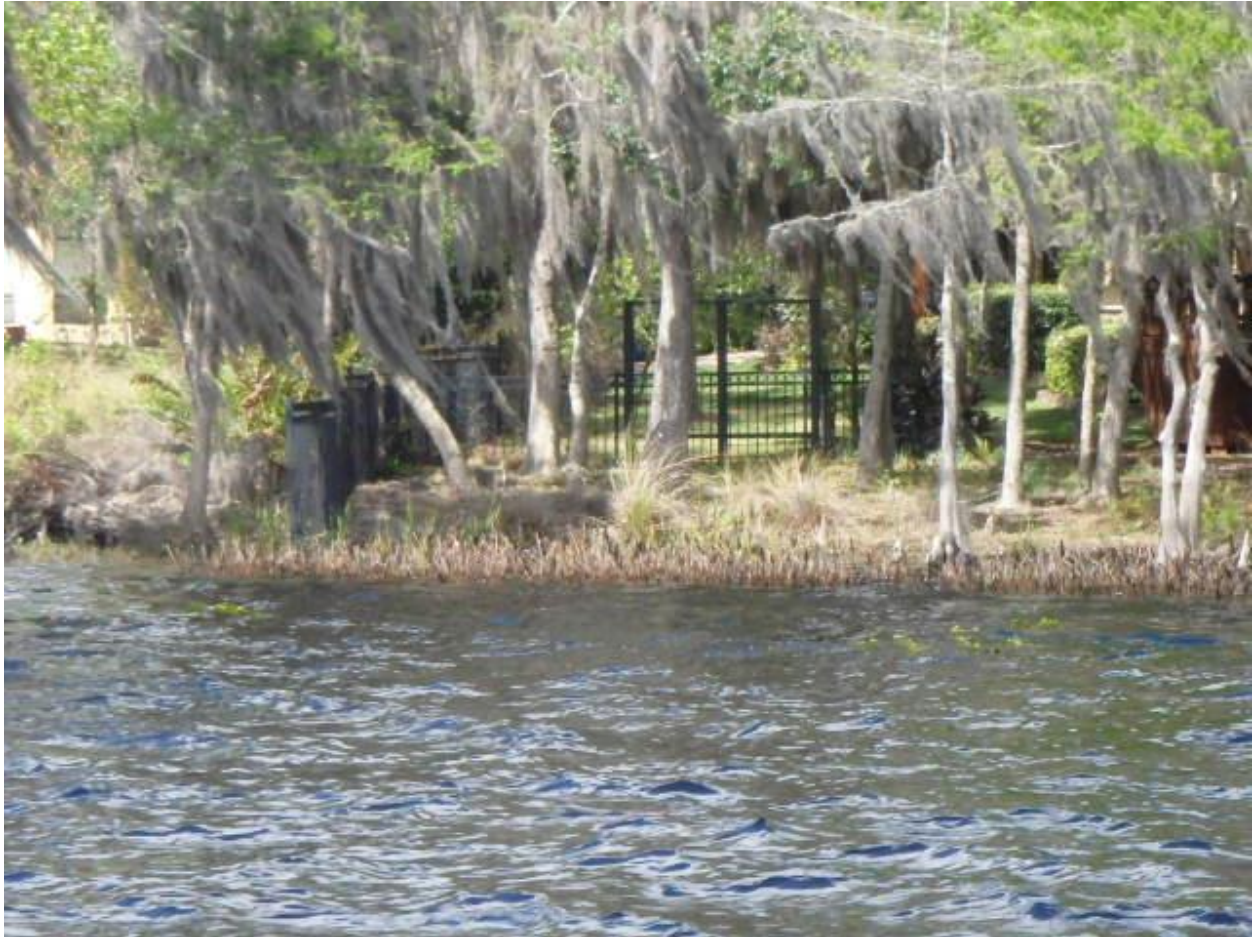
Native emergent vegetation observed during inspection included: sawgrass, swamp lily, yellow cow lily, banana lily, fragrant water lily, maidencane, pickerelweed, duck potato, carolina willow, fireflag, cattail, aster, and pipewort. Most of these native species are expanding around the lake. Pickerelweed is not as healthy as seen in previous inspections. This may be due to the treatment of hydrilla.

Photo: Pickerelweed (native)

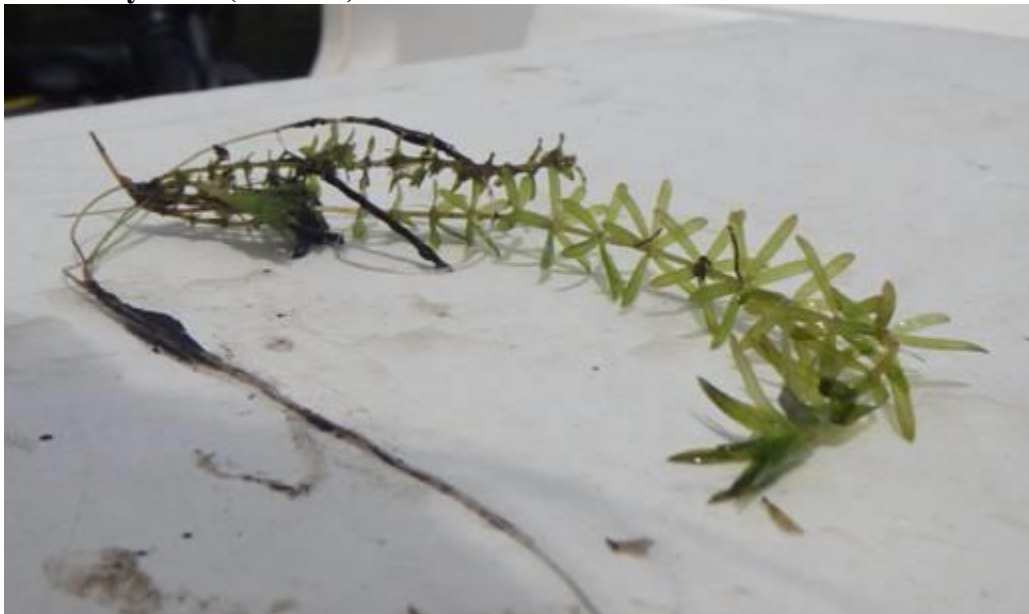
Hydrilla was the only invasive SAV observed during the inspection. December's chemical treatments are showing good results. Small hydrilla sprigs were found in the eastern coves; although, these sprigs were sparse and many had signs of grass carp consumption. The northern west canal contained hydrilla. This is the only place on the lake that hydrilla exists in dense patches.

Photo: Hydrilla (invasive)

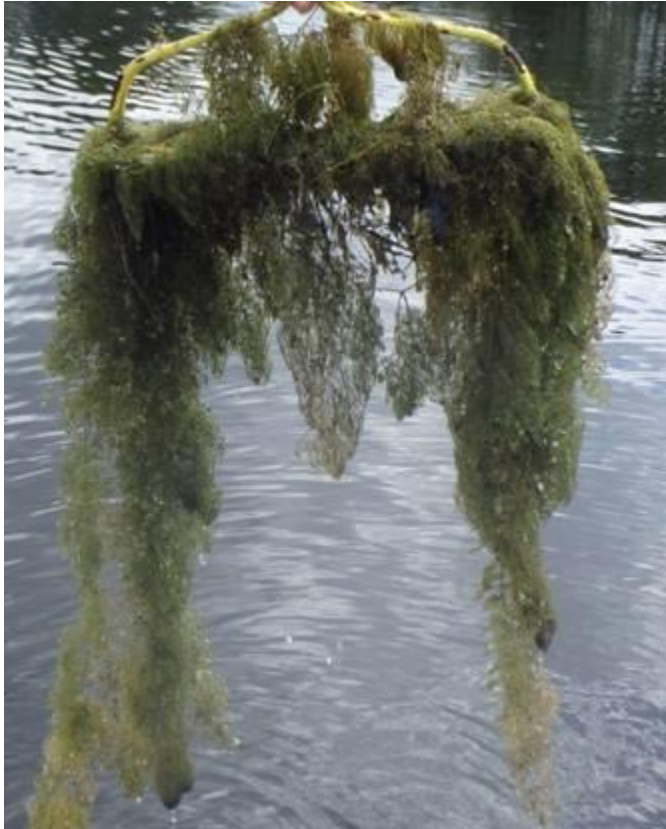
Nine species of native SAV were observed during the inspection. These species included: lemon bacopa to a maximum depth of 6 feet, muskgrass to 4 feet, roadgrass at 6 feet, baby's tears to 6 feet, milfoil to 4 feet, southern naiad to 6 feet, stonewort to 4 feet, bladderwort to 6 feet, and eelgrass to 6 feet. Areas left bare by recent hydrilla treatments are being filled in bladderwort, baby's tears, and lemon bacopa. Bladderwort is currently the dominant species in these treated areas, but both baby's tears and lemon bacopa are showing strong indications of growth.

Photo: Bladderwort (native)

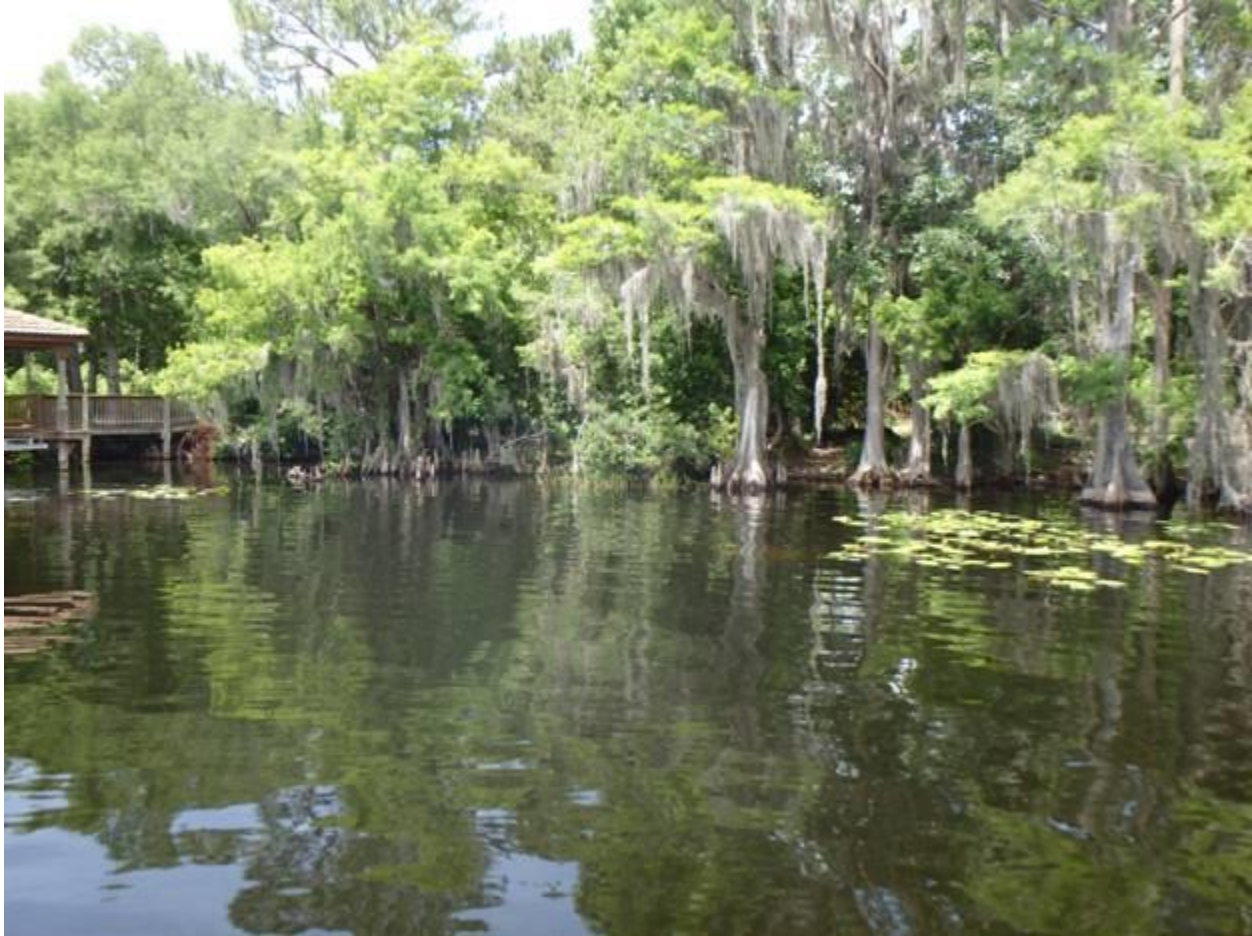
Native emergent vegetation observed during inspection included: buttonbush, swamp lily, pennywort, primrose willow, yellow cow lily, fragrant water lily, pickerelweed, duck potato, carolina willow, fireflag, and cattail. Most of these native species are expanding around the lake.

Invasive emergent vegetation seen during the inspection include: alligator weed, wild taro, torpedo grass, and creeping oxeye. Overall abundance of invasive species was reduced since the previous inspection.

Photo: North shoreline

1. Continue to work together with other lakefront owners to control and if possible, eliminate invasive plants observed during this survey and increase native aquatic plantings along shoreline (such as pickerelweed and duck potato). Have at least one annual lake association meeting to discuss lake specific issues.
2. Utilize the valuable educational outreach programs that are available, i.e. Shoreline Restoration Workshops, Florida Yards and Neighborhoods (FYN) interactive presentations, and Lake Management Video mail-outs. Implement a media campaign within the community to reduce personal pollution by: decreasing overall fertilizer usage, **using only phosphorous free and slow-release nitrogen fertilizers**, keeping a functional shoreline with beneficial native aquatic plants, and keeping grass clippings out of your lake and the
