## LAKE MILLS LAKE BIOASSESSMENTS

### JULY – AUGUST 2015

On **July 14<sup>th</sup>, July 30<sup>th</sup> and August 13<sup>th</sup>, 2015**, Seminole County Lake Management Program biologists (Thomas Calhoun, Joey Cordell, and Gloria Eby) surveyed the aquatic plants in **Lake Mills**.

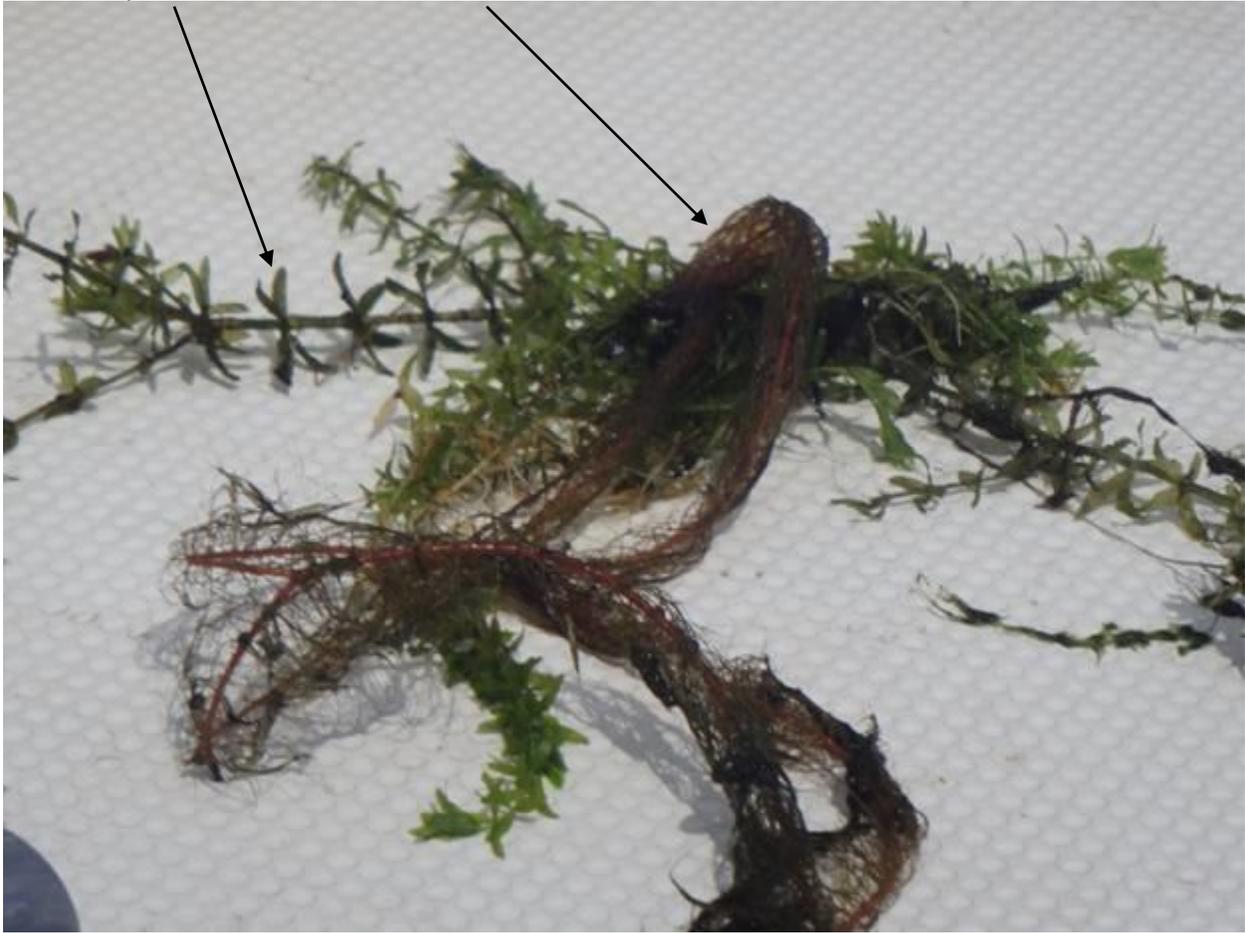
During the assessment we searched for the highly invasive hydrilla. Three patches of hydrilla were found, one at the start of both canals and one at the adjacent boat ramp. These locations were sent to an MSBU funded herbicide contractor to be spot treated. Hydrilla was also observed along the north shoreline. We are currently developing a treatment plan for this area and will update you on treatment date.

**Photo: Hydrilla (invasive) and milfoil (native)**

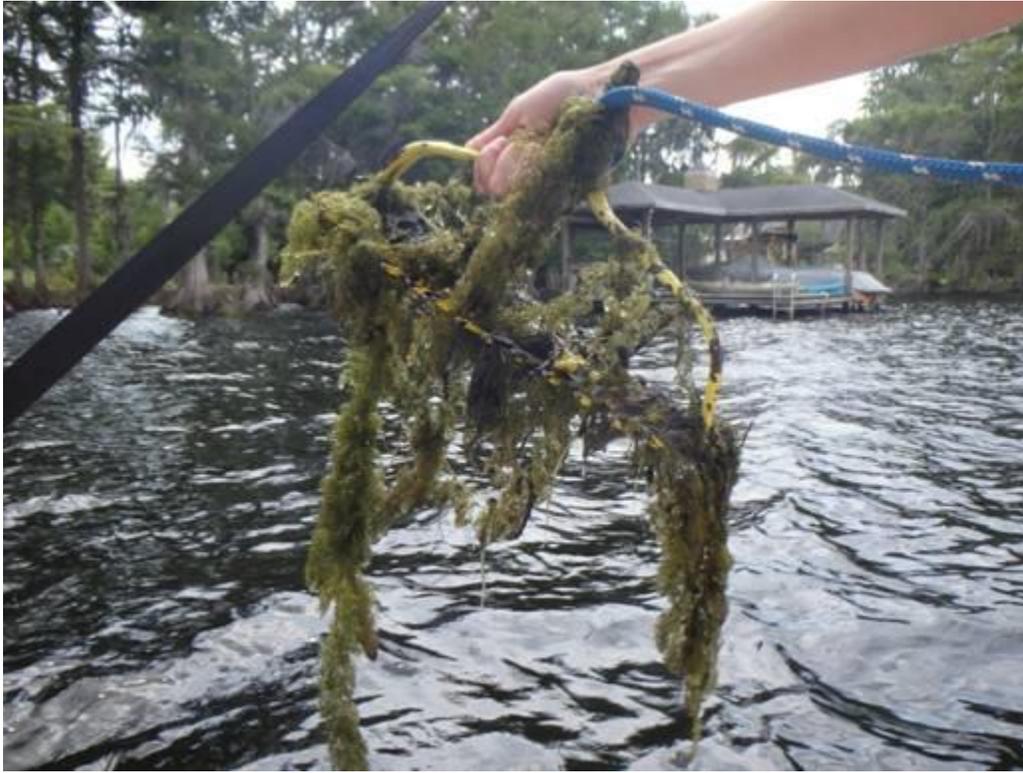
Nine species of SAV were observed during the inspection. These species included: lemon bacopa to a depth of 6 feet, coontail to 3 feet, baby's tears to 7 feet, muskgrass to 2 feet, milfoil to 7 feet, stonewort to 7 feet, roadgrass to 7 feet, eelgrass to 7 feet, and bladderwort to 7 feet. Bladderwort is the dominant SAV and has increased since last inspection.

**Photo: Bladderwort**

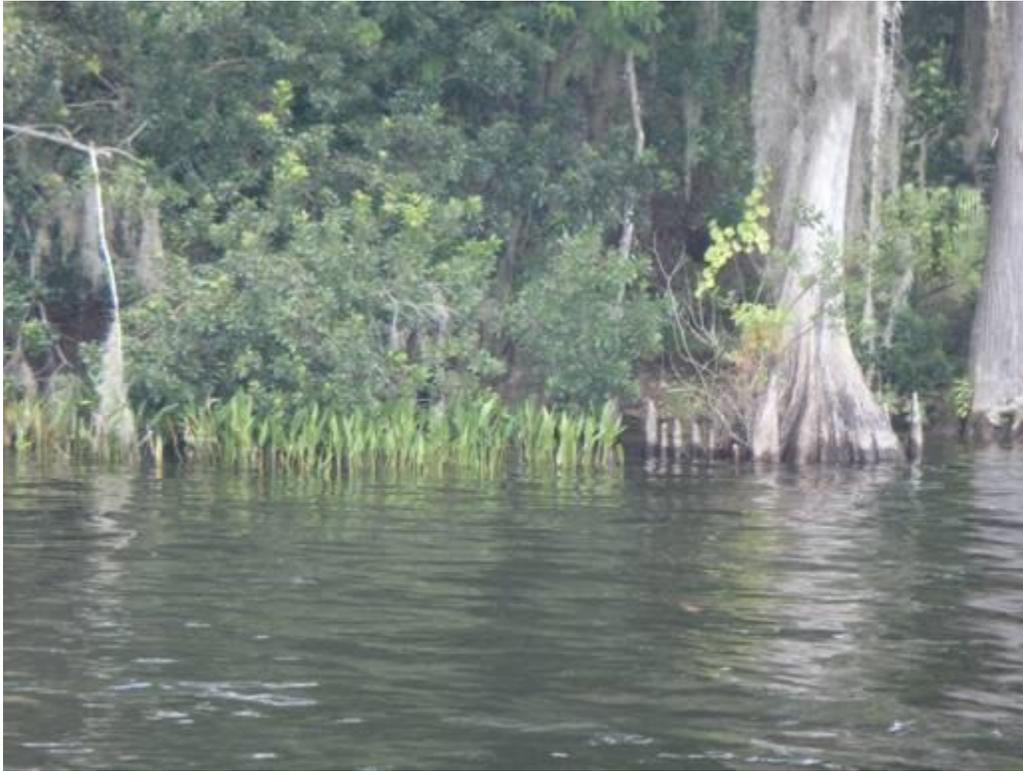
Ten species of native emergent vegetation were observed during the inspection. These species included: rush fuirena, pennywort, yellow cow lily, water grass, maidencane, swamp lily, pickerelweed, buttonbush, cordgrass, and duck potato.

**Photo: Pickerelweed**

1. Work together and establish a lake association with other lakefront owners to increase native aquatic plantings along the shoreline (such as pickerelweed, canna, and duck potato). Have at least one annual lake association meeting to discuss lake-specific issues.
