**MIRROR LAKE**  
**LAKE BIOASSESSMENTS**

**JUNE 2015**

**Bioassessment**

On **June 10, 2015**, Seminole County Lake Management Program biologist, Thomas Calhoun, with student intern, Sophia Pengra, surveyed the aquatic plants in **Mirror Lake**.

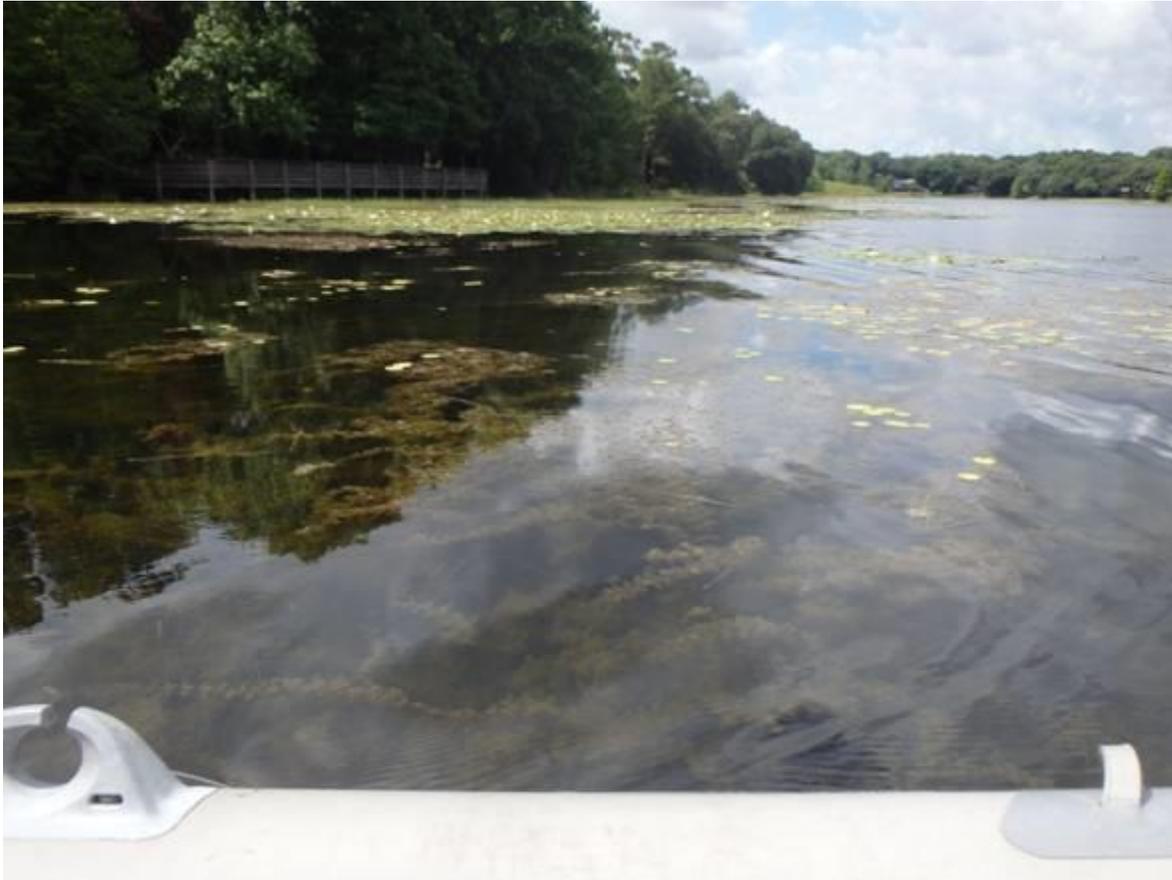
Seven species of native submersed aquatic vegetation (SAV) were found during the inspection. These native species included: southern naiad to 4 feet, baby's tears to 1 foot, eelgrass to 3 feet, lemon bacopa to 2 feet, and three species of bladderwort to 7 feet. Bladderwort was the dominant species of SAV found. Native SAV plays an important part within Mirror Lake by providing wildlife habitat, reducing nutrients, and competing for space with hydrilla.

**Photo: Submersed bladderwort (native)**

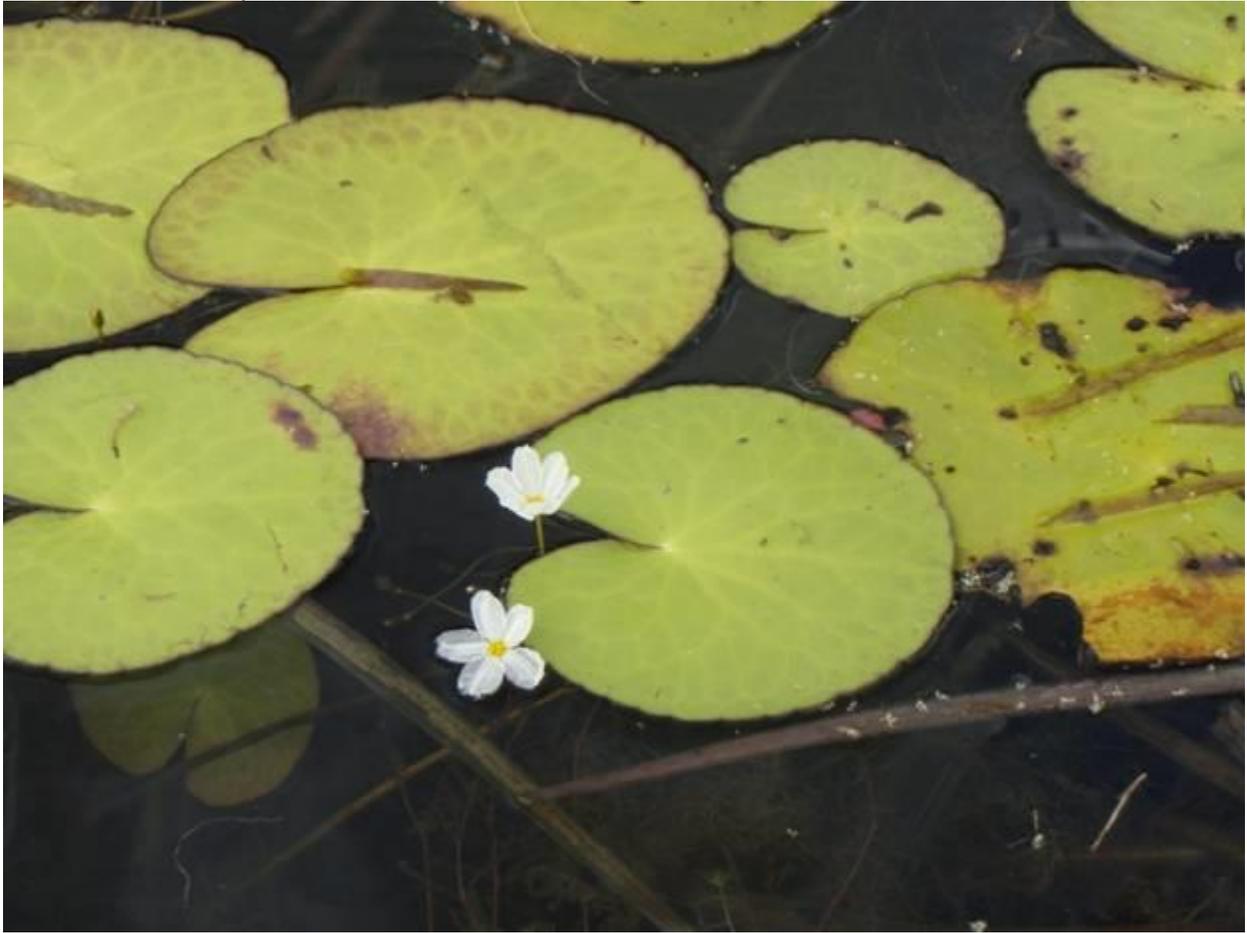
Native emergent vegetation found during the survey included: canna, iris, spike rush, pennywort, climbing hempvine, yellow cow lily, fragrant water lily, banana lily, American lotus, pickerelweed, maidencane, Carolina willow, cordgrass, buttonbush, and duck potato. There was a notable increase in banana lilies from the previous inspection.

**Photo: Banana lily (native)**

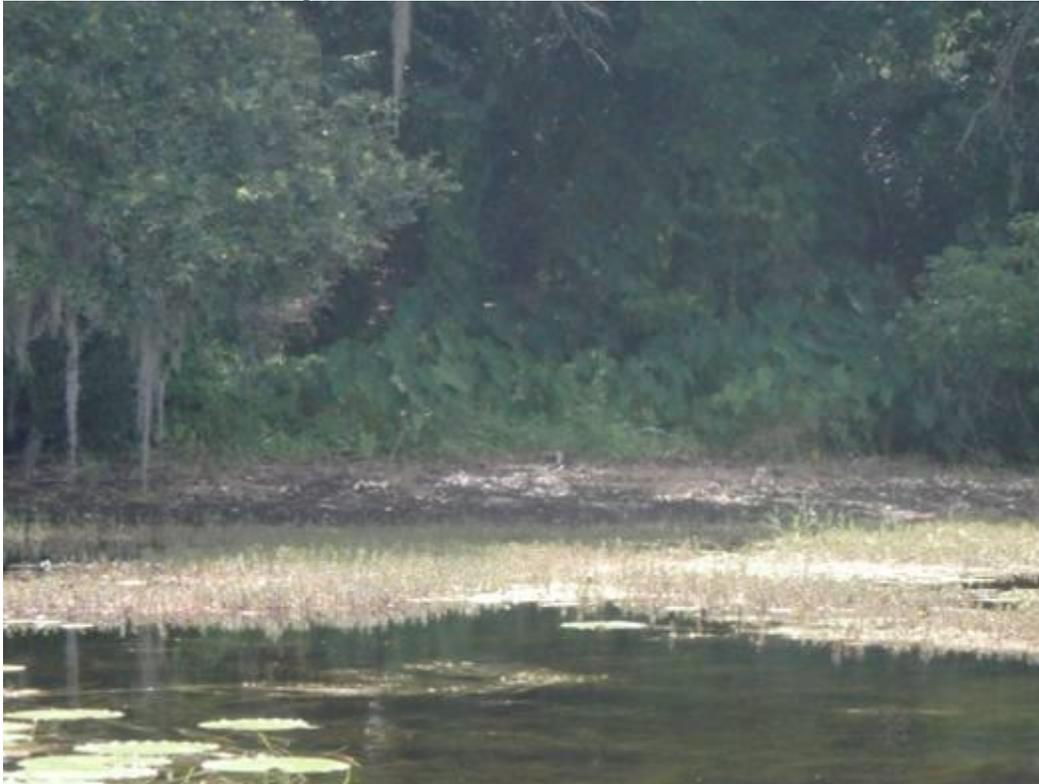
Invasive emergent vegetation included: alligatorweed, wild taro, torpedo grass, wedelia, water primrose, and cattail. Additionally, an algae bloom was observed on the northwest end of the lake. A treatment is being worked on for bladderwort control in several access areas of the lake. However, at the time of inspection, the navigation corridors appeared clear.

**Photo: Wild taro along shoreline (invasive)**

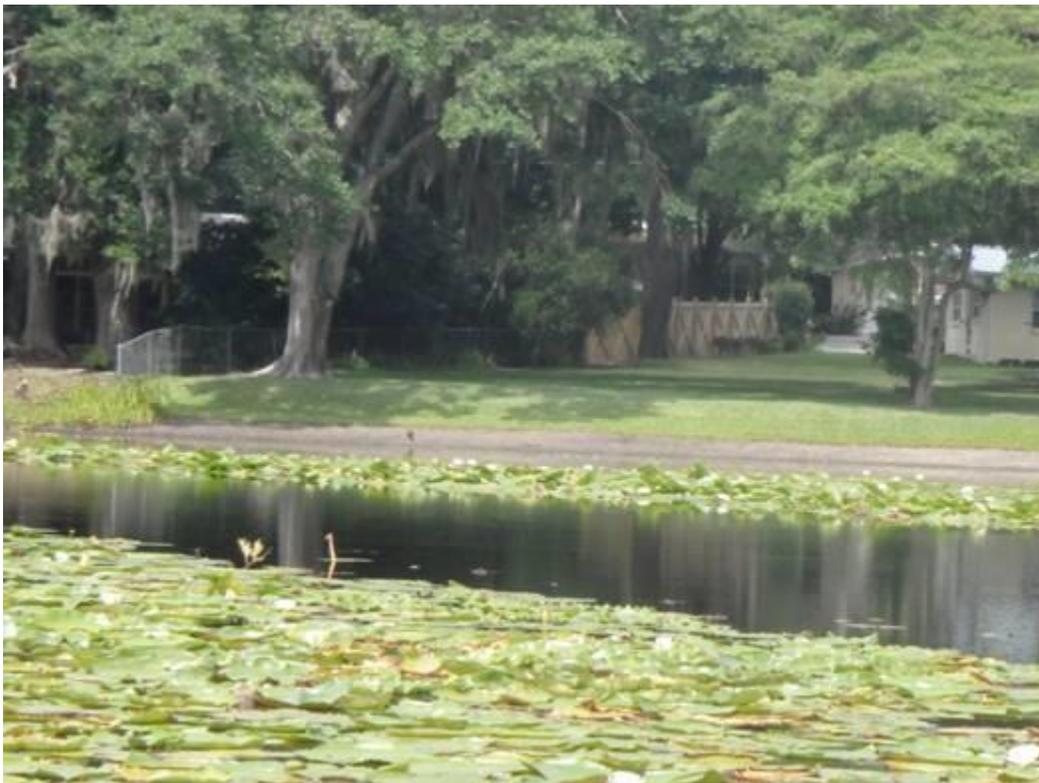
**Photo: Clear access corridor**
