Greetings Mirror Lake Residents,

Please find the latest bioassessment report for your lake below. Key highlights of this update include:

**6/22/2016**

On **June 22<sup>nd</sup>, 2016**, Seminole County Lake Management staff, Thomas Calhoun and Joey Cordell, surveyed the aquatic plants in **Mirror Lake**.

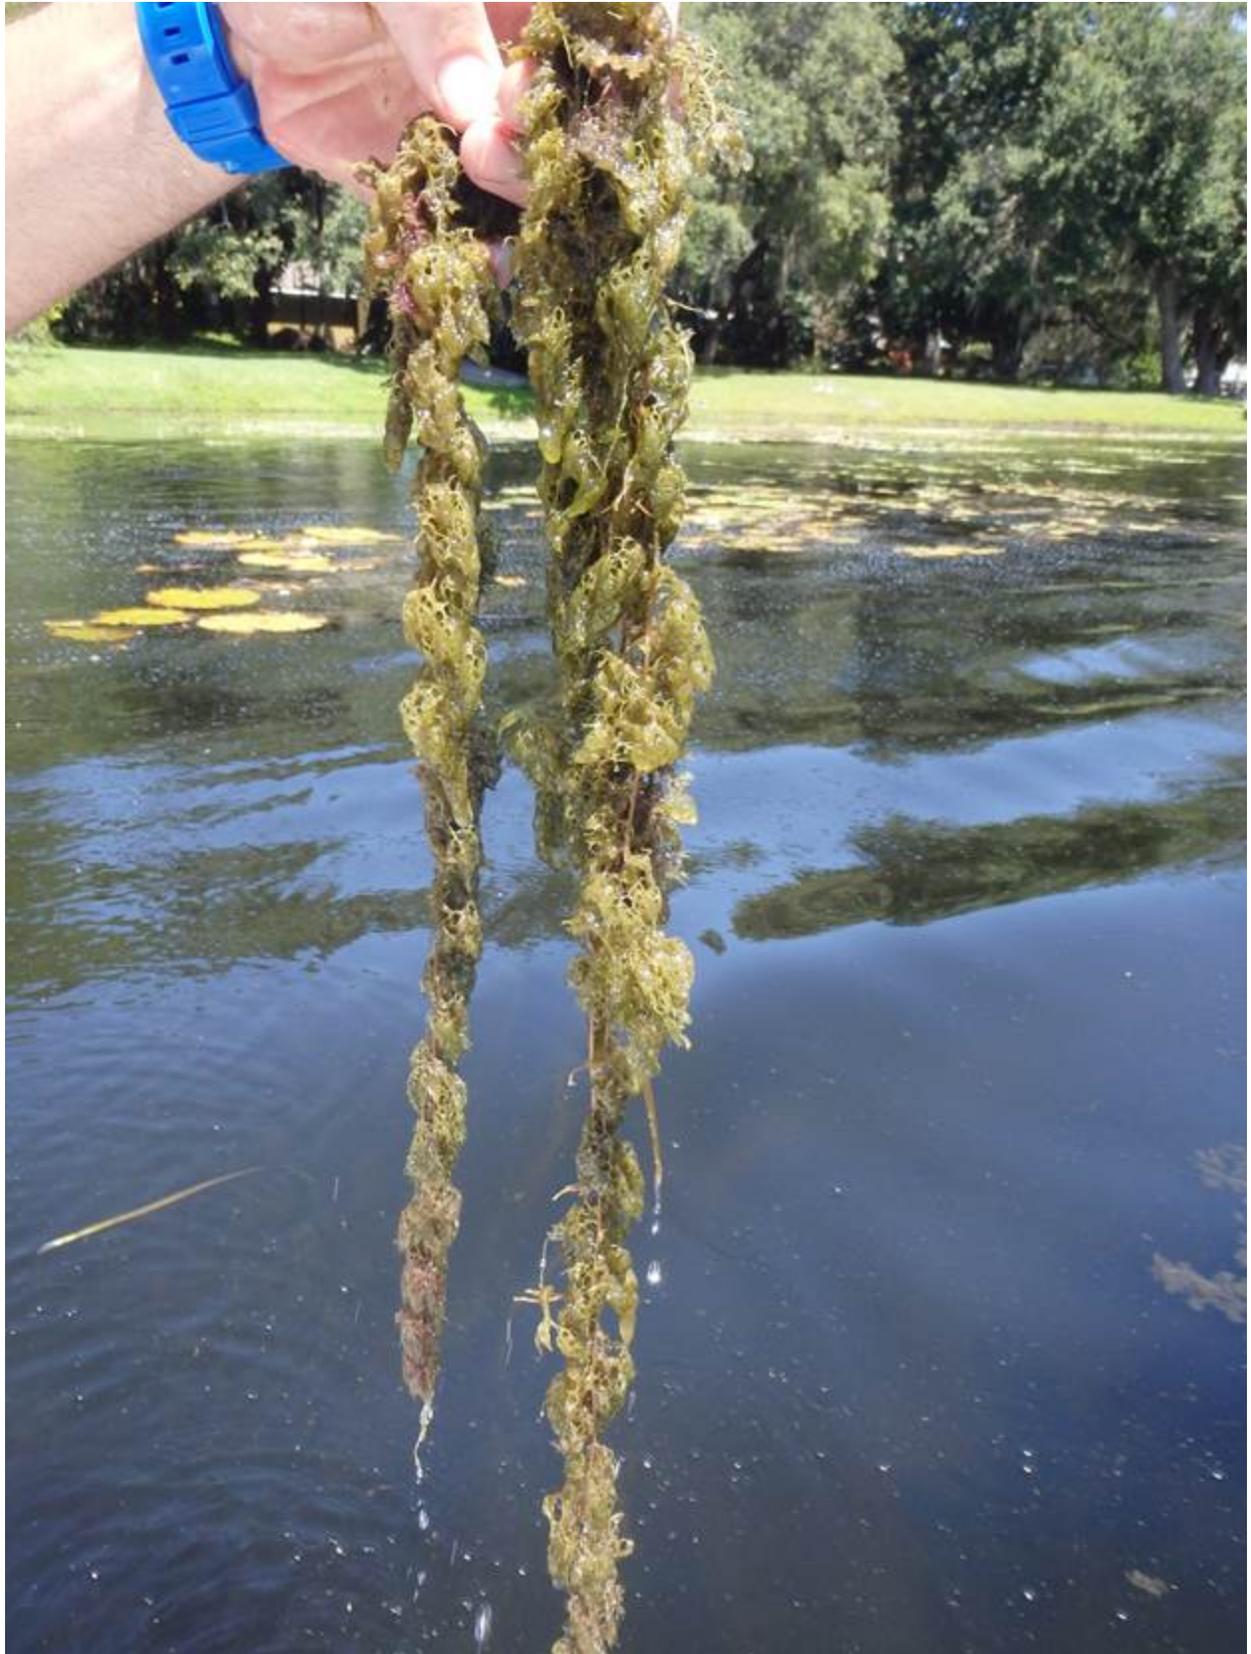
Seven species of native submersed aquatic vegetation (SAV) were found during the inspection. These native species included: lemon bacopa to 3 feet, baby's tears to 5 feet, southern naiad to 5 feet, stonewort to 3 feet, eelgrass to 5 feet, and two species of bladderwort to 7 feet.

**Photo: Bladderwort (native).**

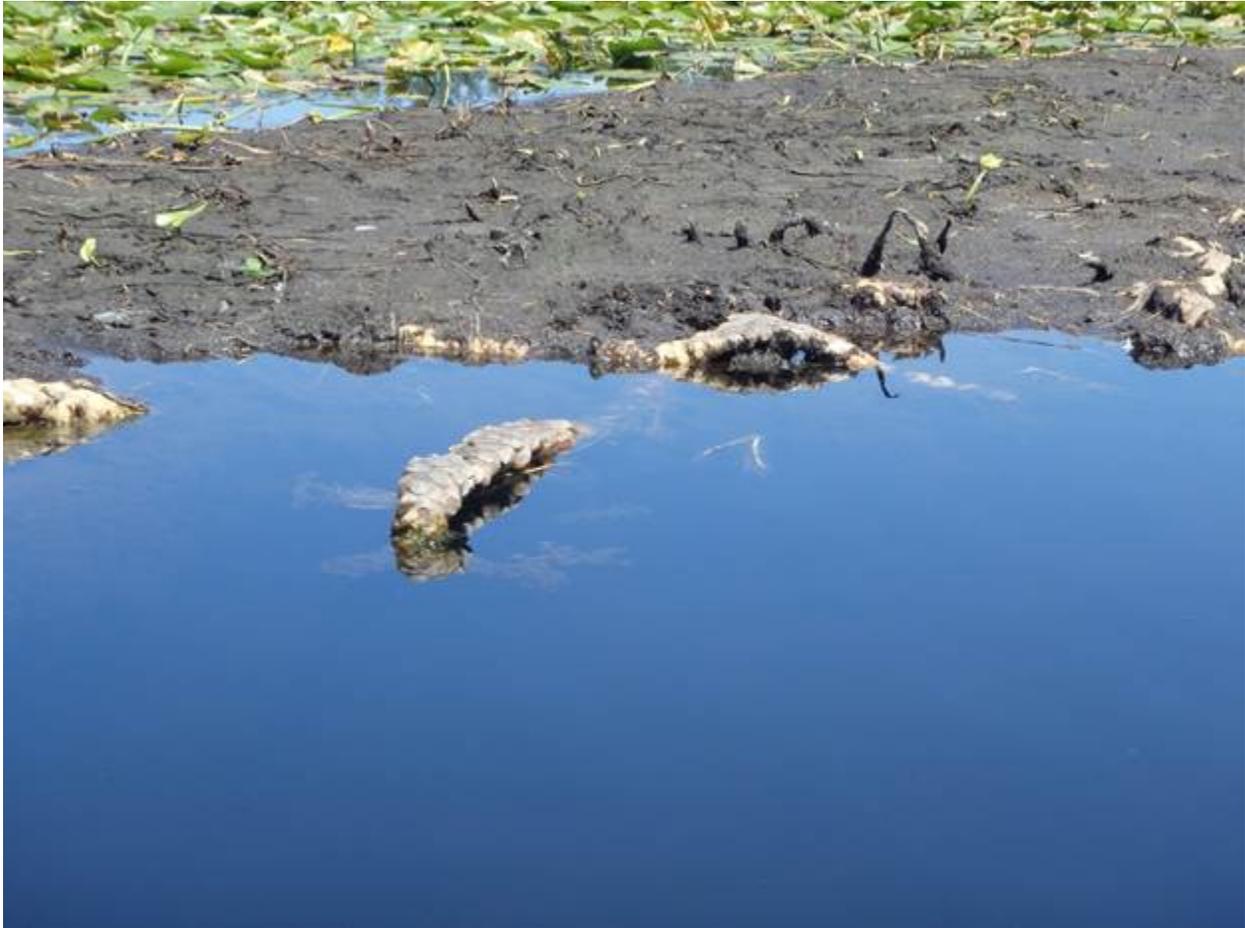
All lily pads have expanded, but the banana lily has been increasing the fastest. The lily pads will be hit hard on the next treatment. Do not be alarmed if lily tubers and mud pockets float to the surface. This is a common occurrence when treating lily pads.

**Photo: Lily pad tubers and mud “burp up”.**

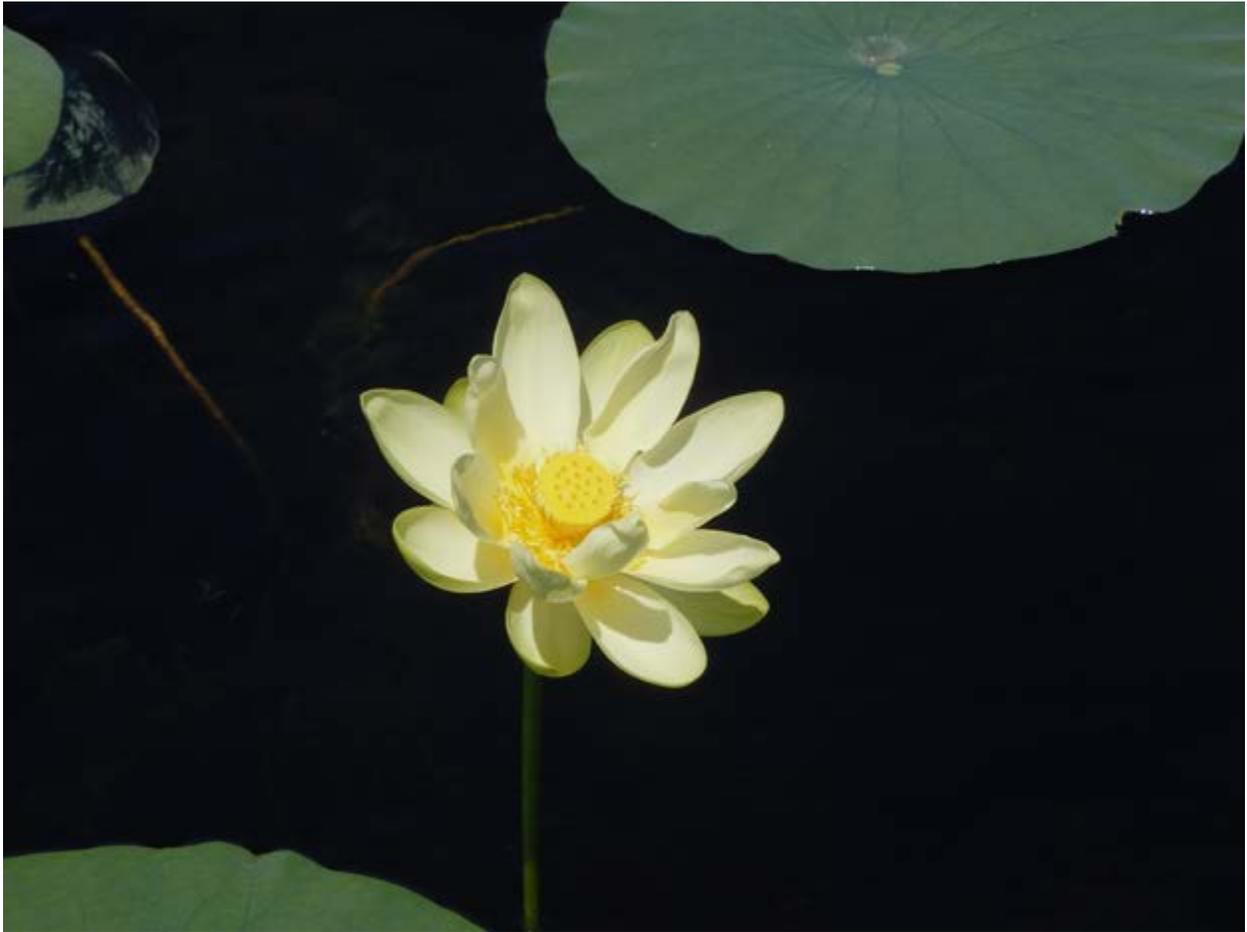
**Photo: American Lotus (native).**

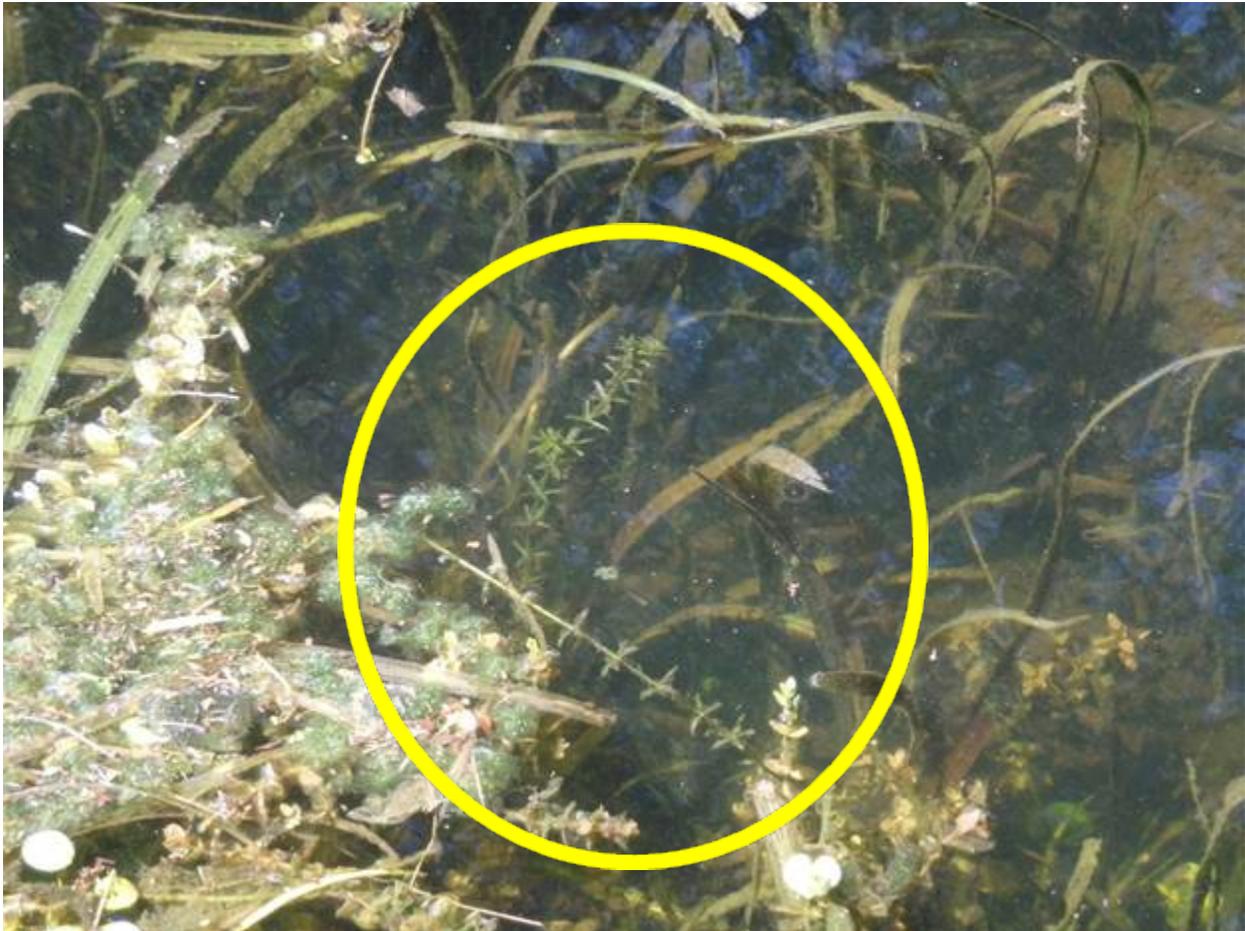
Small amounts of hydrilla were found at several areas of the lake. Single sprigs were present on the west side and the south end, while a small patch was found by the boat ramp.

**Photo: Hydrilla (invasive).**

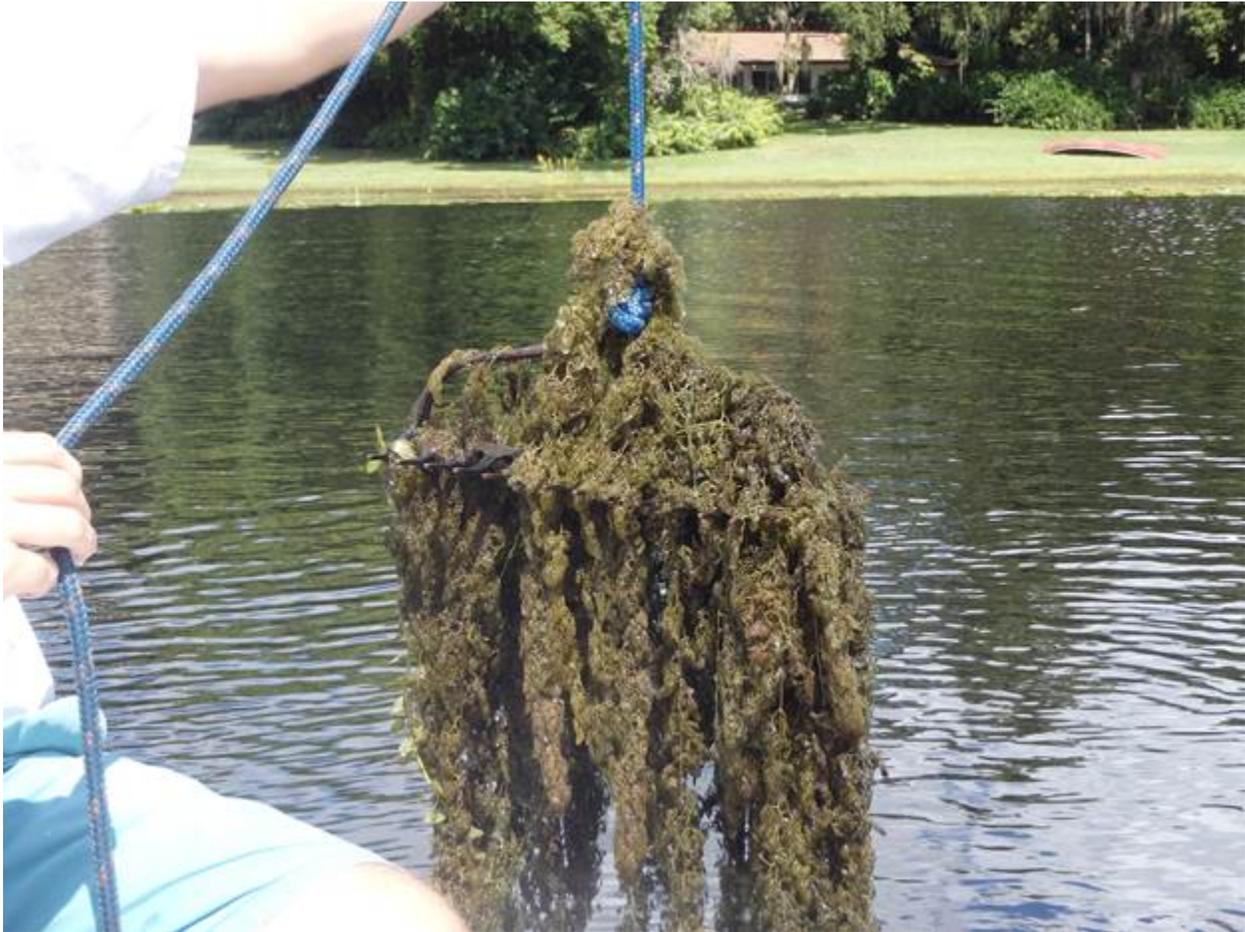
Overall there was an increase in all species of submersed aquatic vegetation. Seven species of native (SAV) were found during the inspection. These native species included: lemon bacopa to 8 feet, southern naiad to 4 feet, stonewort to 3 feet, eelgrass to 4 feet, and three species of bladderwort to 8 feet. Eelgrass continues to be the dominant species however bladderwort is the most visible floating on the surface.

**Photo: Bladderwort (native) can be seen floating at the surface in up to 6 feet of water.**

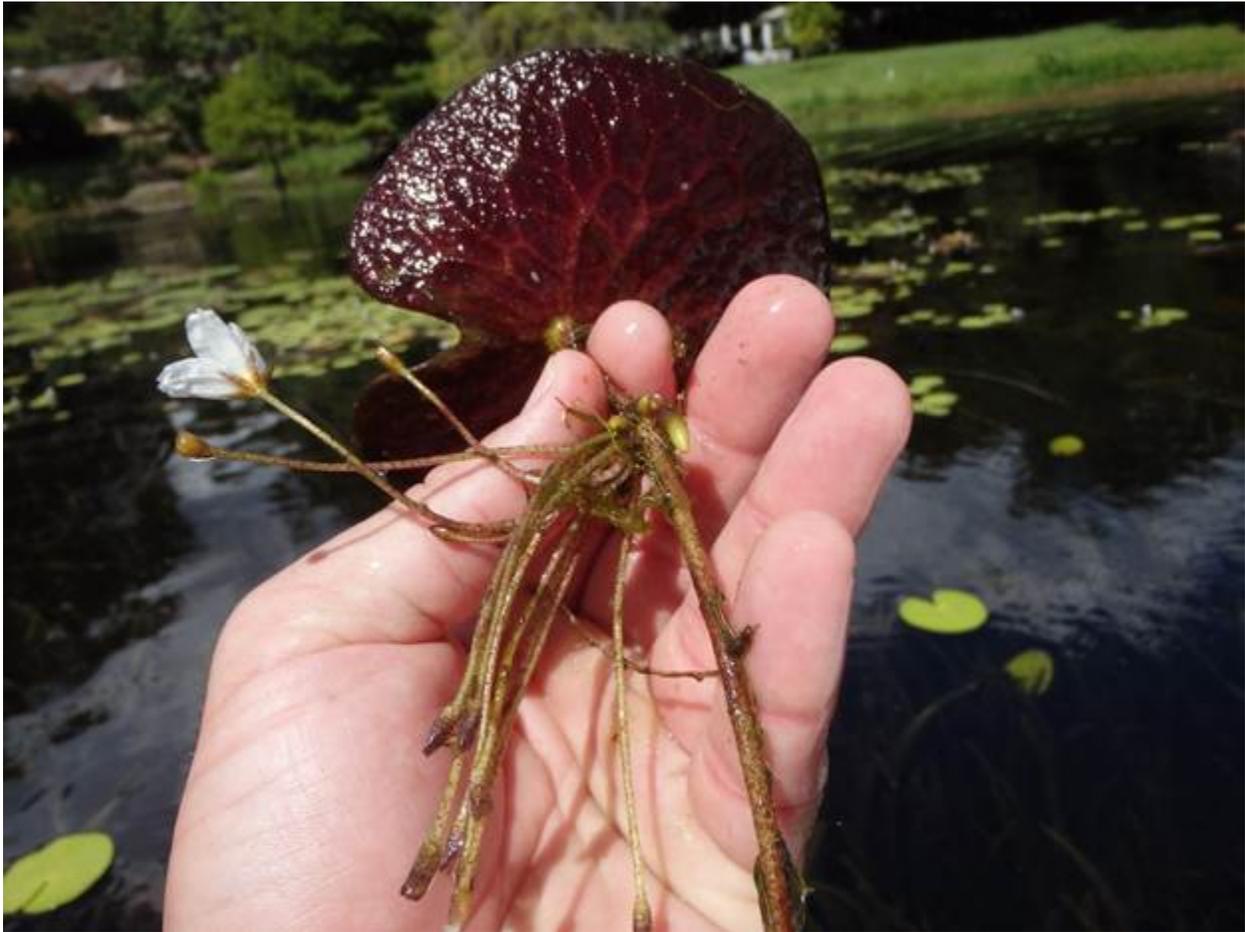
There are fewer lilies as a result of last month's treatment however the native banana lily continues to expand in several areas of the lake. In some areas where lilies have been treated, mud has floated up with the large lily tubers. This is a normal occurrence and will break down on its own.

**Photo: Banana lily (native) has been expanding around Mirror Lake.**

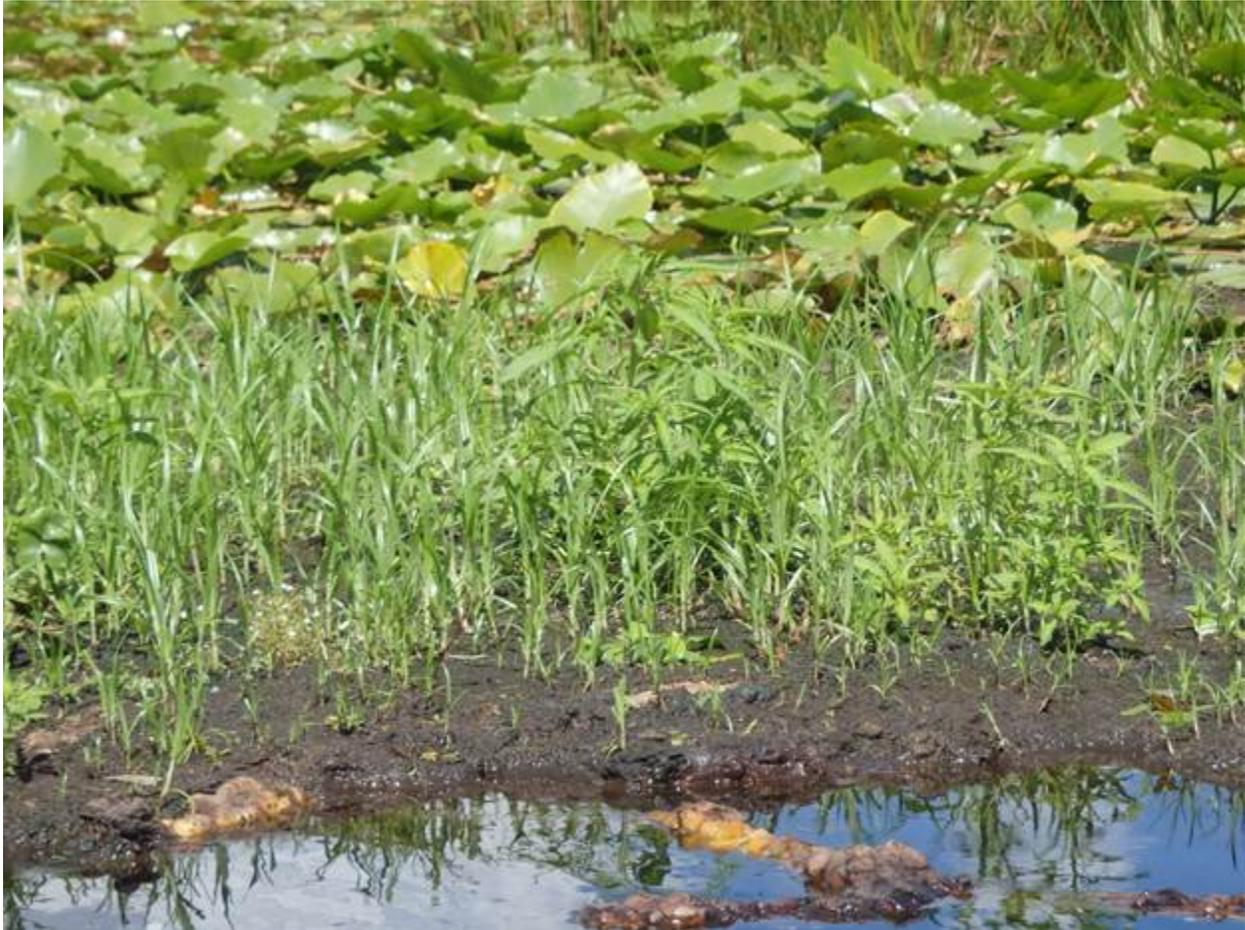
Invasive emergent vegetation included: alligator weed, wild taro, water primrose, torpedograss, cuban bur-head sedge, and creeping oxeye. Some cuban bur-head sedge has started growing on some of the floating tuber mats.

**Photo: Cuban bur-head sedge (invasive) growing on a floating mat.**

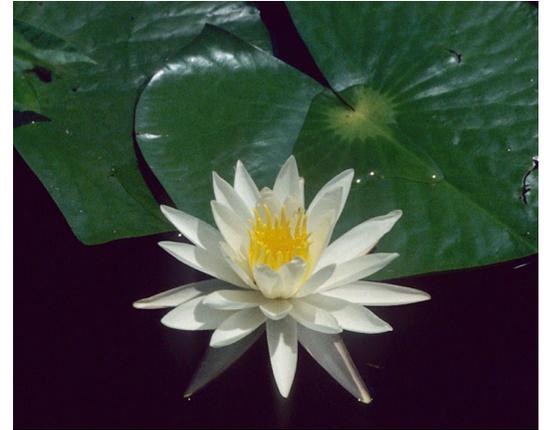
*Nymphaea* spp.  
Water lily

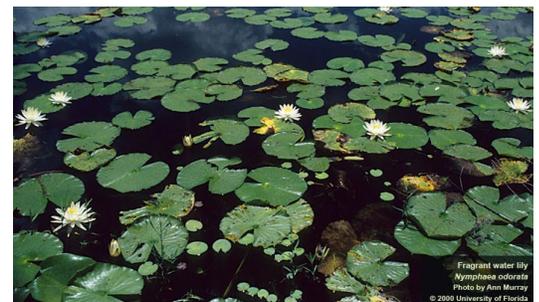
Fragrant water lily is a perennial aquatic plant that can be found floating on the surface of ponds, lakes, and slow-moving streams. The leaves of fragrant water lily float on the surface of the water while the flowers can be found either floating on or rising above the water. The bright green leaves are 6 to 12 inches in diameter, nearly round in shape, and notched to the center. The highly fragrant flowers, which are brilliant white with a yellow center, open in the morning and close each afternoon.

Fragrant water lily  
*Nymphaea odorata*  
Photo by Ann Murray  
© 2000 University of Florida
