MIRROR LAKE
LAKE BIOASSESSMENTS
MARCH – MAY 2015

Bioassessment

On **March 11th, 2015**, SCLMP personnel, Thomas Calhoun and Sophia Pengra surveyed the aquatic plants in **Mirror Lake**.

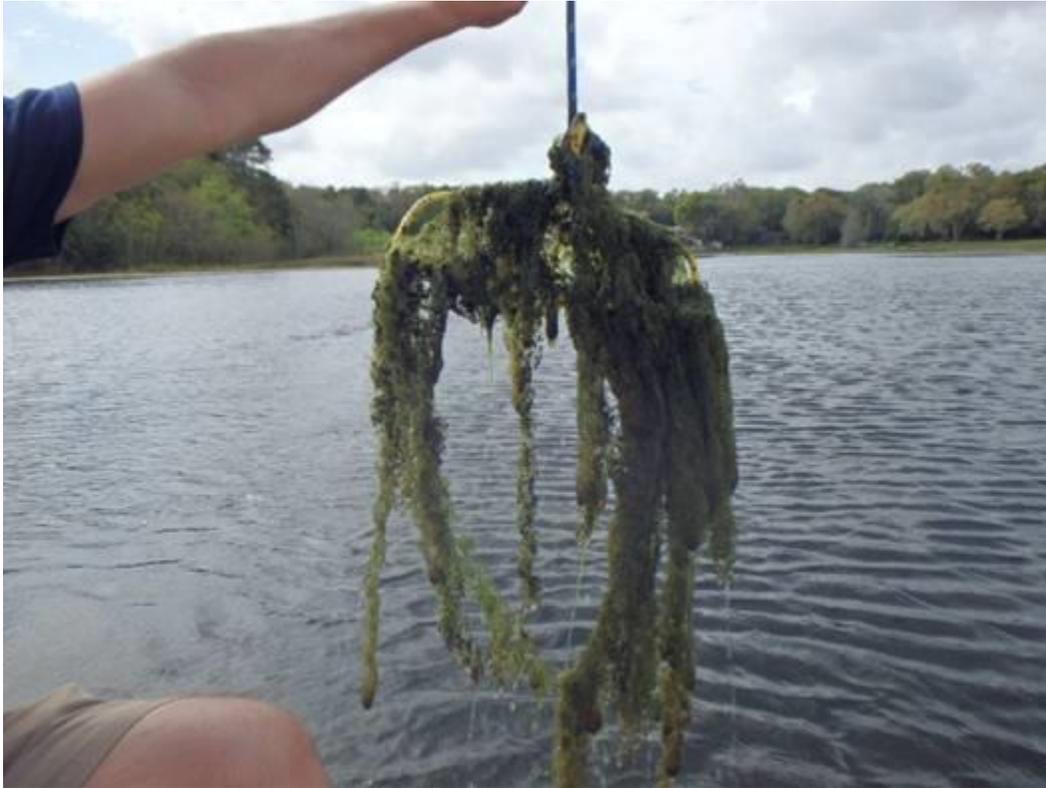
Seven species of native submersed aquatic vegetation (SAV) were found during the inspection. These native species included: roadgrass, baby's tears, eelgrass to 4 feet, lemon bacopa to 3 feet, and three species of bladderwort to 7 feet. Bladderwort was the dominant species of SAV found in Mirror Lake, followed by eelgrass. Native SAV plays an important part within Mirror Lake by providing wildlife habitat, reducing nutrients, and competing for space with hydrilla.

Photo: Bladderwort (native)

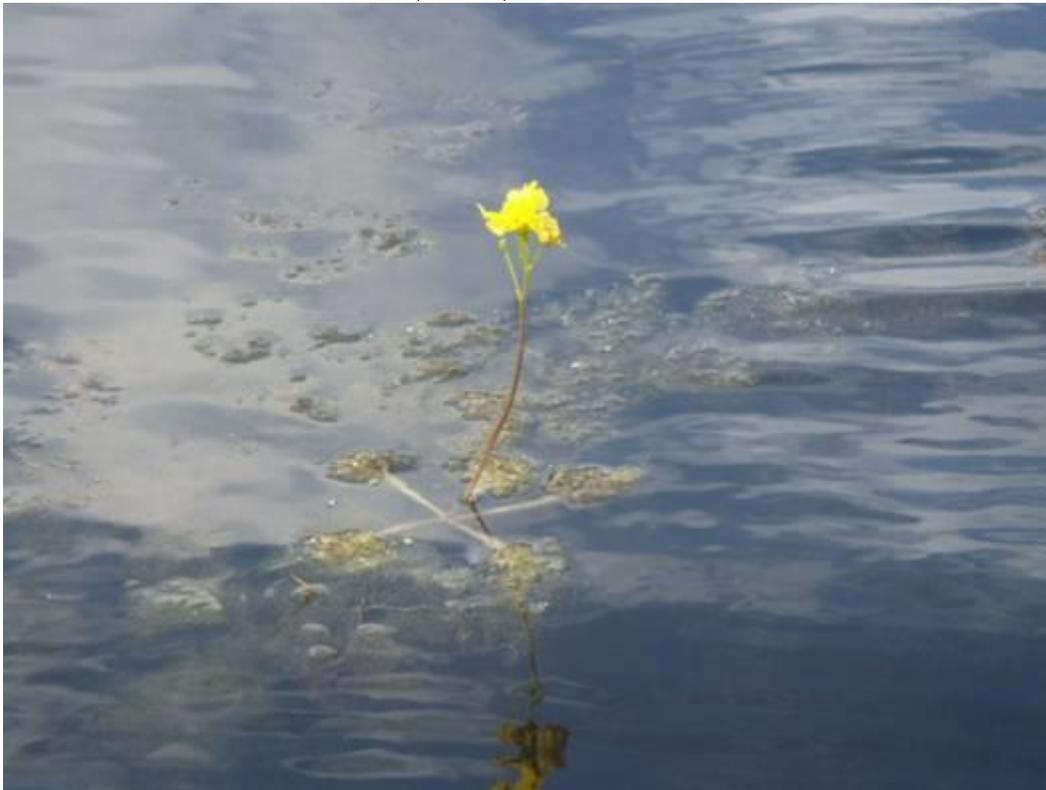
Photo: Bladderwort in bloom (native)

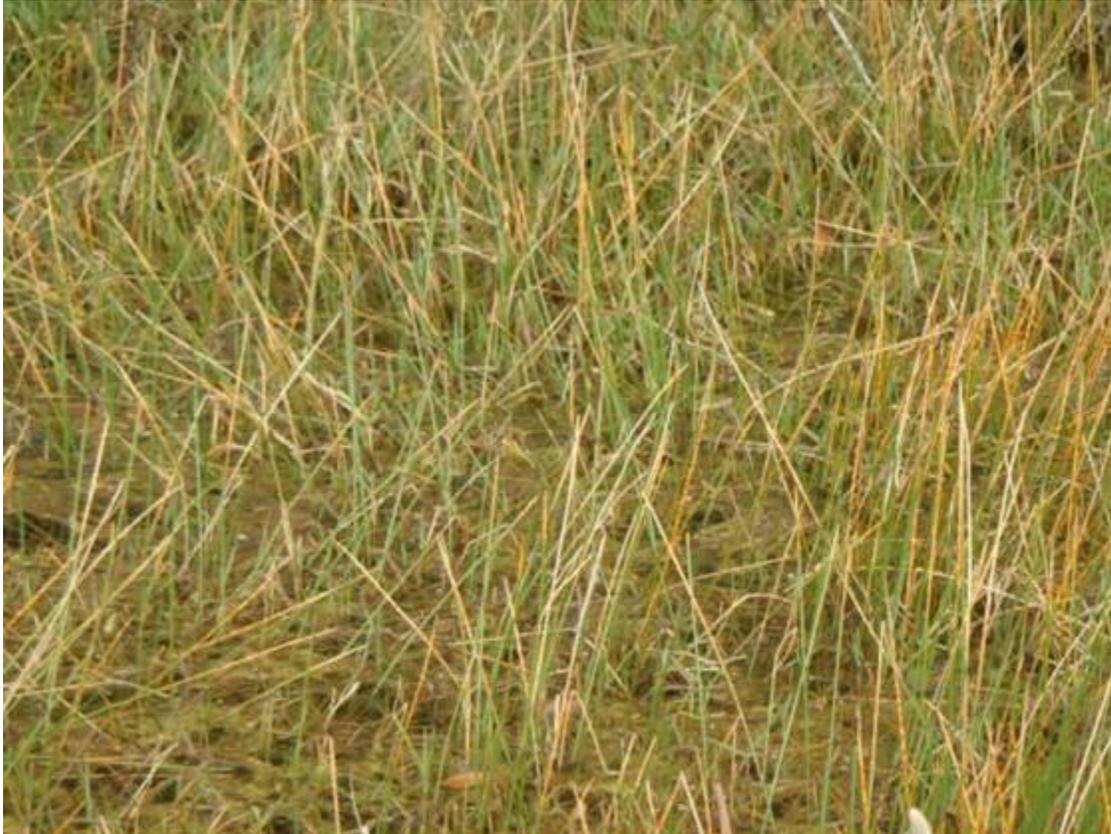
Native emergent vegetation found during the survey included: canna, slender spike rush, pennywort, hempweed, yellow cow lily, fragrant water lily, banana lily, pickerelweed, maidencane, Carolina willow, cordgrass, fire flag, and duck potato.

Photo: Slender spike rush (native)

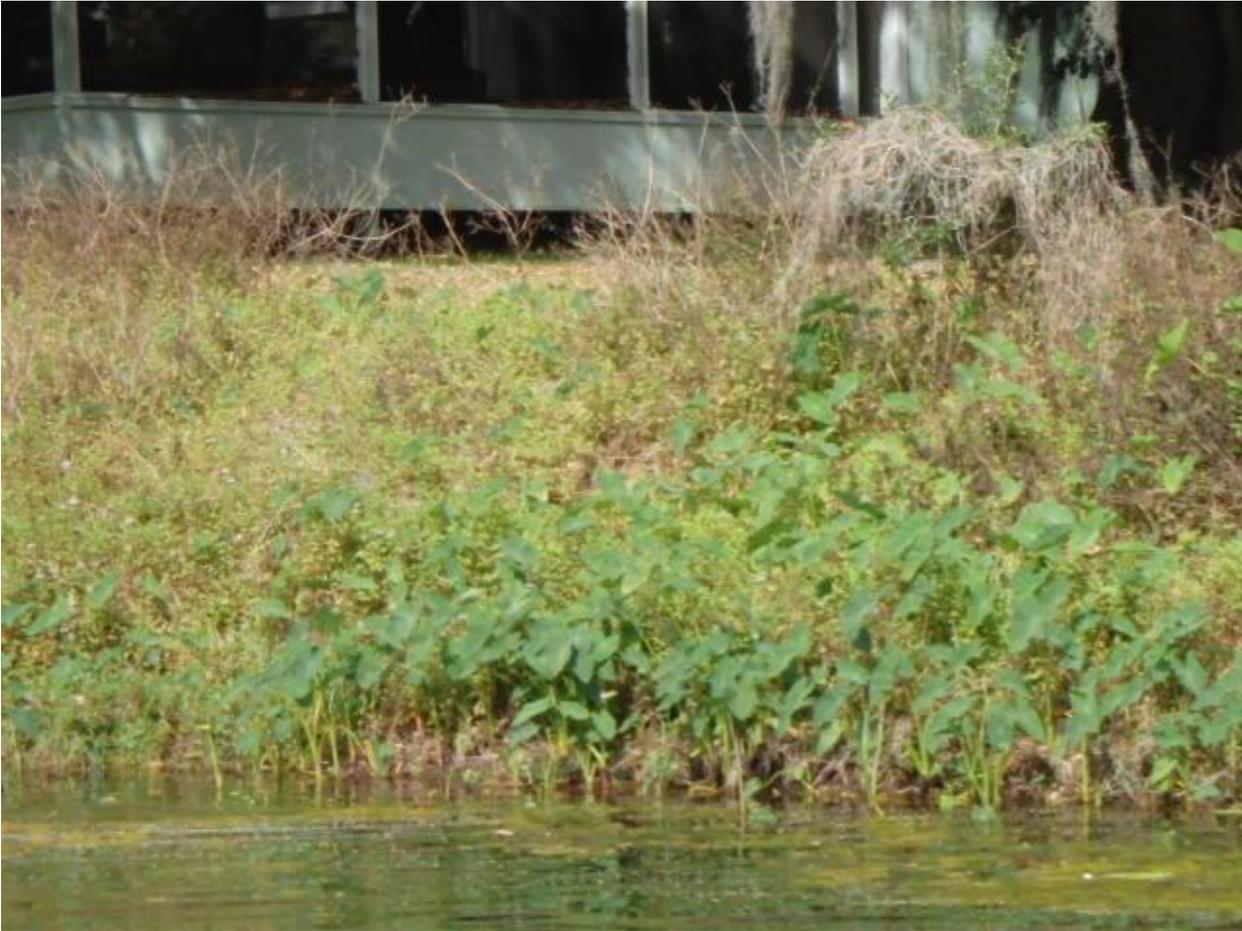
Invasive emergent vegetation included: alligator weed, wild taro, torpedo grass, wedelia, and cattail. No American lotus was present as in previous months. Cattail is coming back and will be targeted during the next herbicide treatment. Access corridors throughout the lake are open and navigable.

Photo: Wild taro (invasive)

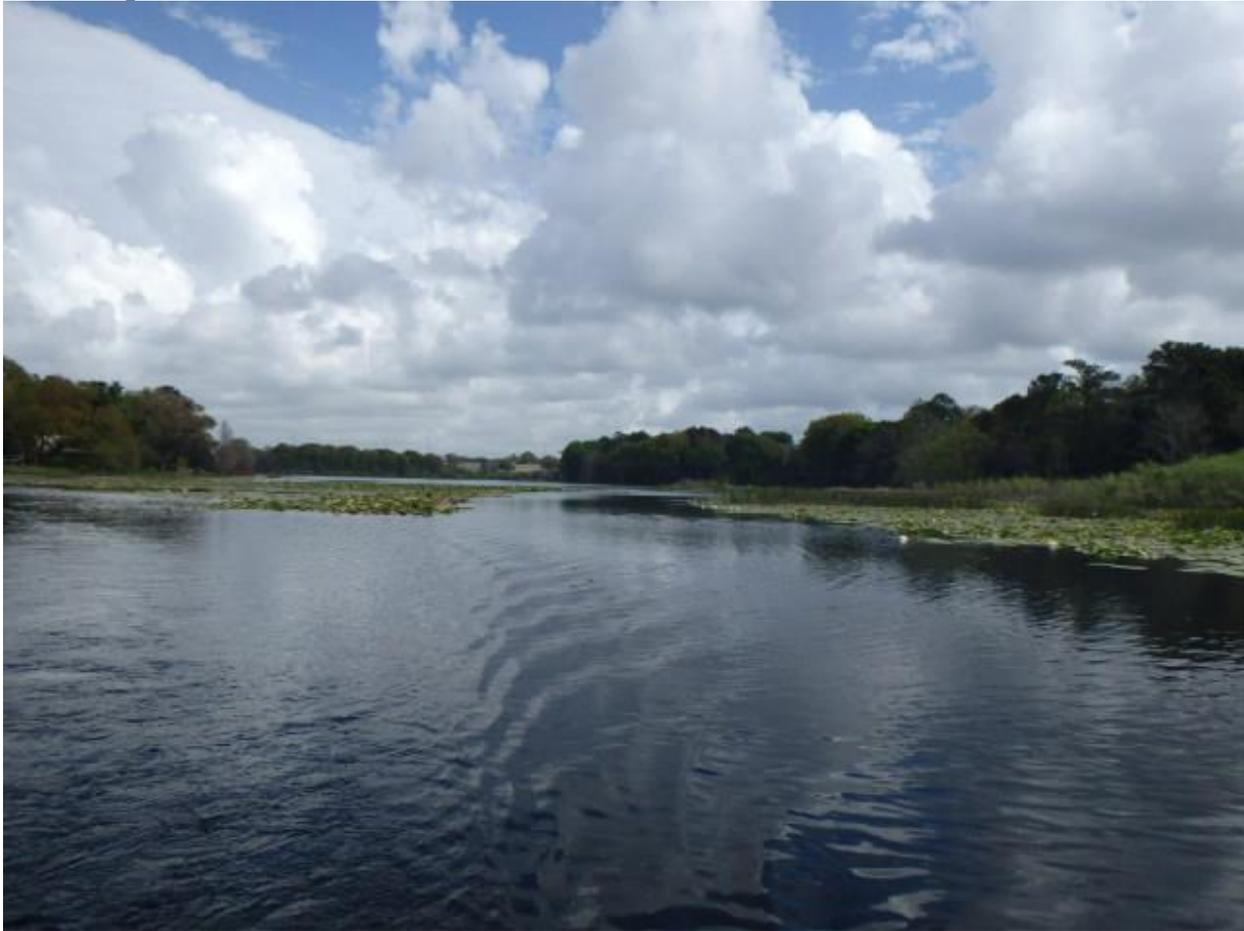
Photo: Open access corridor

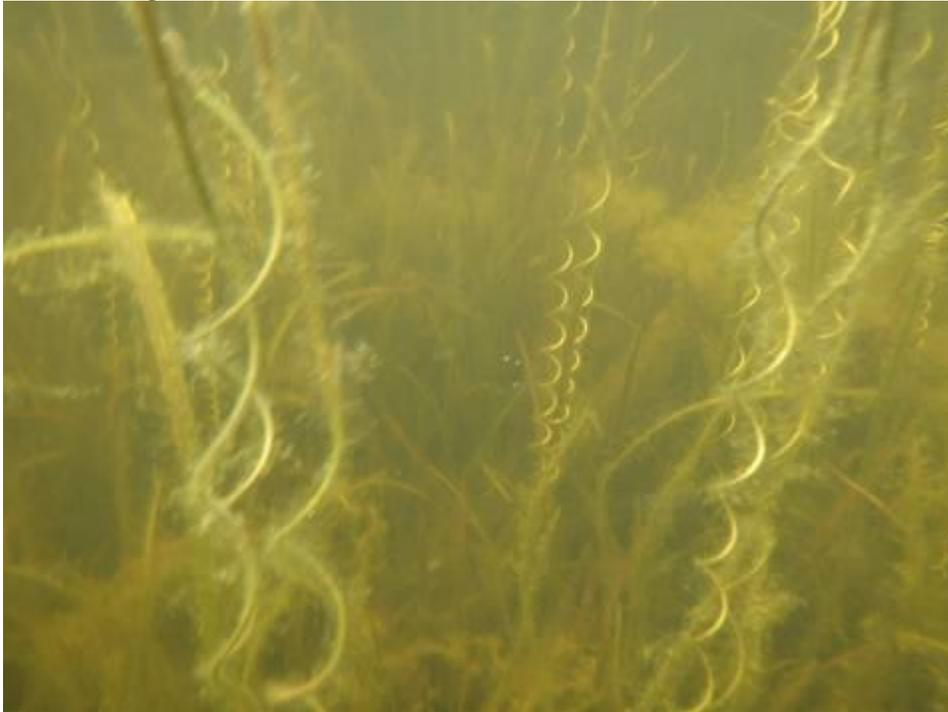
Seven species of native submersed aquatic vegetation (SAV) were found during the inspection. These native species included: southern naiad, baby's tears, eelgrass to 6 feet, lemon bacopa to 3 feet, and three species of bladderwort to 8 feet. Bladderwort was the dominant species of SAV found, with a major increase of topped out bladderwort observed on the south end of the lake. Native SAV plays an important part within Mirror Lake by providing wildlife habitat, reducing nutrients, and competing for space with hydrilla.

Photo: Eelgrass (native)

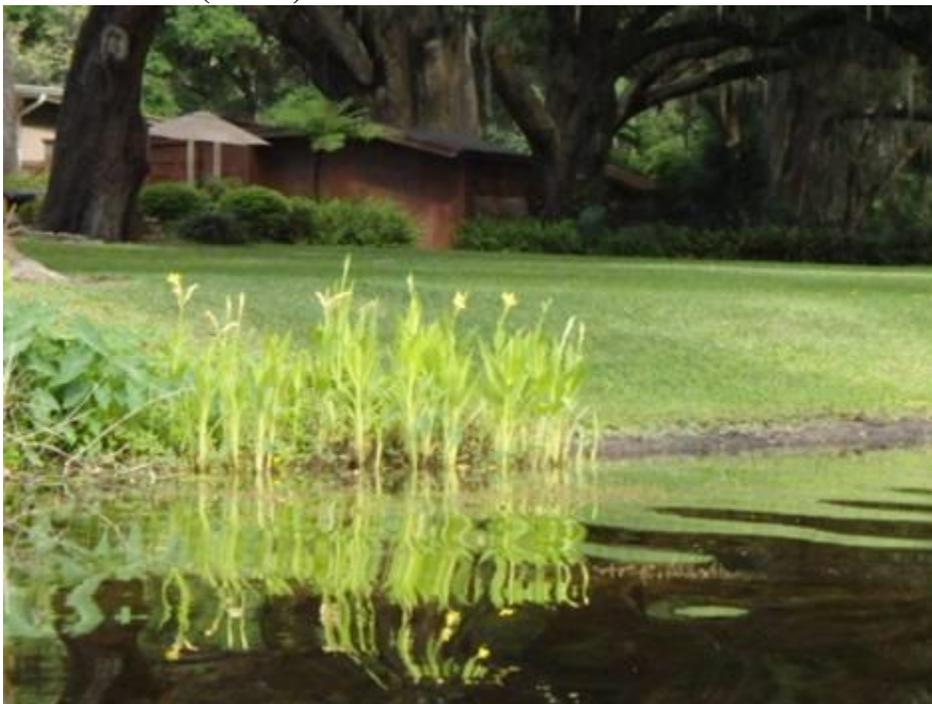
Native emergent vegetation found during the survey included: canna, iris, spike rush, pennywort, climbing hempweed, yellow cow lily, fragrant water lily, banana lily, pickerelweed, maidencane, Carolina willow, cordgrass, fire flag, buttonbush, American lotus, watermeal, and duck potato.

Photo: Canna (native)

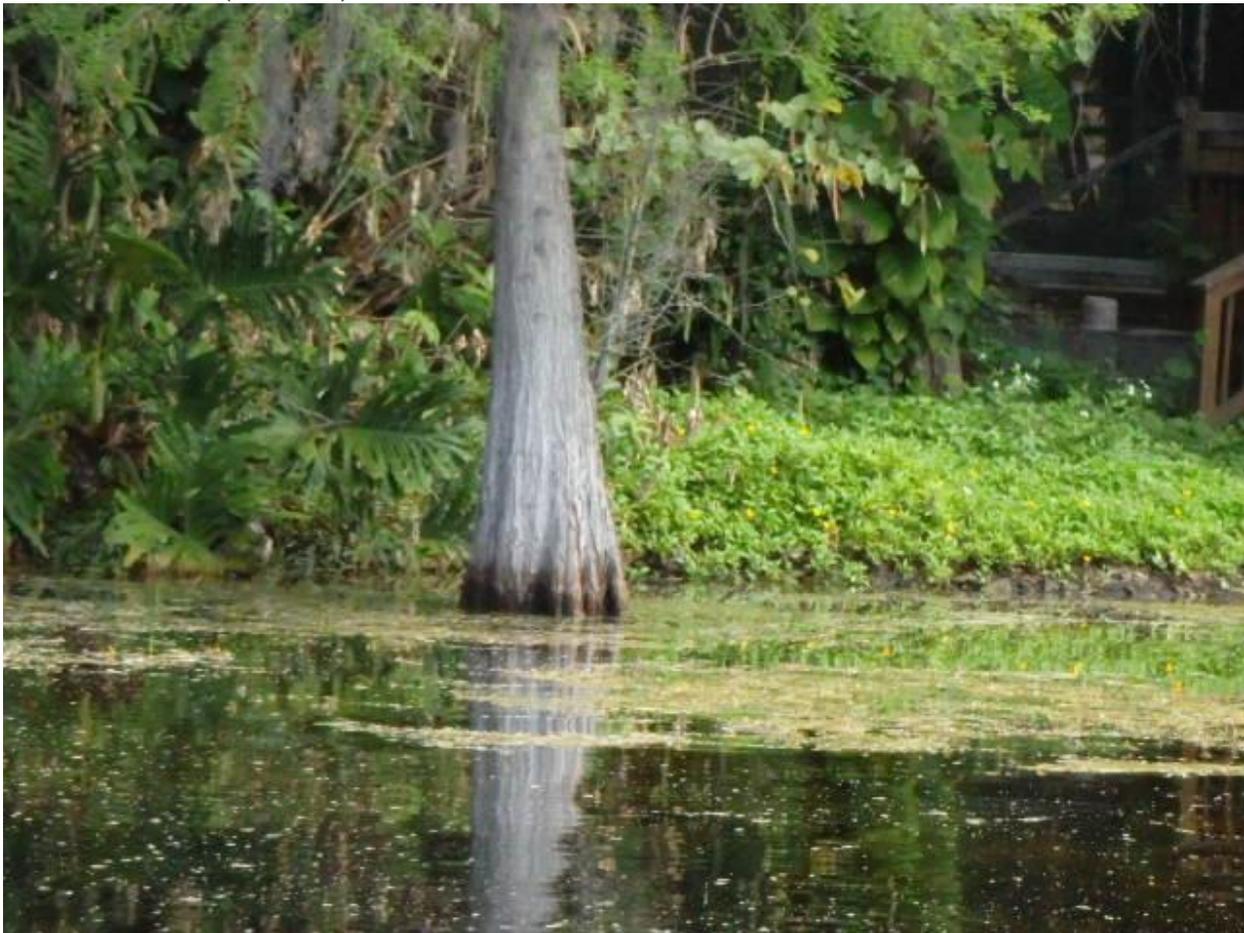
Invasive emergent vegetation included: alligator weed, wild taro, torpedo grass, wedelia, and cattail. Cattail showed signs of recent treatment. Lily pads and bladderwort will be targeted during the next treatment to ensure access corridors throughout the lake remain open and navigable. Additionally, one grass carp per acre will be added to the lake to help control SAV.

Photo: Wedelia (invasive)

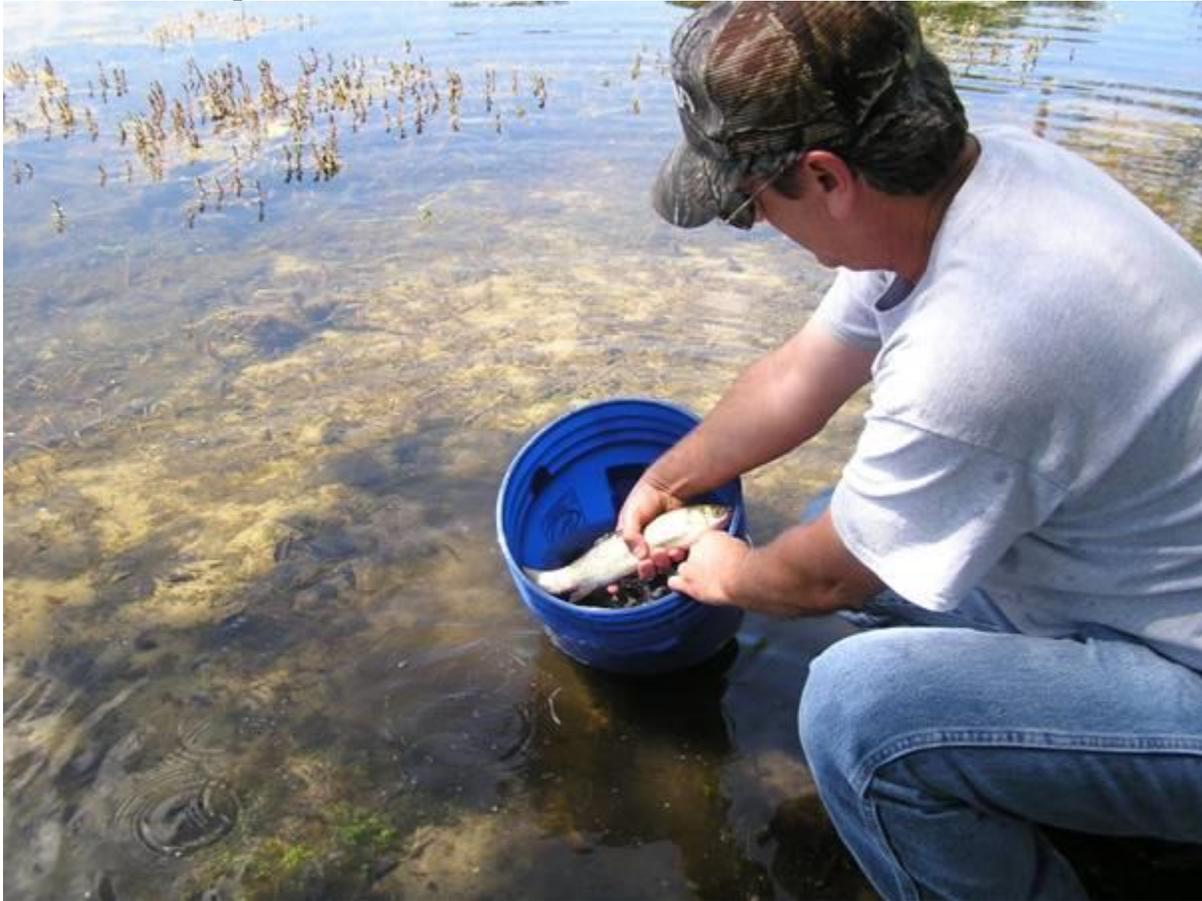
On **May 8th, 2015**, 34 fish were added to Lake Mirror to assist in control of SAVs.

Photo: Grass carp fish added to Mirror Lake.
