Greetings Spring Wood Lake and Springwood Waterway residents,

**Spring Wood Lake**

On **March 1<sup>st</sup>, 2016**, Seminole County Lake Management Program (SCLMP) staff, Thomas Calhoun and Joey Cordell, surveyed the aquatic plants of **Spring Wood Lake**.

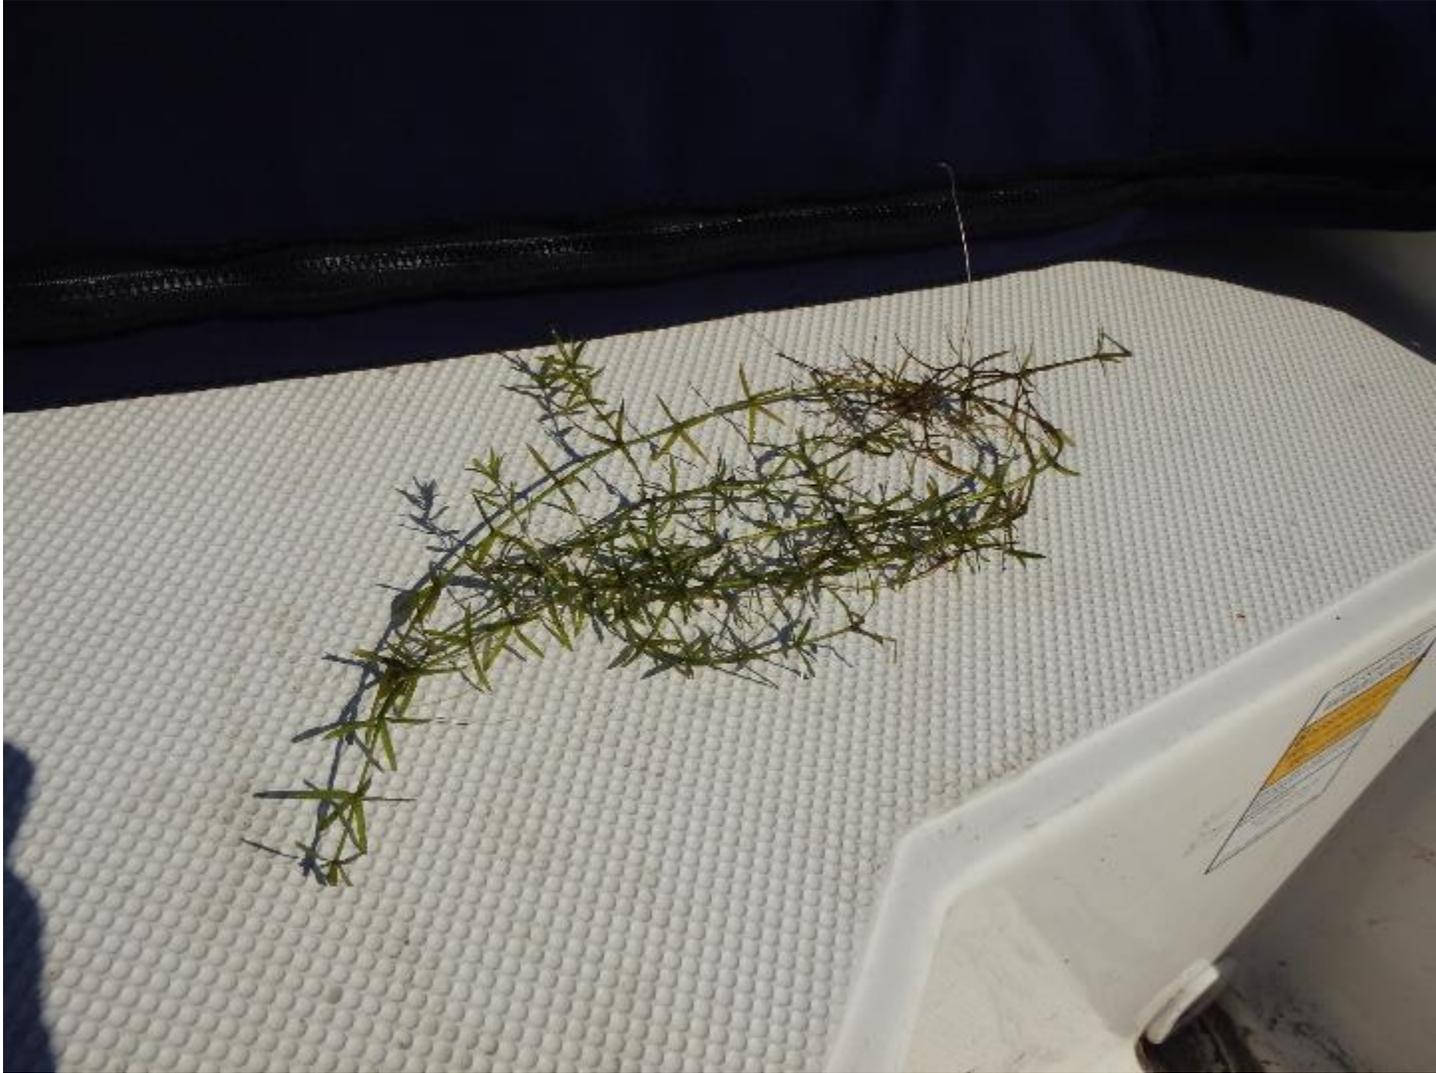
Hydrilla was found mixed in with southern naiad throughout the lake, to a maximum depth of 9 feet. Its distribution was spotty and not dense enough to target with an herbicide application. 40 sterile triploid grass carp were planned to be stocked to control hydrilla in the upcoming weeks.

**Photo: Hydrilla found to a depth of 9 feet.**

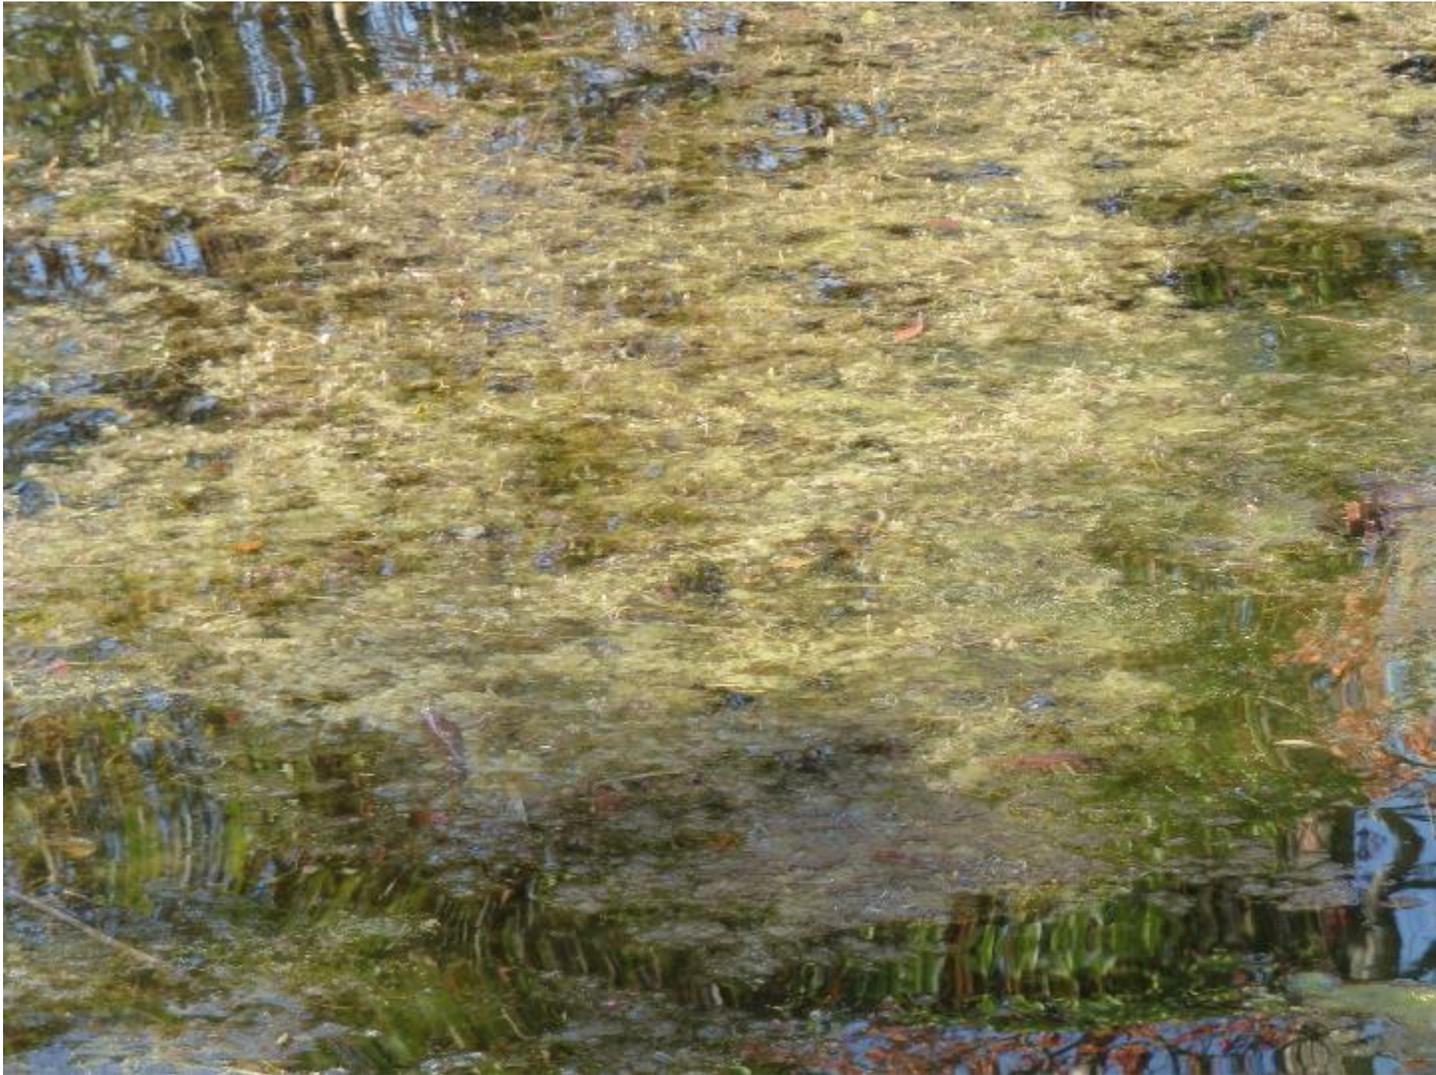
A substrate algae bloom was present at the southern side of the lake. To prevent algae blooms such as this one, it is important to lower the amount of nutrients entering the lake. Lake residents can participate in reducing nutrient levels by preventing yard clippings from entering the lake and only using phosphorus-free and slow-release nitrogen fertilizers.

**Photo: Algae bloom.**

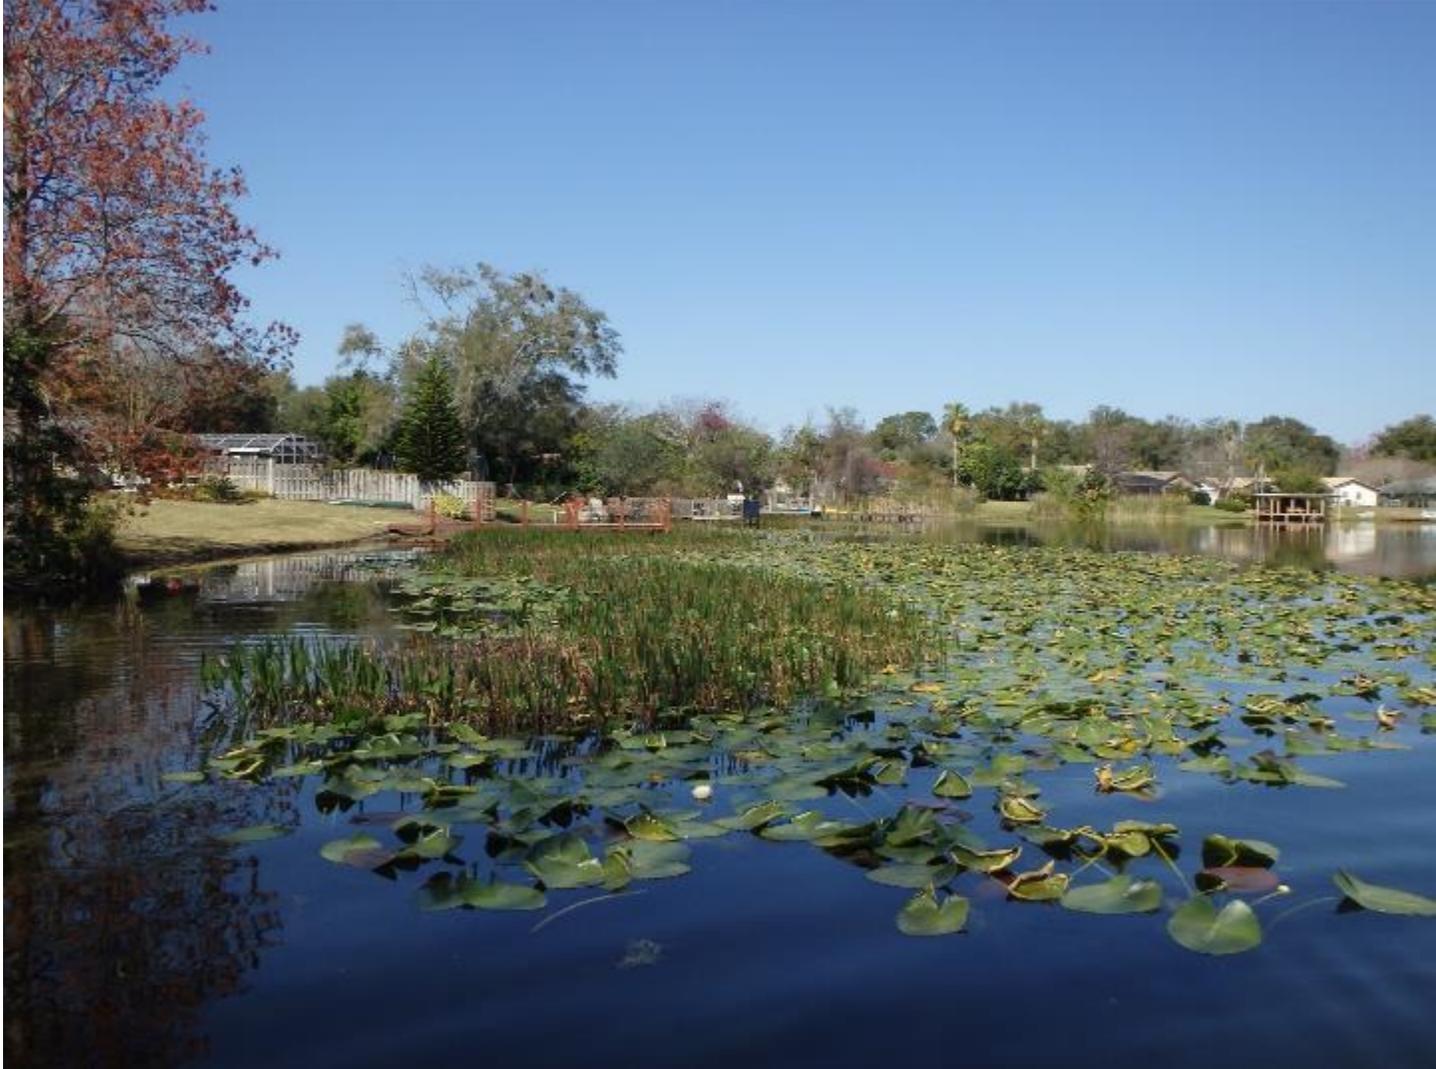
Native emergent vegetation included: umbrella sedge, yellow cow lily, fragrant water lily, pickerelweed, duck potato, fire flag, and cattail.

**Photo: Pickerelweed, yellow cow lily, and fragrant water lily.**

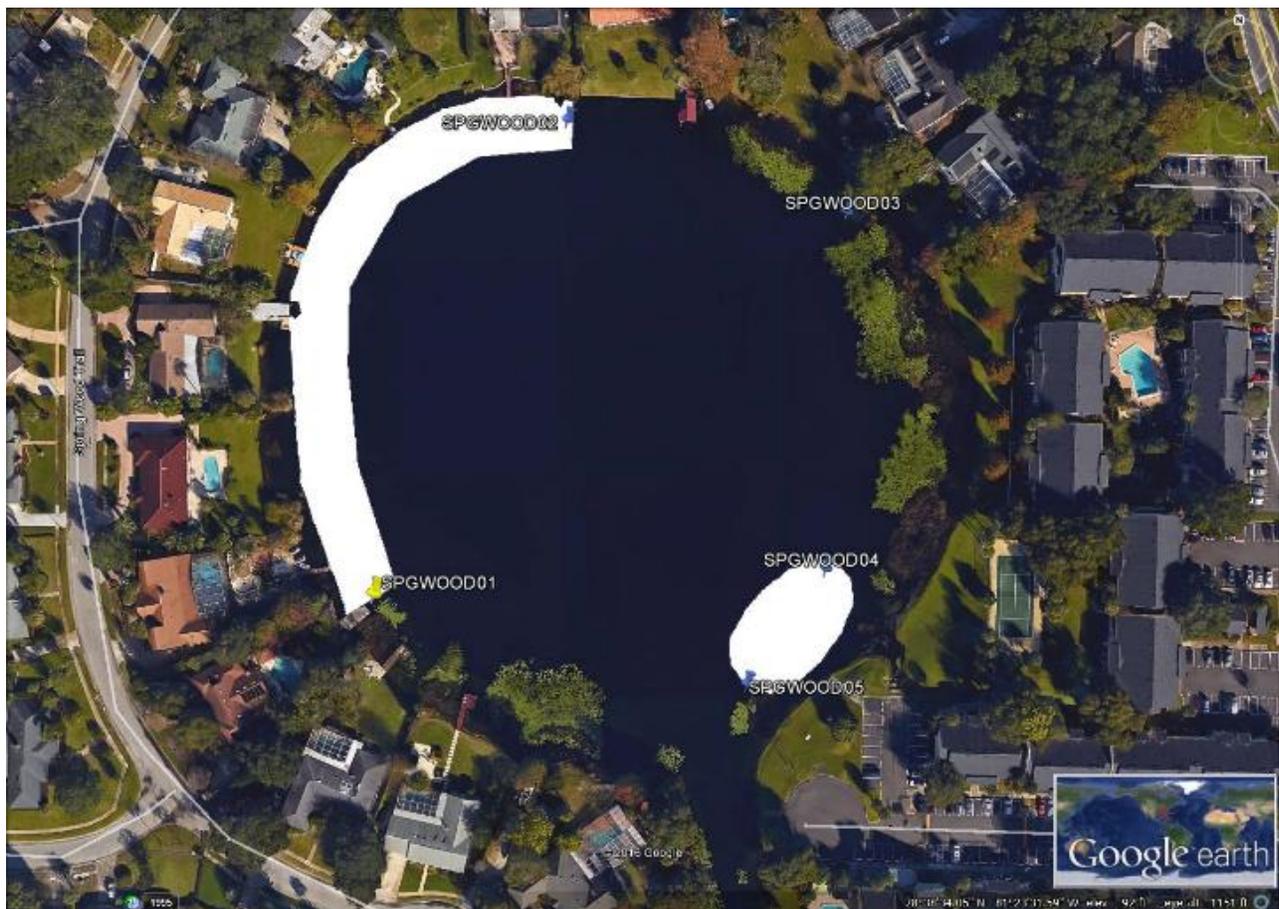
Hydrilla had expanded since the previous inspection. Three areas have been marked to be treated by an MSBU funded herbicide applicator. These areas include: a 50ft perimeter band from the southwest shore to the north seawall, a small but dense patch of hydrilla along the northeast shore, and 100ft x 50ft oval east of the canal. We expect some impact to the native southern naiad that is mixed in with the hydrilla in these treatment zones. On April 14<sup>th</sup>, 2016, 40 sterile triploid grass carp fish were stocked into Spring Wood Lake to control deep water hydrilla and the hydrilla that is too sparse to be spot treated.

**Photo: Hydrilla treatment zones.**

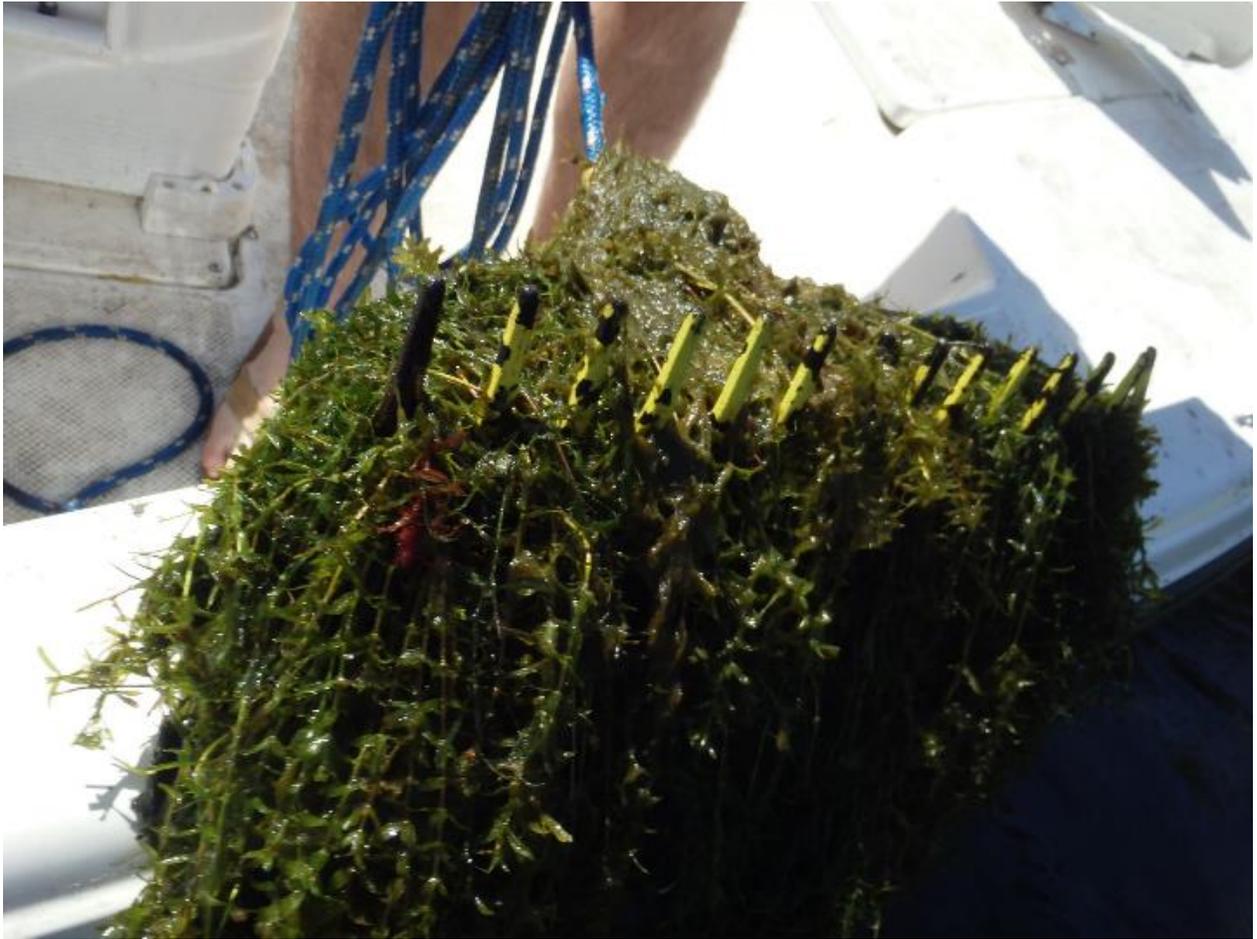
**Photo: Hydrilla.**

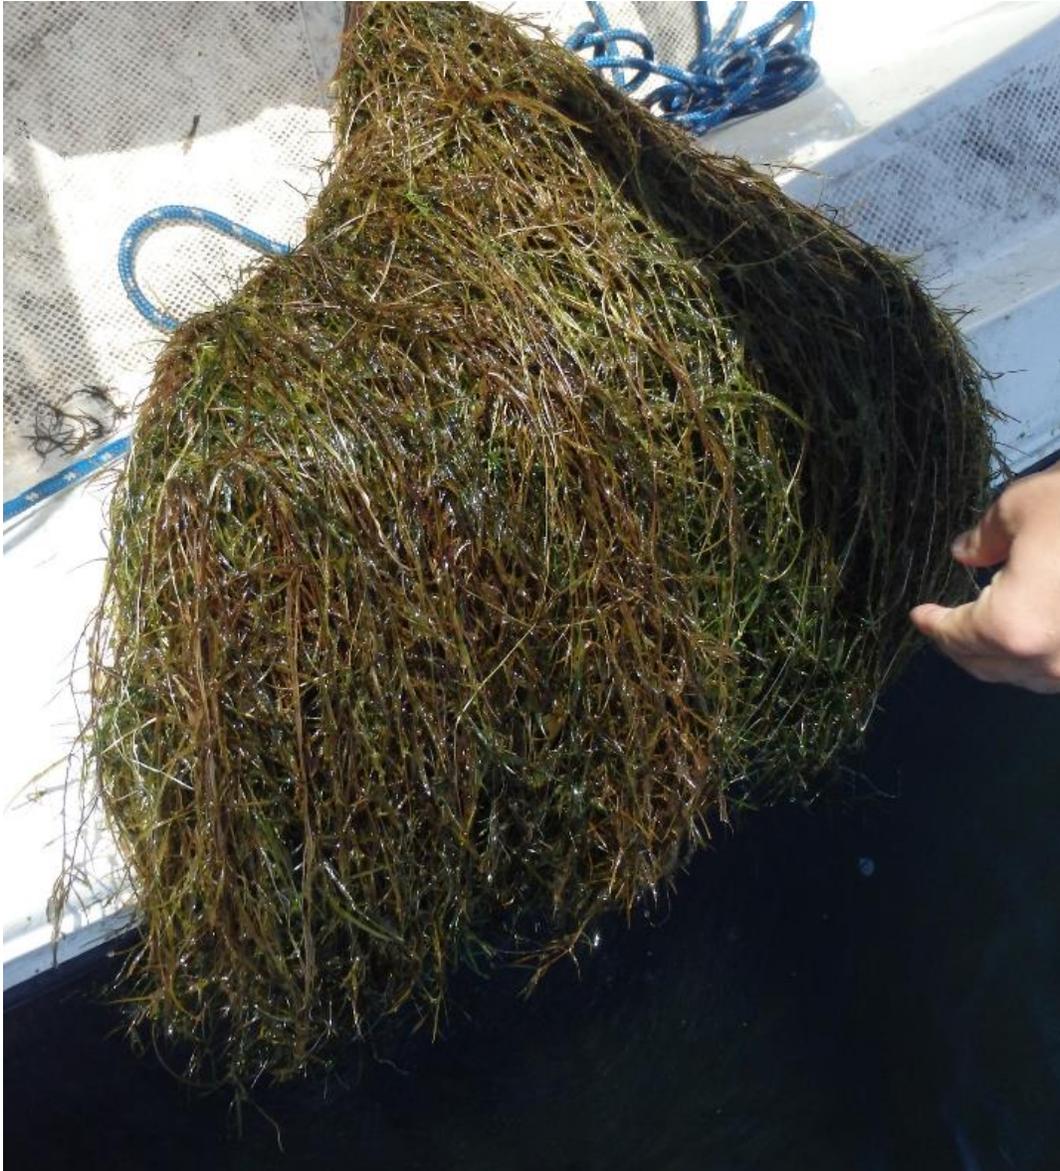
Native SAV included: lemon bacopa, stonewort, bladderwort, and southern naiad to 8 feet.

**Photo: Southern naiad.**
