**Spring Wood Lake**

On **June 6<sup>th</sup>, 2017**, Seminole County Lake Management Program (SCLMP) Thomas Calhoun and Joey Cordell surveyed the aquatic plants of **Spring Wood Lake**.

## **Springwood Waterway**

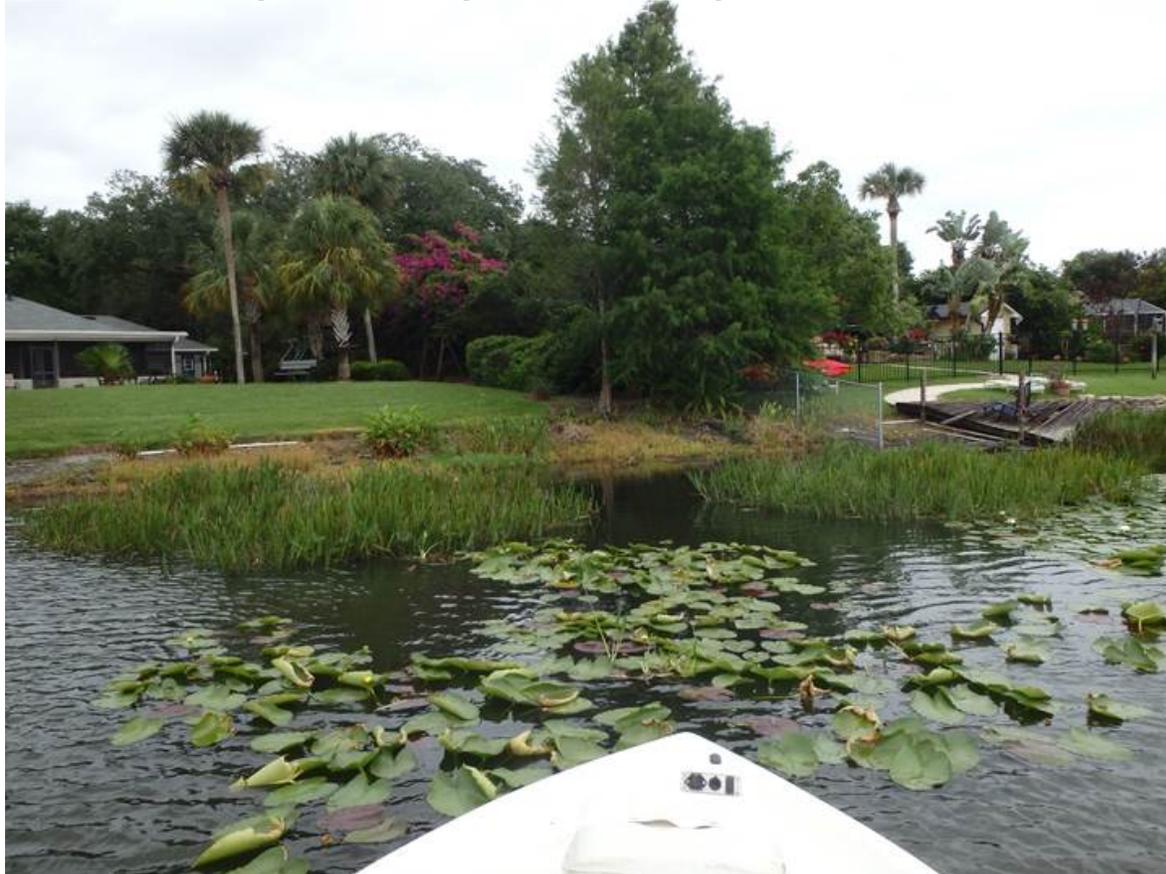
Invasive emergent vegetation included: alligator weed, umbrella grass, primrose willow, torpedograss, and creeping oxeye. Some invasive species, such as alligator weed and torpedograss, had expanded since the previous inspection but have begun to die from a recent MSBU funded herbicide application.

**Photo: Invasive vegetation turning brown after being treated.**

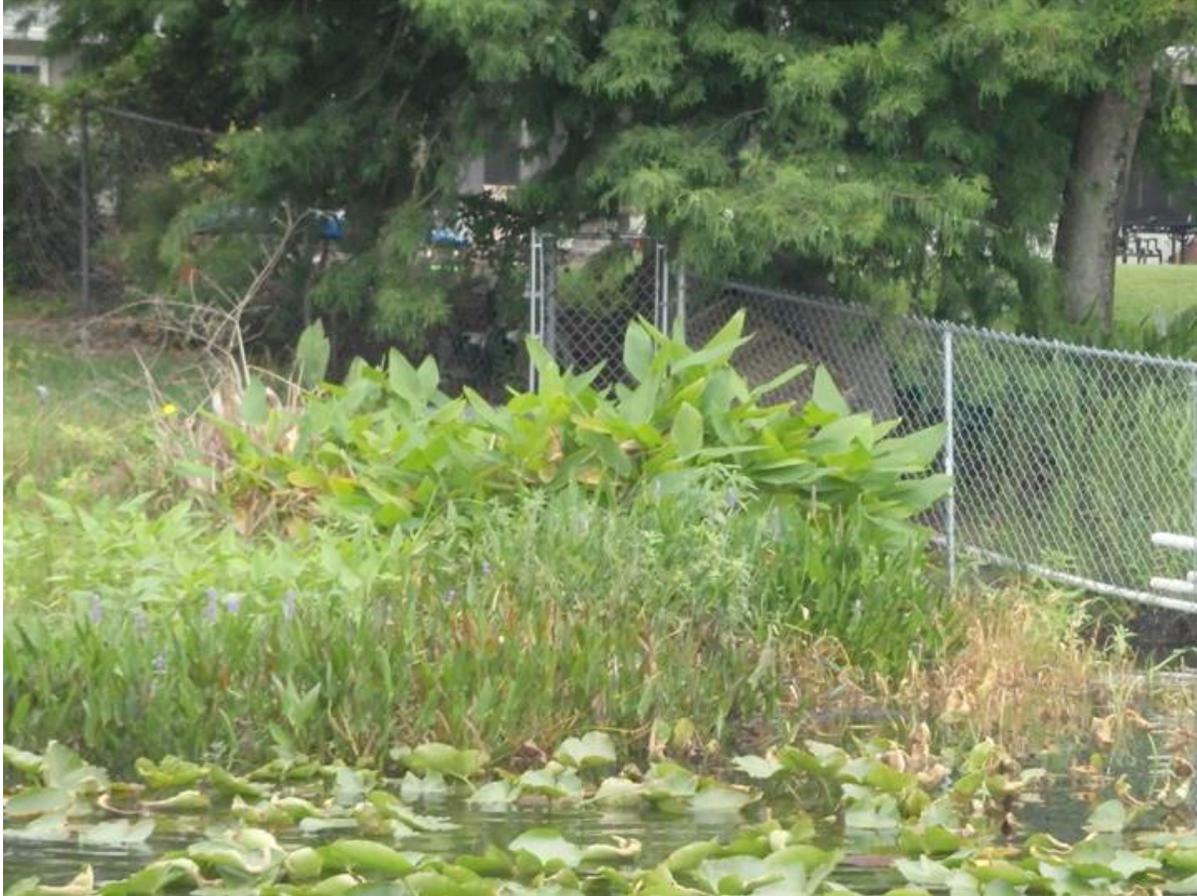
Native emergent vegetation included: flat sedge, pennywort, sofrush, hempvine, spatterdock, fragrant water lily, maidencane, pickerelweed, duck potato, bulrush, and cattail.

**Photo: Fire flag (native), pickerelweed (native), and spatterdock (native).**

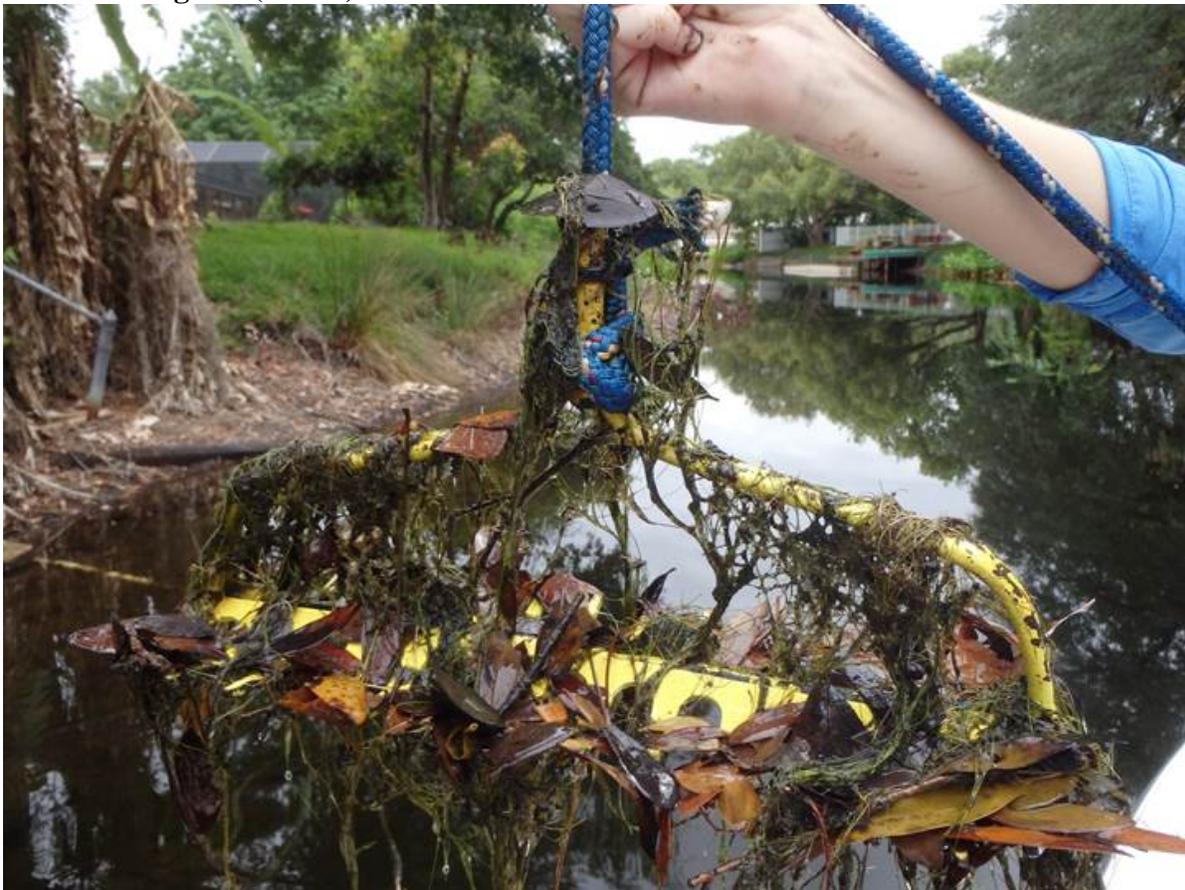
Native SAV found included: lemon bacopa, roadgrass, stonewort, and bladderwort. SAV coverage had decreased throughout the entire waterway, but the presence of roadgrass had increased slightly. The waterway was open and navigable.

**Photo: Roadgrass (native).**

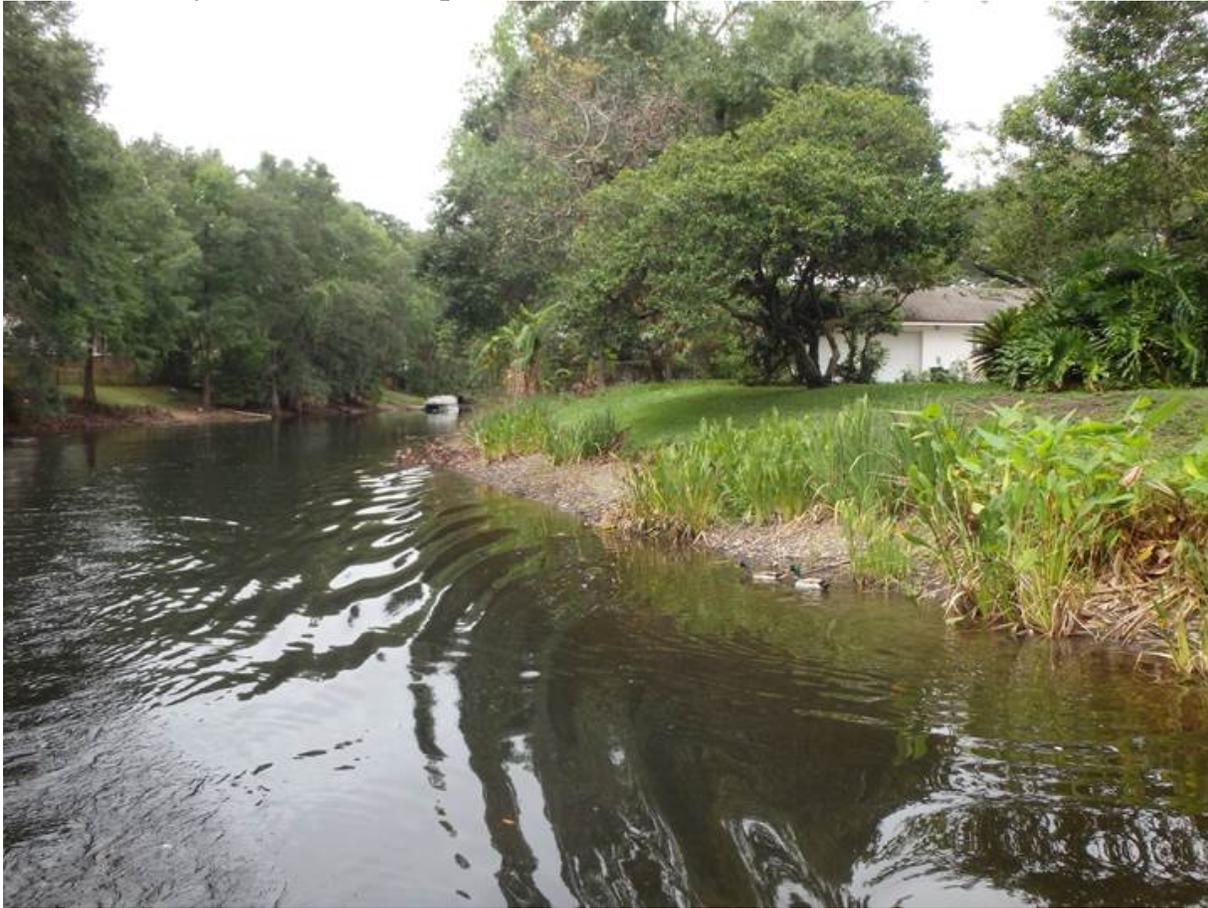
Native emergent vegetation found during the inspection included: bur-marigold, spotted water-hemlock, flat sedge, rush fuirena, pennywort, sofrush, hempvine, fragrant water lily, pickerelweed, duck potato, bulrush, blue flag iris, and climbing aster. The shoreline vegetation was very healthy and robust. Many young fire flag plants were sprouting.

**Photo: Healthy native shoreline plants.**

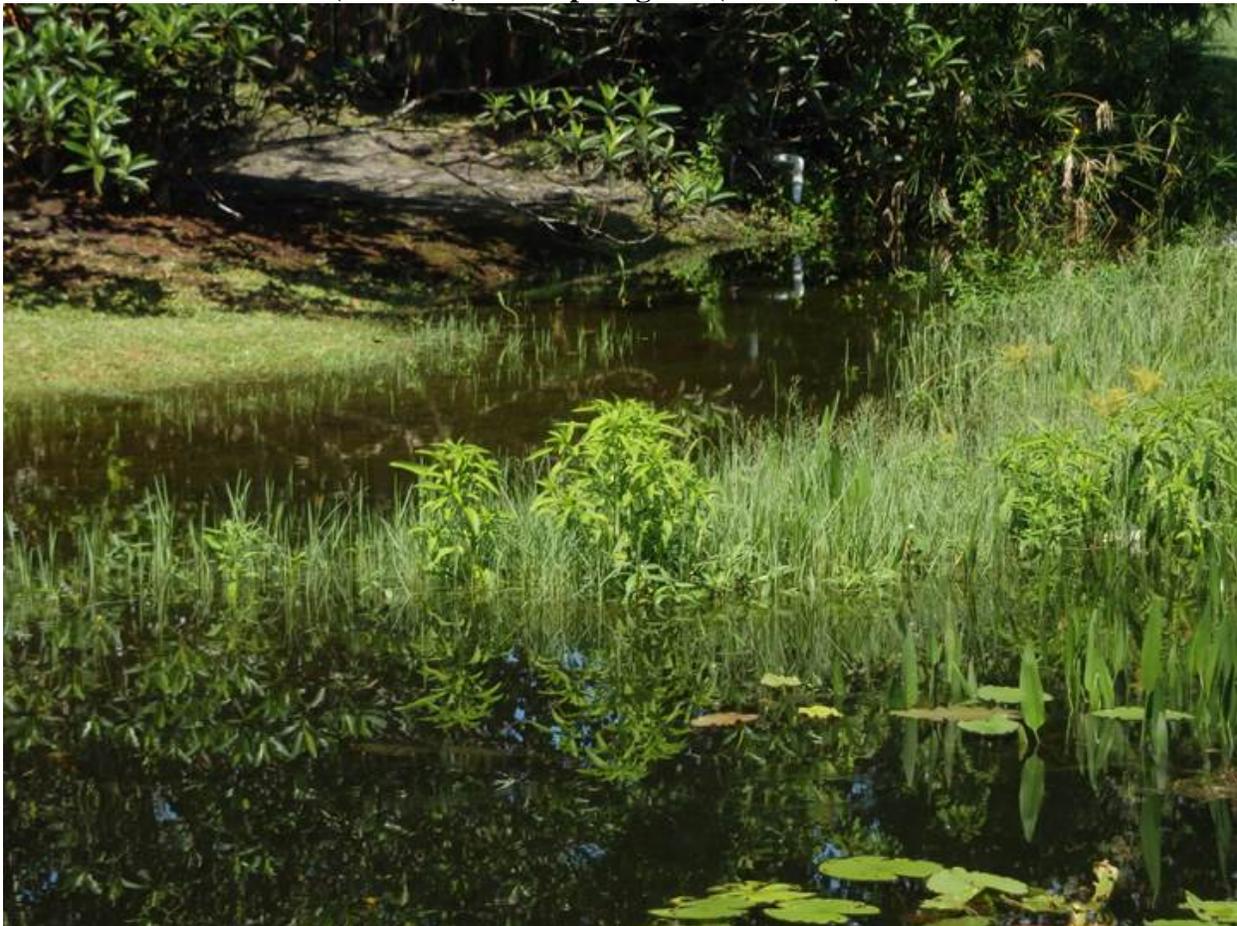
Invasive emergent vegetation included: alligator weed, primrose willow, torpedograss, creeping oxeye, and barnyard grass. Torpedograss had expanded. Barnyard grass had grown along the East shoreline by the apartments.

**Photo: Primrose willow (invasive) and torpedograss (invasive).**

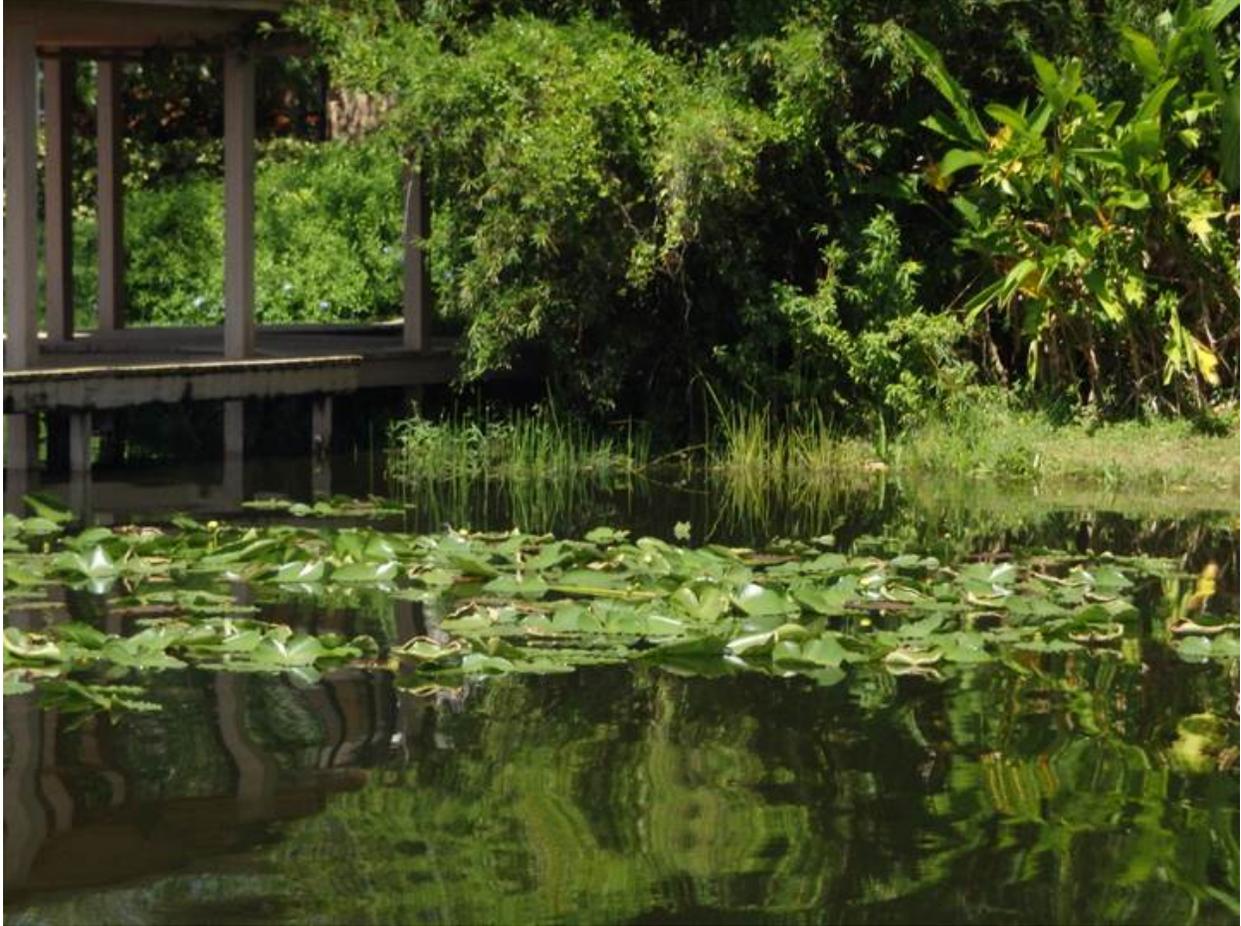
water. The spikerush and sawgrass that was planted during the last shoreline restoration had begun to expand.

**Photo: Spikerush (center left) and sawgrass (center right).**

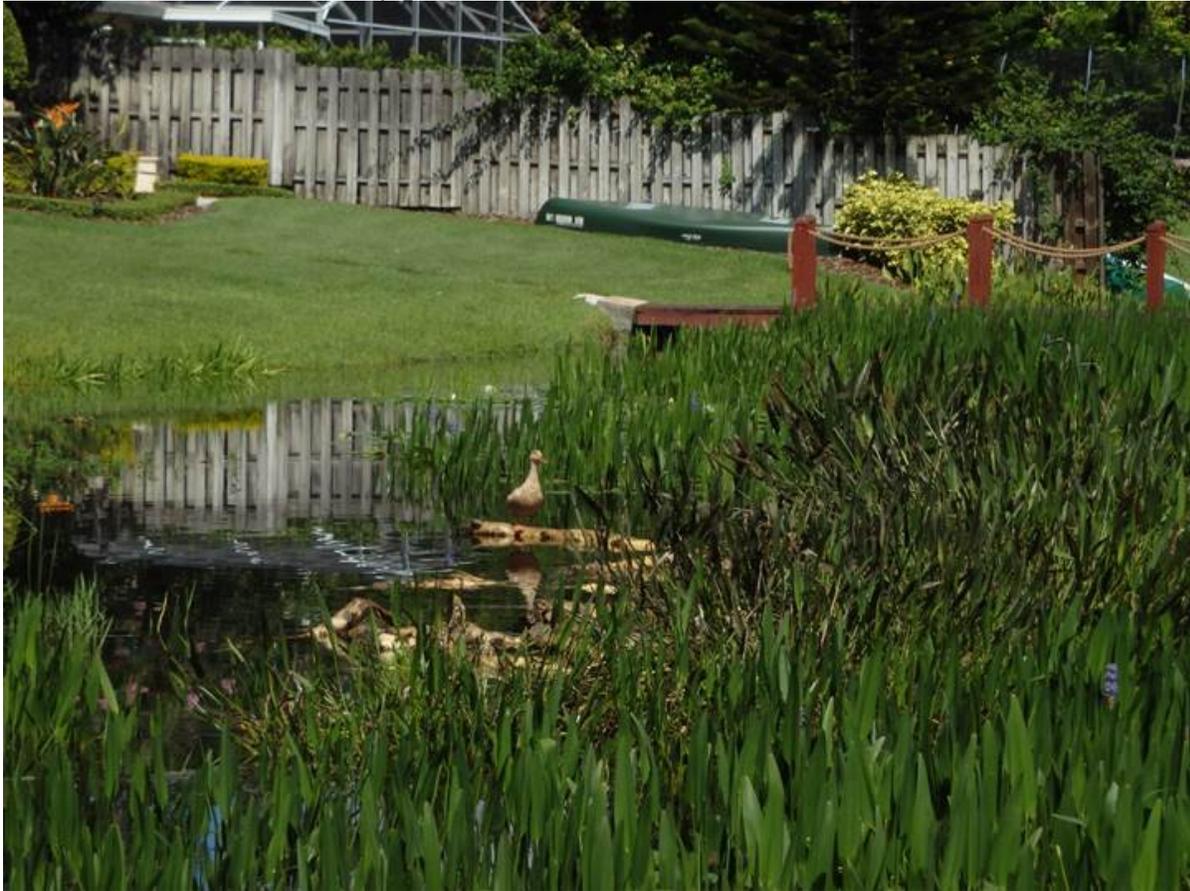
**Photo: Duck on a treated lily pad tuber.**

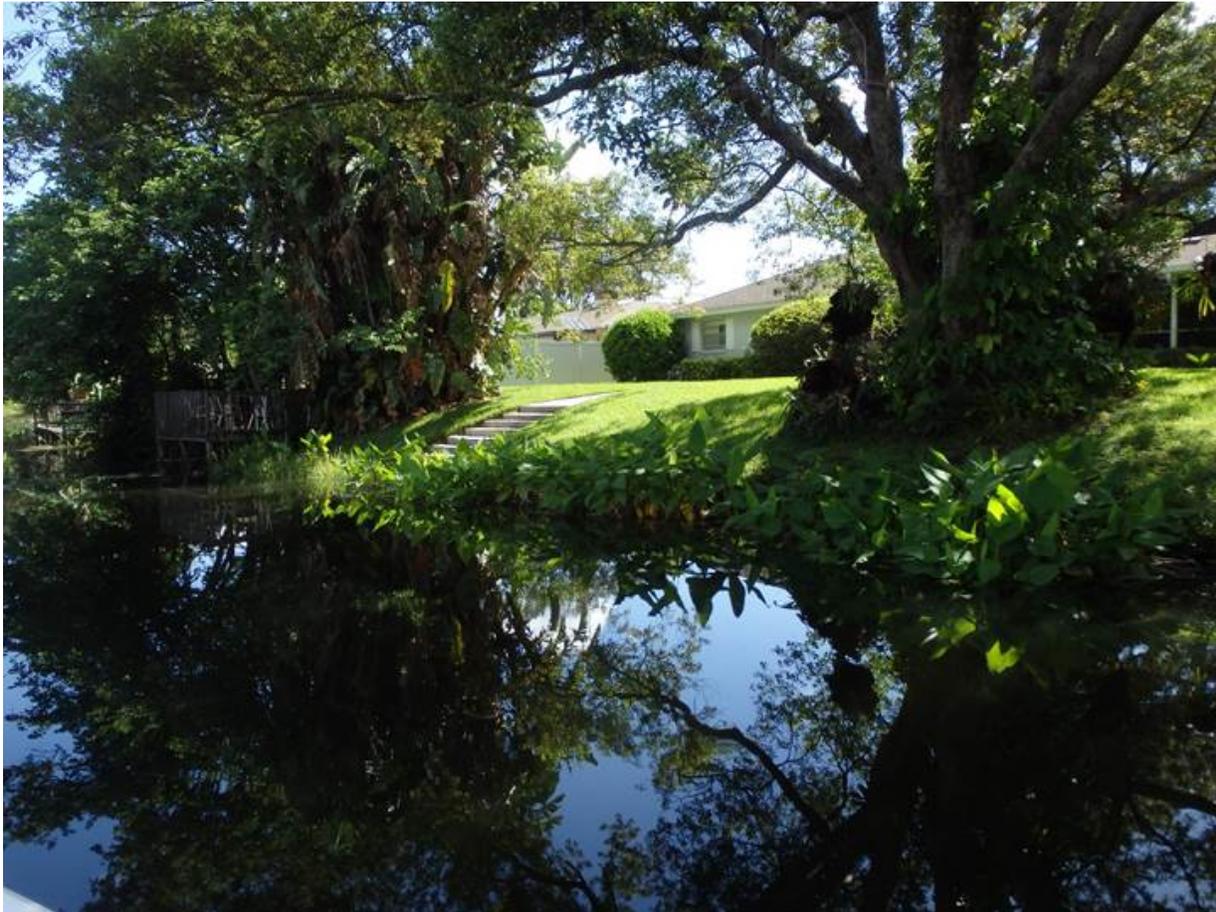
Native emergent vegetation found during the inspection included: bur-marigold, golden canna, flat sedge, rush fuirena, hempvine, fragrant water lily, pickerelweed, duck potato, bulrush, fire flag, and blue flag iris. The native plants were very healthy.

**Photo: Fire flag (native).**

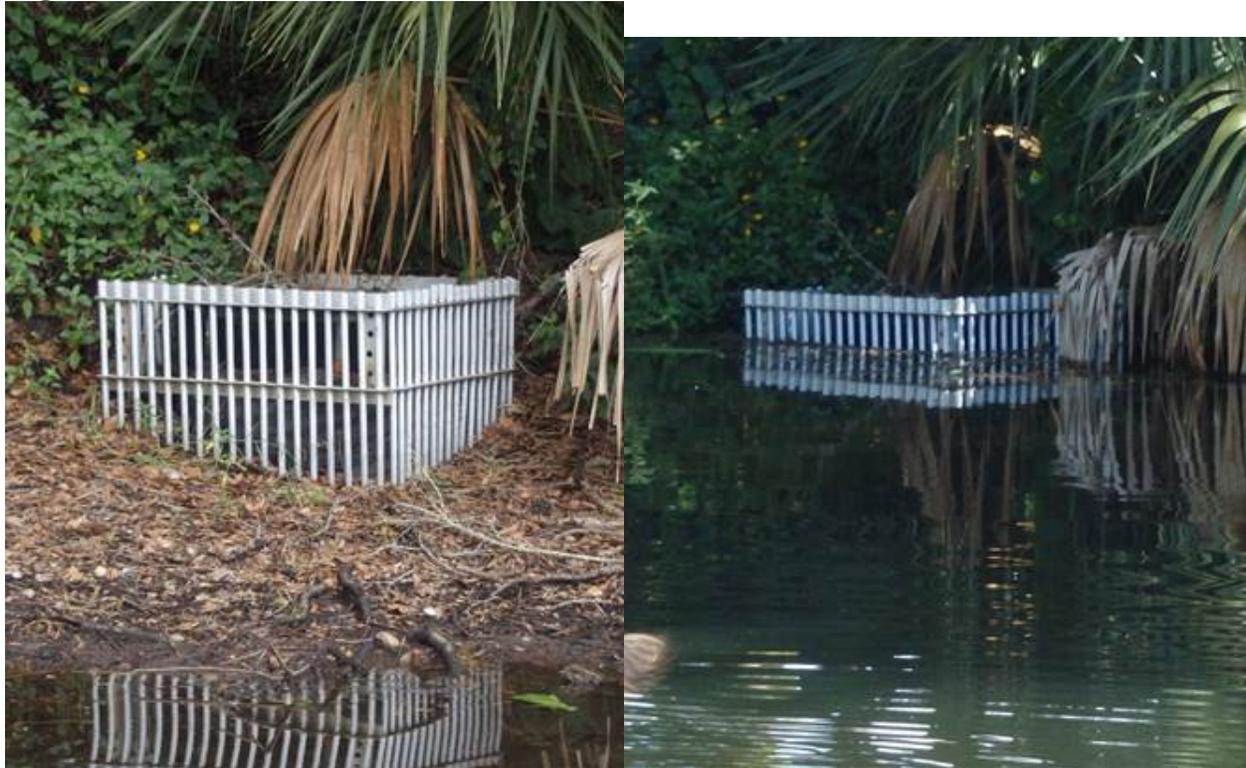
The grass carp barriers were inspected and found to be in good condition and flowing.

**Photo: The same grass carp barrier during June's inspection (left) and July's inspection (right).**
