LAKE PICKETT
INSPECTIONS for AUGUST 15 and DECEMBER 2, 2013

AUGUST 15, 2013

DECEMBER 2, 2013

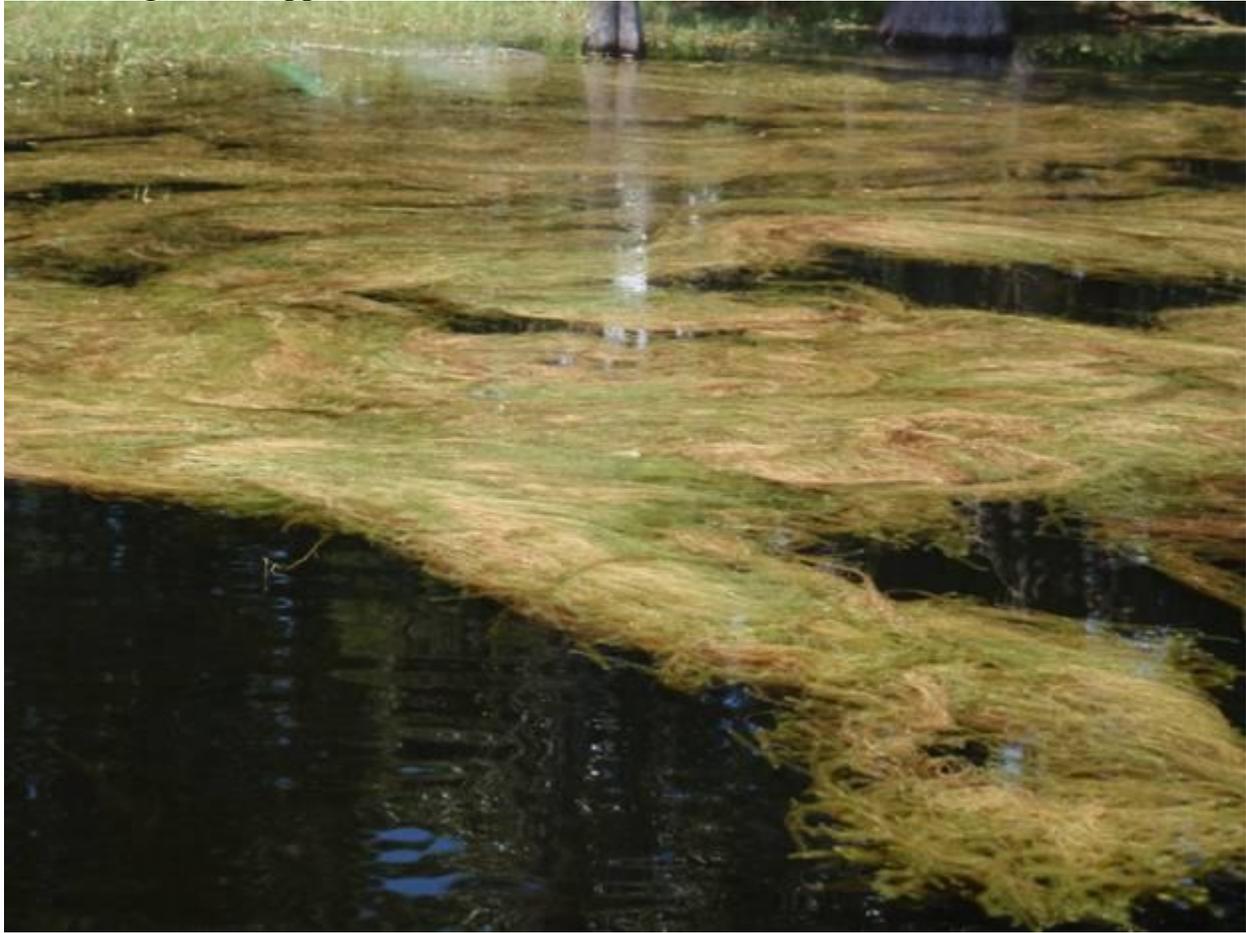
Native submersed vegetation found within the lake included: lemon bacopa to a depth of 3 feet, road grass to 13 feet, southern naiad to 16 feet, stonewort (nitella) to 16 feet, fanwort to 5 feet, and bog moss to 13 feet. The native bog moss was found "topped out" at the surface along the perimeter of the lake to a depth of 9 feet in many areas. The exotic hydrilla was observed sparse and to a depth of 3 feet.

Photo: Bog moss “topped out” near shoreline.

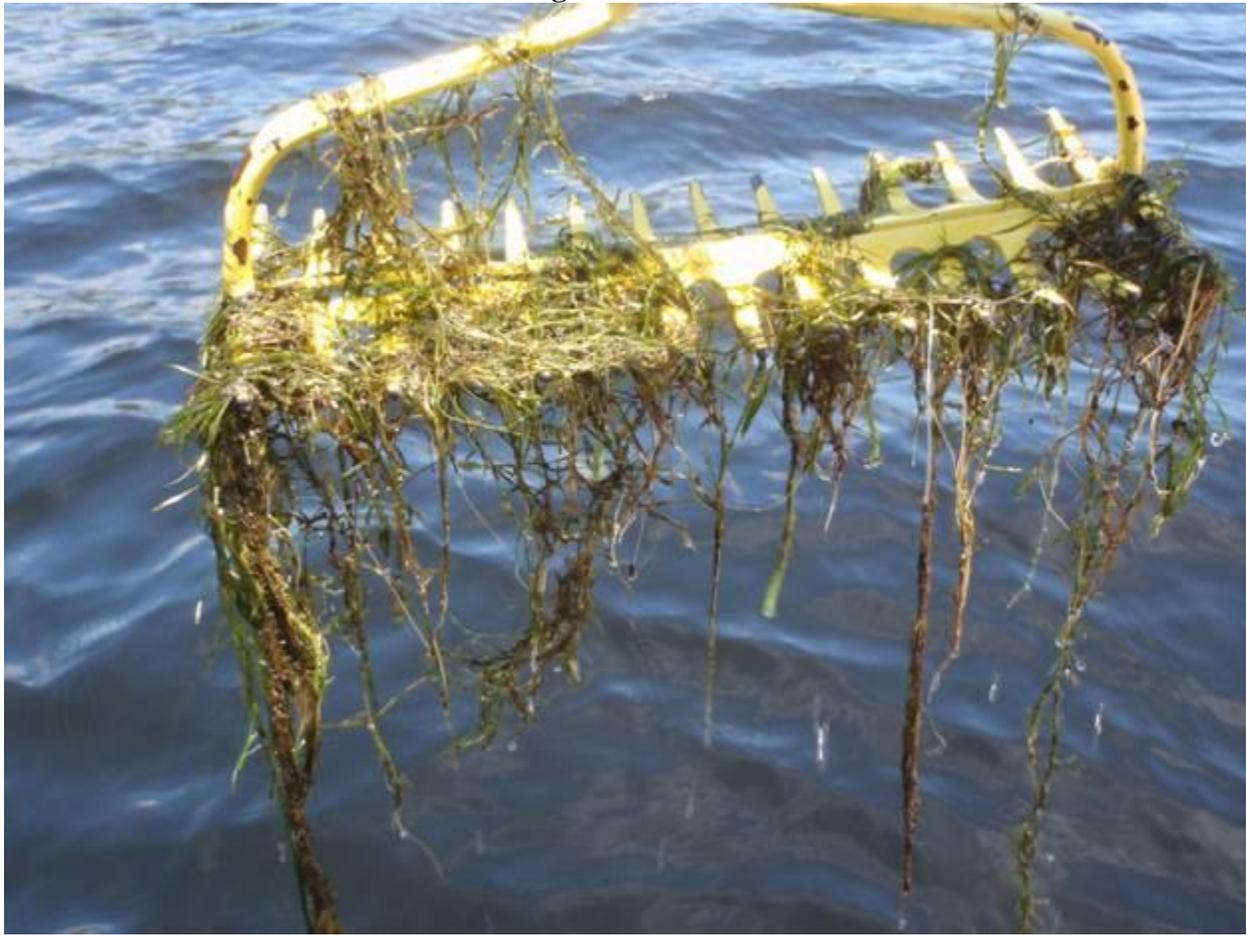
Photo: Southern naiad mixed in with bog moss.

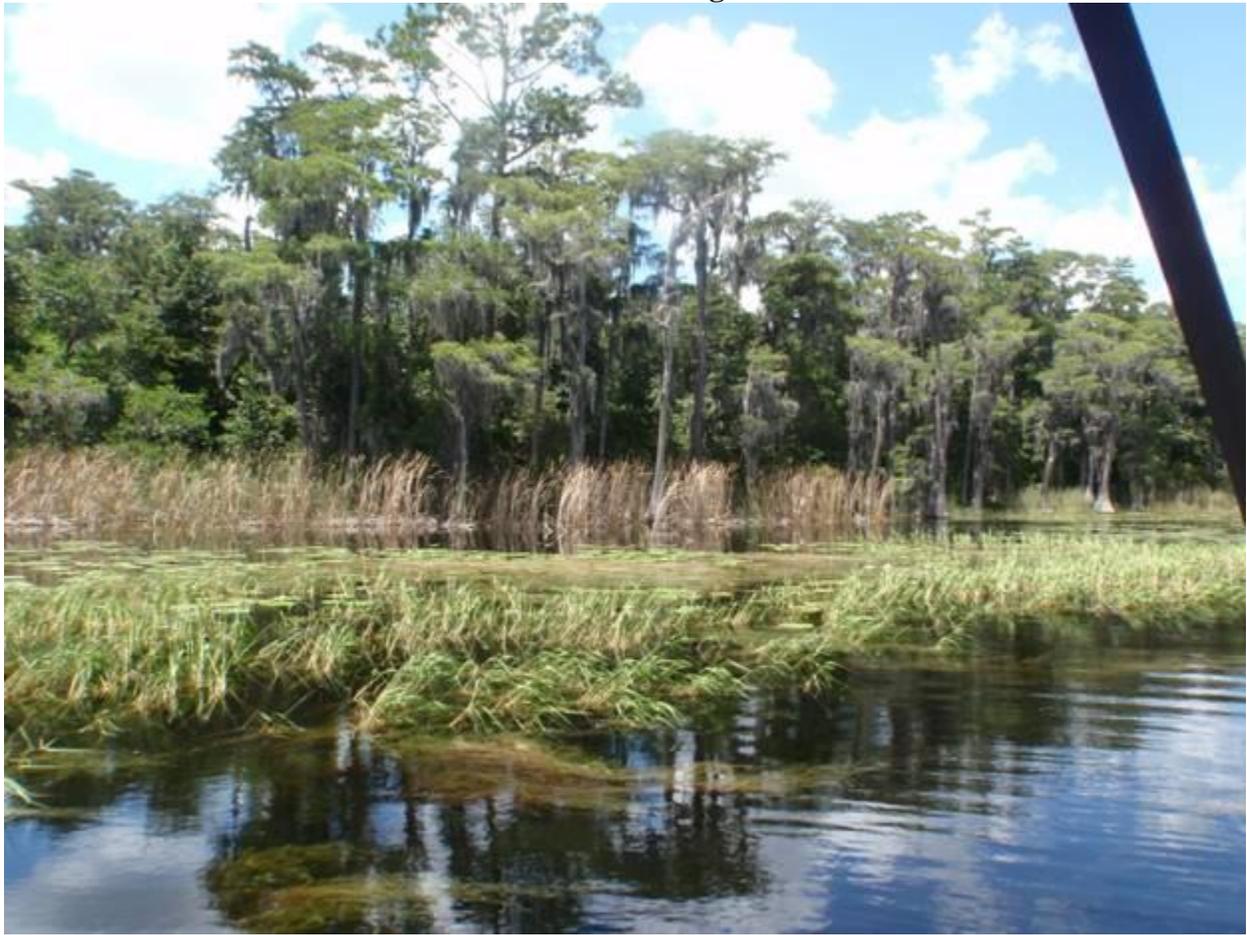
Lake Pickett contained a very healthy amount of native shoreline vegetation. The shoreline vegetation observed during the inspection included: saw grass, rush fuirena, maidencane, pickerelweed, and duck potato.

Photo: Maidencane with treated cattails in the background.

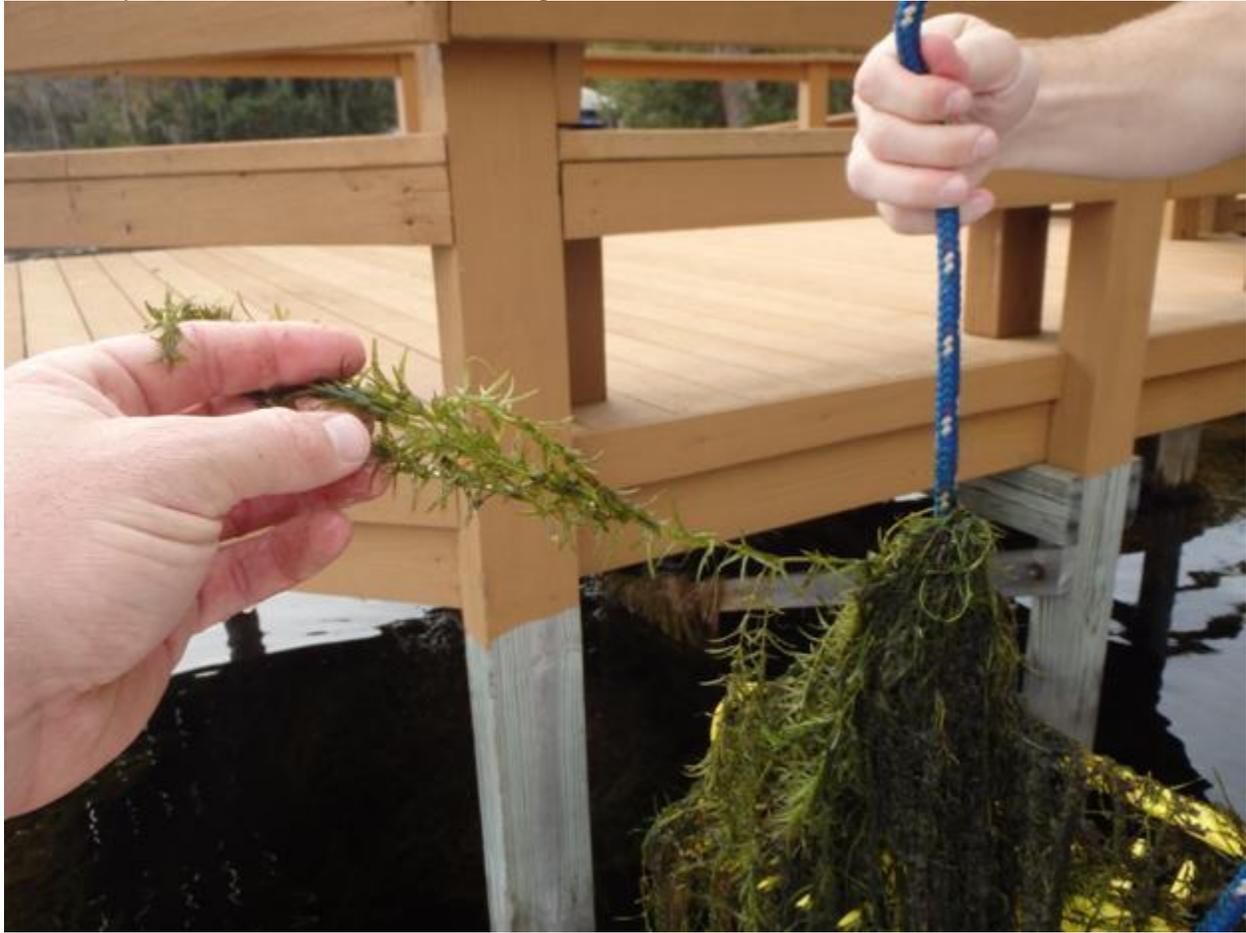
Photo: Hydrilla found mixed in with bog moss.

Native submersed vegetation found within the lake included: lemon bacopa to a depth of 3 feet, road grass to 3 feet, southern naiad to 4 feet, stonewort to 8 feet, bladderwort to 3 feet, and bog moss to a depth of 8 feet. Bog moss was found topped out (floating at the surface) in depths less than 6 feet but was found to be reduced from previous inspections. As winter approaches, bog moss should naturally recede from the surface of the lake as it enters its winter senescence. The invasive Asian marshweed (*Limnophila sessileflora*) was also found in several areas of the lake. As mentioned, hydrilla was found intermixed with the native bog moss along northeast portion of the east lobe and around the Lake Pickett Woods HOA boat ramp. Other points of hydrilla observation coincide with the OCEPD map.

Orange County Environmental Protection Division (OCEPD) conducted a thorough hydrilla inspection October 28th-29th. An herbicide treatment has been scheduled to treat 18 acres of hydrilla and 1 acre of cattails. Collaboratively, we will continue to monitor the inshore areas of the lake to enable rapid response to new hydrilla growth (via chemical spot treatments).

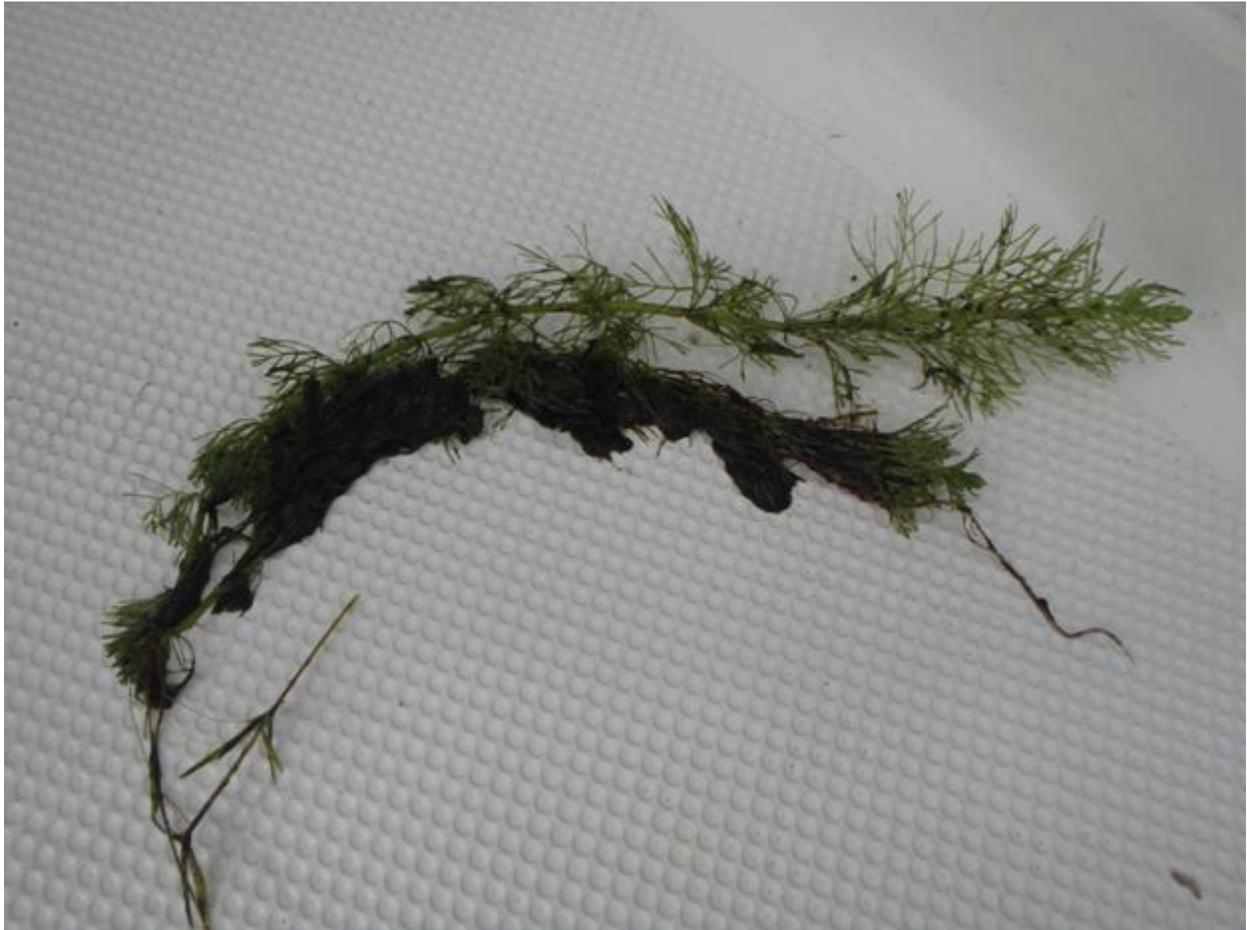
Photo: Asian marshweed.

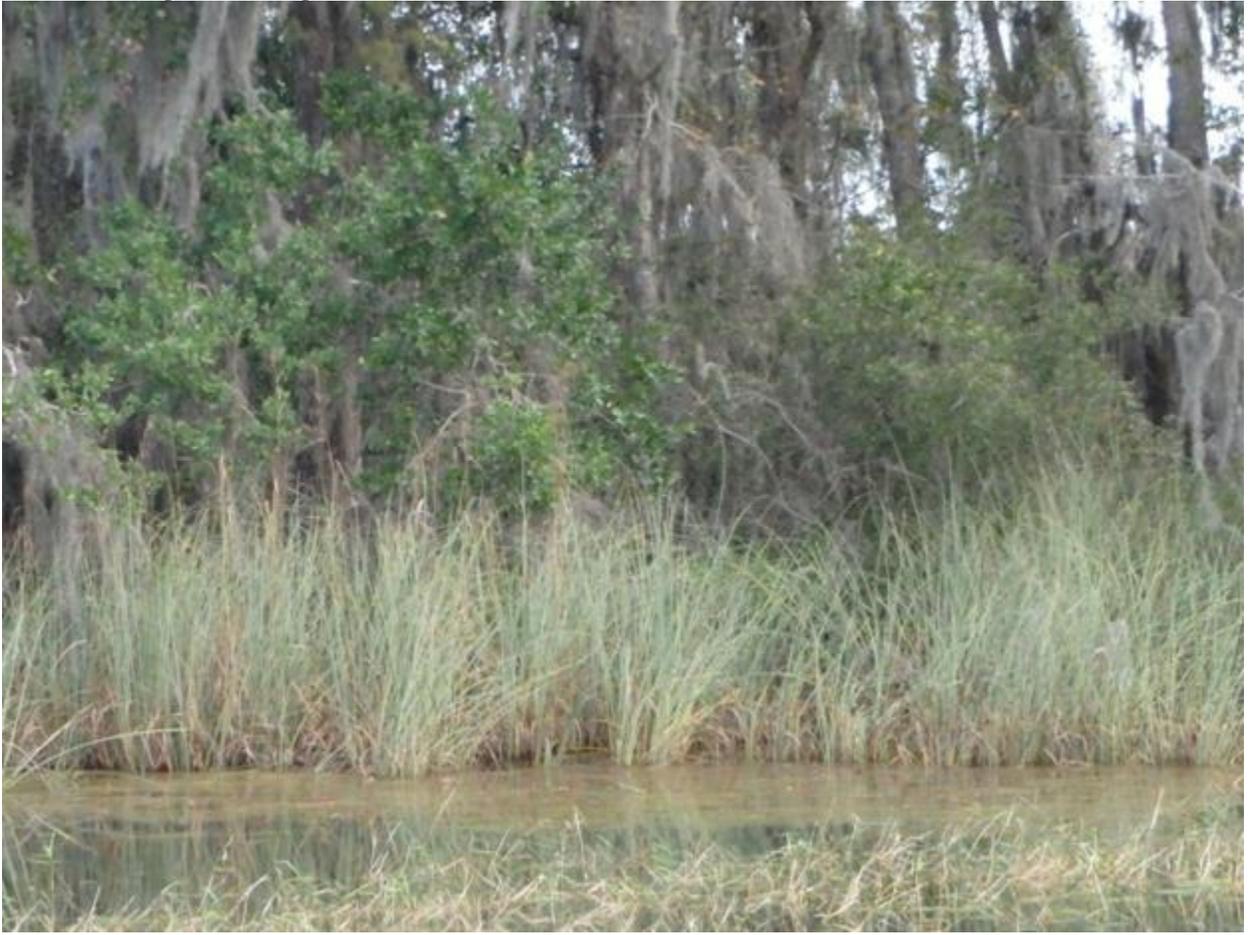
Lake Pickett contained a very healthy amount of native shoreline vegetation and intact shoreline. The vegetation observed during the inspection included: saw grass, rush fuirena, maiden cane, pickerelweed and duck potato. Invasive shoreline vegetation included: bur-head sedge, para grass, and torpedo grass. The majority of torpedo grass was found in disturbed areas such as boat ramps, sea walls, and cleared shorelines.

Photo: Saw grass along the shoreline.

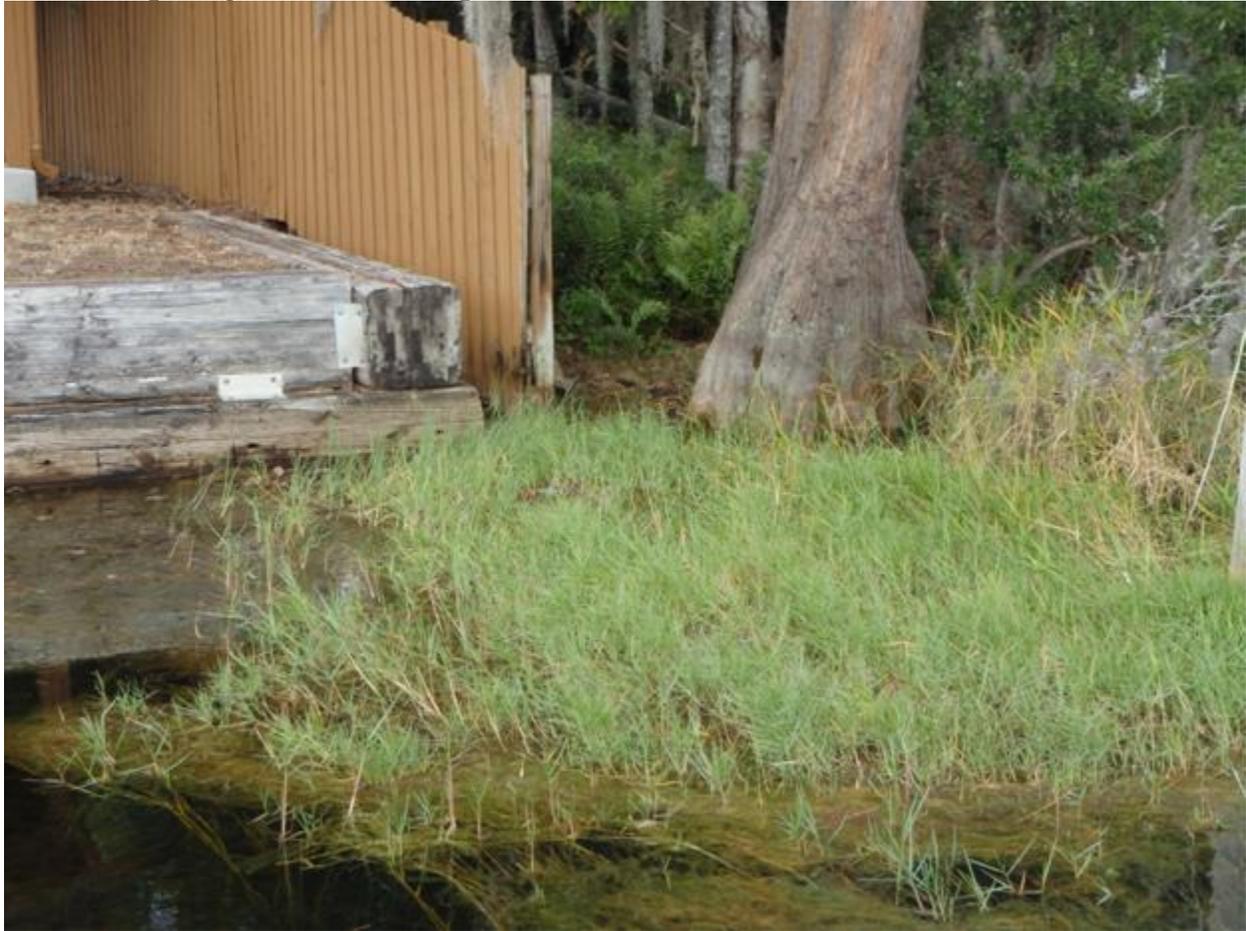
Photo: Torpedo grass at boat ramp.

1 Work together with other lakefront owners. Have *at least* one annual lake association meeting, invite guest speakers (such as county or state biologists) and discuss lake specific issues, especially nutrients/lake management recommendations. Seminole County and Orange County staff would be glad to present our findings from this and other surveys. Continue to increase native aquatic plantings along shoreline (such as pickerelweed, duck potato, and canna) and reduce exotic species such as torpedo grass.
