LAKE MANAGEMENT NEWSLETTER

Managed by Seminole County Lake Management Program • Fall 2021

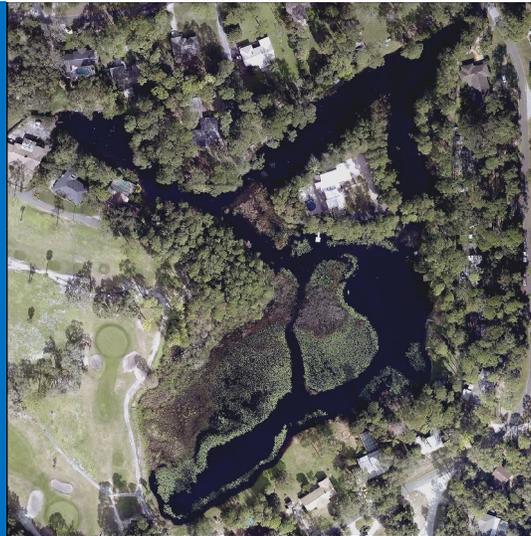
Aerial photo of Lake Amory

Lily pads continue to be treated to open up access and increase circulation. Due to their large tuber system, they are treated gradually in an attempt to prevent the large roots from rising to the surface. Plant matter was removed from the canal and cove area in order to re-establish access to the entire lake; the canal area had become very shallow.

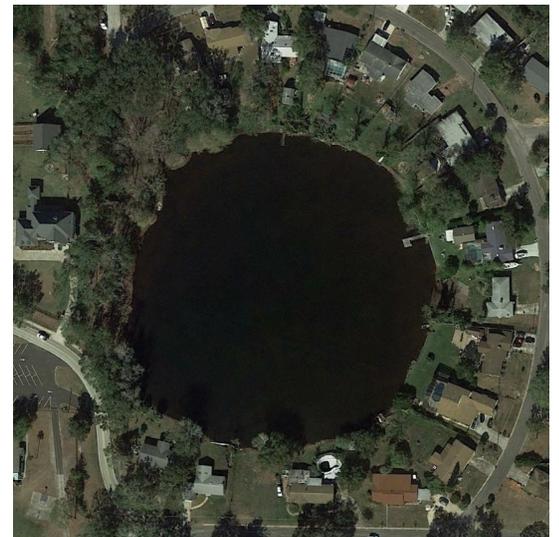
Aerial photo of Lake Asher

The planted vegetation has been very healthy. Road grass, a species of SAV, was found expanding around the lake. Algae blooms have been persistent and will continue to be treated as needed.

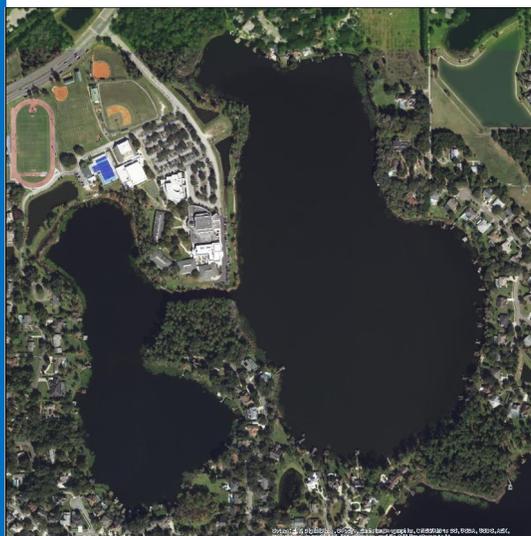
Aerial photo of Lake Burkett

No hydrilla or other invasive SAV was observed during the most recent inspections. SAV was treated to create access corridors for boats; the corridors are now open. Lily pads were treated to help increase circulation on the northern end of the lake. We are coordinating with Orange County to add new grass carp fish to the lakes.

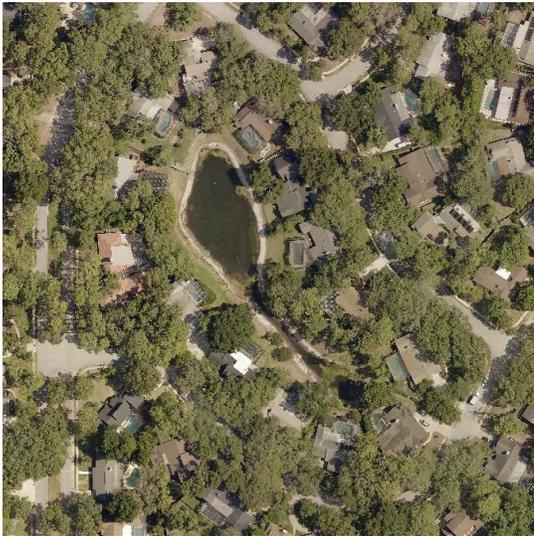
Aerial photo of Buttonwood Pond

Stonewort and musk grass (SAV) were previously topping out, but this has been greatly reduced. Invasive torpedo grass appeared to be damaged from treatments. In our recent inspections, algae blooms have been an issue and treatments have been planned.

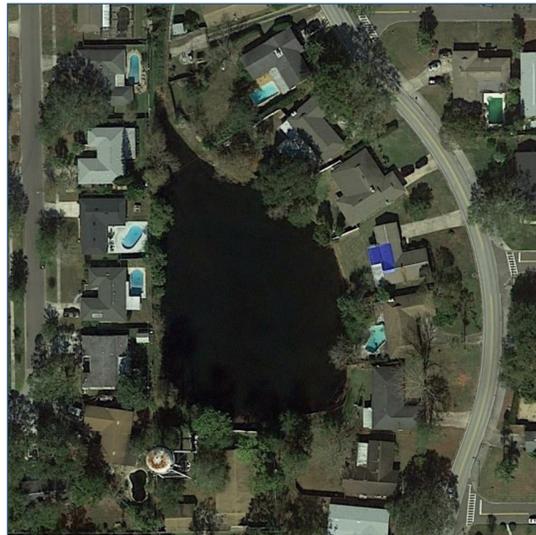
Aerial photo of English Estates Pond

Monthly treatments continue to target alligator weed, torpedo grass, primrose willow and Caesar weed. Algae levels have decreased and will be treated as needed. There was a SERV volunteer event on 10/23/21 to improve the health of the pond. Kudos to the Liaisons for organizing this!

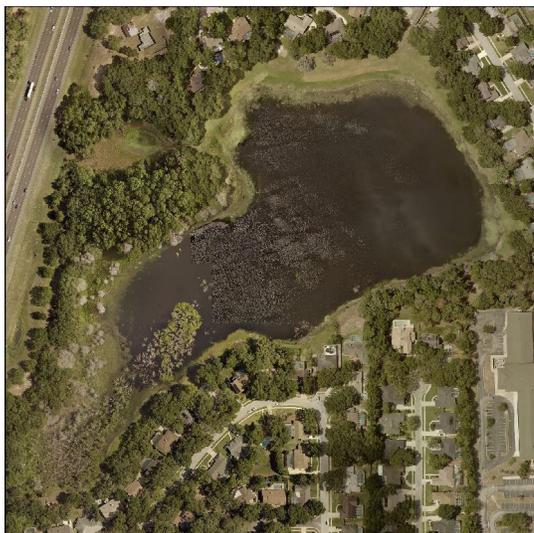
Aerial photo of Grace Lake

During our most recent inspection, invasive hydrilla was observed. The water has risen, inundating most of the emergent vegetation. The area where torpedo grass was harvested continues to be monitored and treated accordingly. Due to high water elevation, the planting effort to add cypress trees to the lake was postponed until Spring 2022.

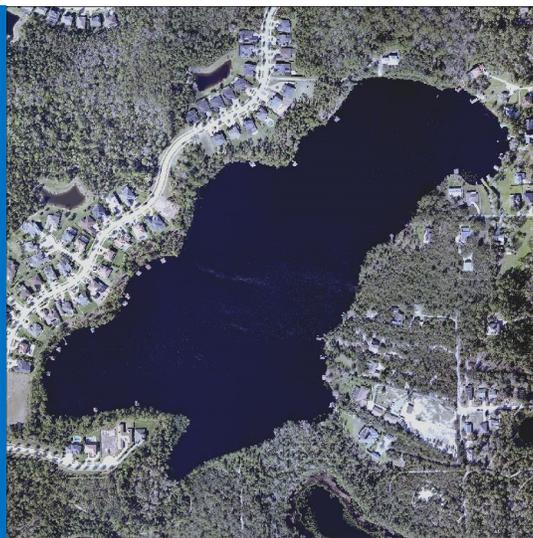
Aerial photo of Horseshoe Lake

Water hyacinth and hydrilla were not observed during our most recent inspection. Native emergent vegetation was healthy and expanding around the lake. In the no treatment zones, it is recommended to hand-pull invasive plants as they are becoming a nuisance. The Liaisons are coordinating an aquatic plant give-away day with LMP. Kudos to them for this effort!

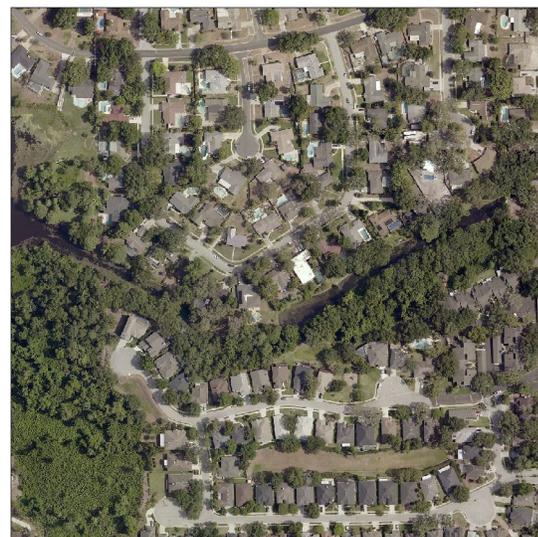
Aerial photo of Howell Creek

Native eelgrass (SAV) is the dominant vegetation in the creek followed by road-grass (an emergent). A small increase in hydrilla clusters was observed throughout the creek during recent inspections.

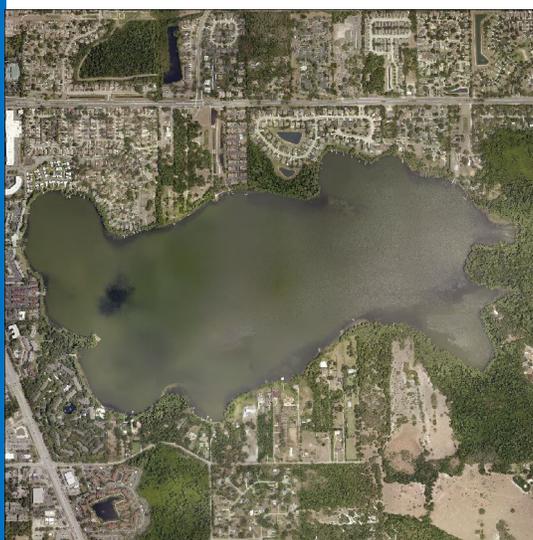
Aerial photo of Lake Howell

The presence of water hyacinth, hydrilla, and hygrophylla continue to be greatly reduced. Cattails and hygrophylla continue to be treated. More SAV, especially eelgrass, was observed in greater abundance than in previous inspections.

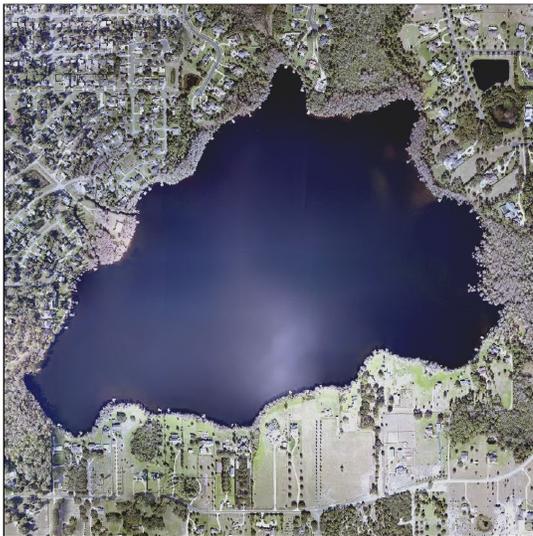
Aerial photo of Lake Mills

With cooler temperatures, baby's tears should grow more slowly. Treatment of this plant requires FWC permitting; up to 1 acre of floating baby's tears can be treated. We are actively managing this floating plant with herbicides because it is causing congestion within the canals. Hydrilla was not observed during our last inspection.

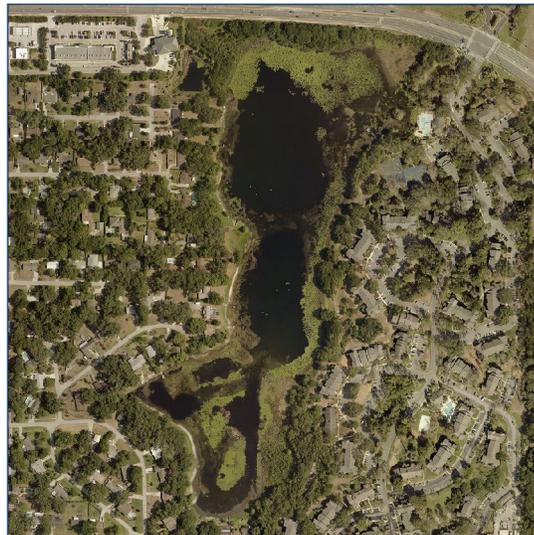
Aerial photo of Mirror Lake

Lily pads have been treated to open access corridors. As a result, some of the root system has been floating to the surface. We are preparing a harvesting plan to remedy the overgrowth. The volunteer aquatic planting event was completed at the Cortland Mirror Lake apartment complex in June; the plants are doing very well. Big thanks again to Cortland for their lake stewardship in enhancing the lake!

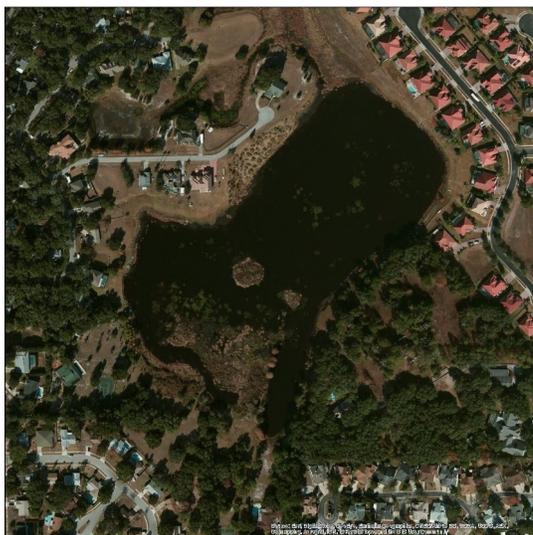
Aerial photo of Myrtle Lake

A small amount of hydrilla was observed along the shoreline. Lilies on the western side have grown abundantly with water elevation changes; a harvester may be required to rake floating debris. We will advise on the feasibility of the harvester. A project to reduce erosion and create a stable launching point at the northern spoil area will be scheduled for Spring 2022. A SERV event is planned in early November.

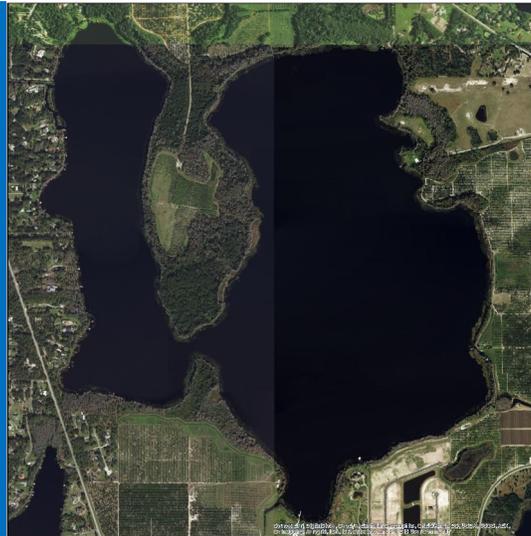
Aerial photo of Lake Pickett

No hydrilla was observed during the previous inspection. Native maidencane, a species of emergent vegetation, continues to expand. A few small patches of the invasive SAV *limnophila* were found along the northeastern shoreline. A decline in biodiversity continues to be observed along the SE shoreline

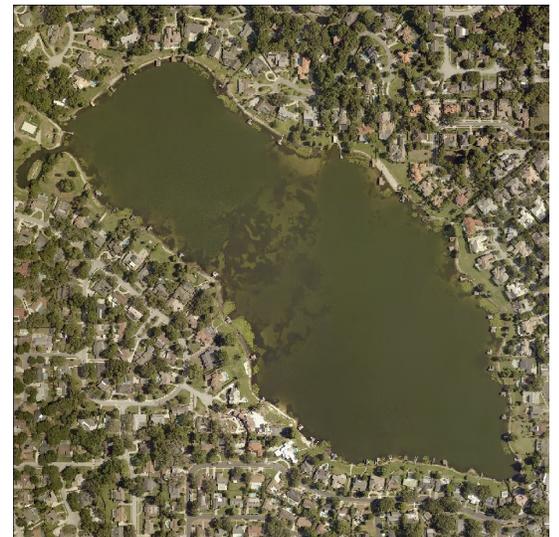
Aerial photo of Spring Lake

Several access corridors are scheduled for treatment. Bladderwort treatments on the east and north side were successful; lily pads have fully recovered from initial impact. A few sprigs of hydrilla were found in pockets of the lake. This is an increase from prior inspection and is scheduled for treatment. Reduction in water clarity was observed upon last inspection as well as sedimentation from the southern inflow pipes.

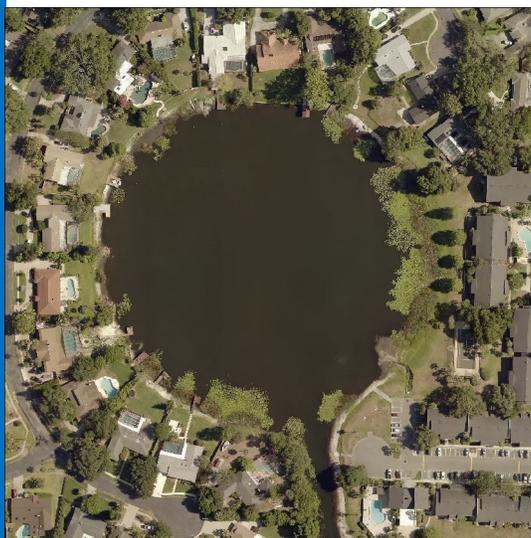
Aerial photo of Spring Wood Lake

Native aquatic vegetation, particularly pickerelweed and fire flag, is gradually returning. The previous hydrilla treatment was successful; however, new growth is observed and scheduled for treatment for the W shoreline. Expect decomposition as the lake is receding in water elevation and we prepare to treat. LMP will be reaching out to verify that owners' access corridors re-open.

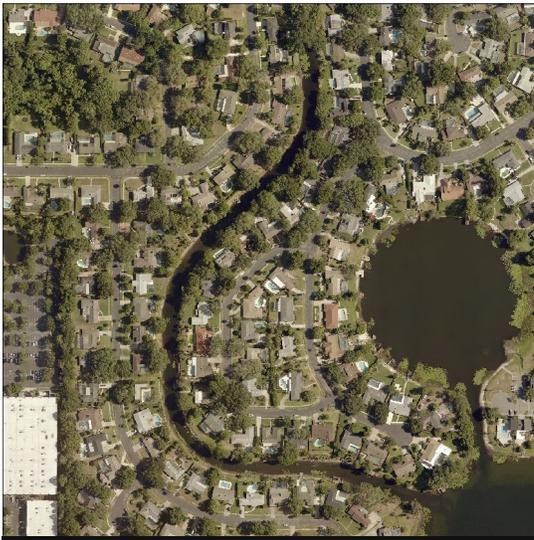
Aerial photo of Springwood Waterway

SAV was treated throughout the canal. Bacopa, a native plant, has become a nuisance along the sides of the canal and is also causing what are known as “mud burps” to occur. A harvester is being coordinated to remedy these conditions. Stay tuned! The sediment barriers were dislodged at time of inspection.

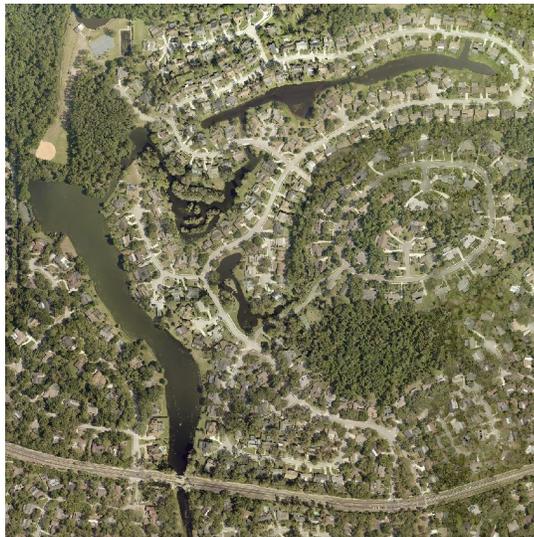
Aerial photo of Sweetwater Lake

Lily pads and salvinia have been successfully treated in the upper cove lakes. Torpedo grass has been treated throughout the Sweetwater Lake shoreline. Upper Cove Lake has increased in vegetation and sediments. A work order has been submitted to the County Stormwater Team for maintenance.

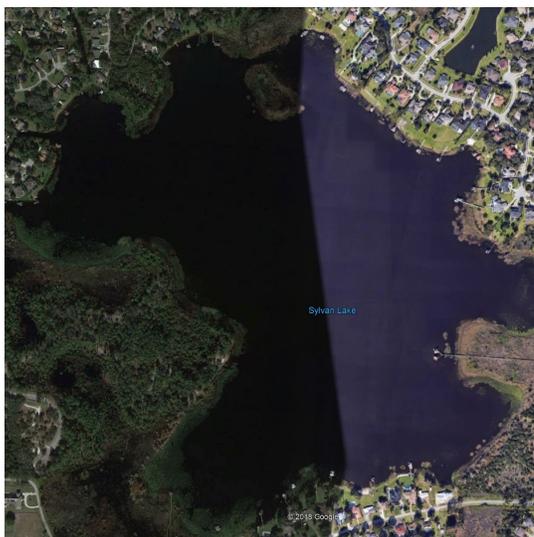
Aerial photo of Lake Sylvan

No hydrilla or water hyacinth were found during the most recent inspection. Cattails have been reduced in some areas of the lake. On 7/2/21, Seminole County was issued a one-time only SJRWMD Emergency Field Permit to lower the weir in increments to alleviate lake levels; it has been extended as the lake remains high. Kudos to the Liaisons and Property Owners who participated in a planting event to enhance the quality of the lake’s shoreline!

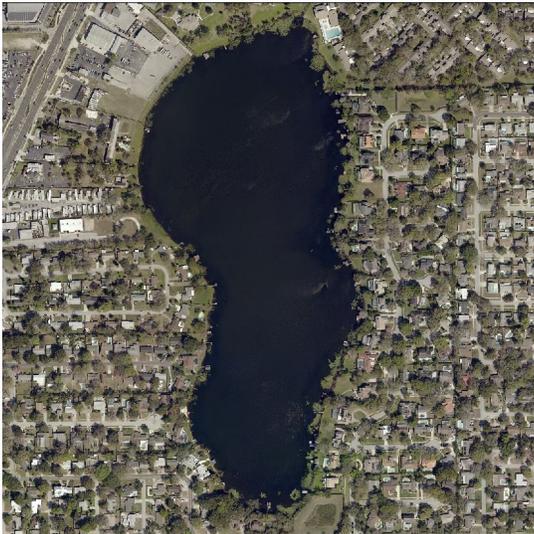
Aerial photo of Lake of the Woods

SAV treatments in access corridors have been executed and touch-ups are scheduled. Additional spot treatments have been executed to deal with the overgrowth of the native coontail. For hydrilla, only sprigs were found and will be scheduled for treatment. We are coordinating with FWC to add new grass carp fish to the lake.

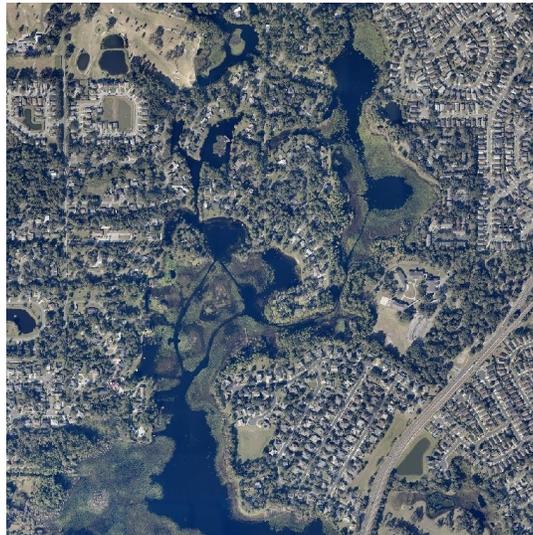
Aerial photo of East Crystal Chain of Lakes

With restoration efforts ending, the chain is moving forward with monthly inspections, access corridor and invasive plant treatments. We are focusing on re-opening access areas in East Crystal. Pine Lake continues to have frequent duckweed blooms, necessitating frequent treatments. Aeration systems are being coordinated for installation. New slow wake signs have been installed; please heed these signs to keep the waterway safe. We are waiting for grass carp fish availability.

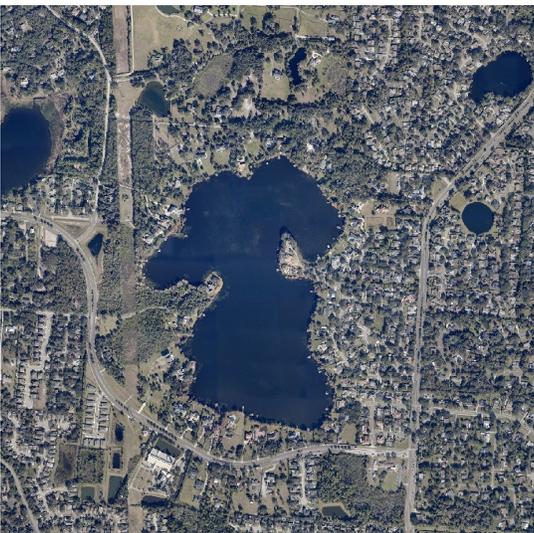
Aerial photo of Lake Tuskawilla

Hydrilla treatments remain successful. Water levels are up, and the heavy rains have kept the grass carp barrier clear. The lake will continue to be inspected and treated monthly for invasive plants and monitored closely for overall health.
