# LAKE MANAGEMENT NEWSLETTER

*Managed by Seminole County Lake Management Program • Winter 2021*

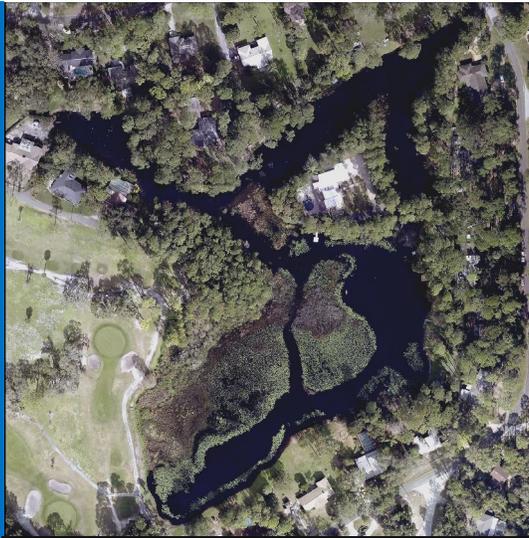
Aerial photo of Lake Amory

Bladderwort was treated lake-wide. Lily pads have been targeted to open up navigation and access corridors; treatment effects will be determined in the next survey. Logs blocking the carp barrier were removed; the barrier continues to be monitored monthly. Sediment removal from the canal and cove area is scheduled for March/April of 2021.

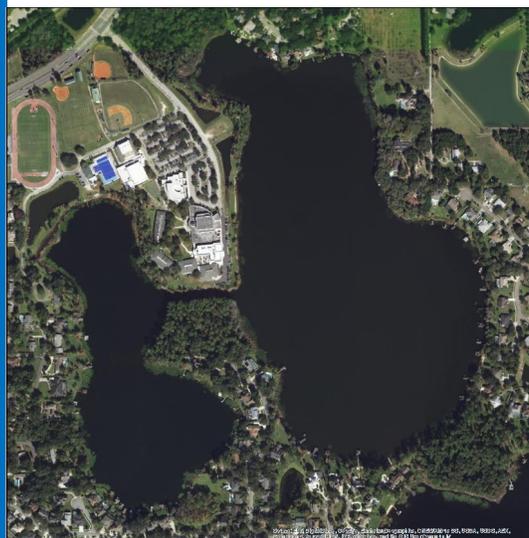
Aerial photo of Lake Burkett

No Hydrilla or other invasive SAV was observed during the last inspection. Native SAV, including eelgrass and bladderwort, continues to expand around the lake, creating a great ecosystem. Treatments will continue to focus on nuisance cattails and primrose willow.

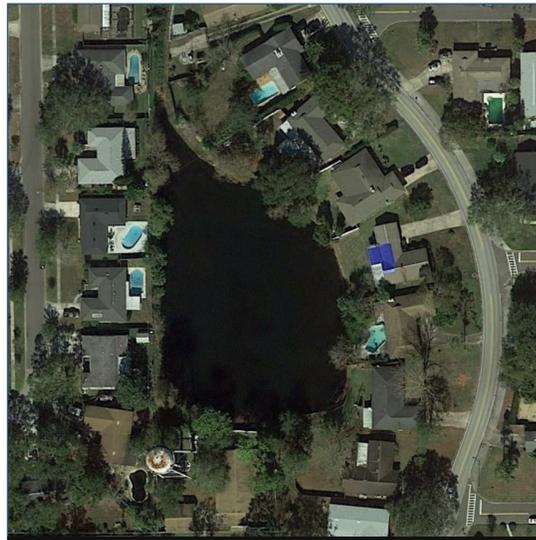
Aerial photo of English Estates Pond

Monthly treatments continue to target alligator weed, primrose willow and Caesarweed. The amount of algae appears to have decreased in comparison with the summer months. Invasive torpedo grass remains a priority for treatment.

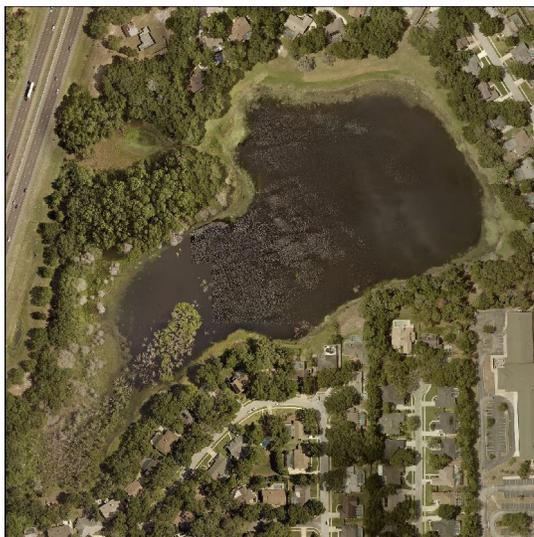
Aerial photo of Grace Lake

During our most recent inspection, invasive *Hydrilla* was not observed (a reduction from previous assessments). High water elevation continues to inundate the majority of emergent vegetation. The harvesting of torpedo grass has taken place. The recent harvesting will be evaluated in our next survey.

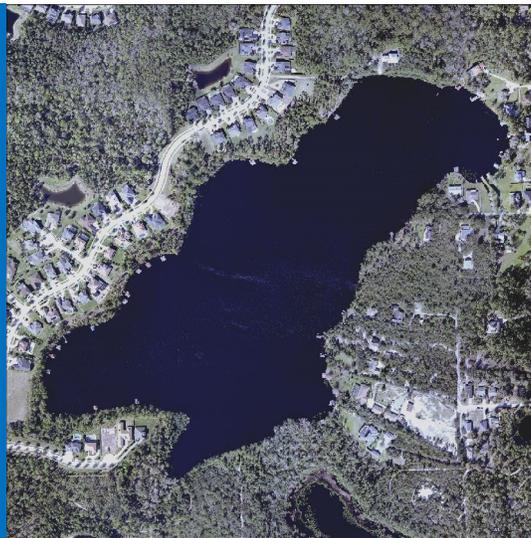
Aerial photo of Horseshoe Lake

Water hyacinth and Hydrilla were not observed in the lake during our most recent inspection but a small cluster of Hydrilla was found in the canal. Native emergent vegetation appears healthy. The invasive [Old World climbing fern](#) continues to be observed on a parcel in the northwest corner of the lake and should be addressed.

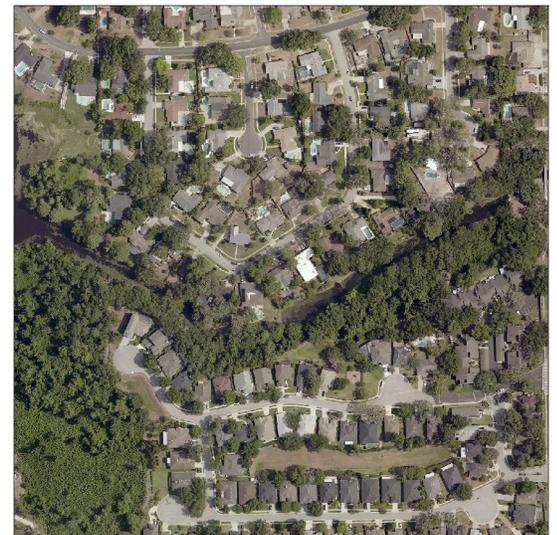
Aerial photo of Howell Creek

Eelgrass, a native species of SAV, and road-grass, a native emergent plant, continue to be the most abundant vegetation found within the creek. Recent inspections have found an increase of small Hydrilla clusters throughout the creek. Future scheduled treatments should address these clusters.

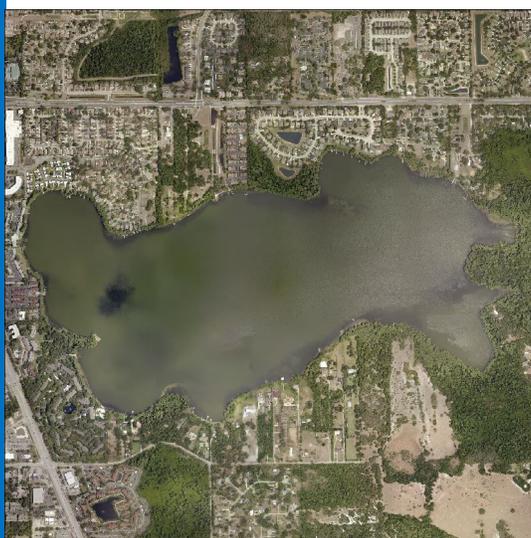
Aerial photo of Lake Howell

Much less Hydrilla was observed in the most recent inspection than in the previous inspection. The presence of water hyacinth has been greatly reduced. Cattails and Hygrophila continue to be treated. More SAV, especially eelgrass, was observed in greater abundance than in previous inspections.

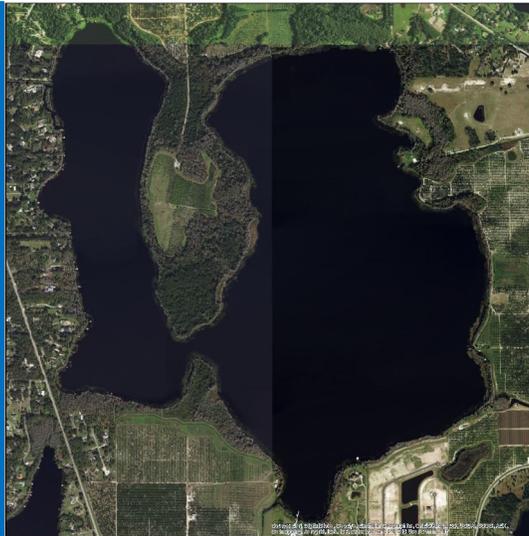
Aerial photo of Lake Pickett

Bogmoss biomass has continued to decrease lake-wide. No Hydrilla was observed during the previous inspection. Maidencane, a native species of emergent vegetation, continues to expand. A few small patches of the invasive SAV *Limnophila* were found along the northeastern shoreline.

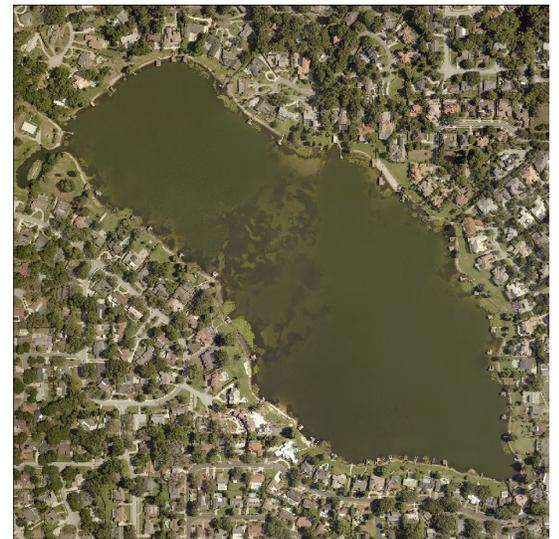
Aerial photo of Spring Lake

Alum treatments have recently taken place. SAV continues to be treated around the inflow pipes. Small clusters of Hydrilla were observed within eelgrass patches and will be treated. Native emergent vegetation is slowly expanding. Eelgrass is reestablishing in deeper water, which is important for nutrient reduction. Some access areas are scheduled to be treated for eelgrass.

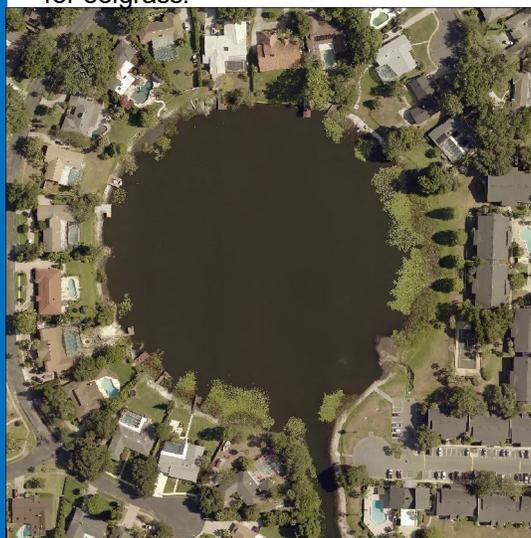
Aerial photo of Spring Wood Lake

SAV around the perimeter of the lake has returned. Hydrilla was found around the full perimeter of the lake; a treatment will be scheduled. Native emergent vegetation is gradually returning, especially pickerelweed and fire flag. Some Hydrilla was observed near the boat launch dock.

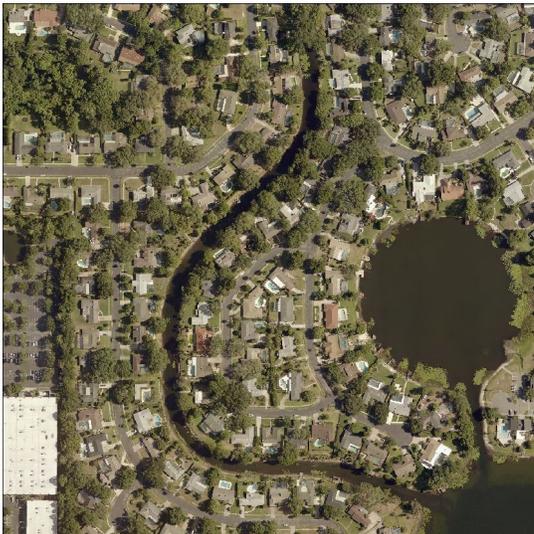
Aerial photo of Springwood Waterway

Large amounts of Nitella have been spotted near the entrance of the waterway and a large infestation of Hydrilla was sighted in the middle of the waterway and will be treated. Native emergent vegetation continues to flourish.

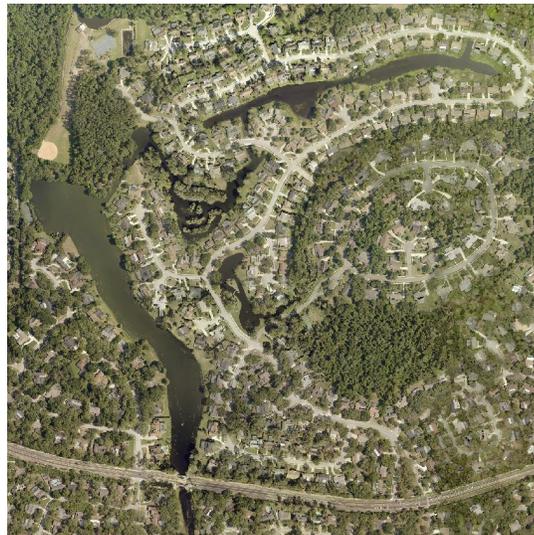
Aerial photo of Sweetwater Lake

Torpedo grass appears to be damaged from recent treatments, and reduced in extent. Lyngbya has decreased in the cove areas. Salvinia continues to be found in several areas of the lake and will be treated. Lily pads continue to be monitored.

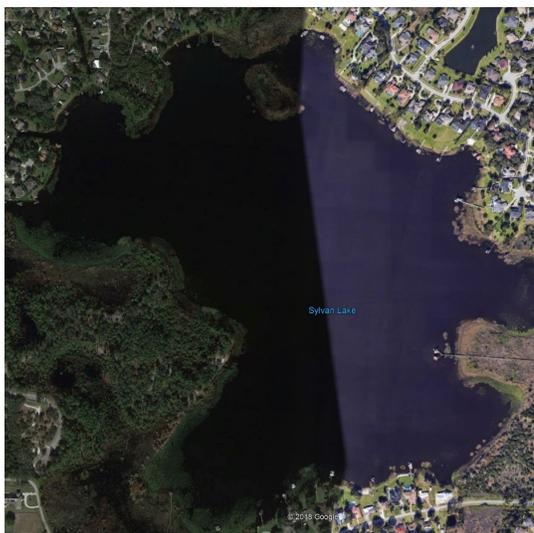
Aerial photo of Lake Sylvan

No Hydrilla or water hyacinth were found during the most recent inspection. Cattails have been reduced in several areas of the lake. Seminole County has been working with FDOT and their contractors to ensure that the outfall of Sylvan Lake will not be blocked.

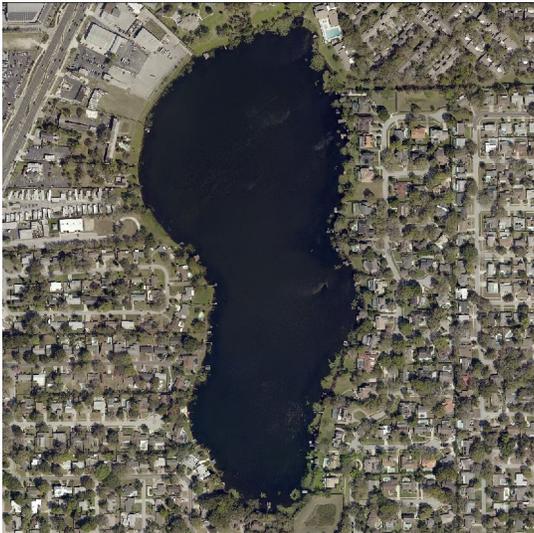
Aerial photo of Lake of the Woods

Beneficial SAV (eelgrass, southern naiad, stone wort, and bladderwort) have been observed during our most recent inspections. Hydrilla sprigs were only found in one area on the west side of the lake and will be scheduled for treatment. High water levels and increased flow have necessitated multiple carp barrier cleanings during recent months. An algae treatment was scheduled for the month of February.
