Greetings Lake of the Woods residents! Below please find the latest bioassessment for your lake below. Key highlights of this update include:

Bioassessments:

On **March 1st, 2016**, Seminole County Lake Management staff, Thomas Calhoun and Joey Cordell, surveyed the aquatic plants in **Lake of the Woods**.

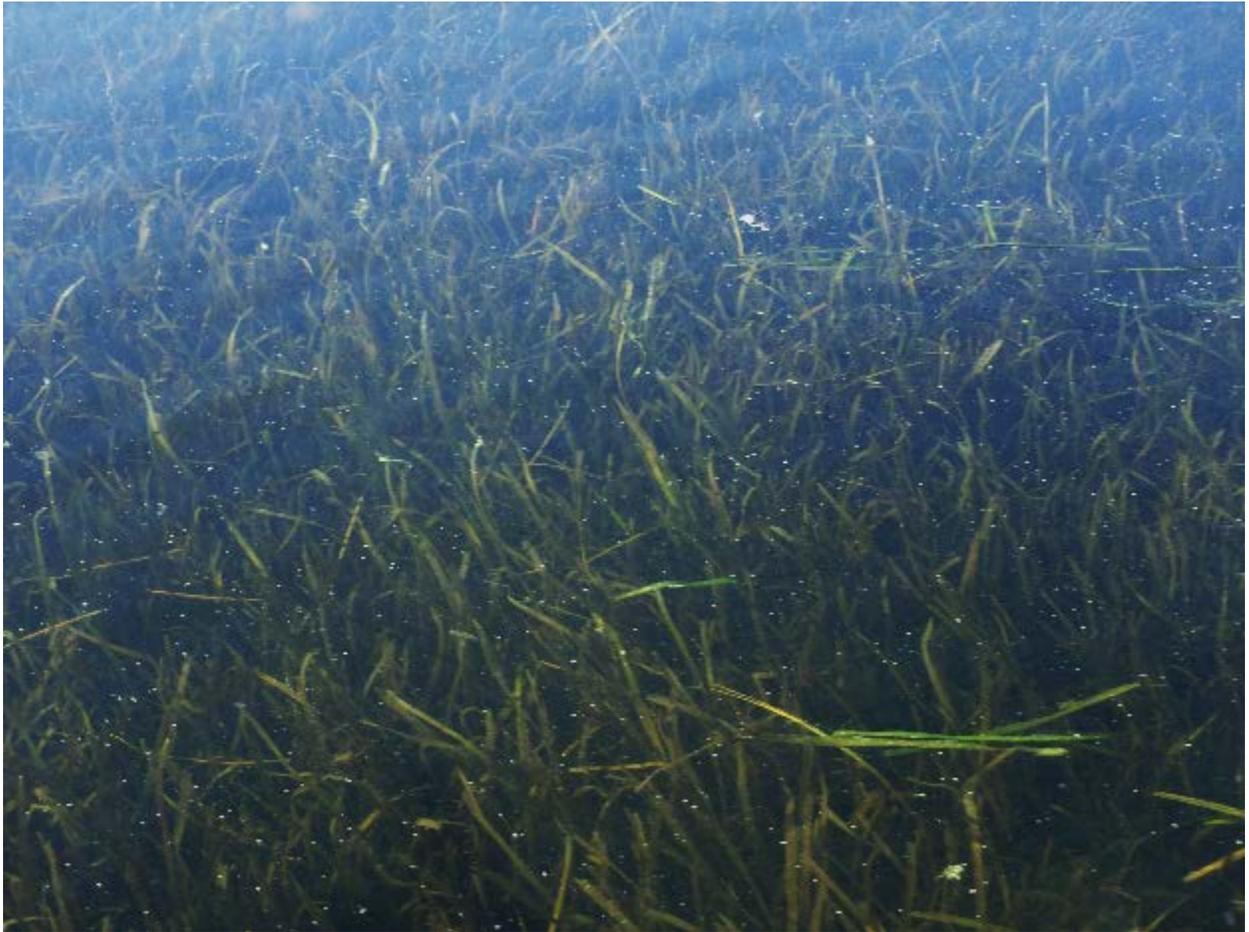
Native submersed aquatic vegetation (SAV) found during the inspection included: coontail to a depth of 9 feet, bladderwort to 3 feet, and eelgrass to 7 feet. Eelgrass was the dominant species. If SAV is impeding access to your boat dock you can apply for an aquatic plant removal permit through the Florida Wildlife Conservation Commission at <http://www.myfwc.com/license/aquatic-plants> or contact FWC regional biologist Kristine Campbell at 321-246-0682 to obtain your free permit.

Photo: Eelgrass (native).

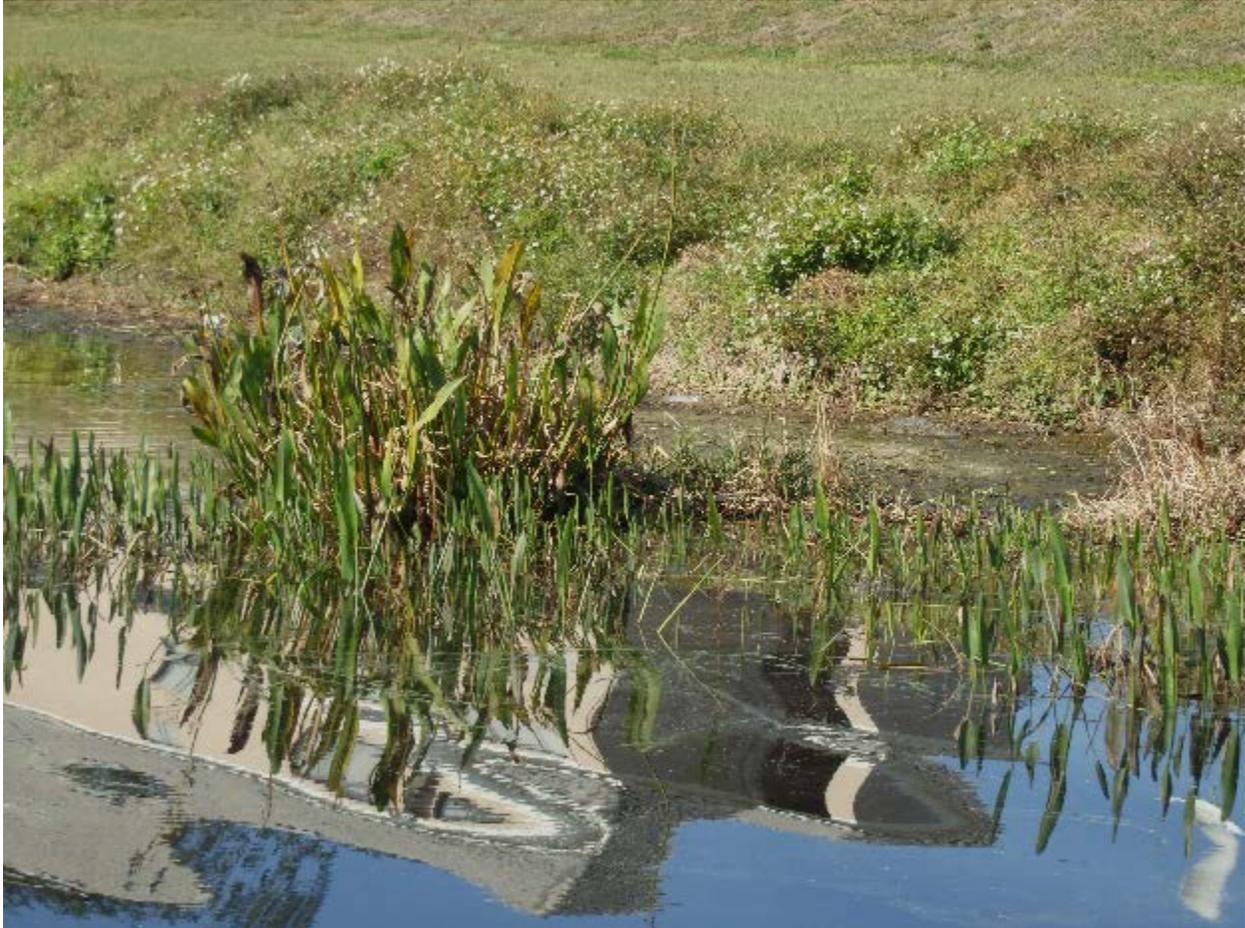
Native emergent vegetation observed during the survey included: bur-marigold, golden canna, water hemlock, flat sedge, pennywort, yellow cow lily, fragrant water lily, pickerelweed, duck potato, Carolina willow, bulrush, fire flag, cattail, and climbing aster. The pickerelweed had thinned out over the winter, but it was growing back at the time of this survey.

Photo: Duck potato and young pickerelweed.

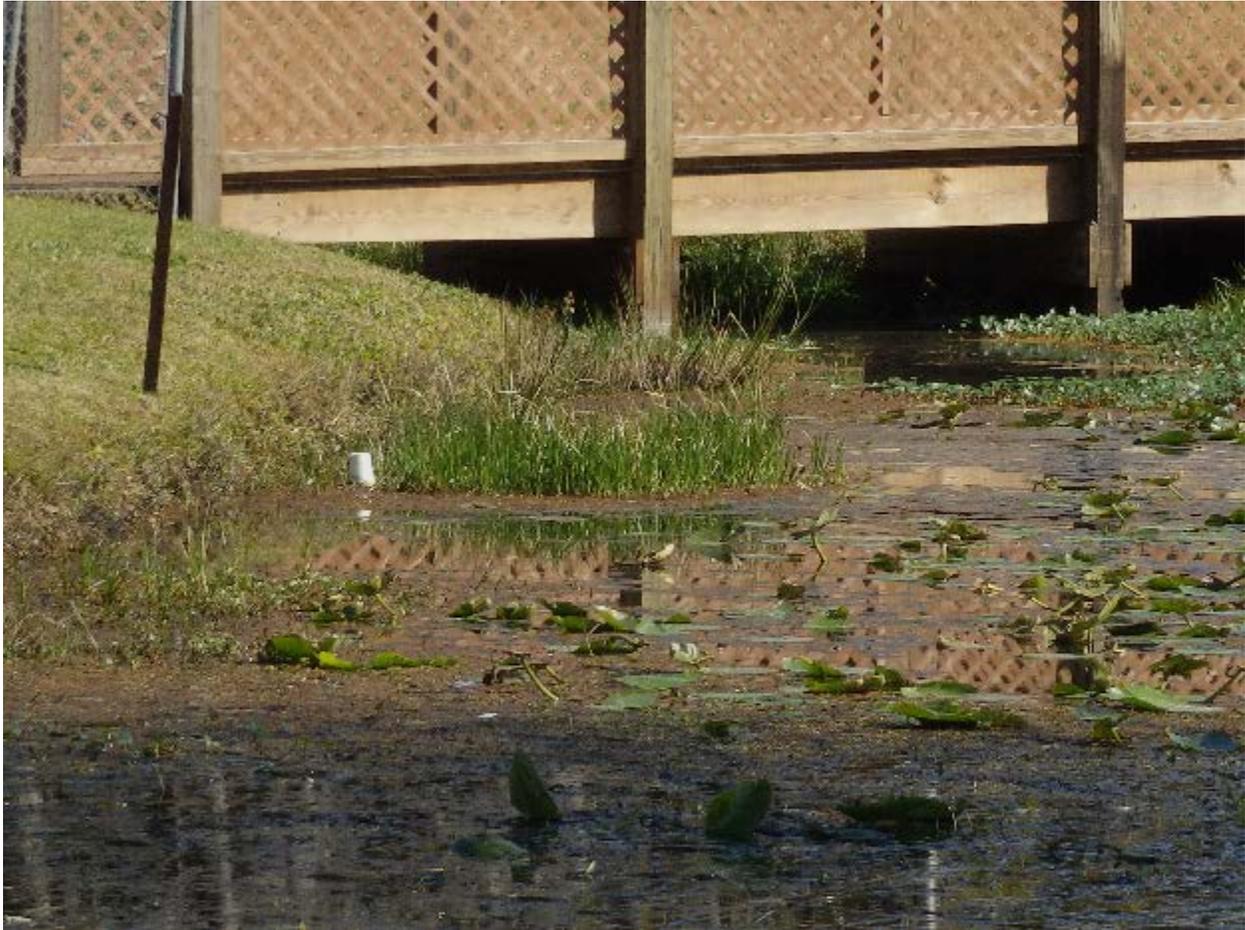
Invasive emergent vegetation observed during the survey included: paragrass, wild taro, primrose willow, torpedograss, Brazilian pepper tree, burhead sedge, papyrus, and creeping oxeye. Minimal torpedograss was found. The Northeast canal will need to be treated for burhead sedge.

Photo: Burhead sedge in canal.

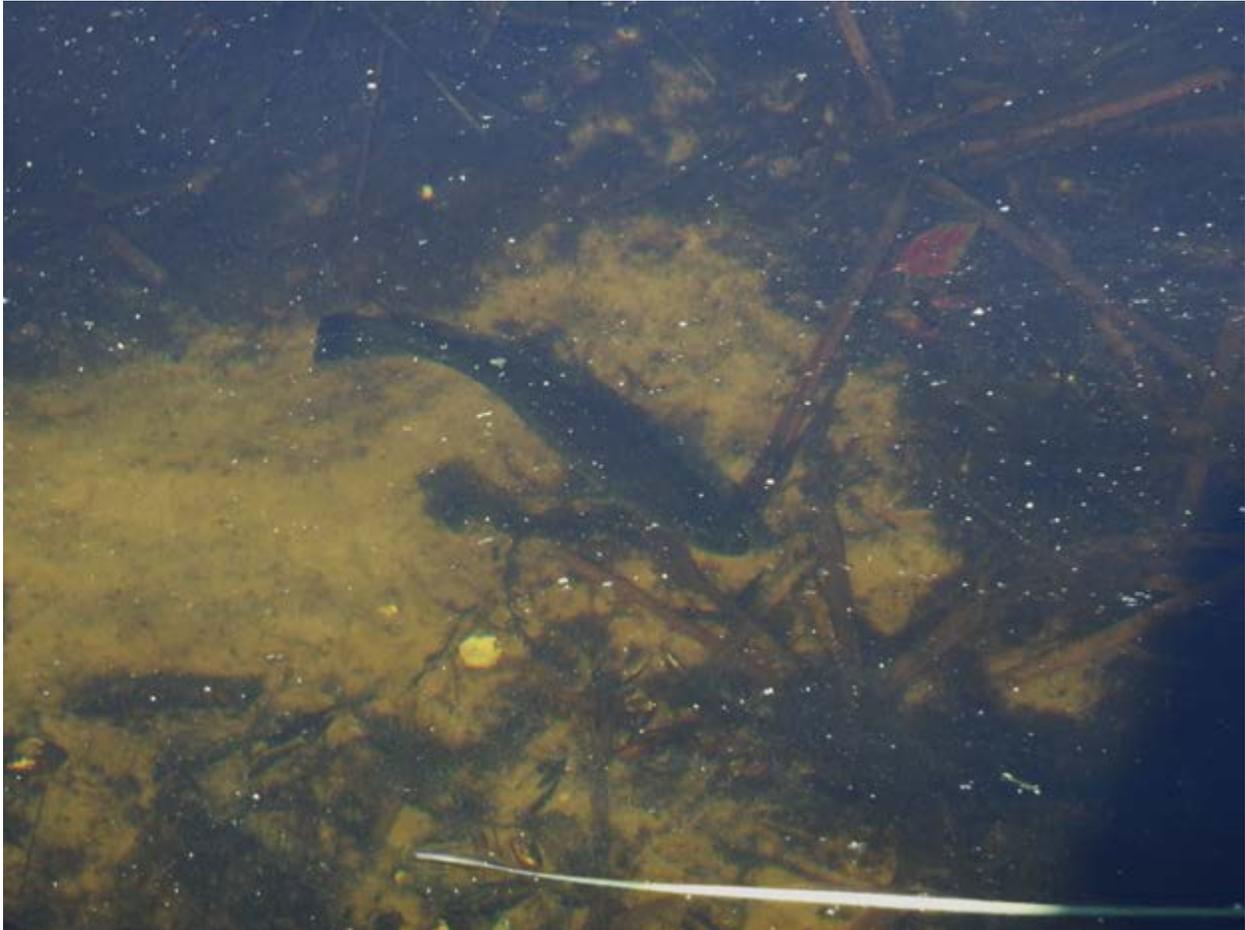
The fish community was very noticeable on the morning of the inspection. In particular, the bass population was active in shallow waters in response to warming waters and their approaching nesting season.

Photo: Largemouth Bass.

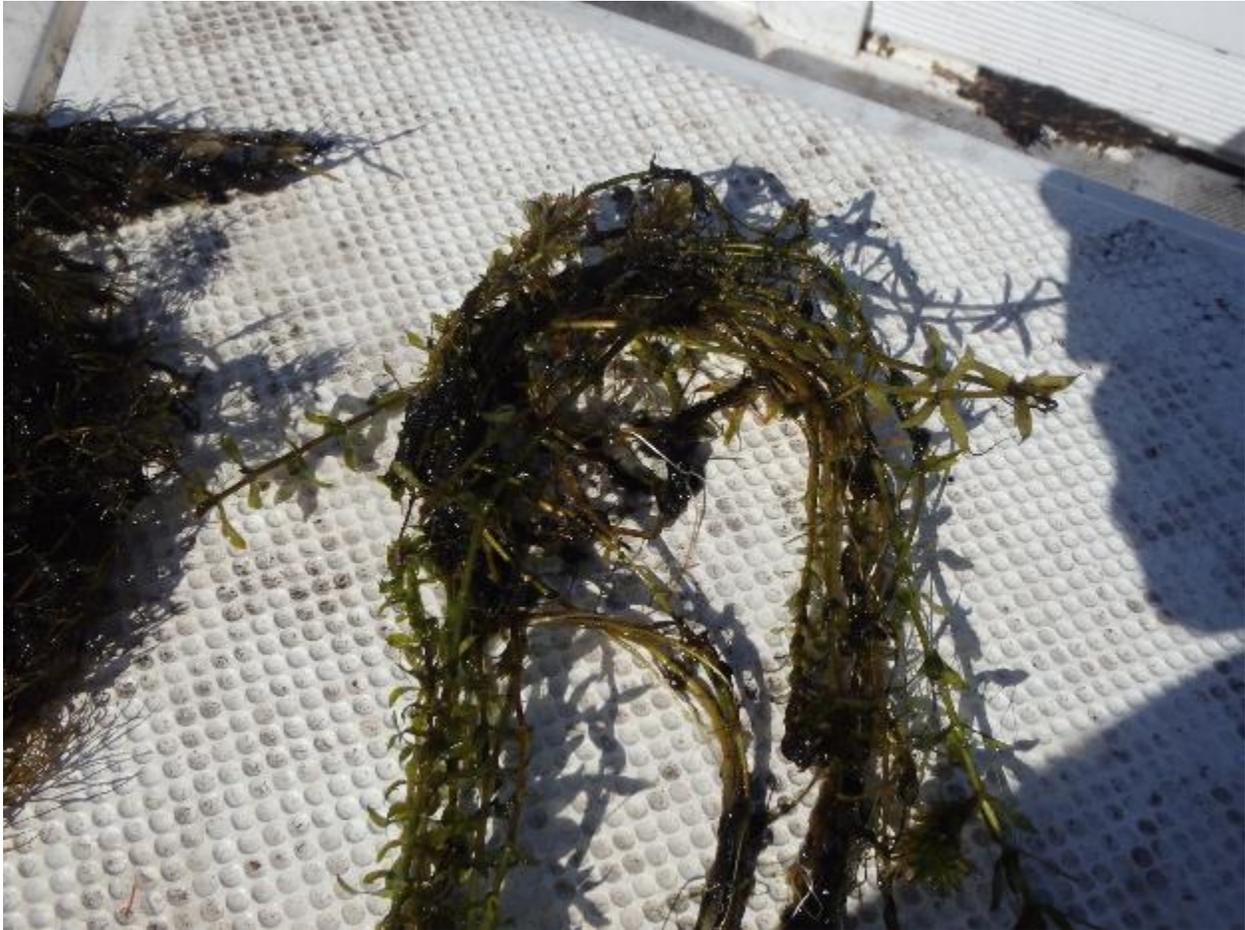
Only small amounts of hydrilla were found during the inspection. A few sprigs were seen by the southwest boat ramp. These areas will continue to be closely monitored for hydrilla.

Photo: Hyrdilla (coontail on left).

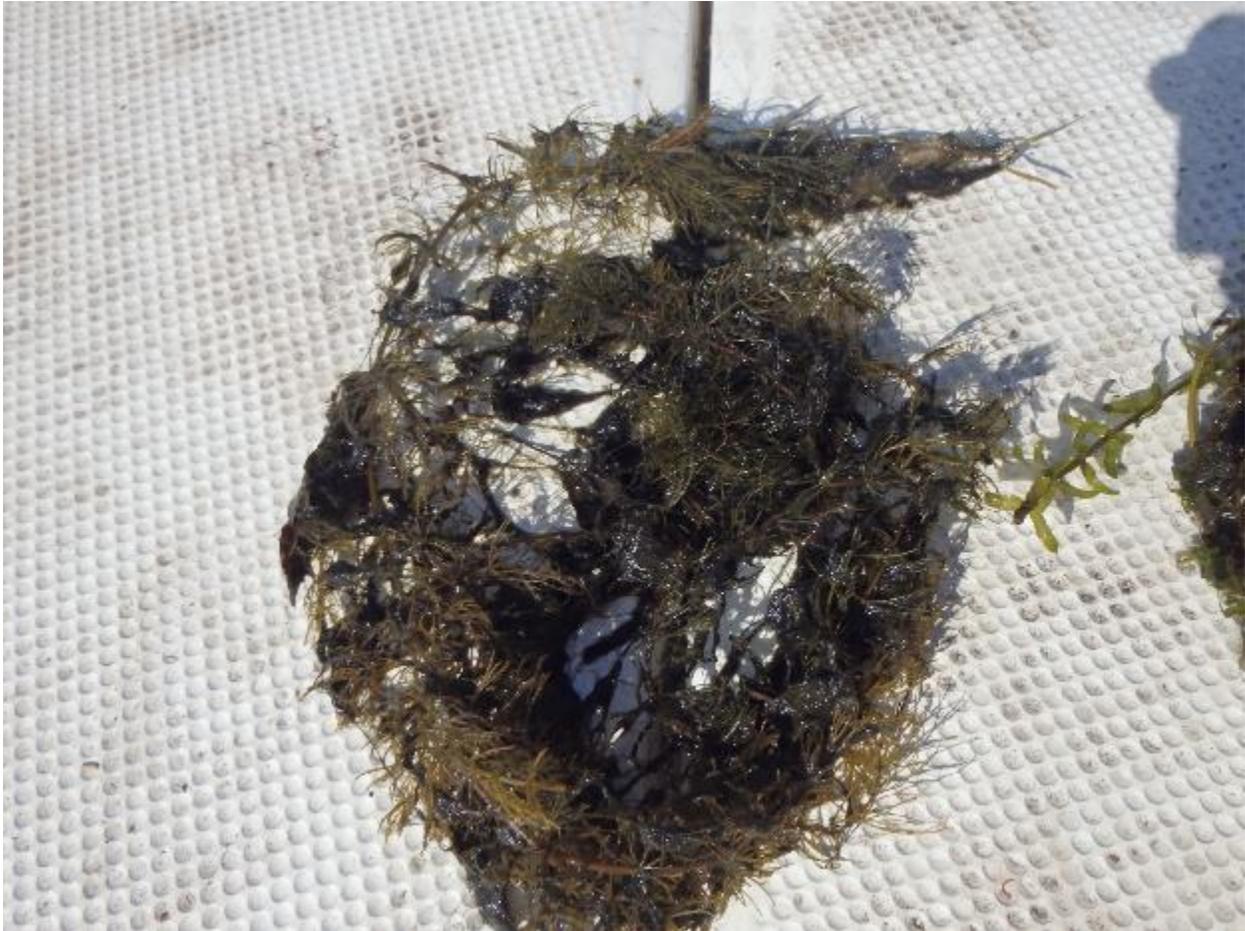
Native submersed aquatic vegetation (SAV) found during the inspection included: southern naiad, coontail to 3 feet and eelgrass to 8 feet. Coontail had been expanding but eelgrass was still the dominant species at the time of this survey. If SAV is impeding access to your boat dock you can apply for an aquatic plant removal permit through the Florida Wildlife Conservation Commission at <http://www.myfwc.com/license/aquatic-plants> or contact FWC regional biologist Kristine Campbell at 321-246-0682 to obtain your free permit.

Photo: Coontail (hydrilla on right).

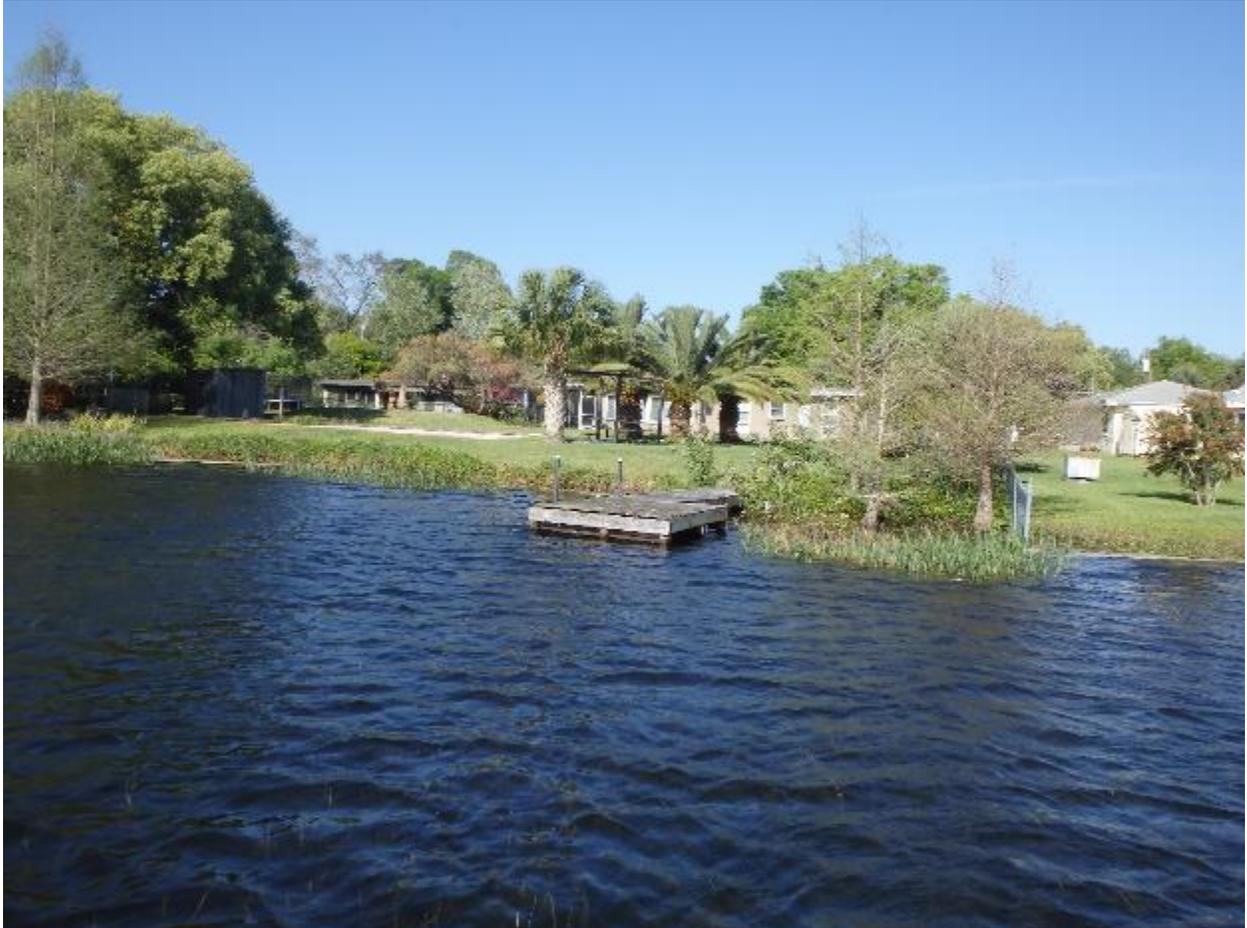
Native emergent vegetation observed during the survey included: golden canna, water hemlock, pennywort, hempvine, spatterdock, fragrant water lily, maidencane, pickerelweed, duck potato, arrow arum, Carolina willow, bulrush, fire flag, cattail, Elliott's aster, climbing aster, and blue flag iris.

Photo: Stands of pickerelweed.

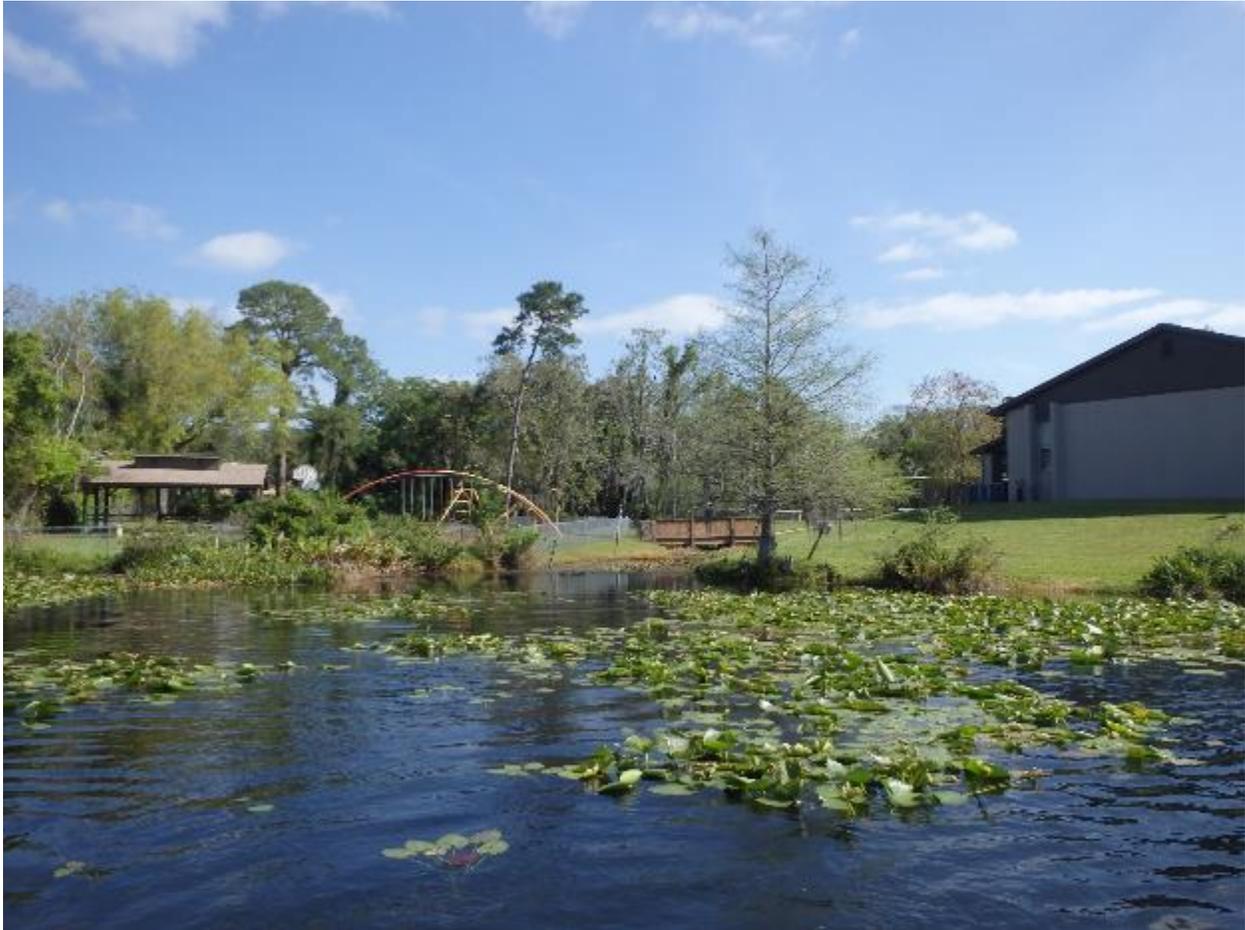
Invasive emergent vegetation observed during the survey included: alligator weed, wild taro, primrose willow, torpedograss, salvinia, Chinese tallow, Cuban burhead sedge, Brazilian pepper tree, creeping oxeye, and papyrus. Very little alligatorweed and torpedograss were found.

Photo: North canal.

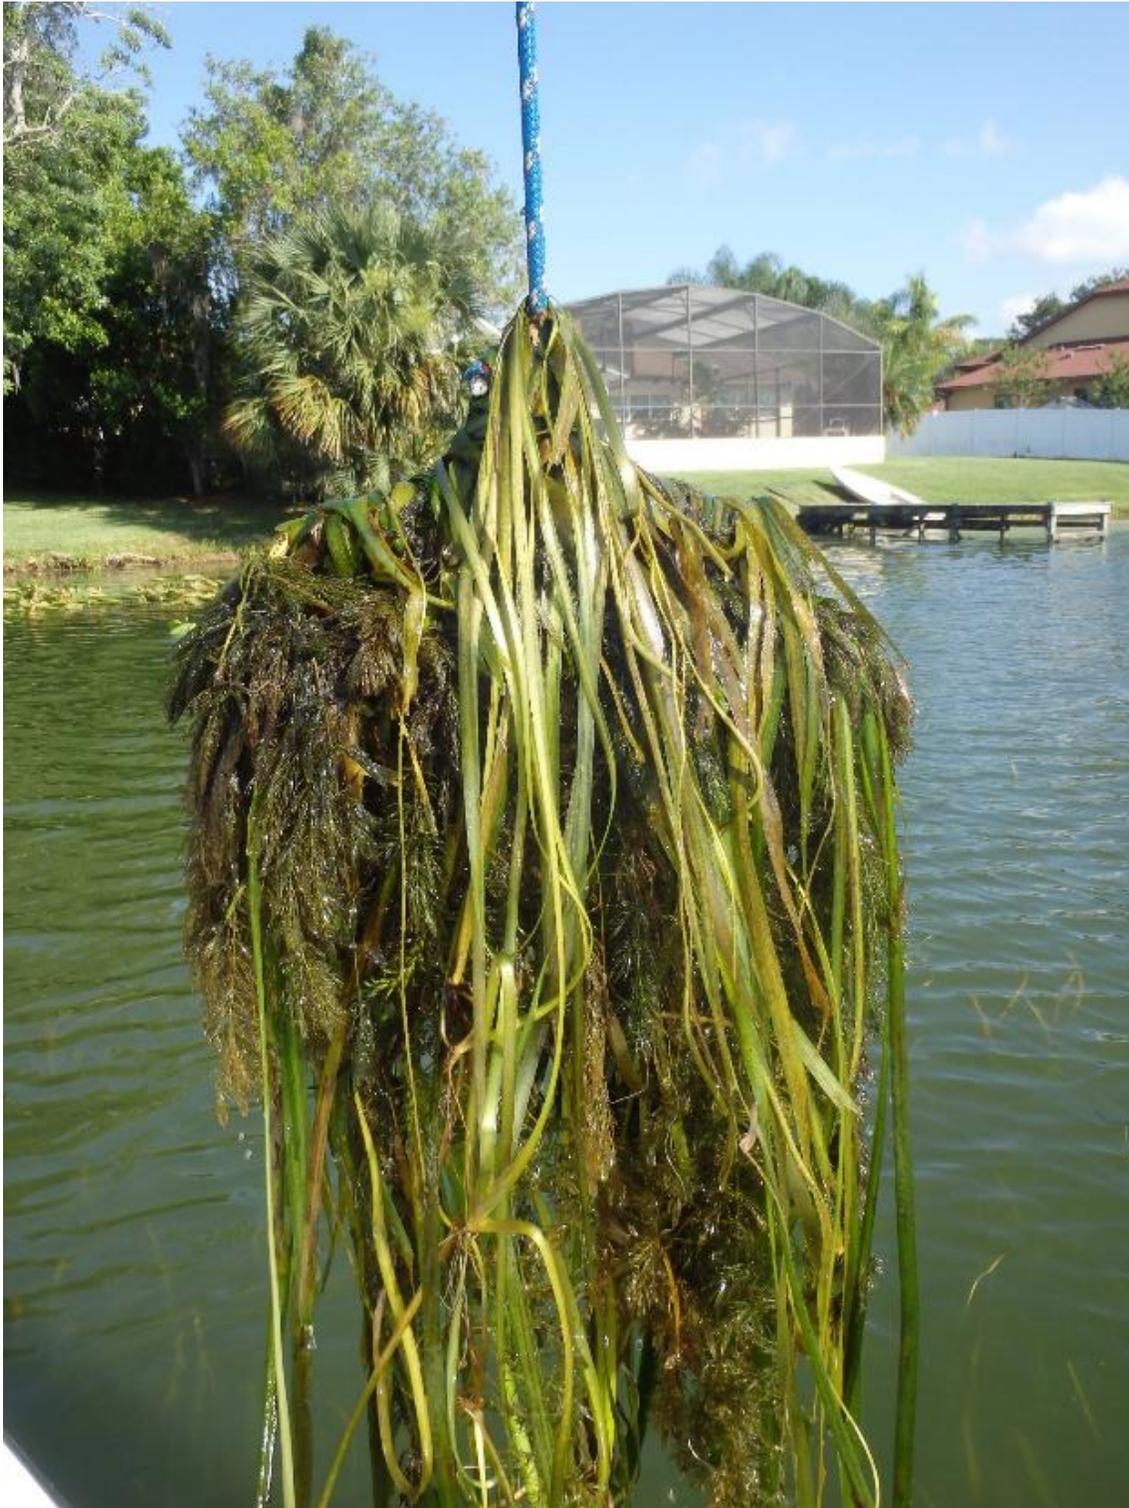
Several residents had reported their observations of hydrilla in the lake. After an extensive search throughout the lake, one sprig of hydrilla was found during the inspection. However, an increase in coontail was noted again in the lake.

Photo: Native SAV eelgrass and coontail.

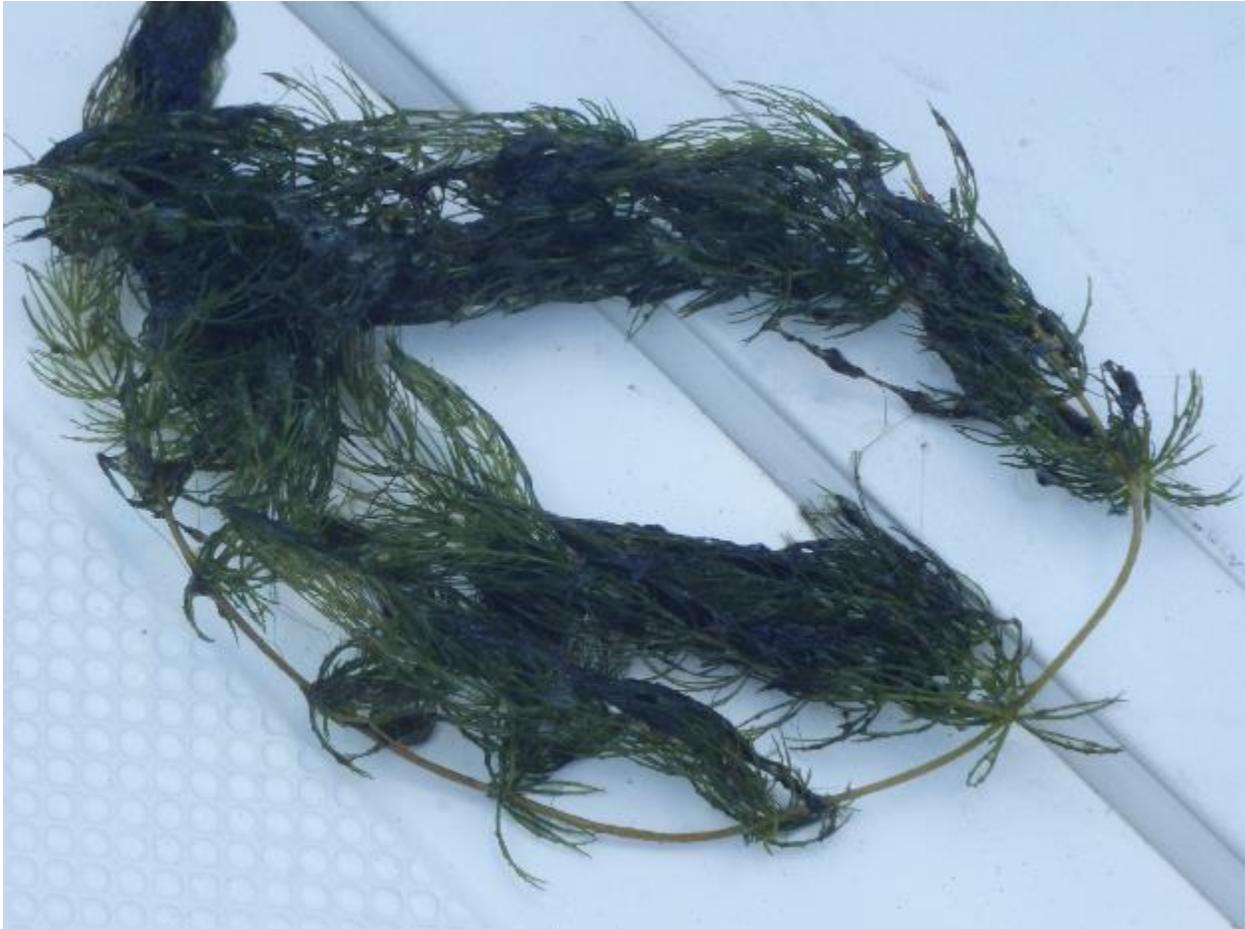
Native submersed aquatic vegetation (SAV) found during the inspection included: coontail to 6 feet, and eelgrass to 9 feet. Coontail had been expanding but eelgrass was still the dominant species. If SAV is impeding access to your boat dock you can apply for an aquatic plant removal permit through the Florida Wildlife Conservation Commission at <http://www.myfwc.com/license/aquatic-plants> or contact FWC regional biologist Kristine Campbell at 321-246-0682 to obtain your free permit.

Photo: Native SAV coontail.

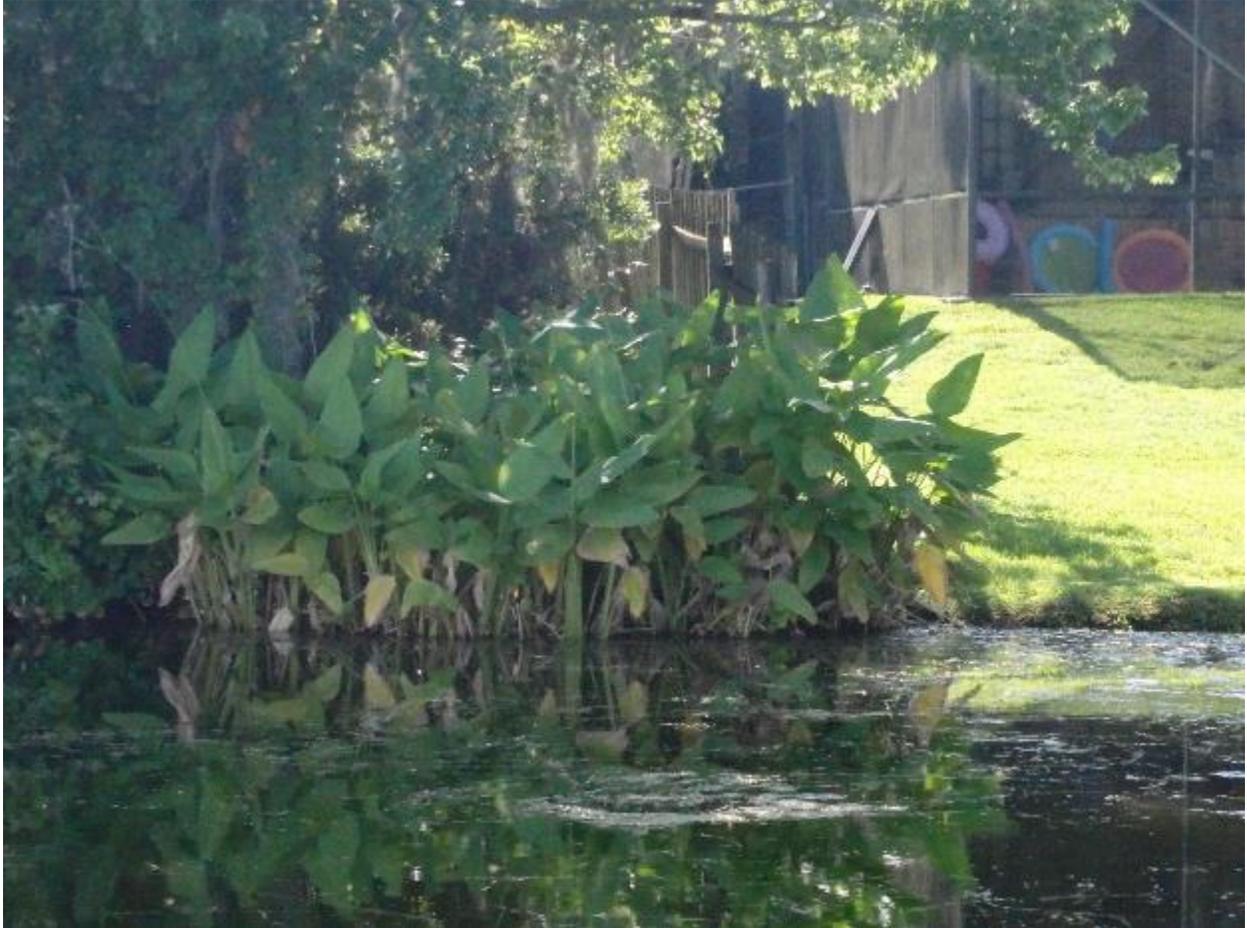
Native emergent vegetation observed during the survey included: golden canna, water hemlock, pennywort, spatterdock, fragrant water lily, maidencane, pickerelweed, duck potato, bulrush, fire flag, cattail, Elliott's aster, climbing aster, and blue flag iris.

Photo: Stand of native fire flag.

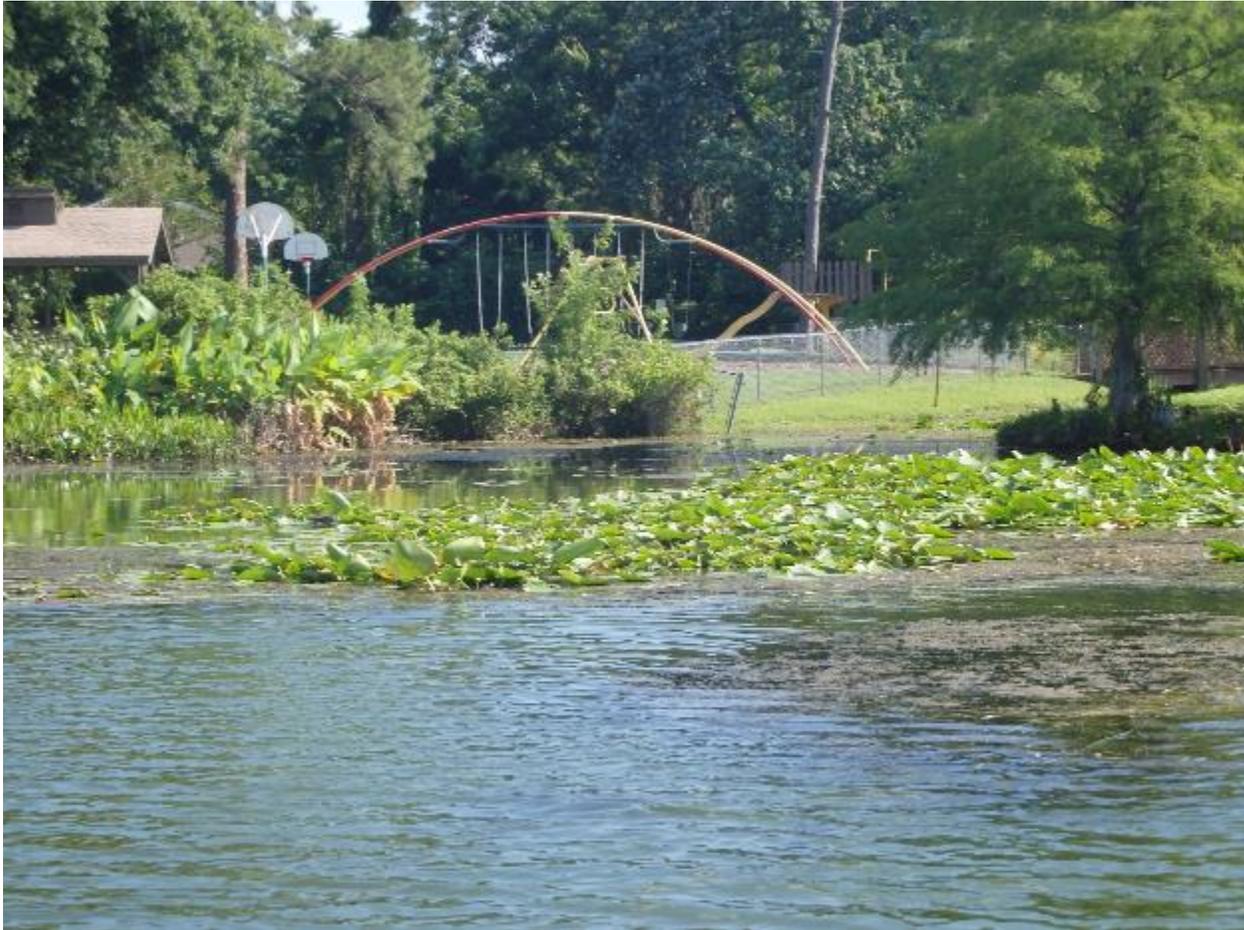
Invasive emergent vegetation observed during the survey included: alligator weed, wild taro, primrose willow, torpedograss, salvinia, Chinese tallow, Cuban burhead sedge, Brazilian pepper tree, creeping oxeye, and papyrus. Very little alligatorweed and torpedograss were found.

Photo: North canal.
