Greetings Buttonwood Residents,

On **January 26<sup>th</sup>, 2016**, SCLMP personnel, Joey Cordell, surveyed the aquatic plants in **Buttonwood Pond**.

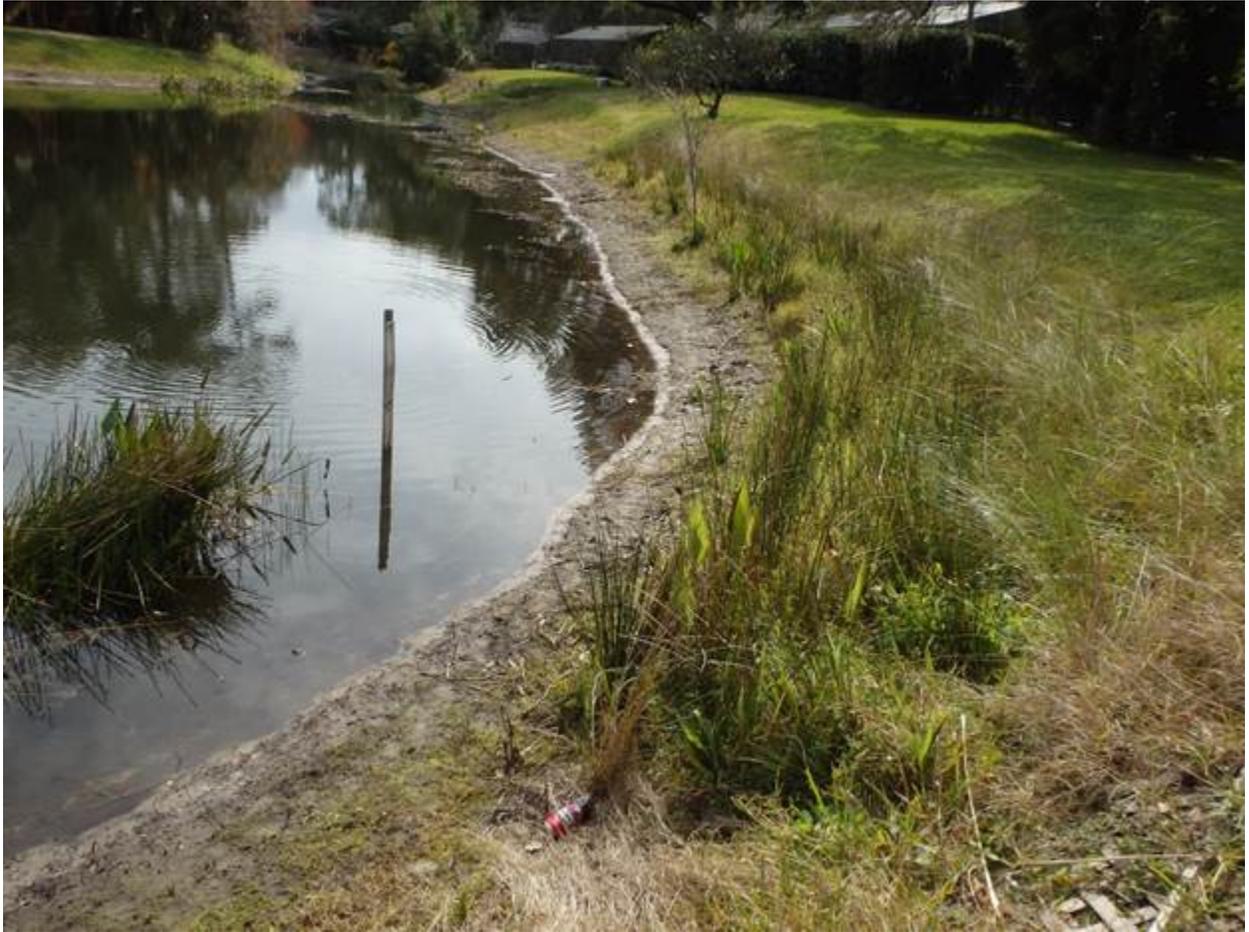
**Photos: Example restoration site.**

All of the pickerelweed planted at the restoration site died. This was most likely due to low water levels. The amount of canna and duck potato also decreased in this area. However, the cordgrass and soft rush were still very healthy. Pickerelweed will be replanted at a lower level to determine its habitable range.

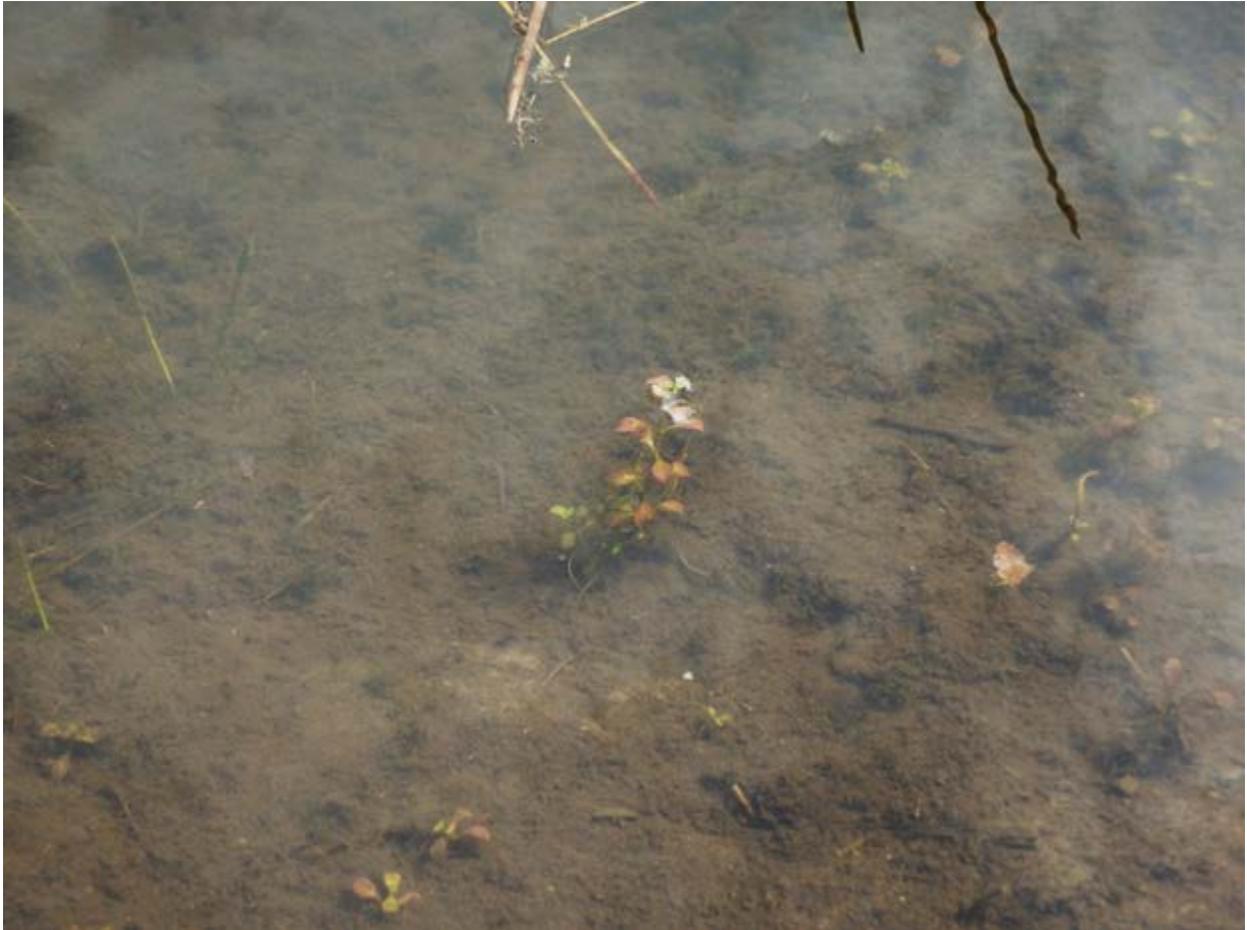
**Photo: Red ludwigia.**

Red ludwigia was the only submersed aquatic vegetation (SAV) observed during the inspection.

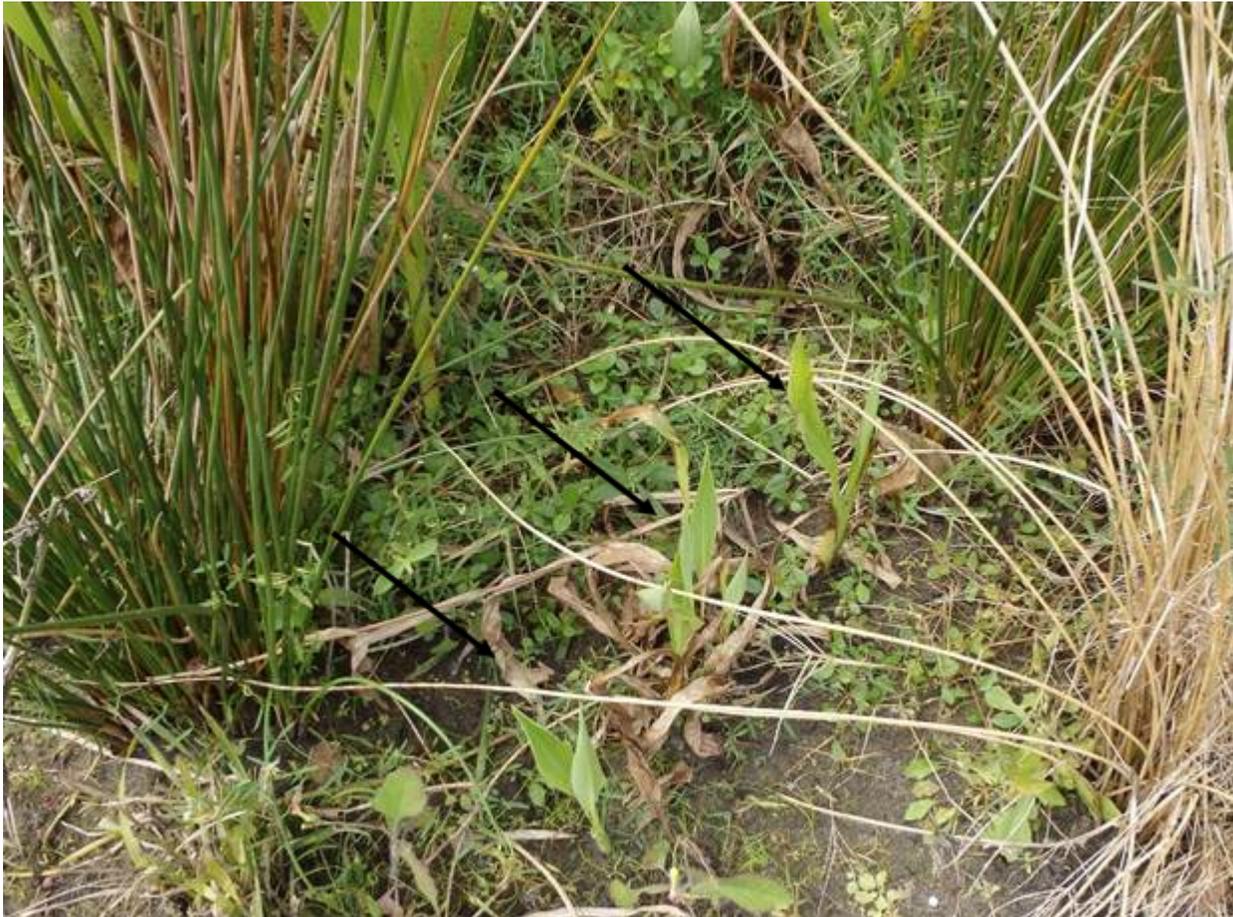
**Photo: New canna growth.**

Native emergent vegetation observed during the survey included: golden canna, buttonbush, spike rush, pennywort, soft rush, hempvine, pickerelweed, duck potato, cordgrass, and fire flag. Overall, there was less canna and duck potato than at the previous inspection, although there was an increase in young growth of these species.

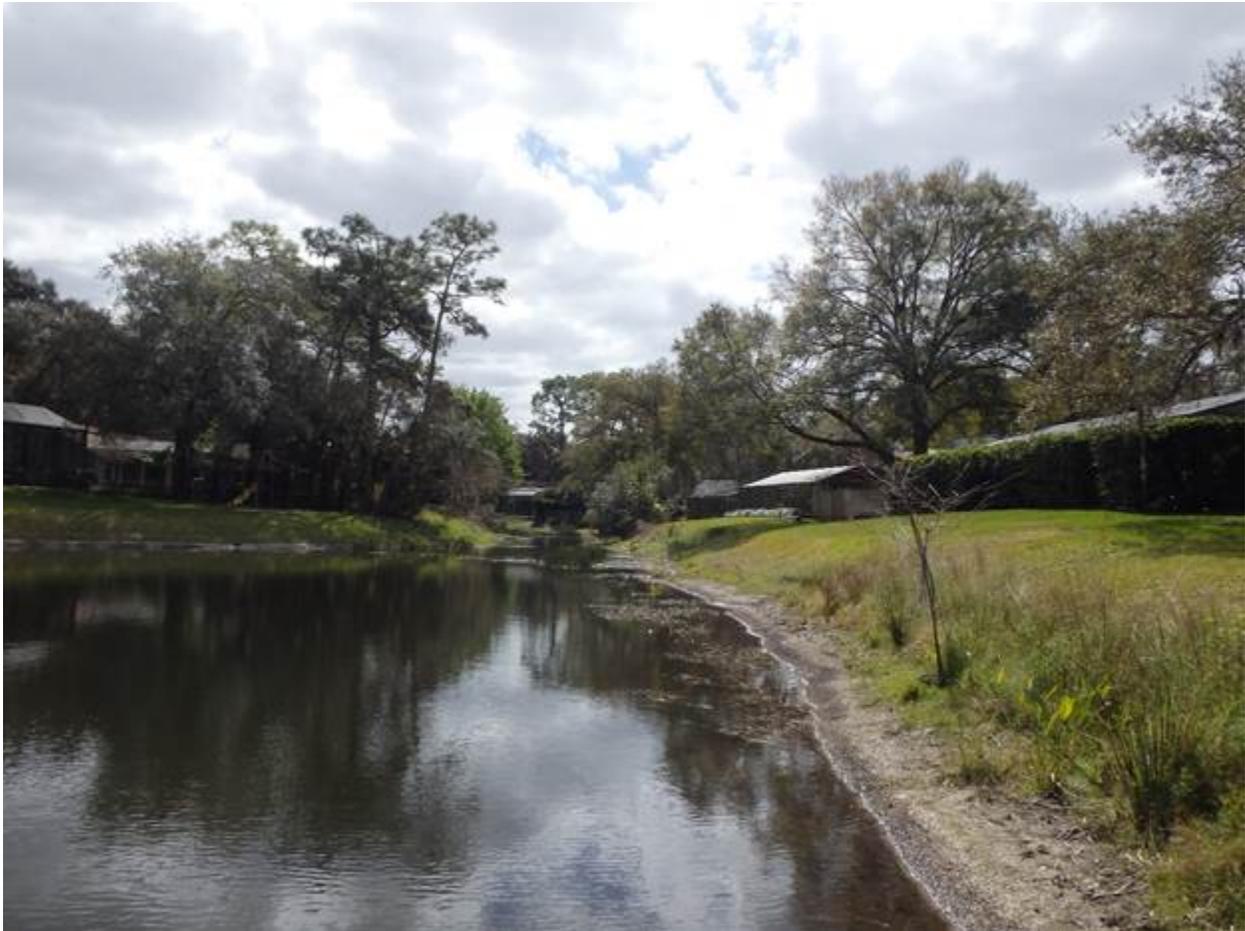
**Photo: Example restoration site.**

In the restoration zone, the pickerelweed and duck potato died due to the low water level. These species will be replanted lower on the shoreline.

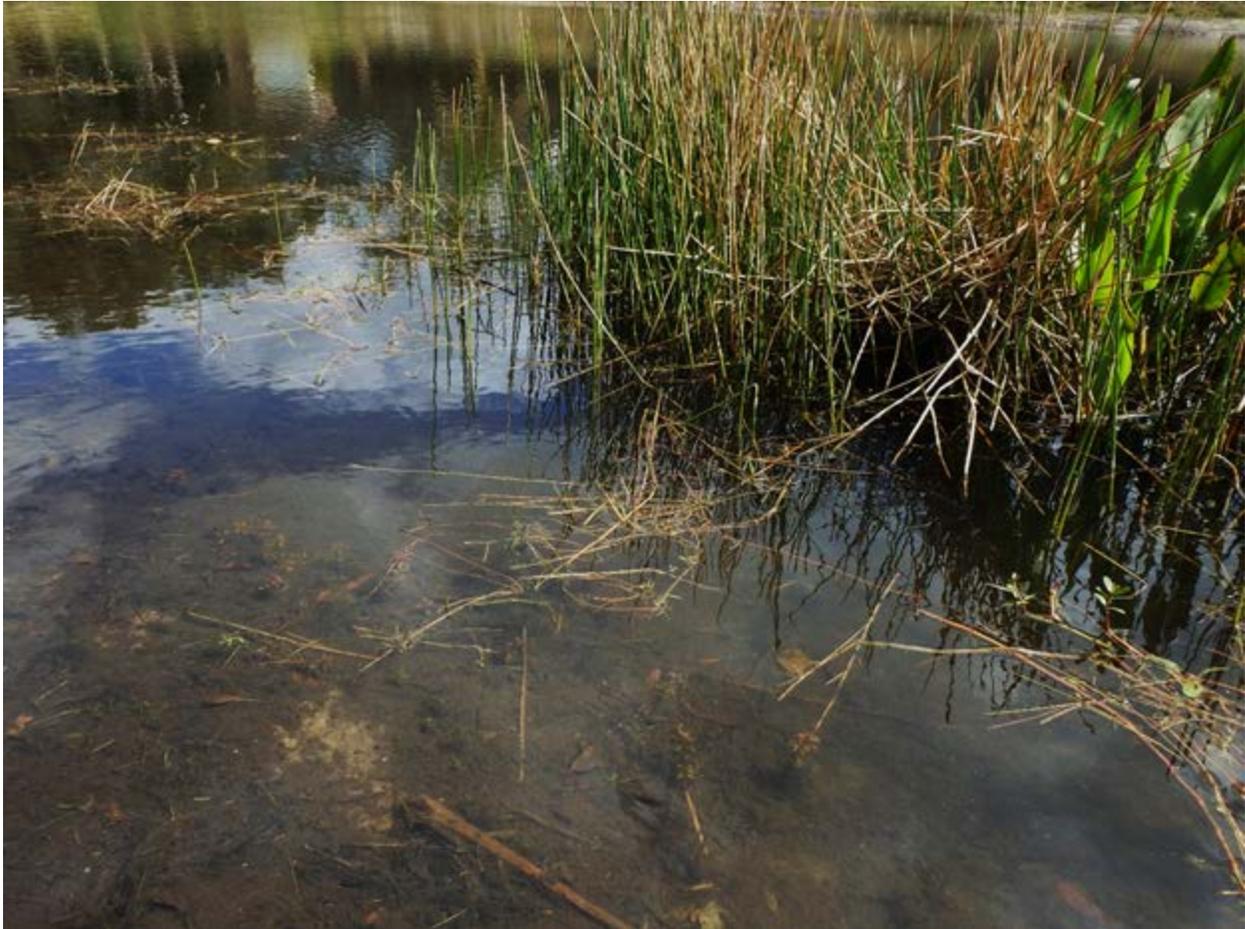
**Photo: Submersed Red Ludwigia.**

Submersed aquatic vegetation (SAV) observed during the inspection included: red ludwigia, roadgrass, and baby's tears. All species were found in shallow water.

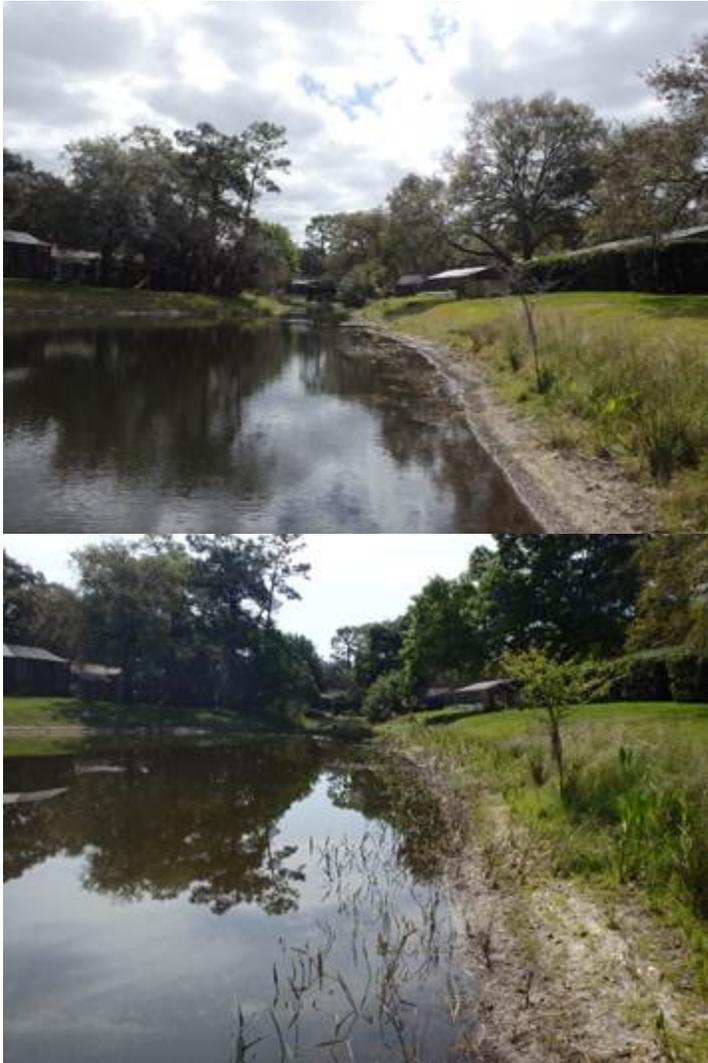
**Photo: Restoration site.**

The restoration example site has been extended and replanted with duck potato, pickerelweed, canna, blue-flag iris, soft rush and cord grass. Low water elevation has made it difficult for plantings to survive. We will continue to monitor to see which species will survive best.

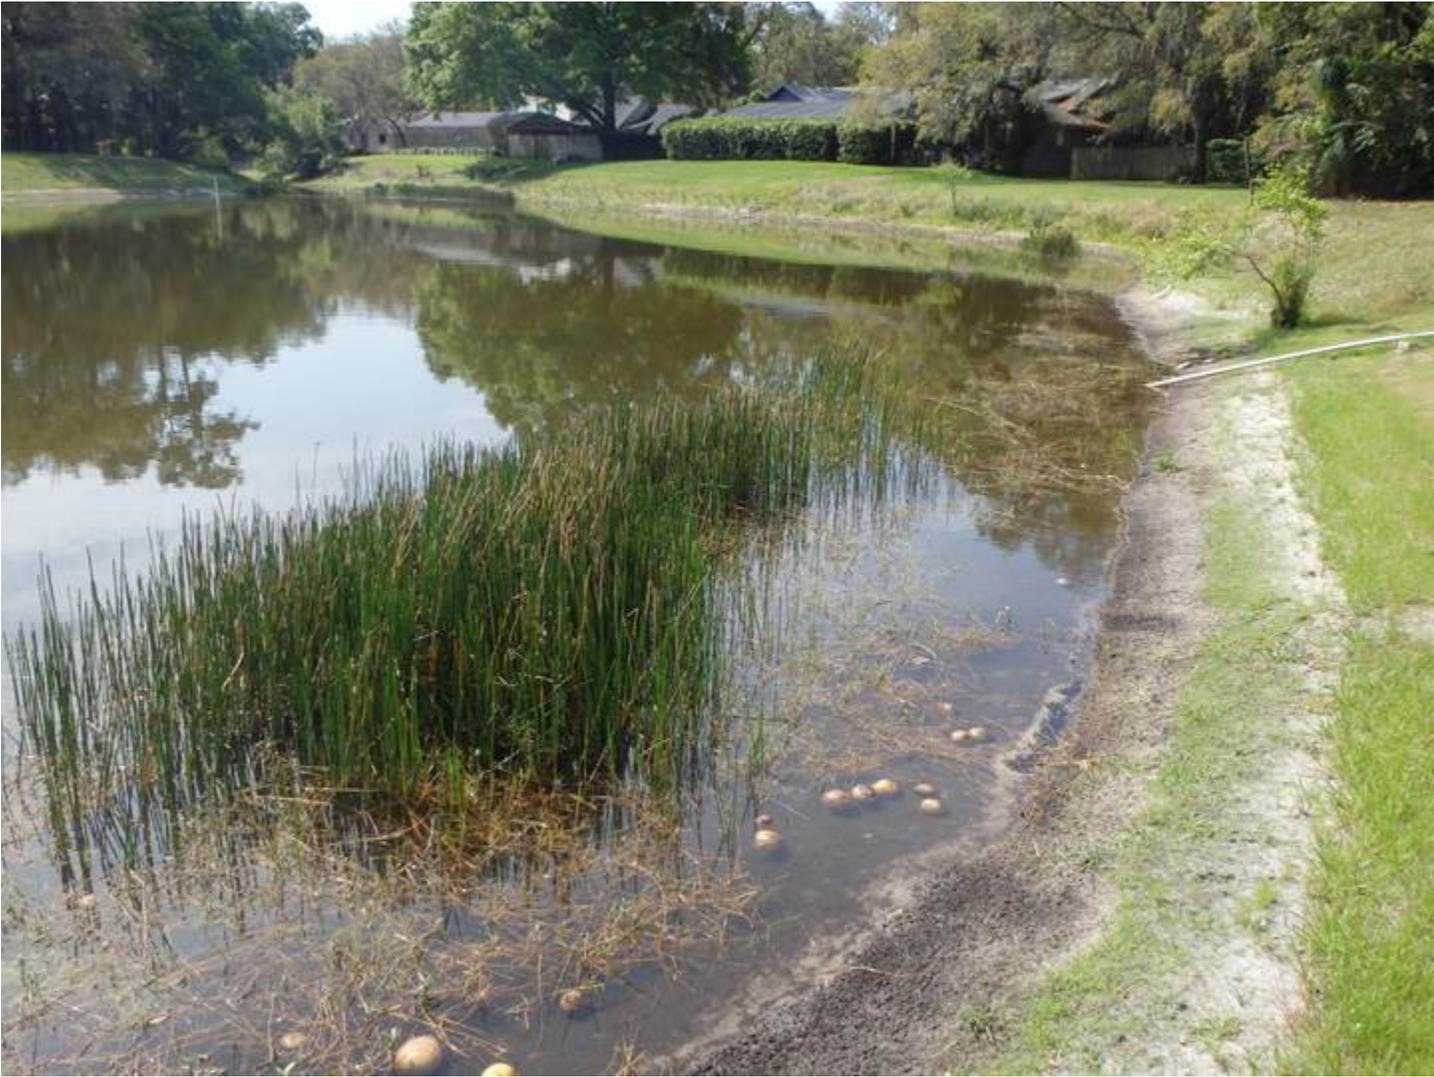
Native emergent vegetation found during the survey included: spike rush, soft rush, pickerelweed, duck potato, fire flag, canna, blue-flag iris and cordgrass.

**Photo: Spike rush.**

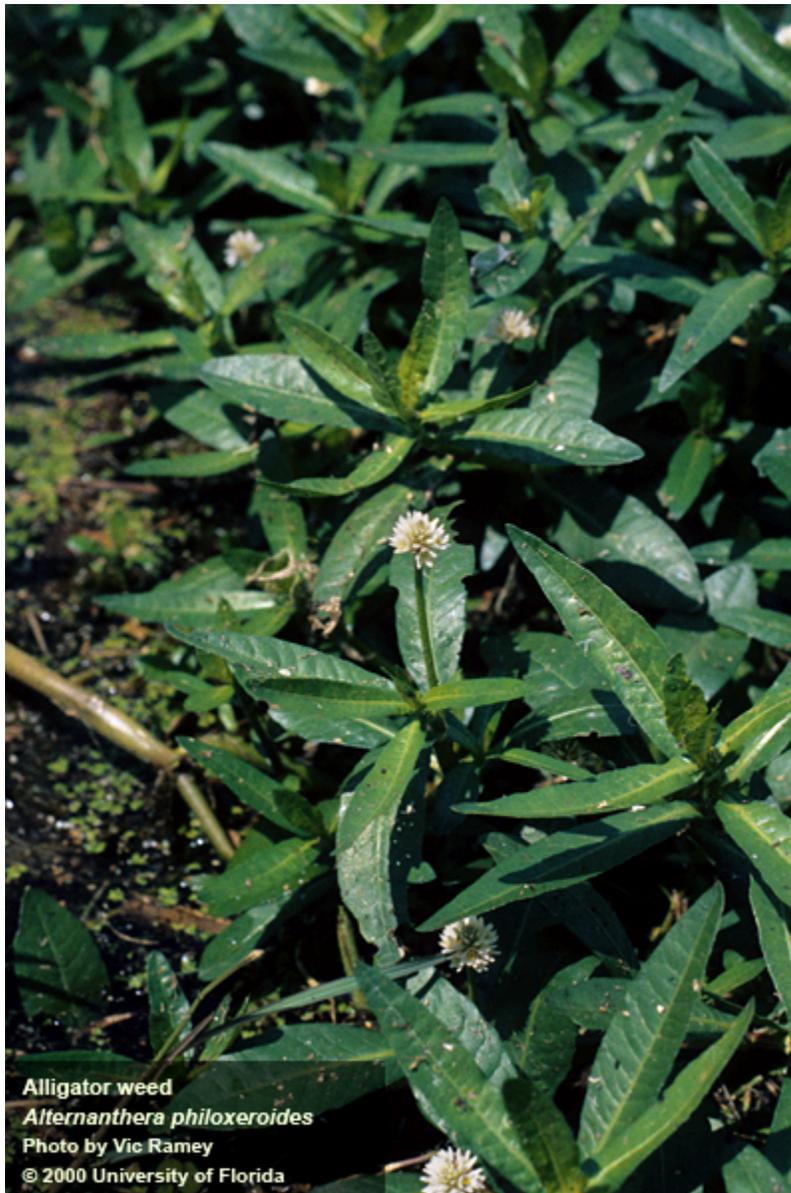
Invasive emergent vegetation included: alligator weed, and torpedo grass.

**Photo: Example of the invasive exotic alligator weed.**

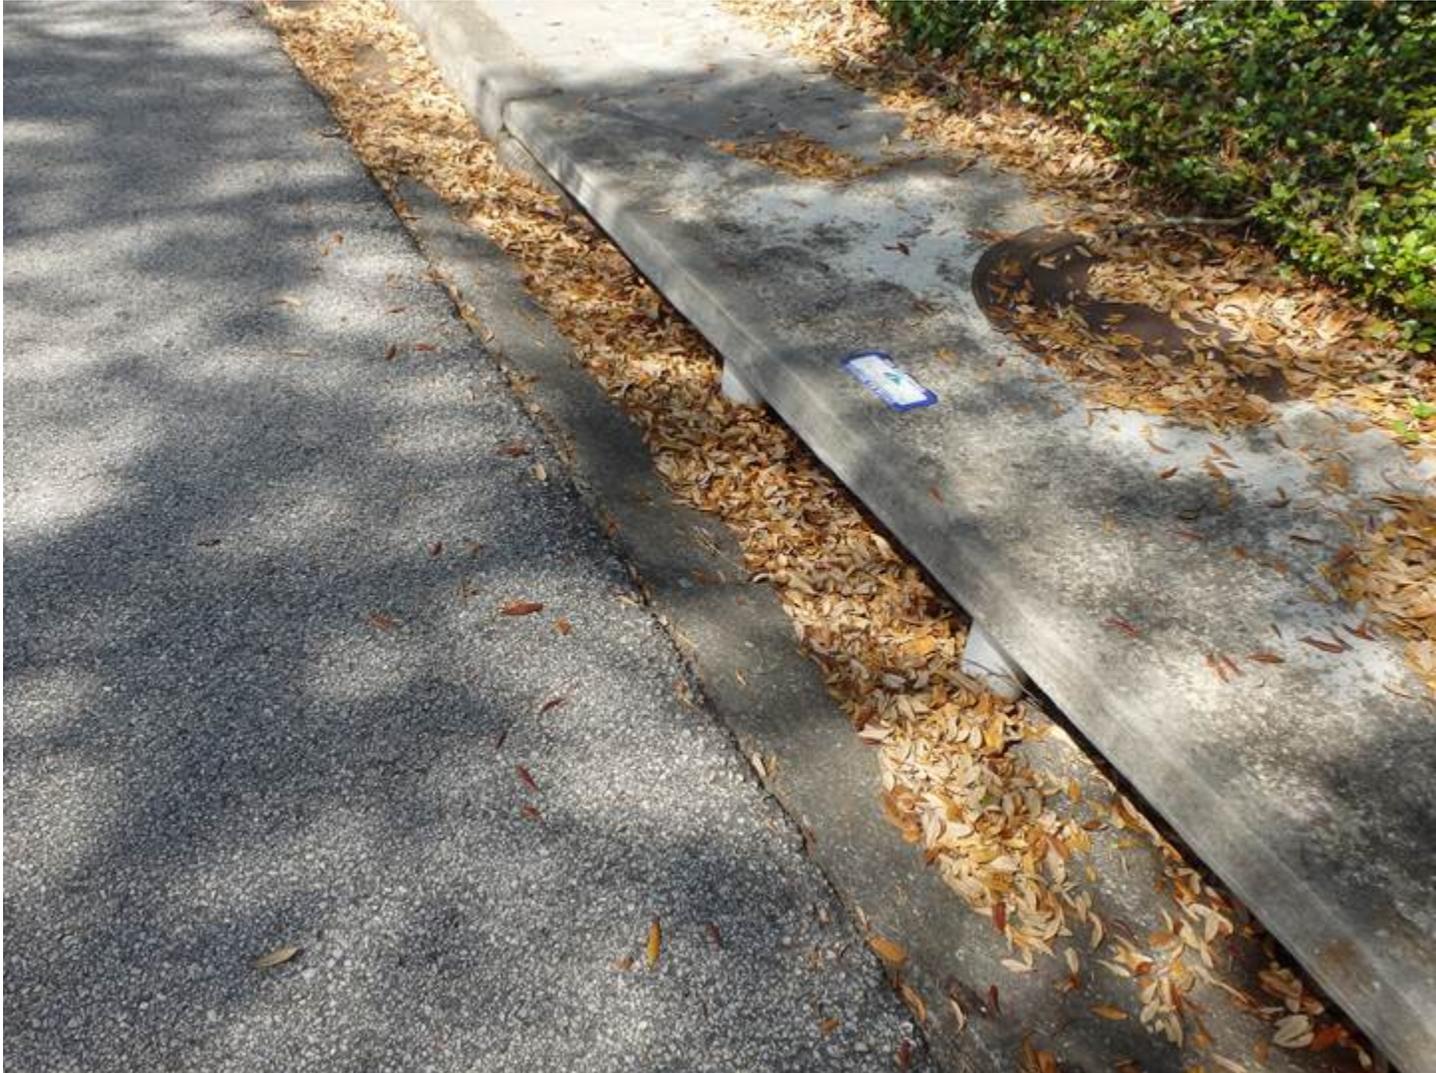
**Photo: Leaves in storm drain. Consider increasing street sweeping services during times of peak leaf fall.**

2. Consider increasing street sweeping services during times of peak leaf fall to ensure that this debris does not enter waterways. Leaf debris contains high levels of phosphorous that can negatively impact your lakes.
