## HOWELL CREEK BIOASSESSMENTS

MARCH to APRIL 2015

### **Bioassessment**

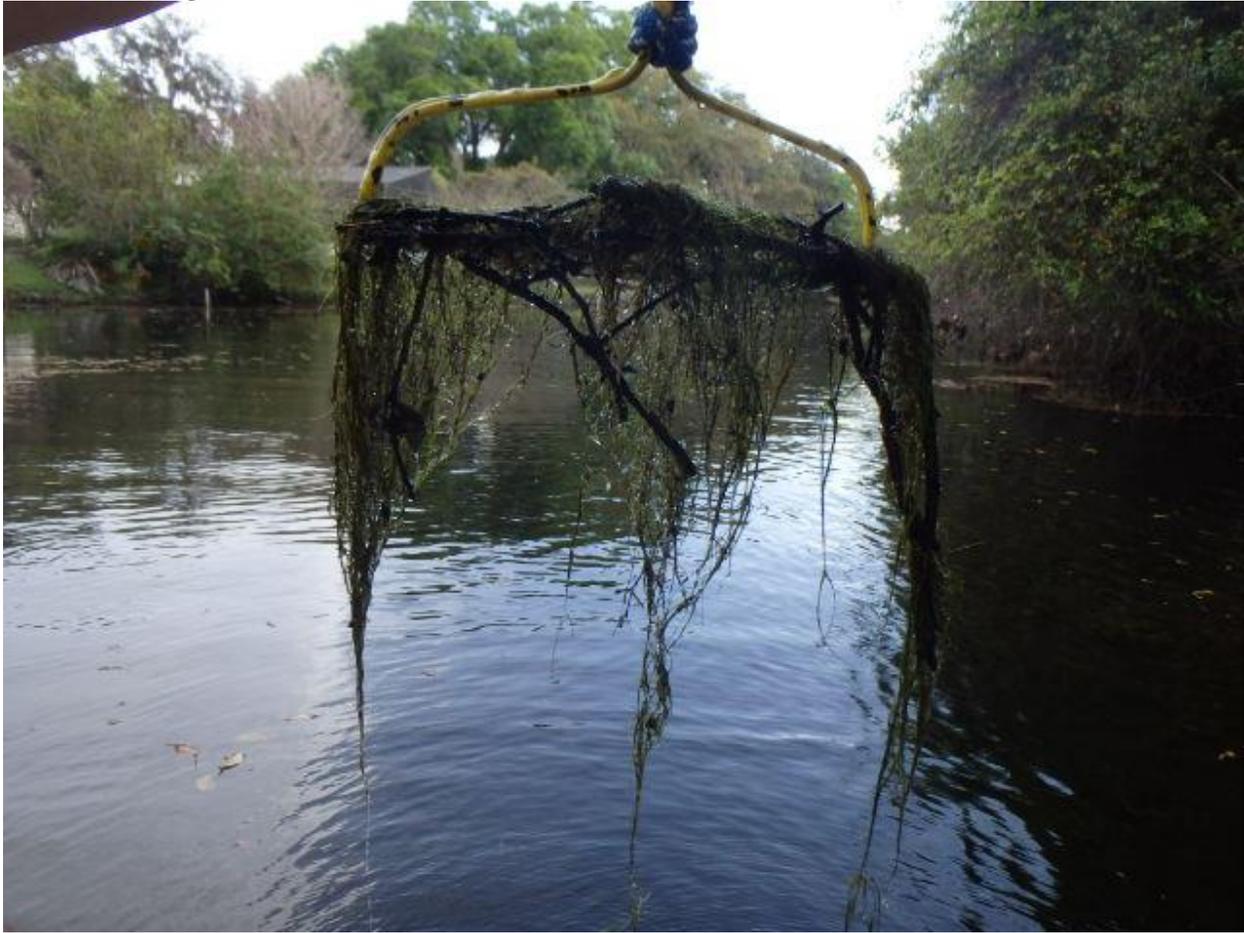
Native submersed aquatic vegetation (SAV) species found during the inspection included road-grass and eelgrass, with road-grass being identified as the dominant SAV species. One sprig of invasive hydrilla was observed. A bottom filamentous algal bloom was observed.

**Photo: Road-grass (native).**

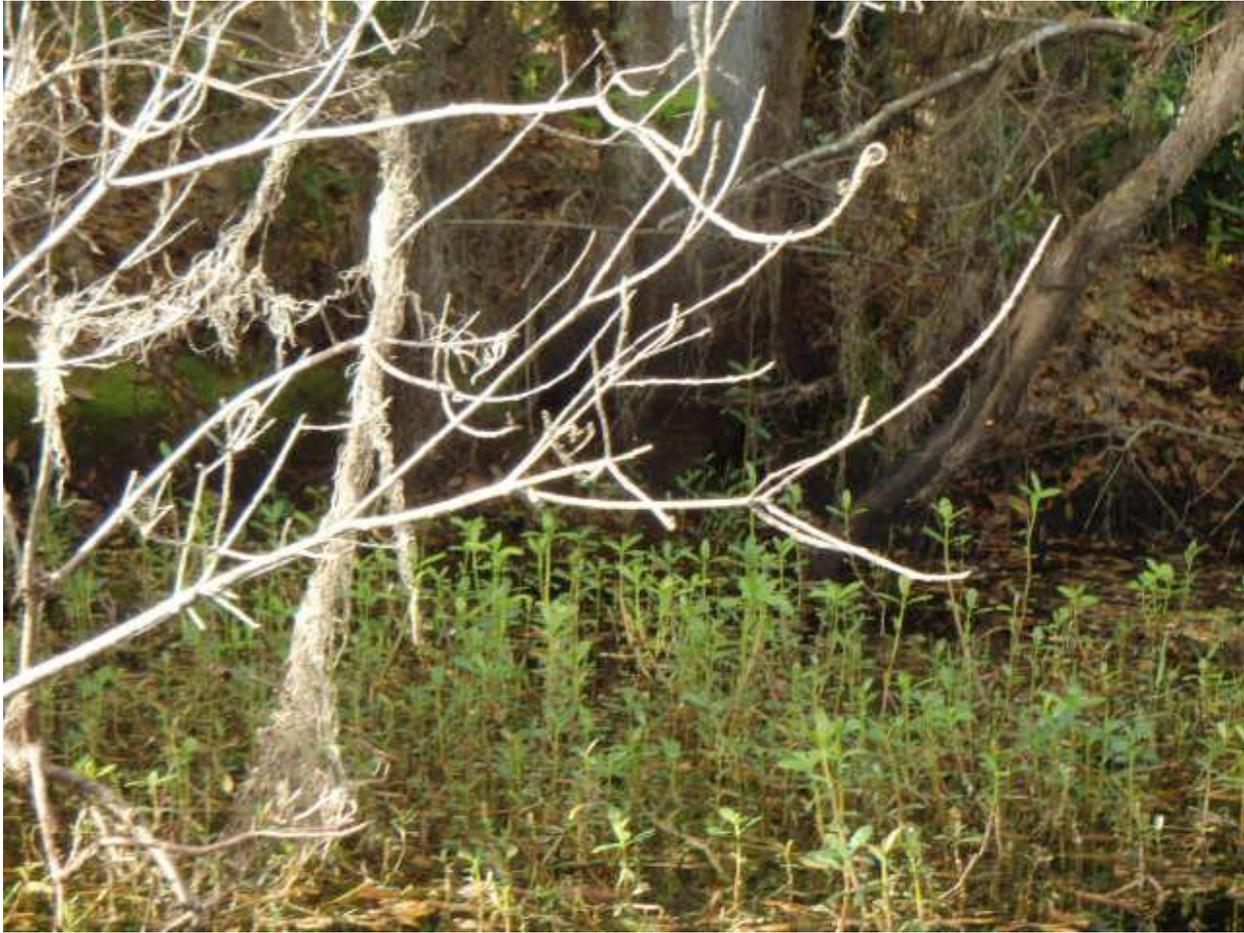
Invasive emergent vegetation observed during the inspection included: alligatorweed, wild taro, wedelia, torpedo grass, and water hyacinth. Torpedo grass and alligatorweed growth have increased in comparison to the last survey in December. Only two water hyacinth plants were observed during this survey, which was a reduction from the last survey.

**Photo: Alligatorweed (invasive)**

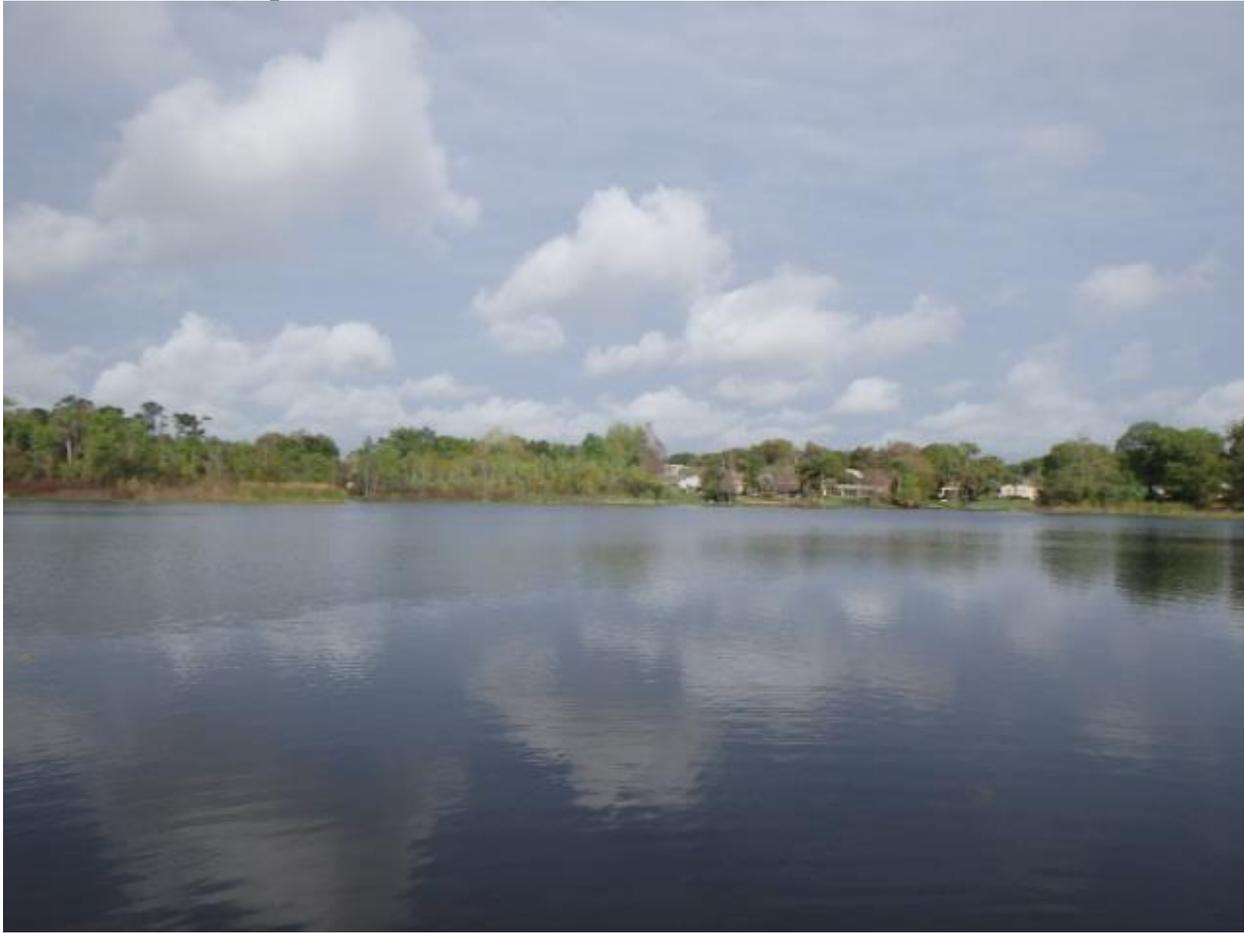
Lake Waumpi was also surveyed during this inspection. Lily pads showed signs of recent treatment and no water hyacinth was observed. Emergent species found on Lake Waumpi include: cattail, yellow cow lily, banana lily, and primrose willow.

**Photo: Lake Waumpi**

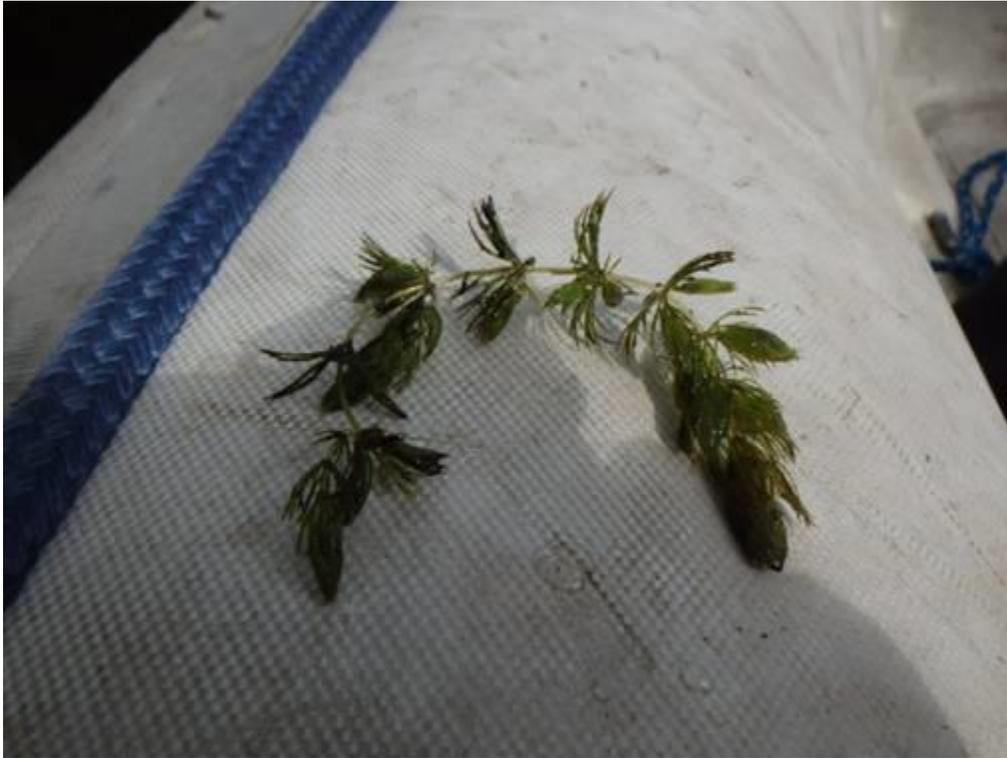
Native submersed aquatic vegetation (SAV) species found during the inspection included road-grass, coontail, bladderwort, and eelgrass, with eelgrass being identified as the dominant SAV species, followed by bladderwort. A few sprigs of invasive hydrilla were observed. The bottom filamentous algal bloom appeared to have been slightly reduced.

**Photo: Coontail (native)**

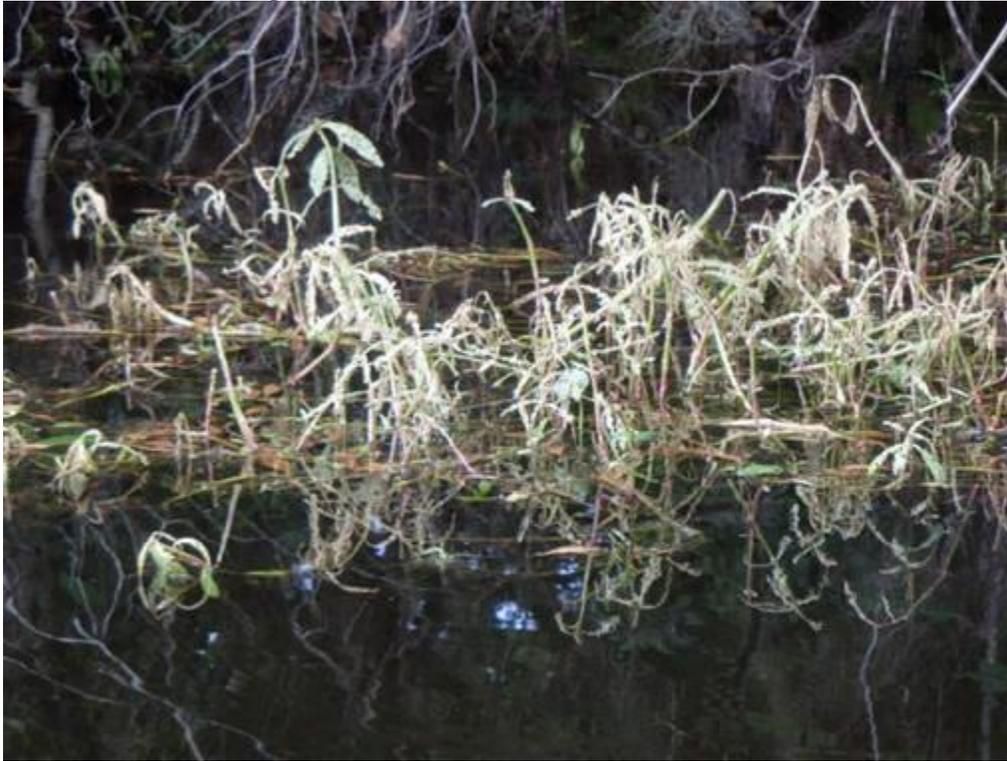
Invasive emergent vegetation observed during the inspection included: alligatorweed, wild taro, torpedo grass, and water hyacinth. Torpedo grass and alligator weed showed signs of recent treatment. Five water hyacinth were observed during this survey, which was an increase from the last survey.

**Photo: Treated Alligatorweed (invasive)**

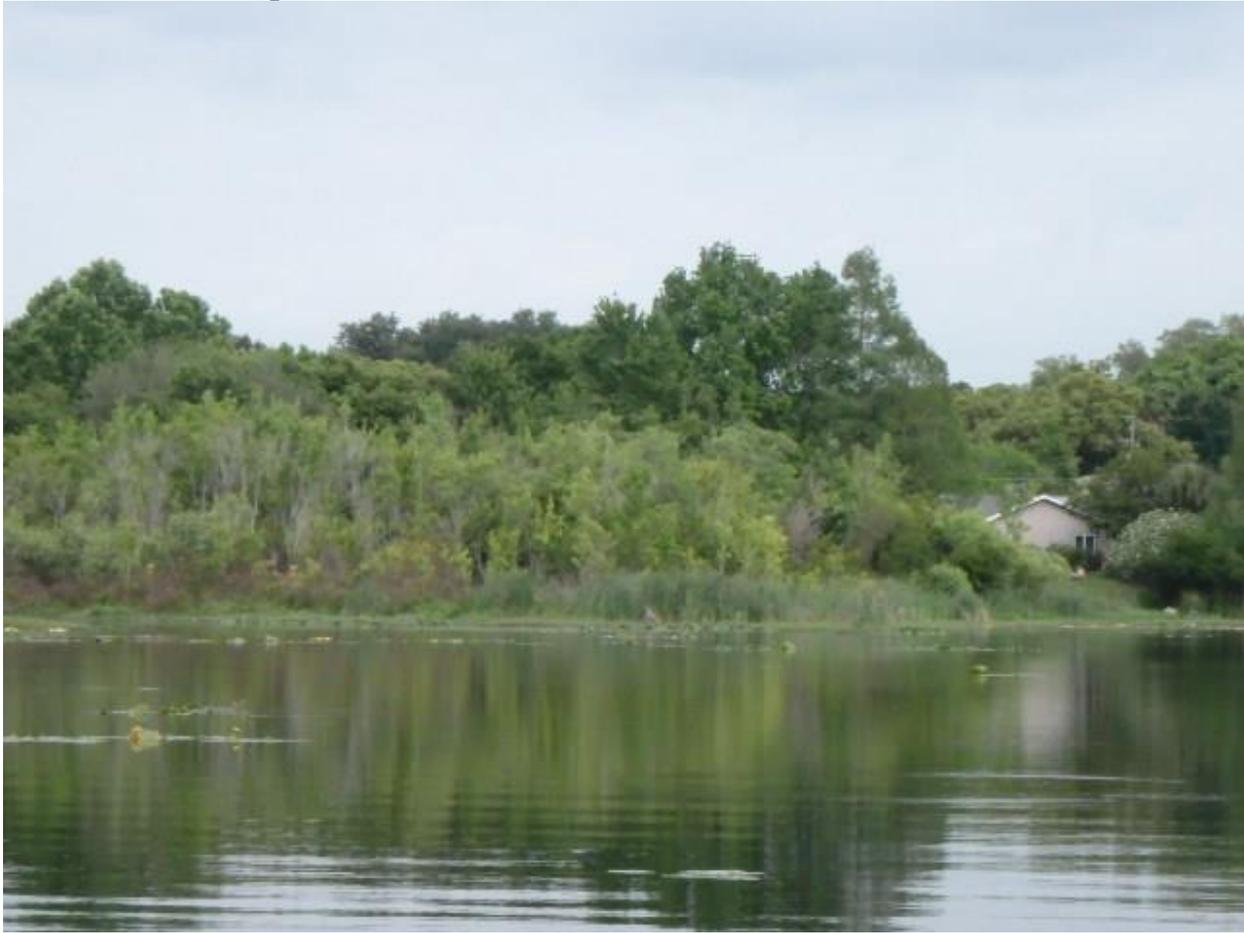
Lake Waumpi was also surveyed during this inspection. Lily pads had been visibly reduced by a recent treatment. Invasive species observed included water hyacinth, alligator weed, and torpedo grass. Emergent species found on Lake Waumpi included cattail, yellow cow lily, banana lily, canna, and primrose willow. Submersed species observed included coontail and southern naiad.

**Photo: Lake Waumpi**
