Greetings Lake Howell Residents!

Please find the bioassessment report for your lake below. Key highlights of this update include:

On **June 14th, 2016**, Lake Management Program staff, Joey Cordell and Beth Beals, surveyed the aquatic plants in **Lake Howell**.

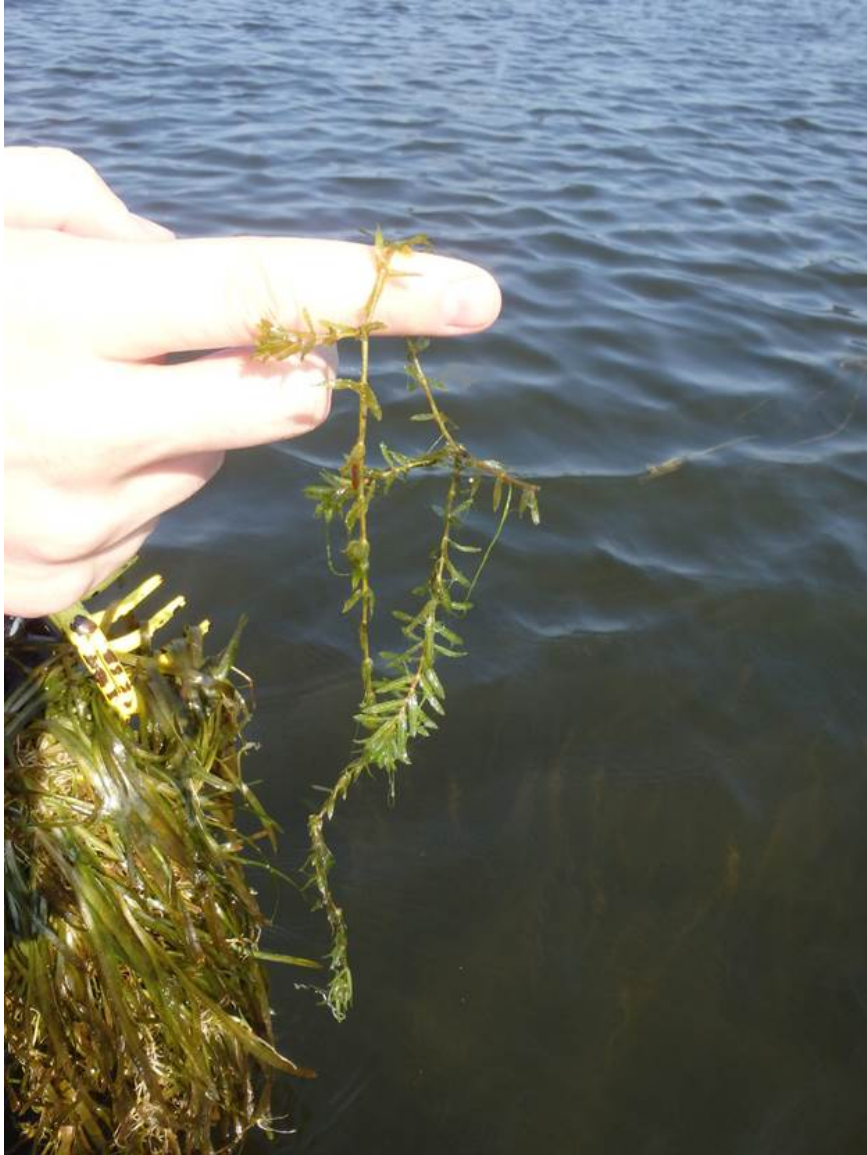
Hydrilla was again found in areas along the North shore, particularly the Sausalito Shores Park and Lago Vista areas. Hydrilla tubers were also found in the Southeast cove. The hydrilla has not expanded since the previous inspection, though.

Photo: Hydrilla with new growth.

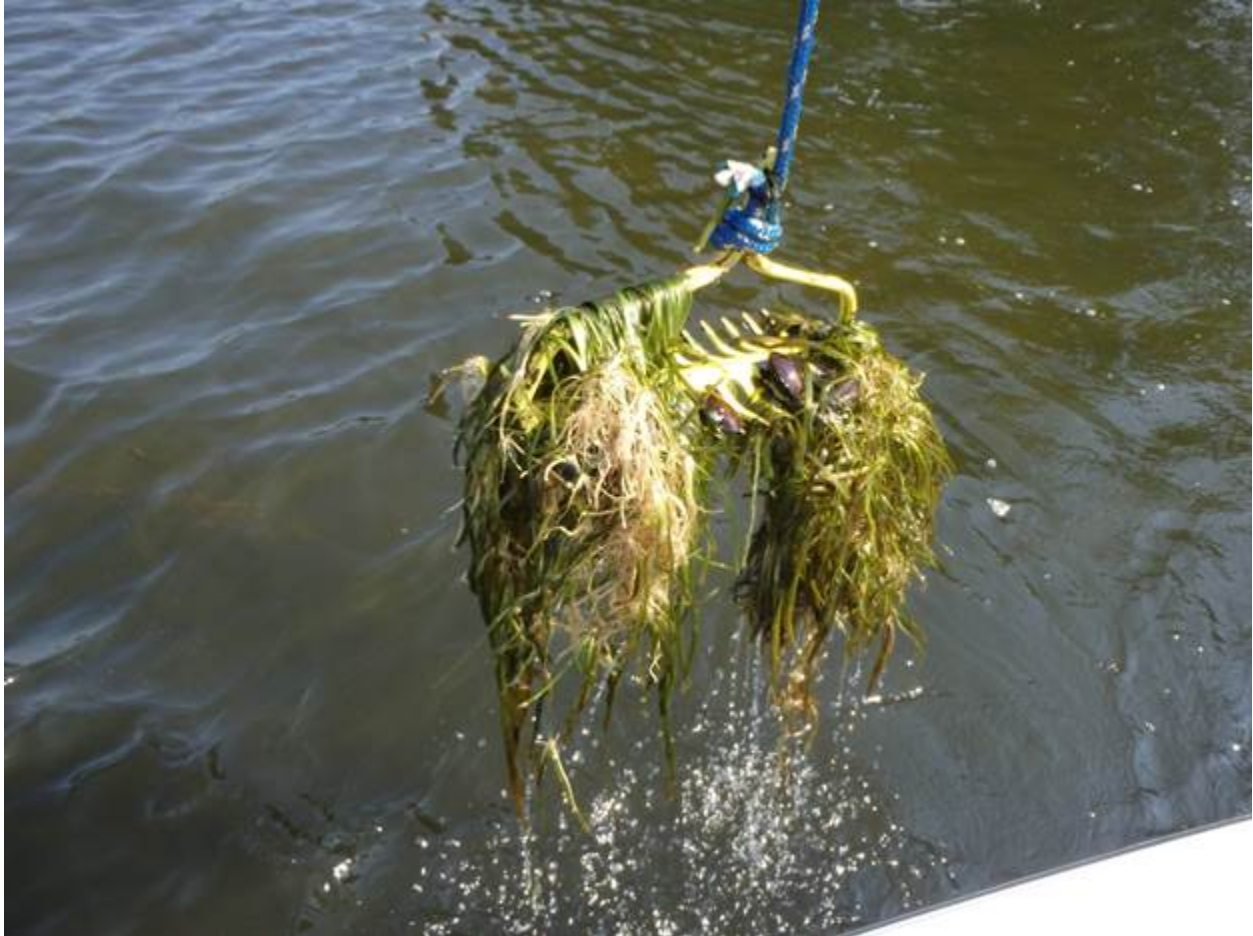
Eelgrass was the only native submersed aquatic vegetation (SAV) observed during the inspection. The maximum depth for the eelgrass was 5.5 feet.

Photo: Eelgrass and freshwater mussels.

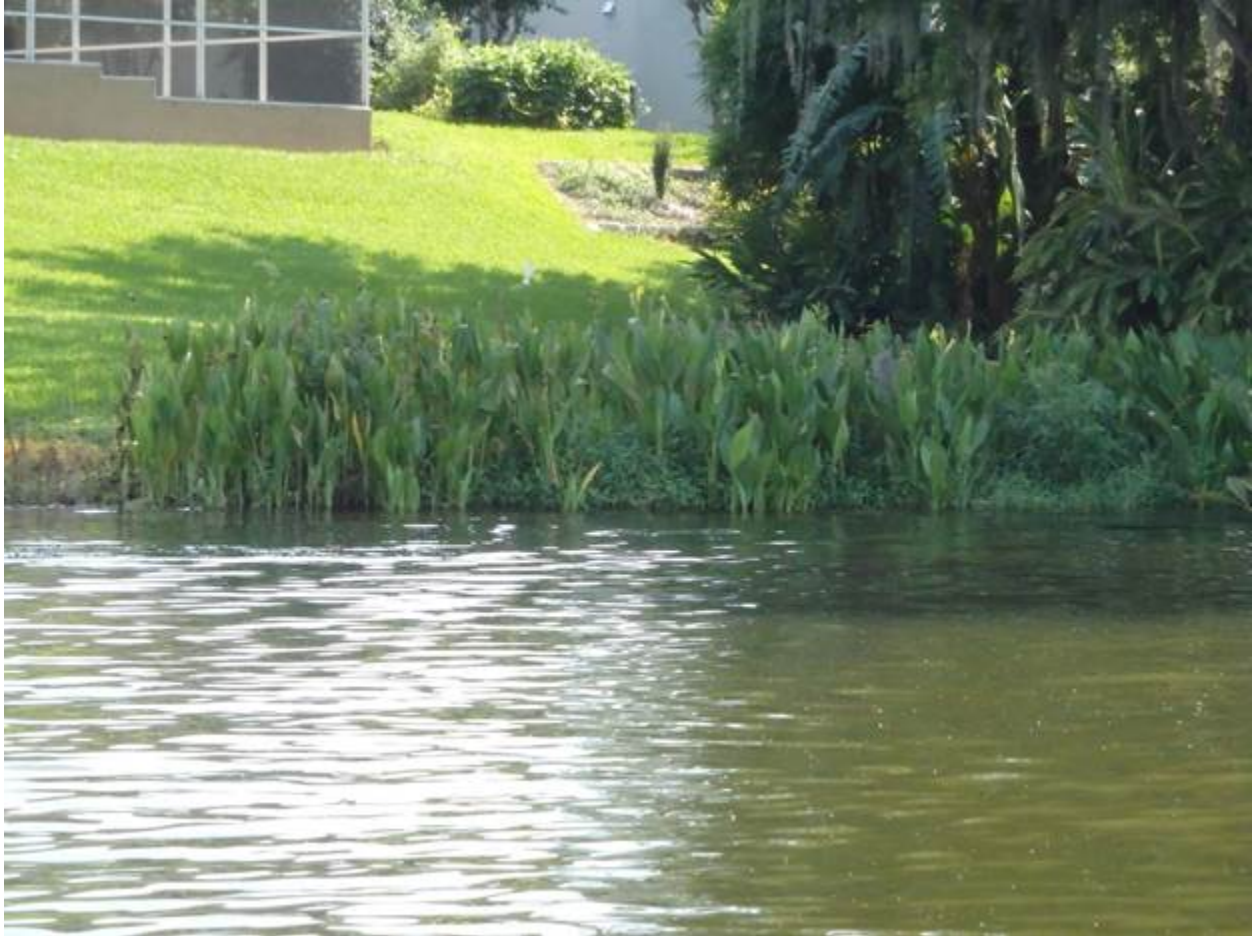
Native emergent vegetation observed during the survey included: golden canna, buttonbush, water hemlock, swamp lily, flatsedge, pennywort, sofrush, hempvine, spatterdock, maidencane, smartweed, pickerelweed, duck potato, carolina willow, cordgrass, fire flag, and cattail. The native vegetation is expanding.

Photo: Golden canna.

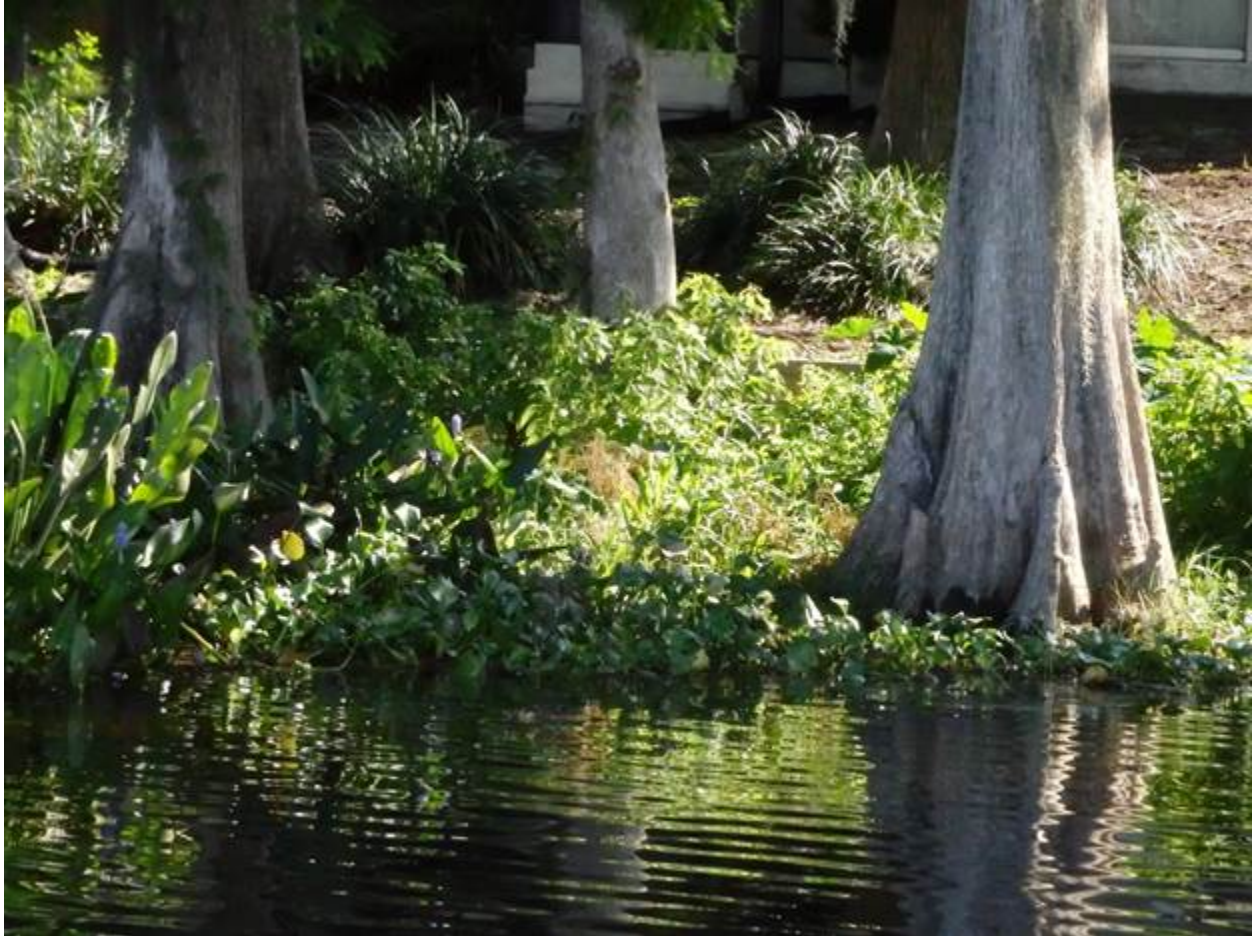
Invasive emergent species observed included: alligator weed, paragrass, wild taro, umbrella grass, barnyard grass, water hyacinth, primrose willow, parrot feather, torpedograss, creeping oxeye and papyrus.

Photo: Water hyacinth.

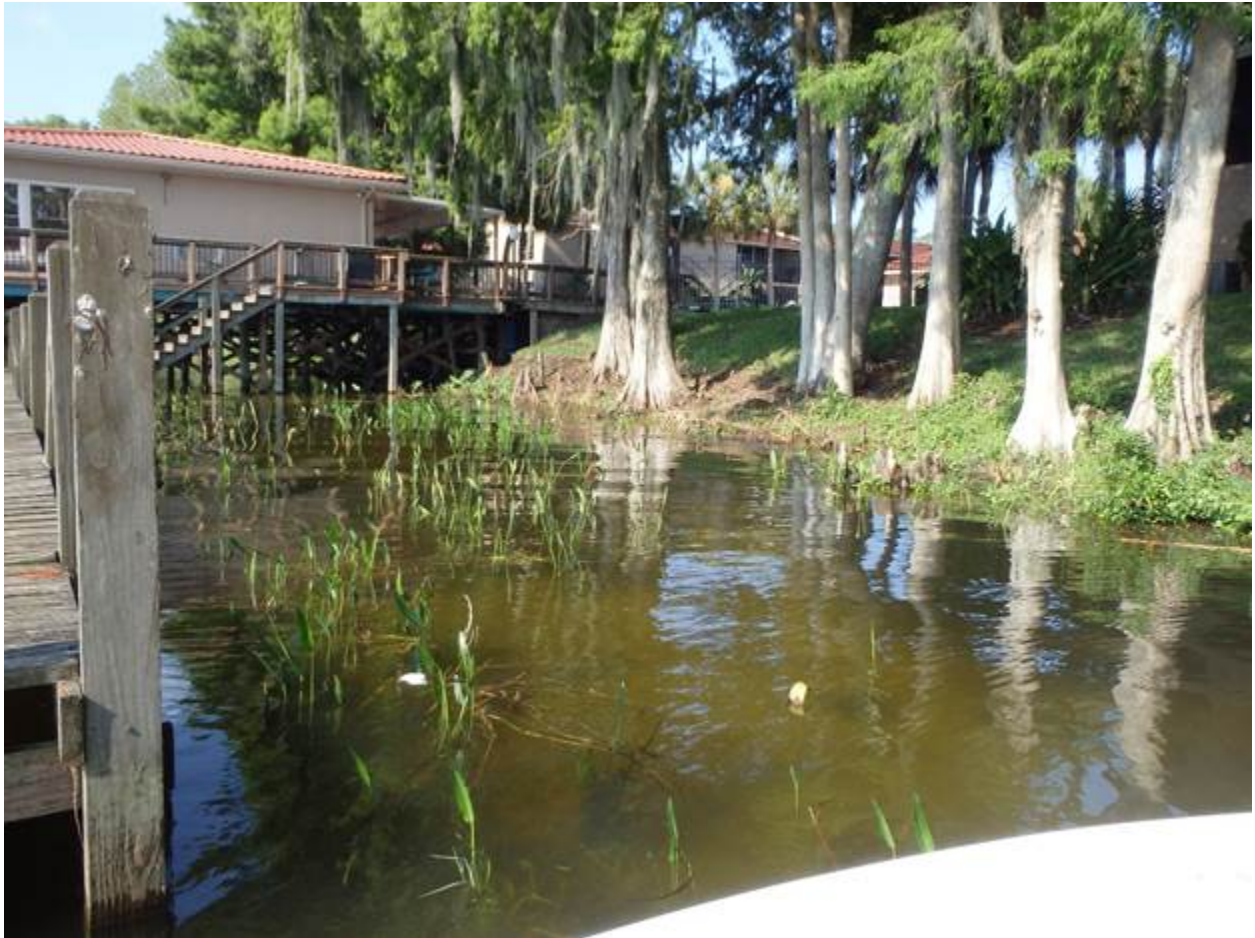
On May 14th Seminole County's SERV program held an event to plant native shoreline vegetation. With the help of 67 volunteers, 5320 plants were installed at 8 sites around the lake. Those species planted included: duck potato, pickerelweed, softrush, and fireflag. Having a healthy population of shoreline vegetation filters runoff pollutants, protects against erosion, and provides habitat for the wildlife. Most of the planting sites are in healthy condition, but a few sites had a lower than desired survival rate.

Photo: SERV planting site.

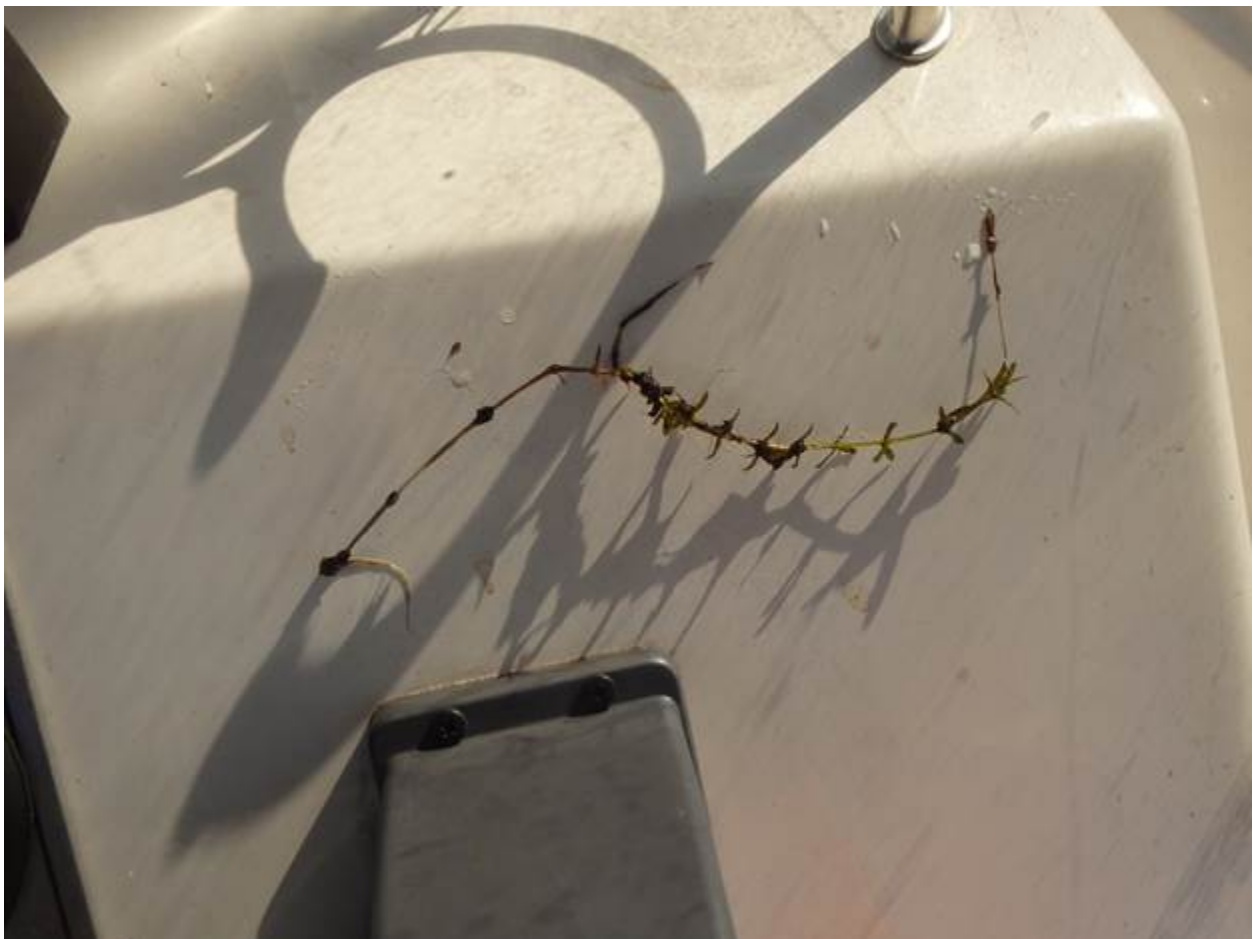
Hydrilla was found on seven occasions during the inspection, indicating that it is scattered sparsely around the lake. Hydrilla did not exceed a depth of 4 feet.

Photo: Hydrilla growing from tuber.

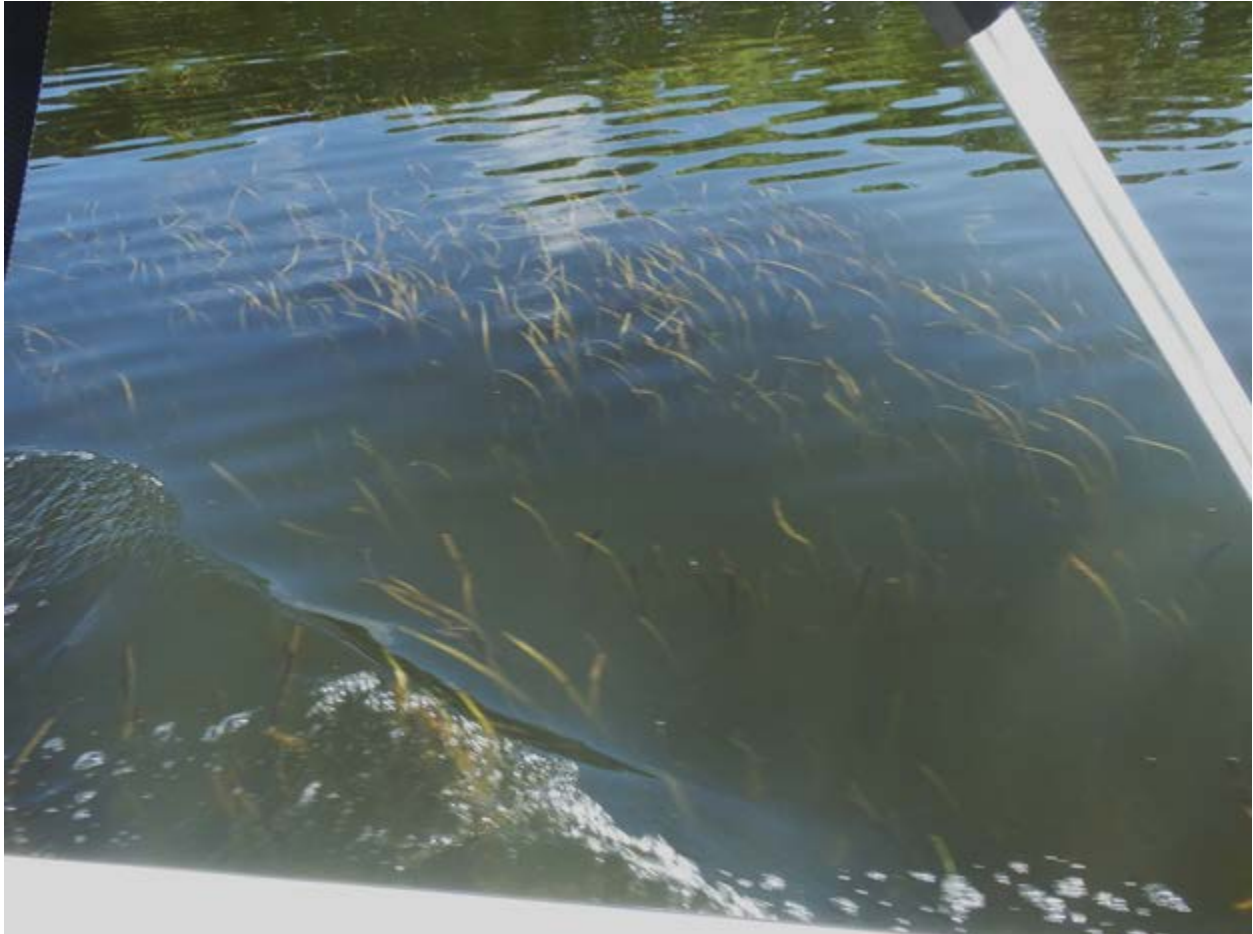
Native submersed aquatic vegetation (SAV) observed during the inspection included: coontail to a depth of 6 feet, southern naiad to 3 feet, and eelgrass to 6 feet. Eelgrass is the dominant species on the lake and is increasing in area.

Photo: Eelgrass found to a depth of 6 feet.

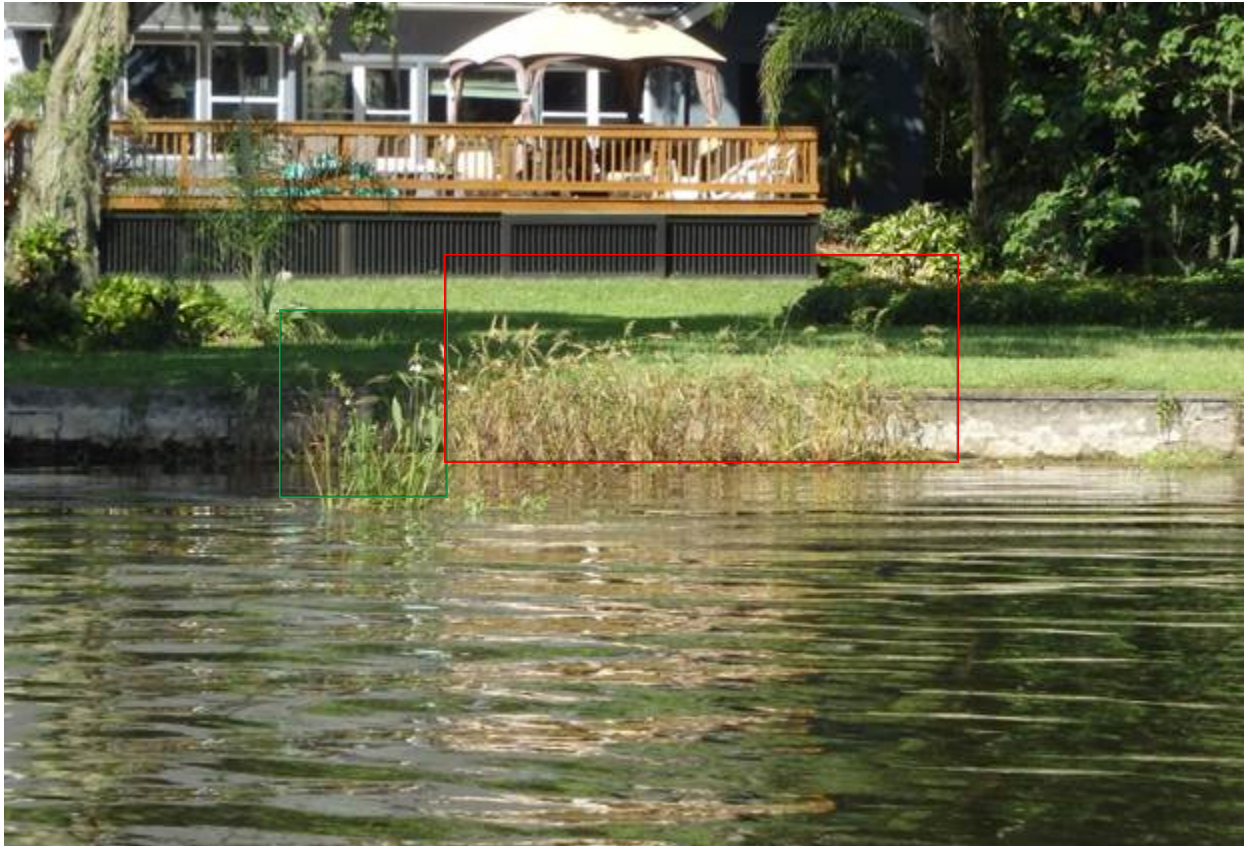
Invasive emergent species observed included: alligator weed, barnyard grass, wild taro, water hyacinth, primrose willow, torpedograss, and creeping oxeye. Three clusters of water hyacinth were found around the lake. The torpedograss and barnyard grass populations are up.

Photo: Native **duck potato** and invasive **barnyard grass**.

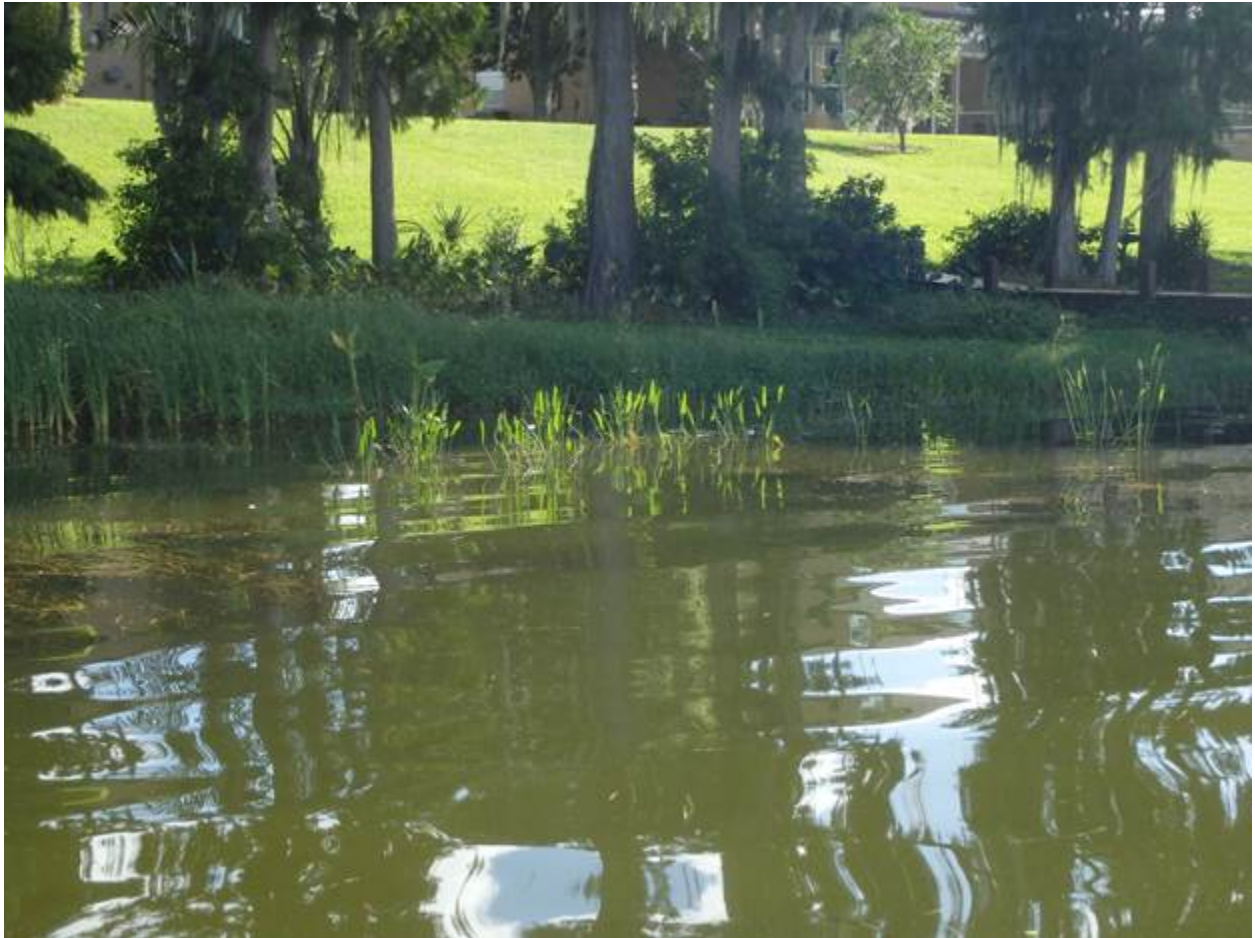
On May 14th Seminole County's SERV program held an event to plant native shoreline vegetation. Species planted included: duck potato, pickerelweed, softrush, and fireflag. The plants have begun to establish themselves in the soil. A good percentage of the plants have survived.

Photo: SERV planting site.

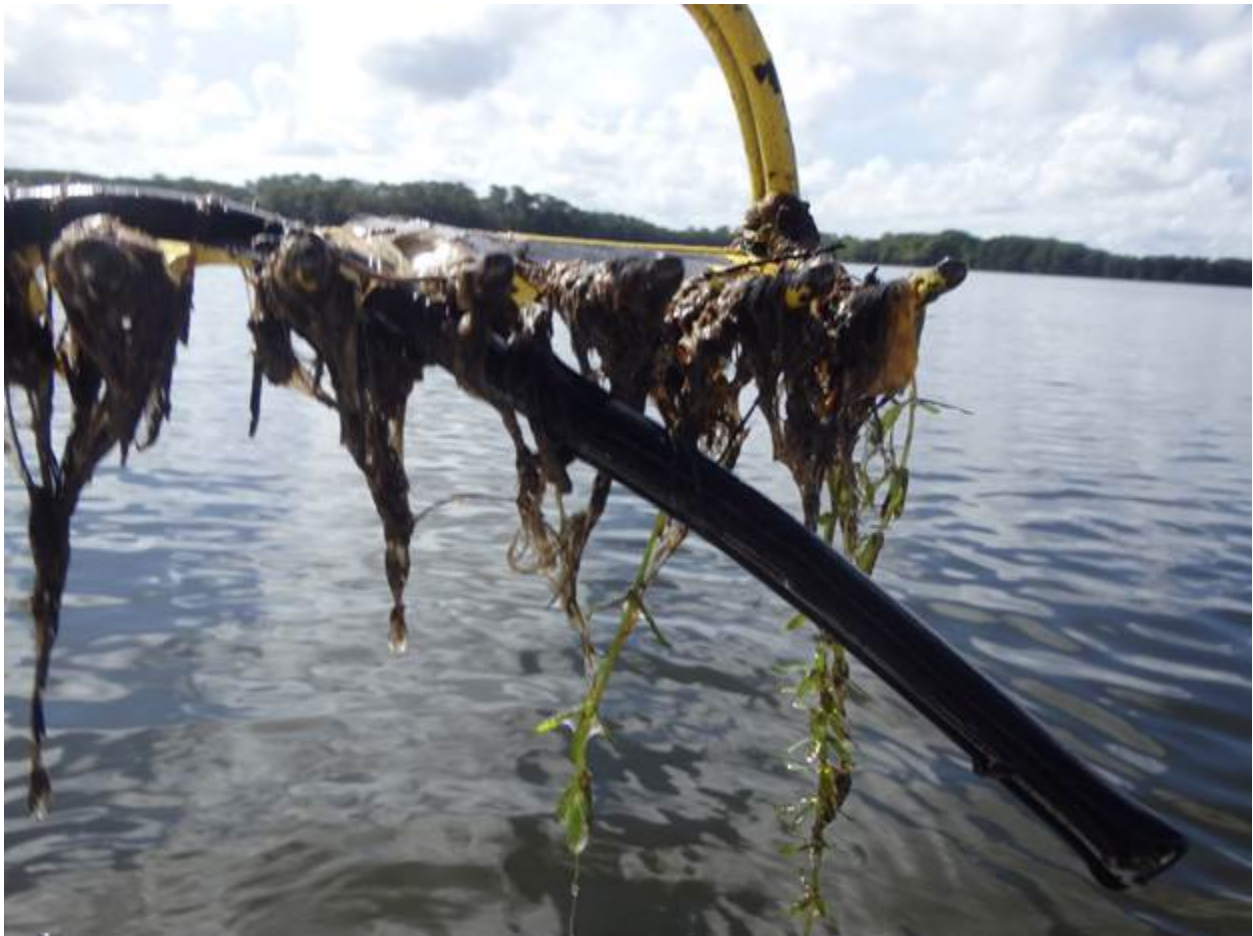
Hydrilla was found during the inspection. The maximum depth for hydrilla was 8 feet. This is 4 feet deeper than it was found on the previous inspection.

Photo: Hydrilla on a frotus (rake for collecting submersed vegetation).

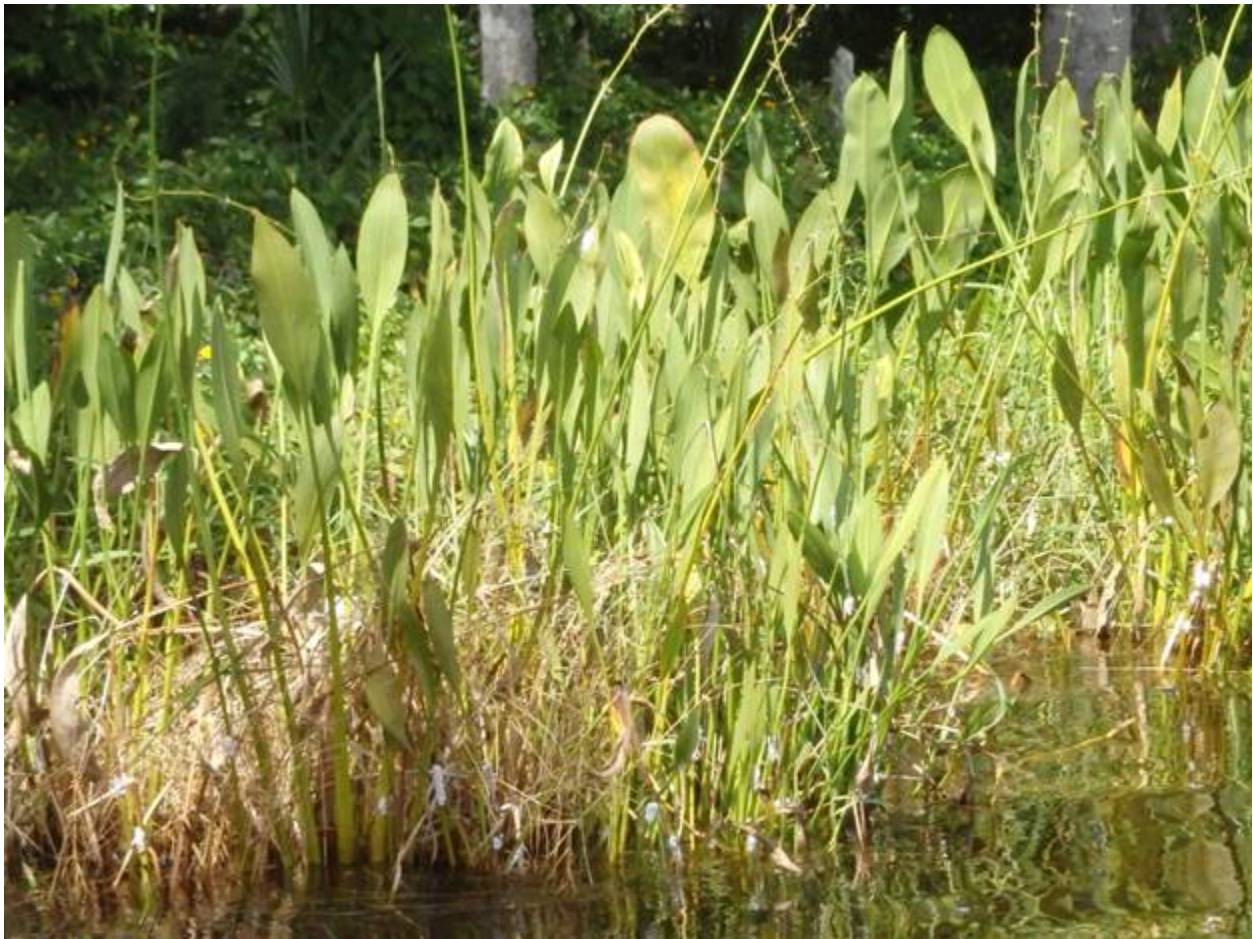
Native emergent vegetation observed during the survey included: buttonbush, flat sedge, pennywort, hempvine, golden canna, spatterdock, fragrant water lily, pickerelweed, duck potato, carolina willow, lizard's tail, fire flag, and cattail.

Photo: Native duck potato.

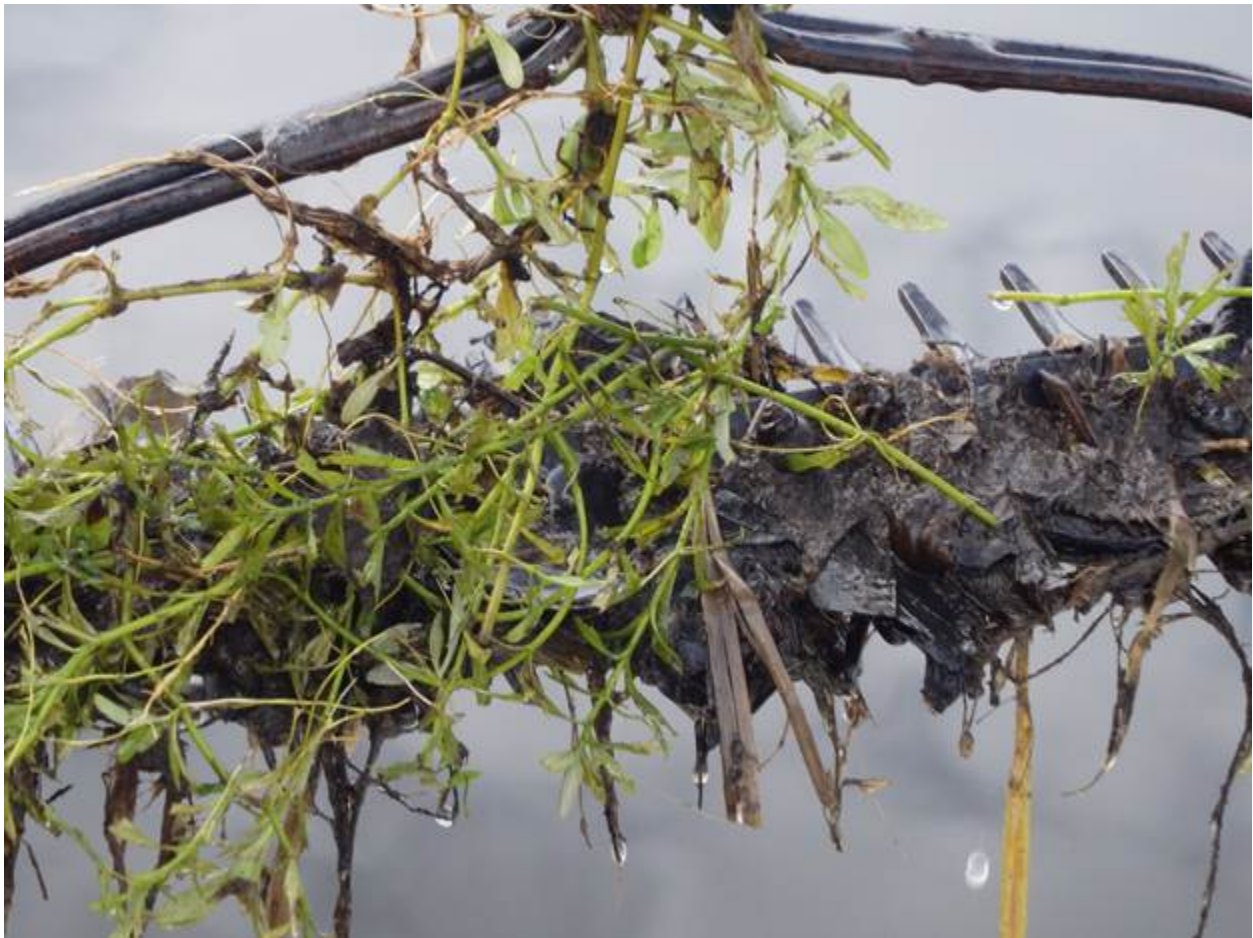
Small amounts of hydrilla were found scattered sparsely throughout the lake. The maximum depth for hydrilla was 6 feet. Hygrophila and parrot feather are two there invasive submersed species found during the inspection. Hygrophila, a species more commonly found in streams and rivers than lakes, was found by the mouth of Cassel Creek. Hygrophila does not have a historic presence in Lake Howell. It will be added to the aquatic vegetation permit to allow herbicidal treatment. A patch of parrot feather was found by the regional stormwater facility.

Photo: Invasive hygrophila.

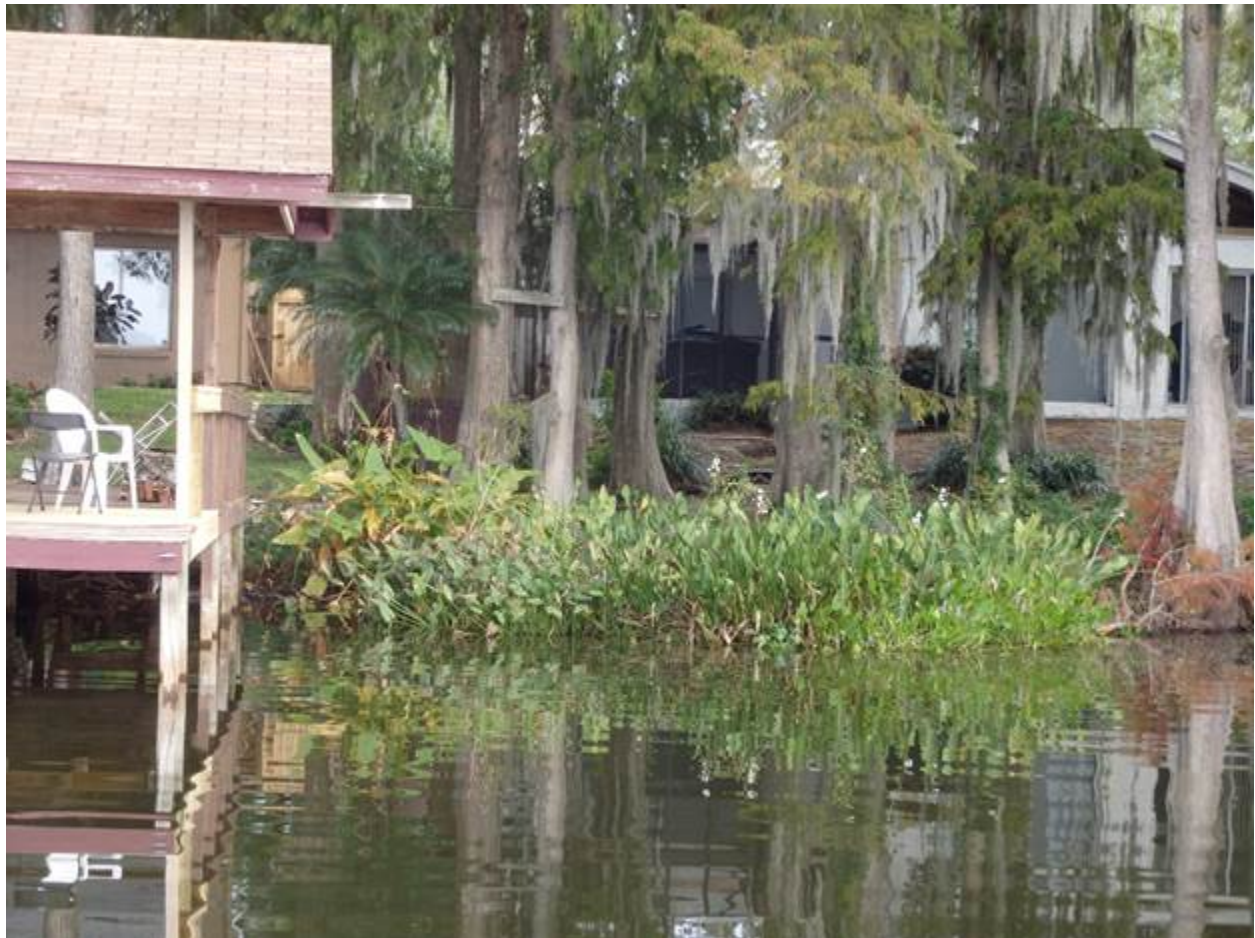
Native emergent vegetation observed during the survey included: swamp lily, spatterdock, fragrant water lily, pickerelweed, duck potato, bulrush, cordgrass, fire flag, and cattail.

Photo: Healthy stand of pickerelweed, duck potato, and fireflag.
