Summary Memorandum

Snow Hill Road / Jacobs Trail Outfall Improvement Project

**Singhofen & Associates, Inc.
Stormwater Management and Civil Engineering**

September 2008

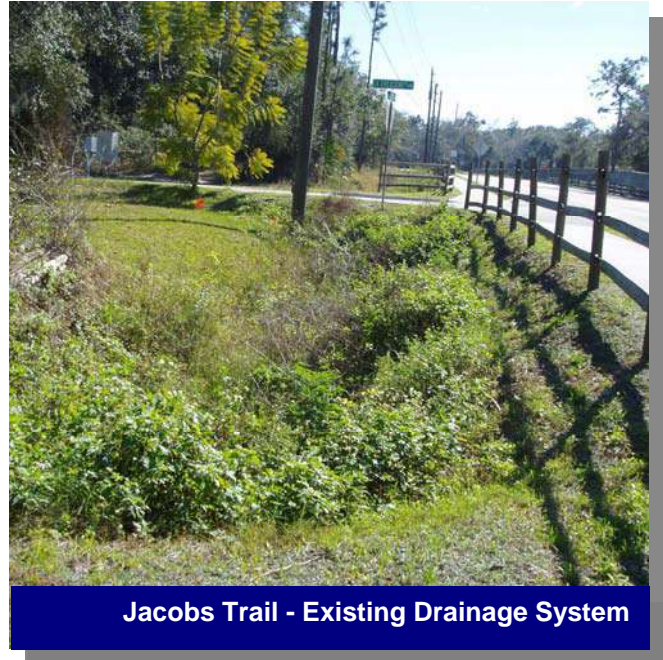
The Snow Hill Road/Jacobs Trail outfall ditch is located in Sections 20 & 21, Township 21 South, Range 32 East of eastern Seminole County, Florida. More specifically, the ditch and driveway culvert drainage system extends from the northeast intersection of Snow Hill Road and Jacobs Trail to the ditch's outfall at Lake Crescent (See **Figure 1**).

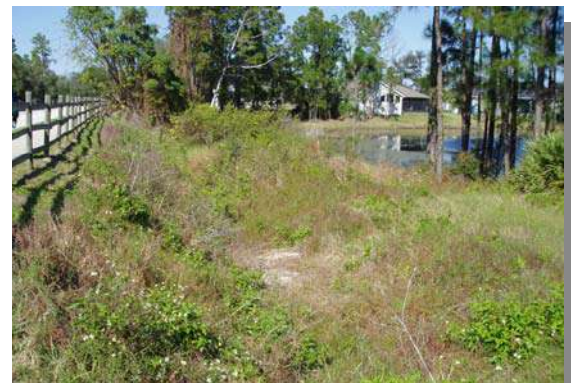
Outfall to Crescent Lake

The outfall consists of a manmade upland cut roadway ditch (approximately 4' bottom width) that includes a single 36" reinforced concrete pipe (RCP) crossing at Snow Hill Road, three 18" driveway culvert crossings, and two concrete check dams. The current configuration of the ditch and sidewalk along Jacobs Trail north of Snow Hill Road limits access of equipment for maintenance activities. Consequently, sediment, vegetation, and trash were observed in the ditch which restrict the designed conveyance of the system. In addition, the 18" driveway crossings appear to be undersized based on the capacity of the ditch cross section and upstream Snow Hill Road culvert.

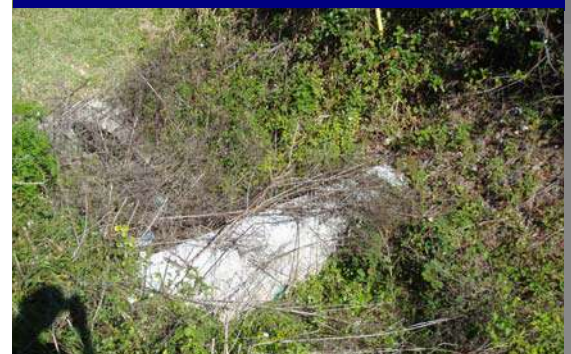
Concrete Check Dam

Two concrete weir structures were located in the ditch. It should be noted that a total of three check dam structures were identified in construction plans for the Osprey Lakes development which appear to have been designed for stormwater treatment purposes. Detailed information on the two observed dam structures is provided in the survey documents and is included in the existing conditions model. The third check dam is believed to have been removed in 2005 during construction of three properties along Jacobs Trail to accommodate new septic fields.

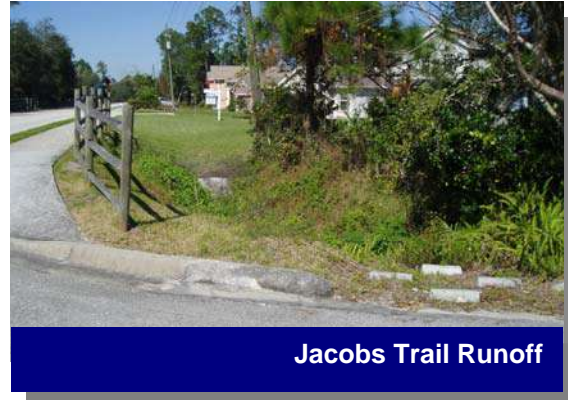
Jacobs Trail Runoff

Jacobs Trail is a curb and gutter roadway with two sets of curb inlets that discharge to the roadside ditch. Lake Crescent Drive and several residential driveways also direct runoff directly into the ditch (see photo). Runoff from the northern portion of Jacobs Trail is directed to the Osprey Lakes stormwater system to the north.

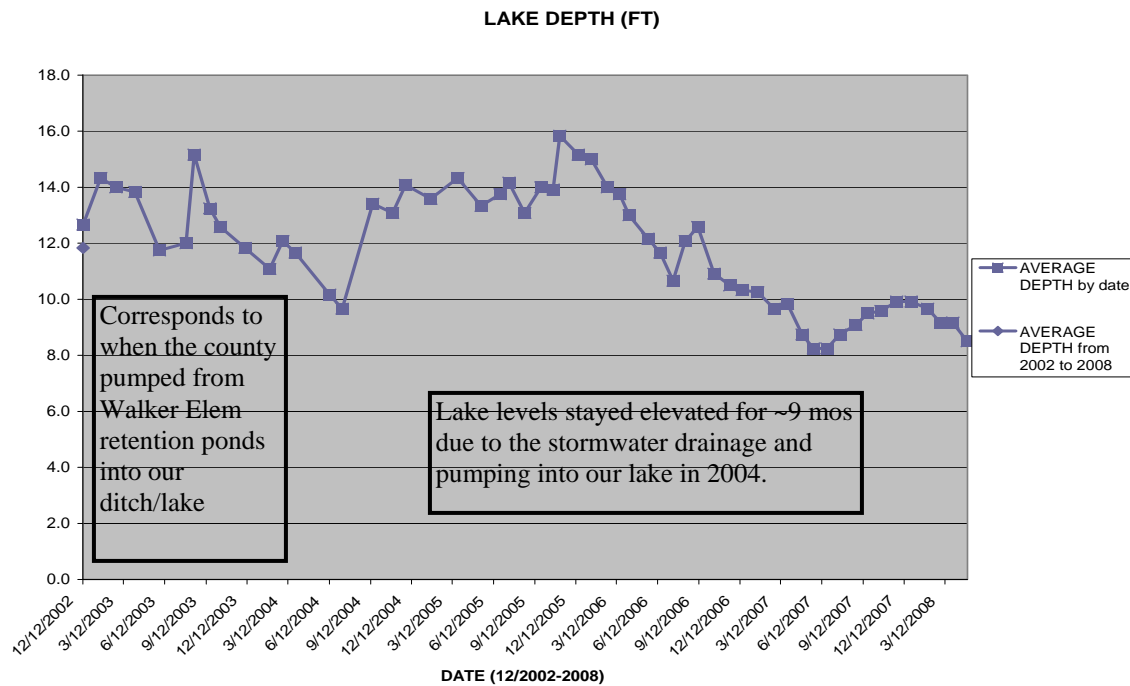
Figure 2.1. Crescent Lake Depth Information
 (Source: Lake Crescent homeowner: Connie Perry)

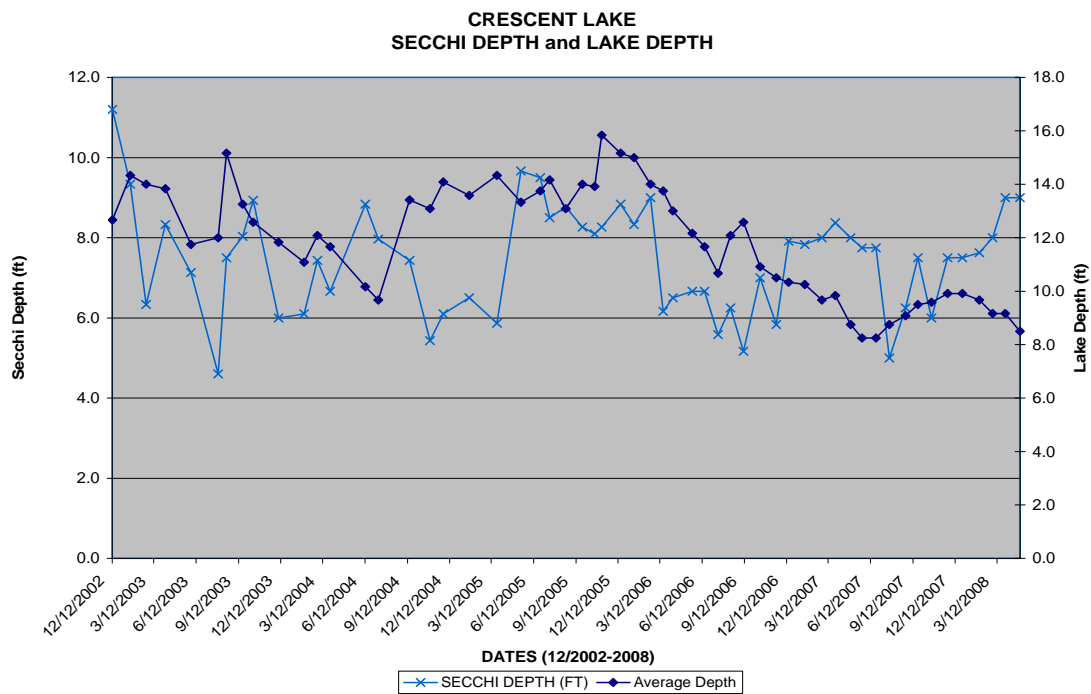
Figure 2-3. Crescent Lake Secchi Depth and Lake Depth
(Source: Lake Crescent homeowner: Connie Perry)

Two sources of runoff discharge into the lake, however, which have limited or reduced treatment. The first is Jacobs Trail itself. Runoff from the road flows into the ditch which, as mentioned above, has reduced treatment capacity as a result of the new driveway culverts and removal of one of the check dams originally constructed with the paving of the roadway. The second is runoff from the residential development immediately surrounding the lake. Jacobs Trail can be expected to contribute suspended solids, greases and oils but would not be expected to contribute significant nutrient loads. The adjacent lawn areas, however, would be expected to contribute nutrients which tend to stimulate algal growth. Unfortunately, measurements of lake turbidity are not available to confirm sediments as a source of reduced clarity. Total chlorophyll is measured, however, and appears to correlate with reductions in clarity (See Figure 2-4). Periods of increased chlorophyll (i.e., increased algae concentrations) coincide with reductions in the Secchi depth and vice versa.

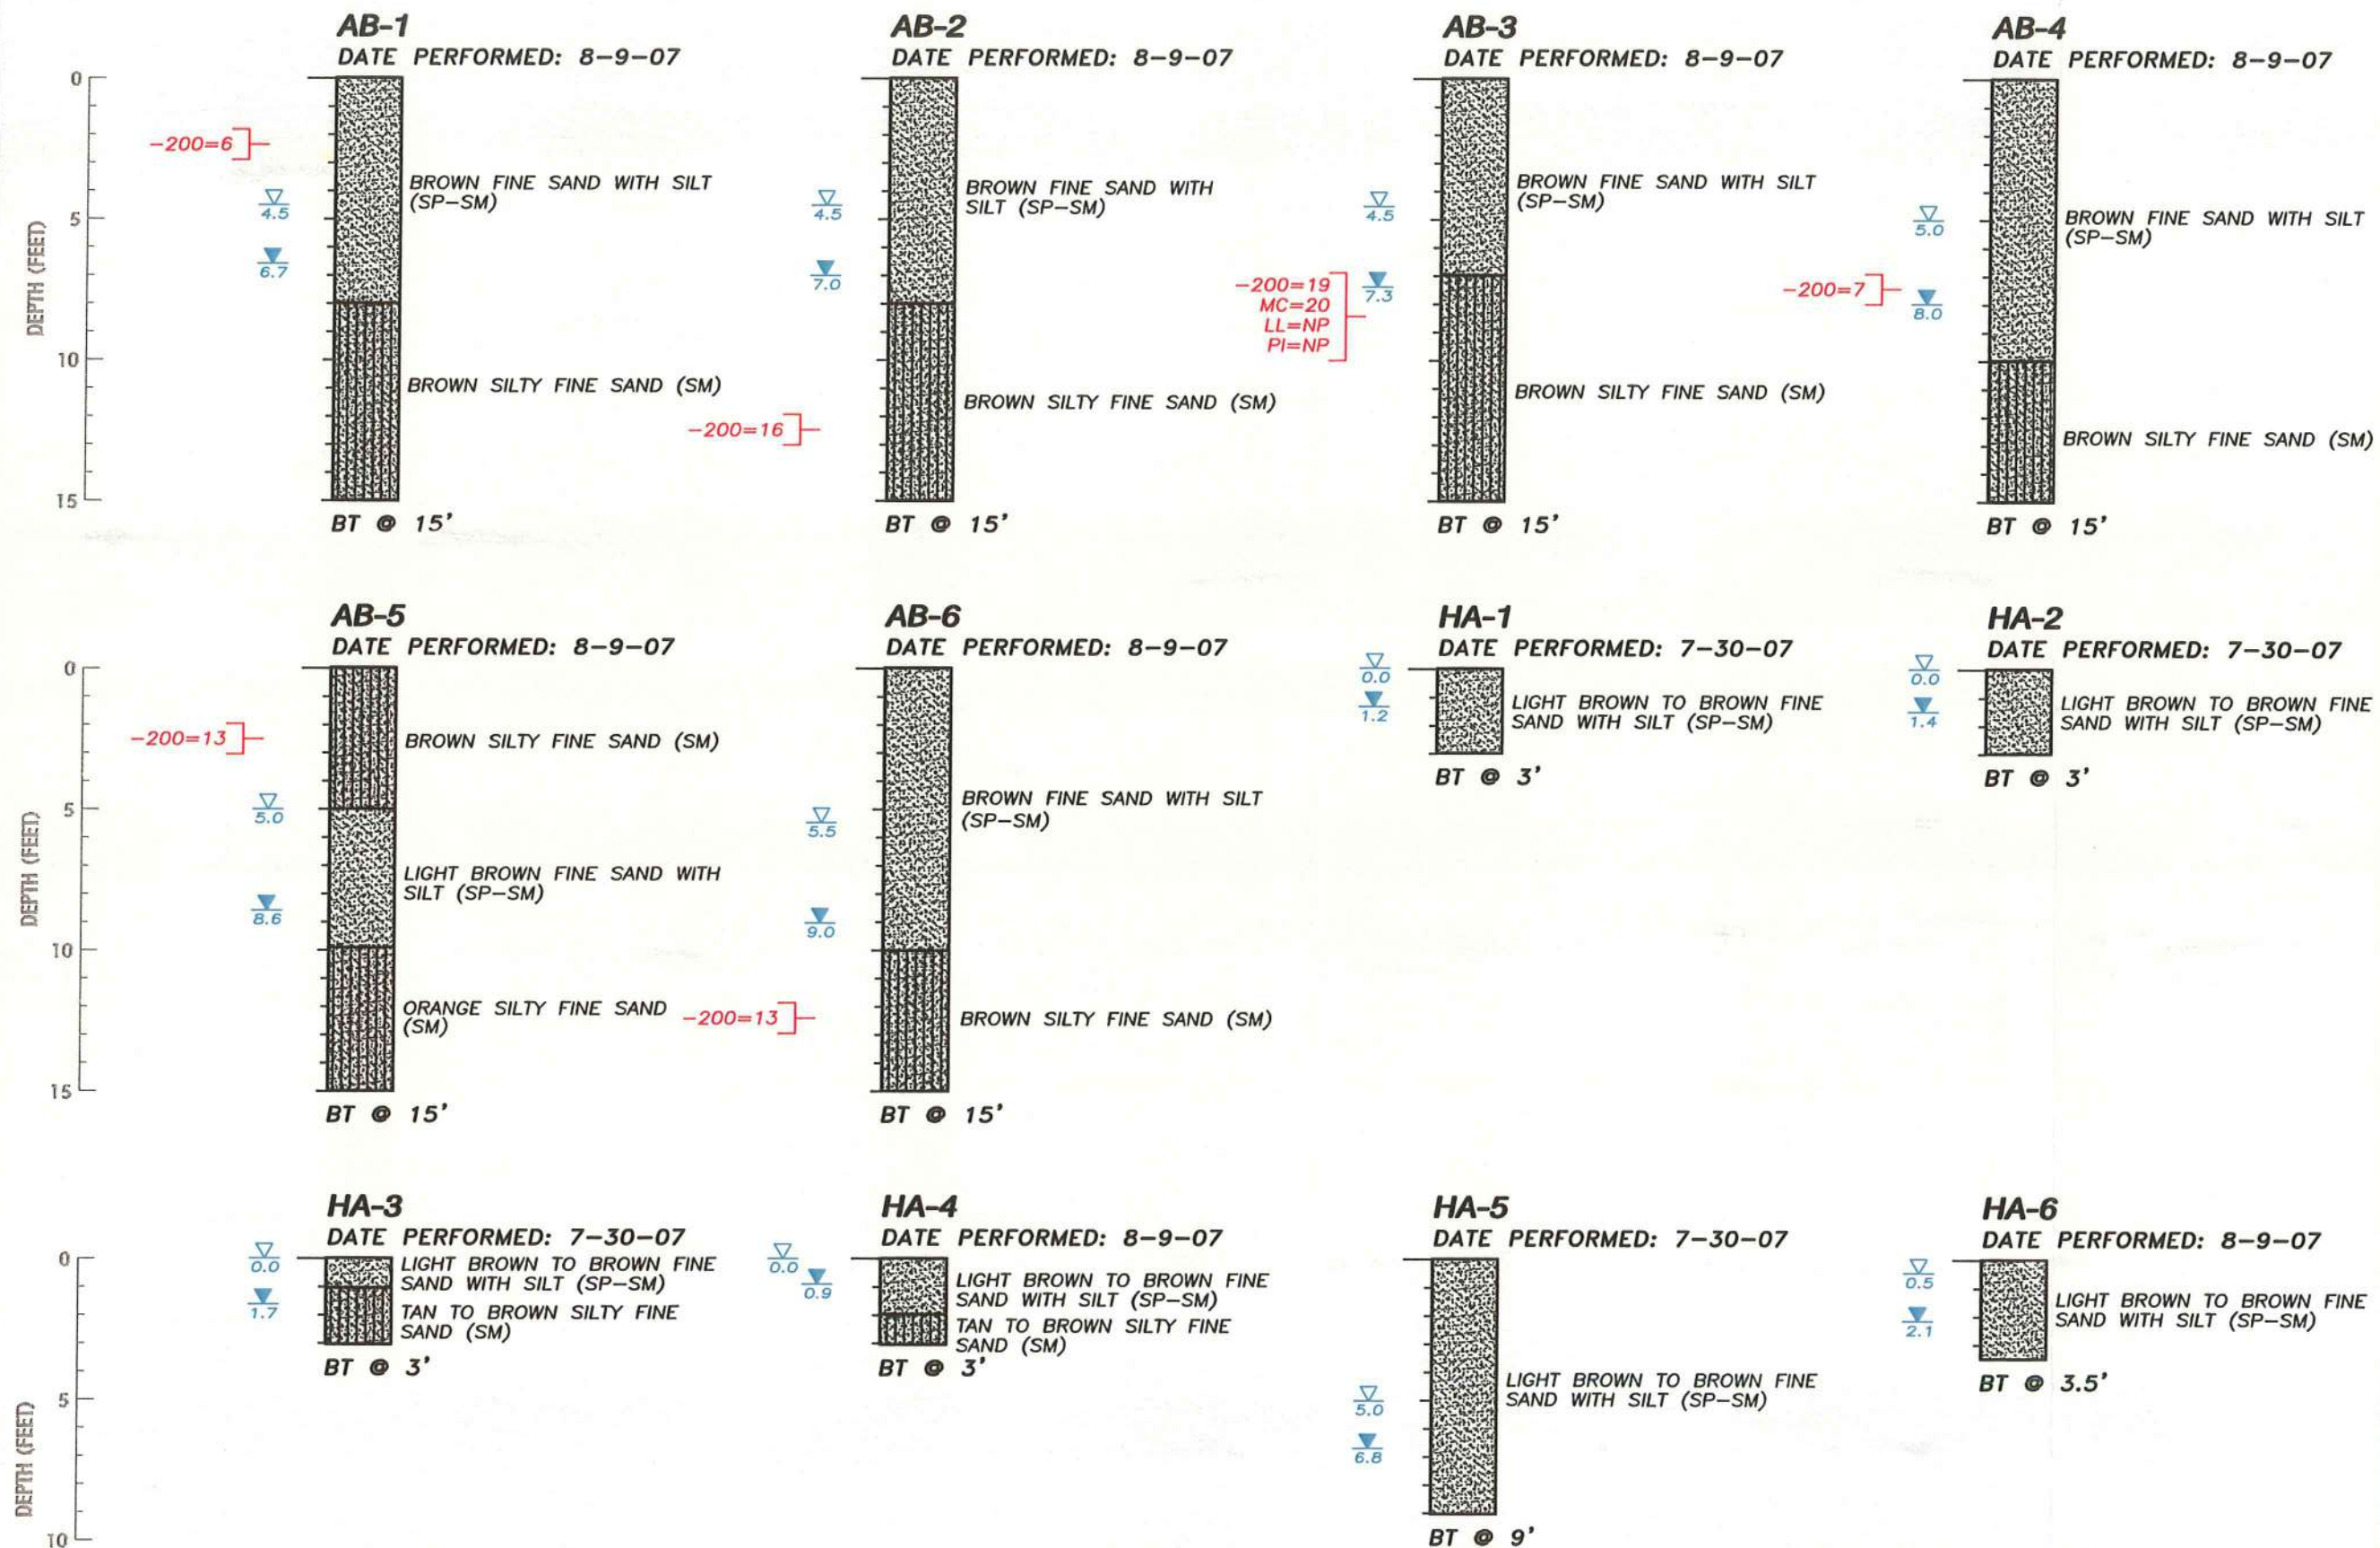
BORING RESULTS

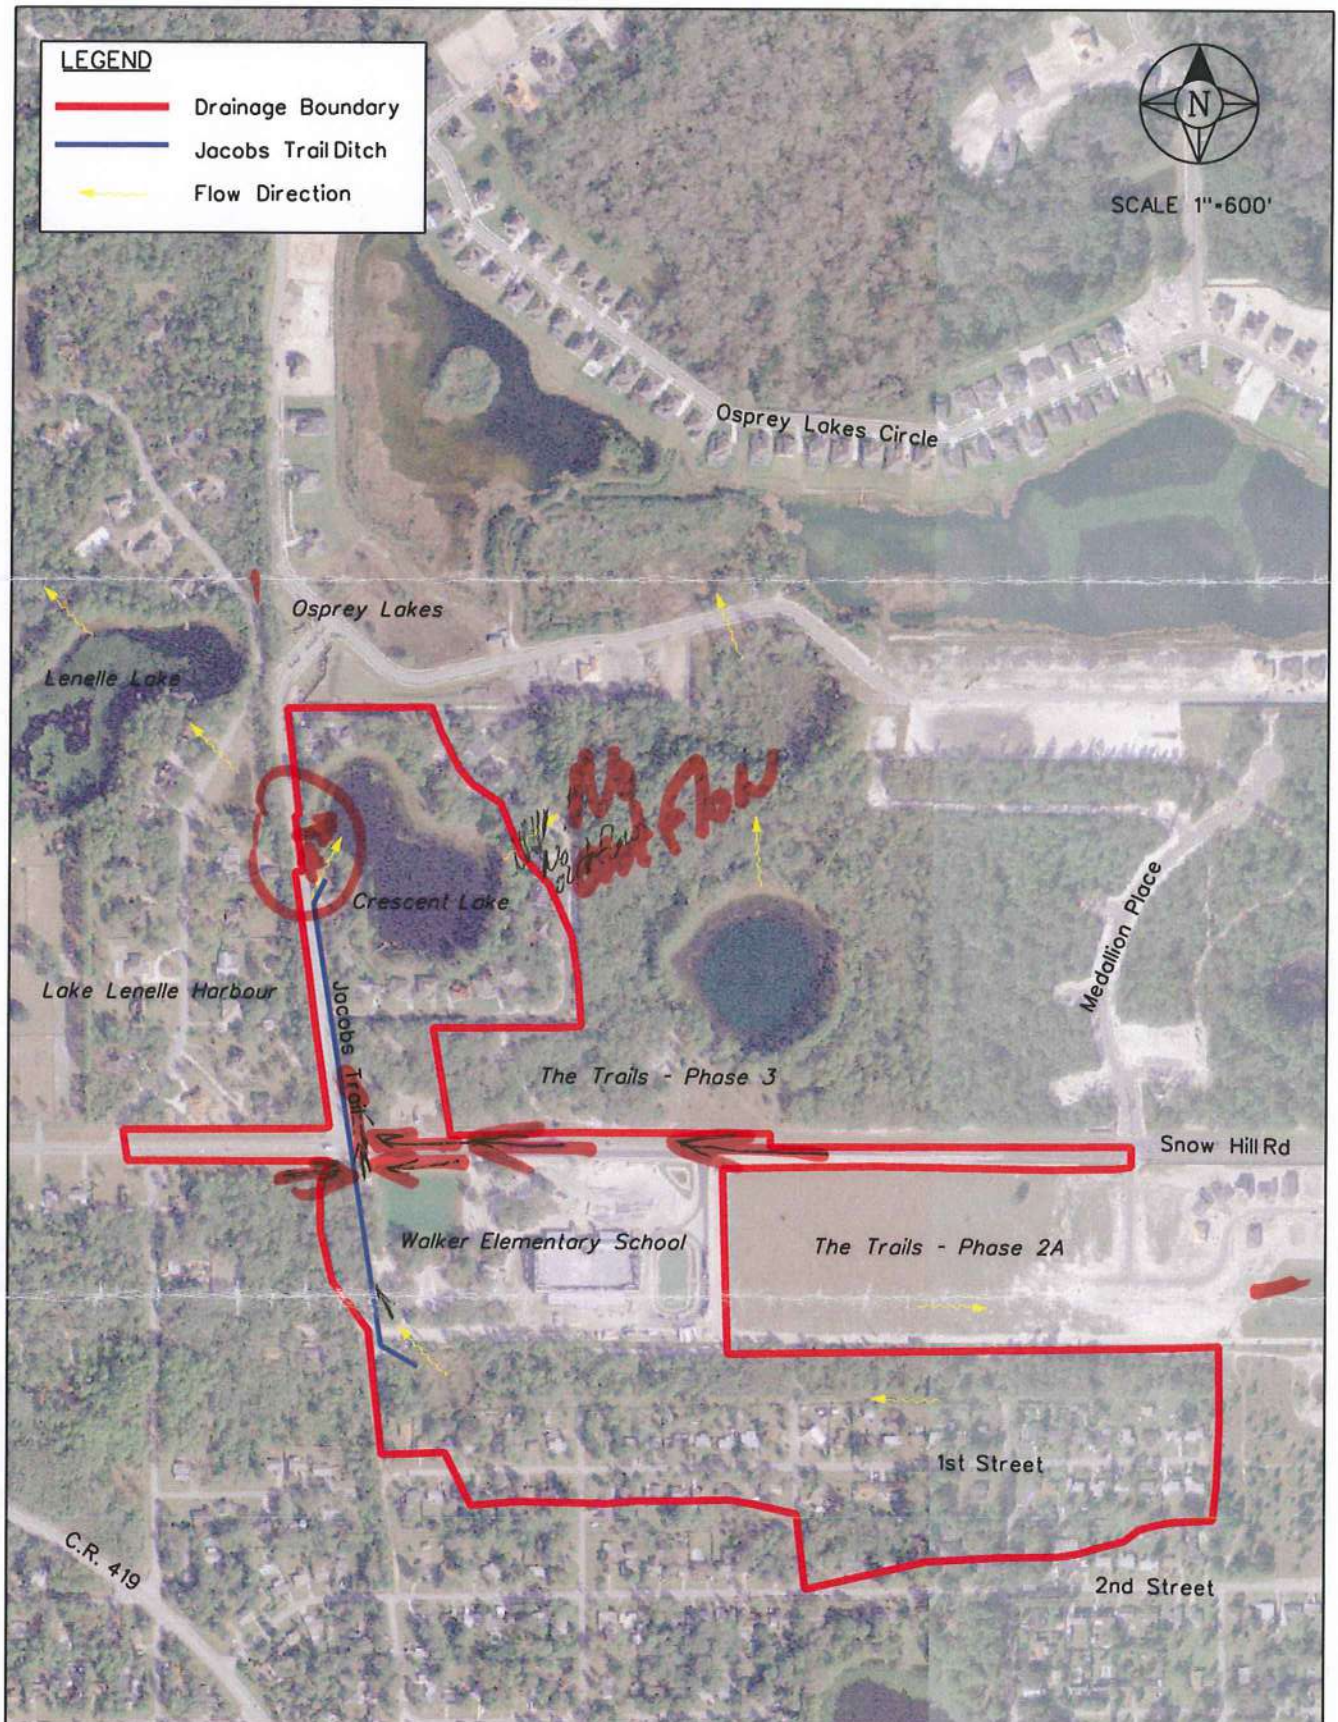
2008 DRAINAGE MAP
