PROPERTY CONDITION ASSESSMENT

SUMMARY REPORT

1096 Merritt St, Altamonte Springs, FL 32701

July 31, 2019

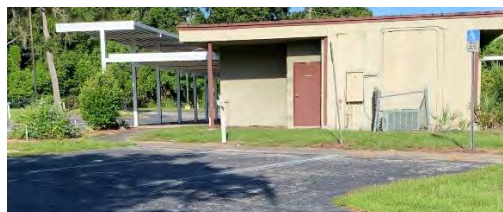
Fig. 4.9.3 Substandard Accessible Parking

Seventy (70) parking spaces are designated. Two (2) parking spaces are signed as accessible spaces. The current Florida Accessibility Code (FAC) requires three (3) parking spaces for a parking facility with seventy (70) spaces. The location of the accessible space, remote from the primary building entrance, is also a concern but subject to code interpretation. The markings do not meet current FAC requires by not having adjoining accessible routes, access aisles.

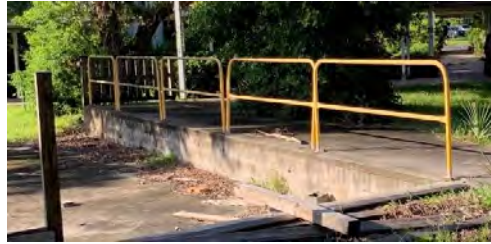
Fig. 4.9.4 Substandard Pedestrian Railing

There is not a delineated pedestrian route from the public sidewalk in the right of way of Merritt Street to the buildings. There is not a dedicated or marked pedestrian route from all parking facilities to the buildings. The sidewalk condition along the south face of Building 1 indicates that the sidewalk may be under water during heavy rainfall events and appears to hold standing water. Several sections of sidewalk are cracked and sufficiently broken to be unstable, vertically uneven with enough elevation difference to be classified as a trip hazard or horizontally separate to be classified as a trip hazard. Substandard pedestrian railing shields drop pedestrian drop off hazards. Sections of sidewalk that do not meet slope criteria should be reconstructed.

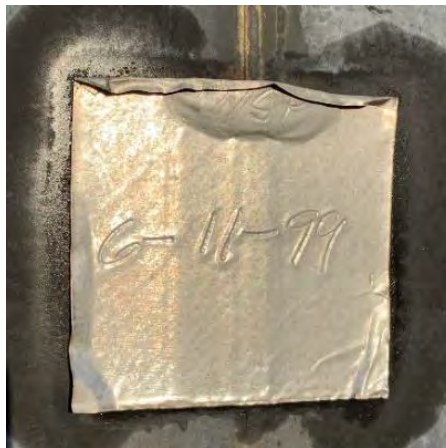
Fig. 4.9.5 Light Pole Date Data

The site lighting was powered during the field review. Very few of the lights worked during the field review. The age of the existing lighting fixtures varies. The fixtures within the south/front parking facility appear to be at least twenty (20) years old based on the date stamped into the fixture pole. Lighting levels of the existing system is not known and was not measured.

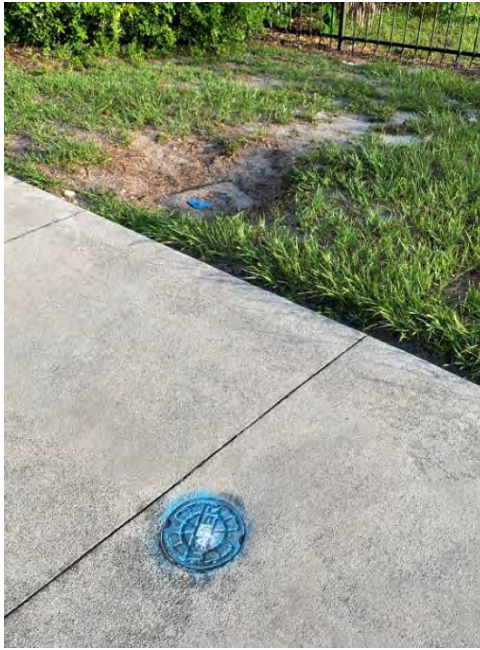
Fig. 4.9.8.A – Potable Water Meter & Fire Line Valve

Seminole County provides water service to the site. A water meter is located at the back of sidewalk along Merritt Street. A potable water back flow preventer was not observed on site. Numerous hose bibs are located throughout the site. It is not known if these hose bibs are fed by the irrigation line or the potable water line. No vacuum breakers were observed on the hose bibs. For compliance with current standards, the potable water line should be isolated from the main along Merritt Street with a reduce pressure back flow preventer. In addition, all hose bibs connected to a potable water source should be equipped with back flow prevention. A single fire hydrant is located on site near the southwest end of Building 1. Based on review of historical plans, a six (6) inch line ties to the main along Merritt Street and is upsized on site to eight (8) inches with a dead-end connection to the existing fire hydrant.

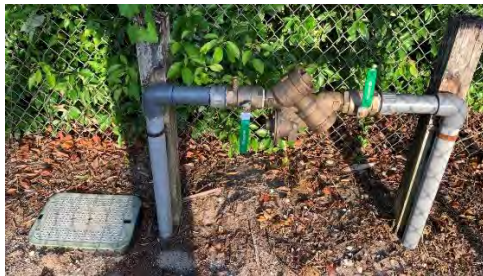
Fig. 4.9.8.B – Irrigation Backflow Preventer

The irrigation system is in various stages of disrepair. The irrigation backflow preventer is a Wilkins reduced pressure backflow prevention device. The irrigation appears to be tied to potable water rather than reuse water based on the color of the infrastructure used, green irrigation box. The date of the last backflow prevention test is not known. The pipe integrity of the onsite irrigation distribution is not known. At a minimum irrigation replacement of irrigation controller, timer and heads should be anticipated due to the age of the system.

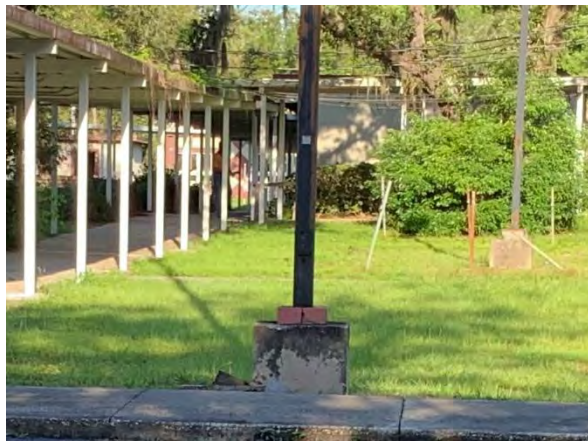
Fig. 4.9.8.D Misc. Overhead Utilities

A pole mounted transformer is located at the southwest corner of the property. Overhead power lines run northward along the westerly property line to an apparent service drop on the west of Building 9. The power meter is located on the exterior west wall of Building 9. Secondary power lines extend from Building 2 and Building 5 to a pole south of the greenhouse. Power service requirement will need to be addressed for any new uses. Communication may also be on the same poles. The clear height of the lowest utilities is of concern. These overhead lines are easily accessible as they drop below the adjacent sidewalk canopy.
