**HORSESHOE LAKE BIOASSESSMENT**  
**JUNE AND JULY 2015**

On **June 9<sup>th</sup>, 2015**, Seminole County Lake Management Program (SCLMP) personnel, Thomas Calhoun and Joey Cordell, surveyed the aquatic plants in Horseshoe Lake North.

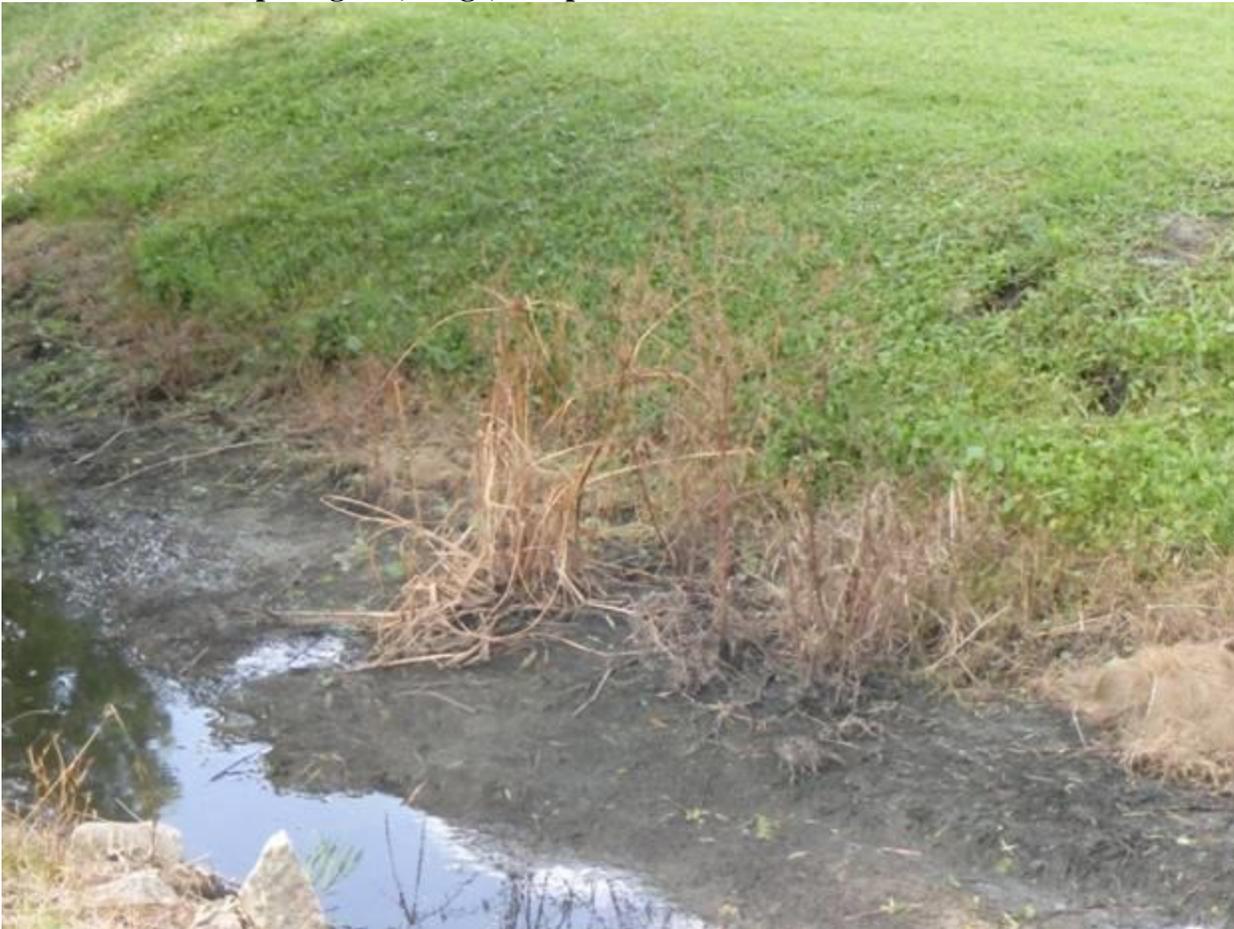
Ramp access was blocked on this date. Canal was inspected and found to be in good condition with impact on invasives from the previous herbicide treatment. Due to the performance of the previous herbicide treatment, no herbicide treatment was scheduled for the month of June.

**Photo: Treated torpedo grass, sedge, and primrose willow in canal.**

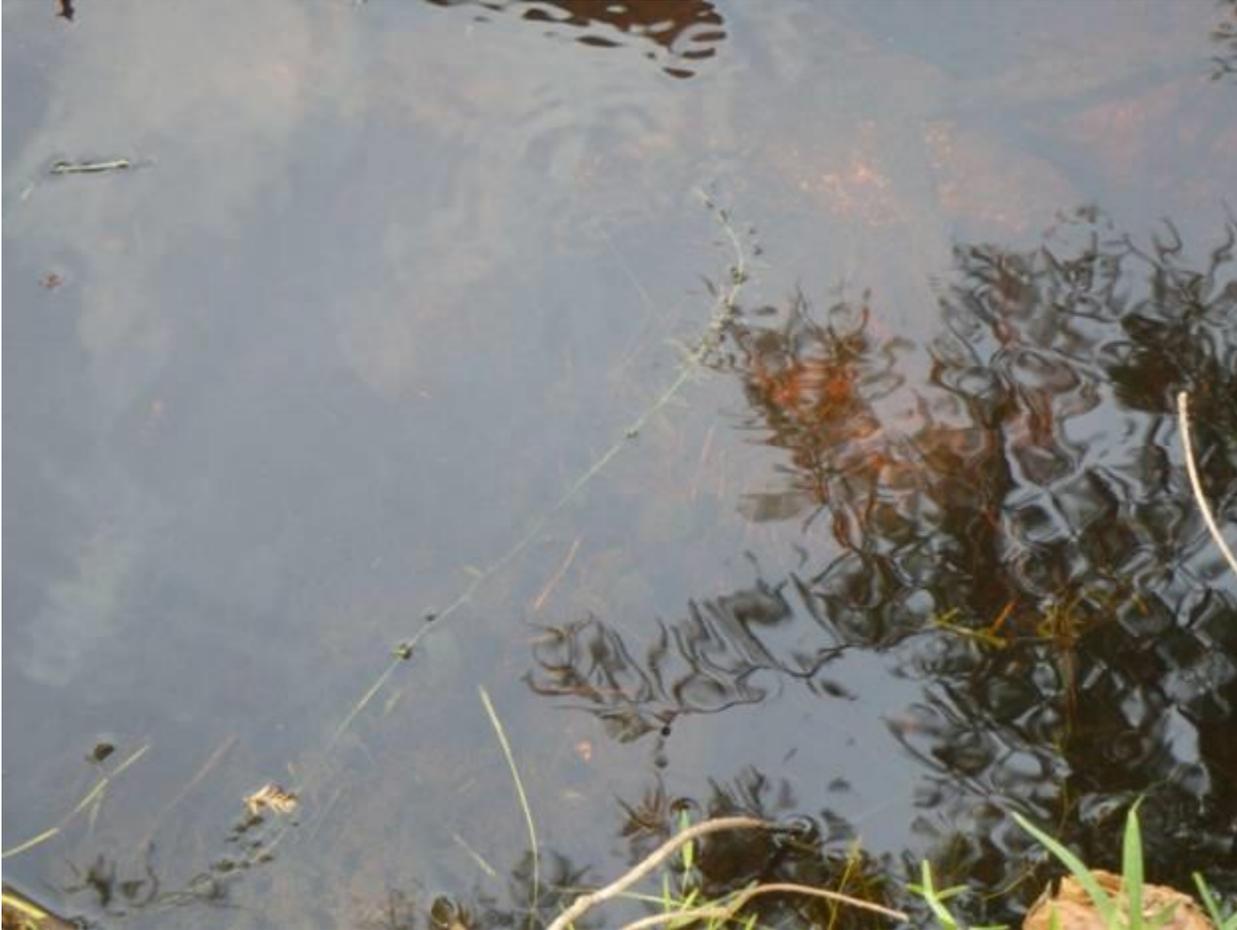
One sprig of hydrilla was found during this inspection at the culvert of the stormwater canal. This area will be treated for hydrilla as well as torpedo grass and alligatorweed during the July treatment.

**Photo: Hydrilla sprig in the canal.**

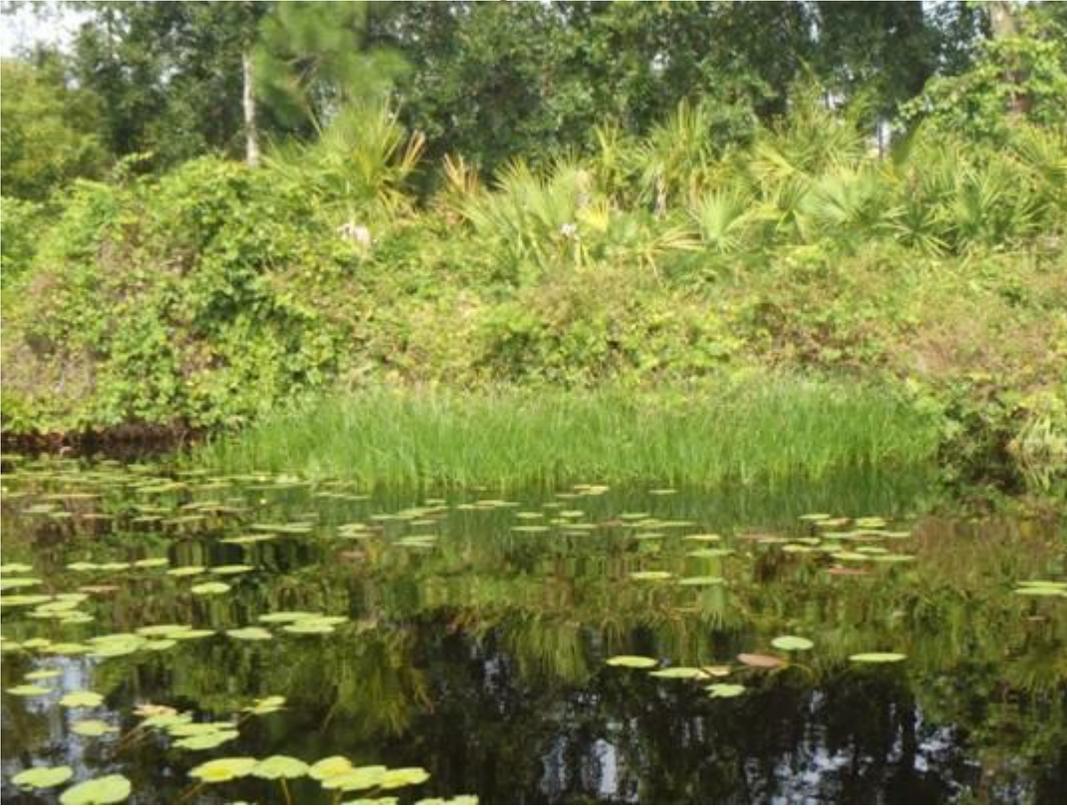
Other invasive species included: alligatorweed, wild taro, water hyacinth, torpedo grass, bur-head sedge, and salvinia. Bur-head sedge has expanded since the previous inspection and will be targeted during this month's herbicide treatment. A few small pockets of water hyacinths were observed during this inspection and will be treated as well.

**Photo: Monoculture of bur-head sedge scheduled for treatment.**

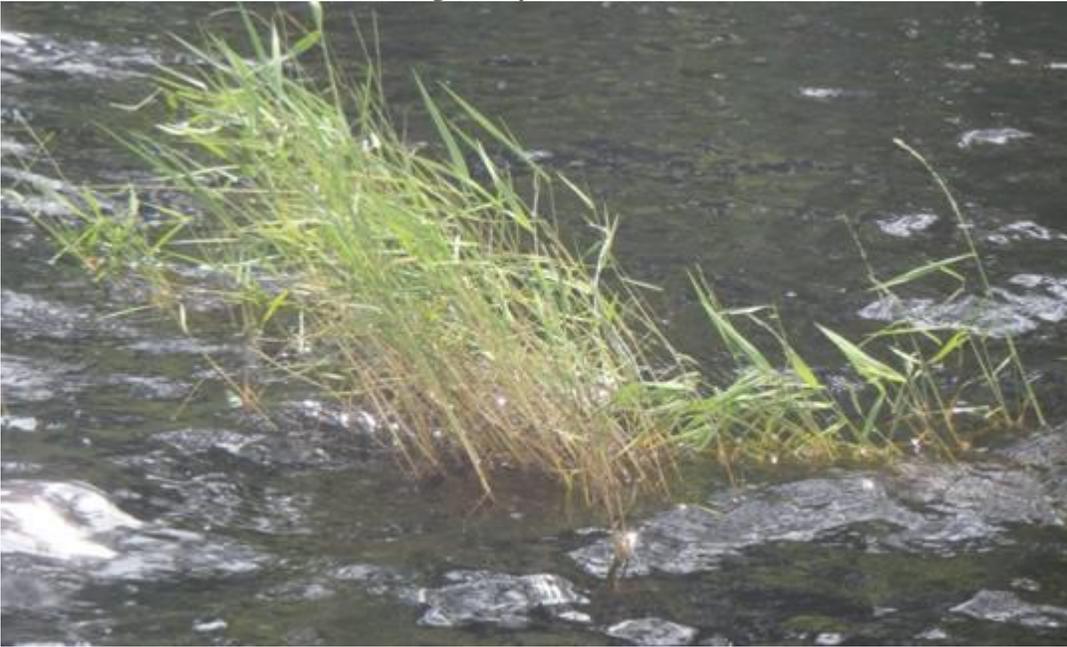
Much of the native vegetation planted during the March 28<sup>th</sup> restoration event were found in great condition. We are seeing a better success rate in establishment than in previous years! Thank you to all residents who have replanted “pop-ups” and cared for these beneficial natives

**Photos: Maidencane establishing nicely.**

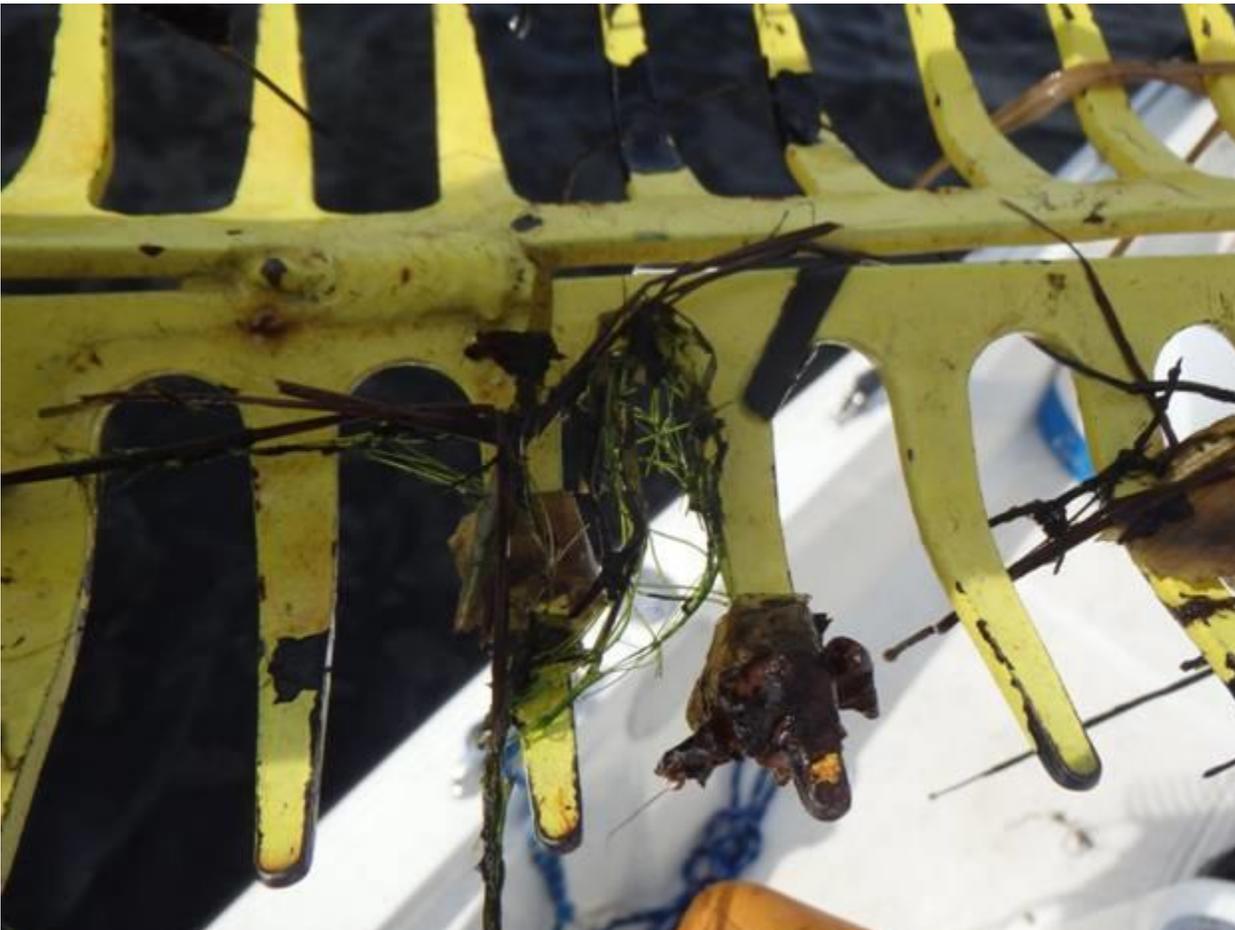
Native vegetation including duck potato, pickerelweed, fire flag, lizard tail, and southern water grass was found expanding around the lake. Native SAV found included eelgrass, baby's tears, stonewort, and roadgrass.

**Photo: Stonewort.**
