Greetings Horseshoe Lake Residents,

Please find the latest bioassessment report for your lake below. Key highlights of this update include:

On **March 17th, 2016** Seminole County Lake Management Program (SCLMP) personnel, Joey Cordell and Dean Barber, joined by lake residents Leza Harrison and Patty Searcy, surveyed the aquatic plants in **Horseshoe Lake North**.

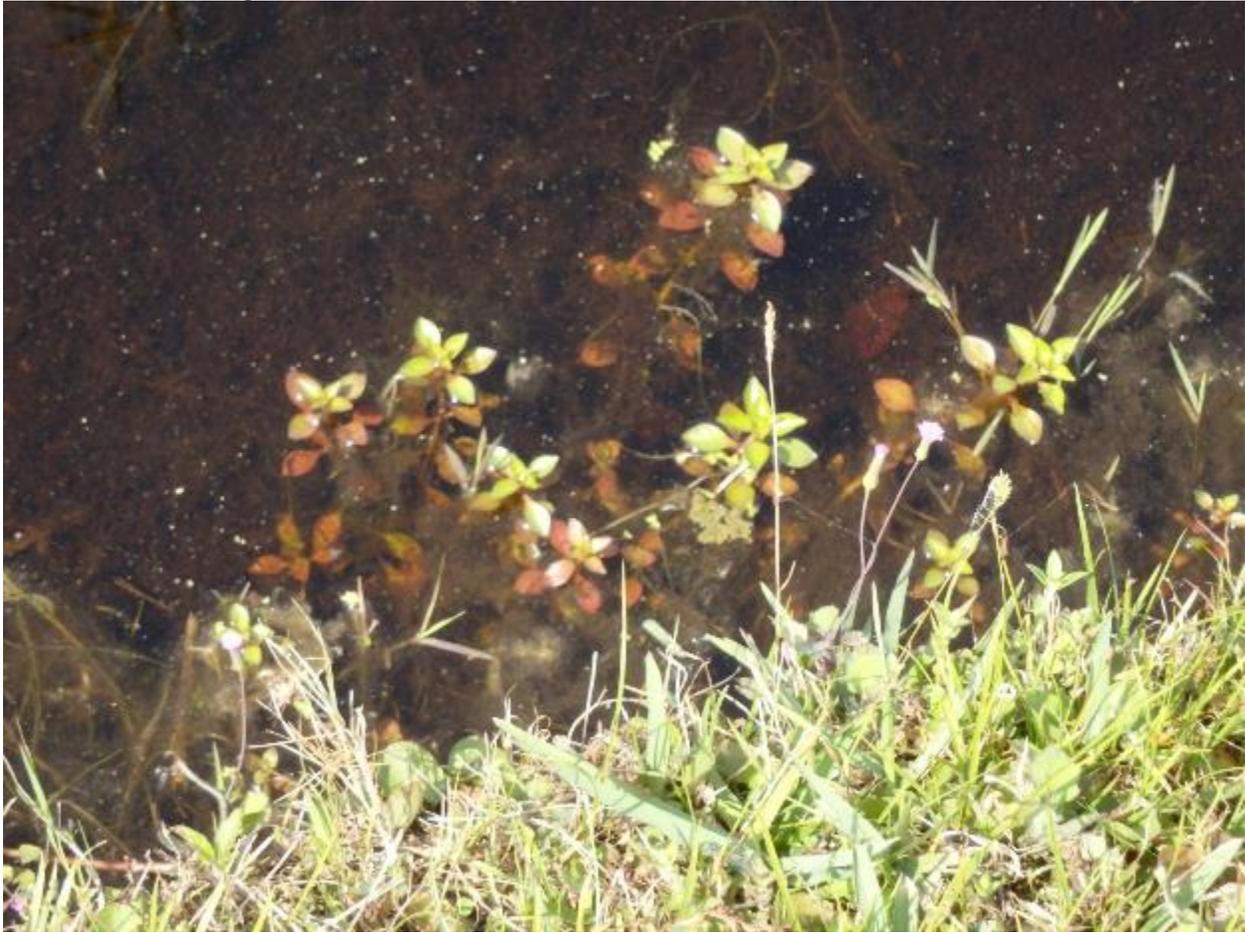
The eastern canal had a substantial amount of plant growth since the previous inspection. Observed species included: barnyard grass, torpedograss, pennywort, red ludwigia, alligator weed and hydrilla. Water hyacinth was found in multiple small patches around the lake. No hydrilla was found in the lake.

Photo: Red ludwigia found in the eastern canal.

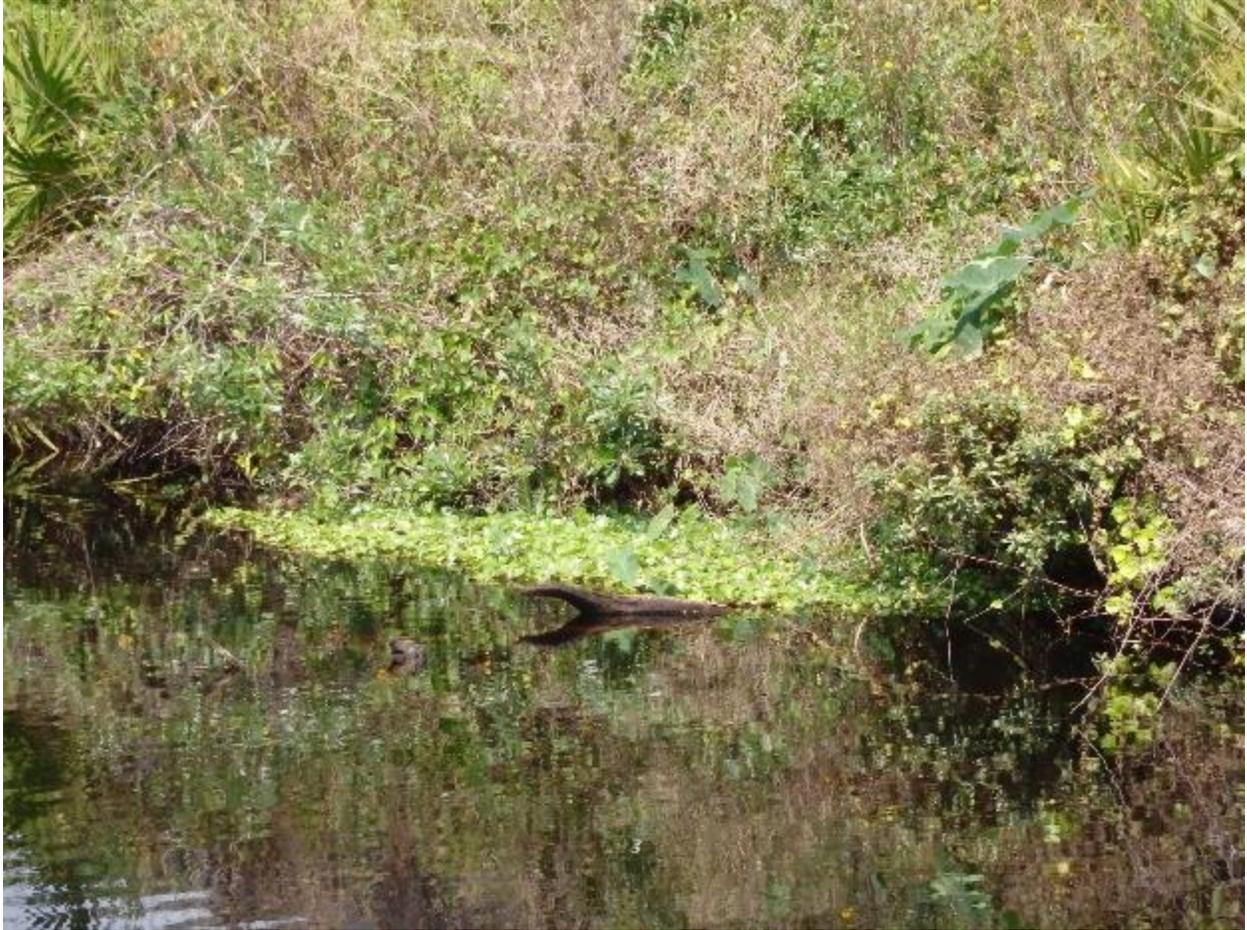
Invasive emergent species included: alligator weed, wild taro, primrose willow, torpedograss, salvinia, bur-head sedge, and two patches of water hyacinth. Alligator weed, water hyacinth and torpedograss will be targeted during the next herbicide treatment.

Photo: Water hyacinth.

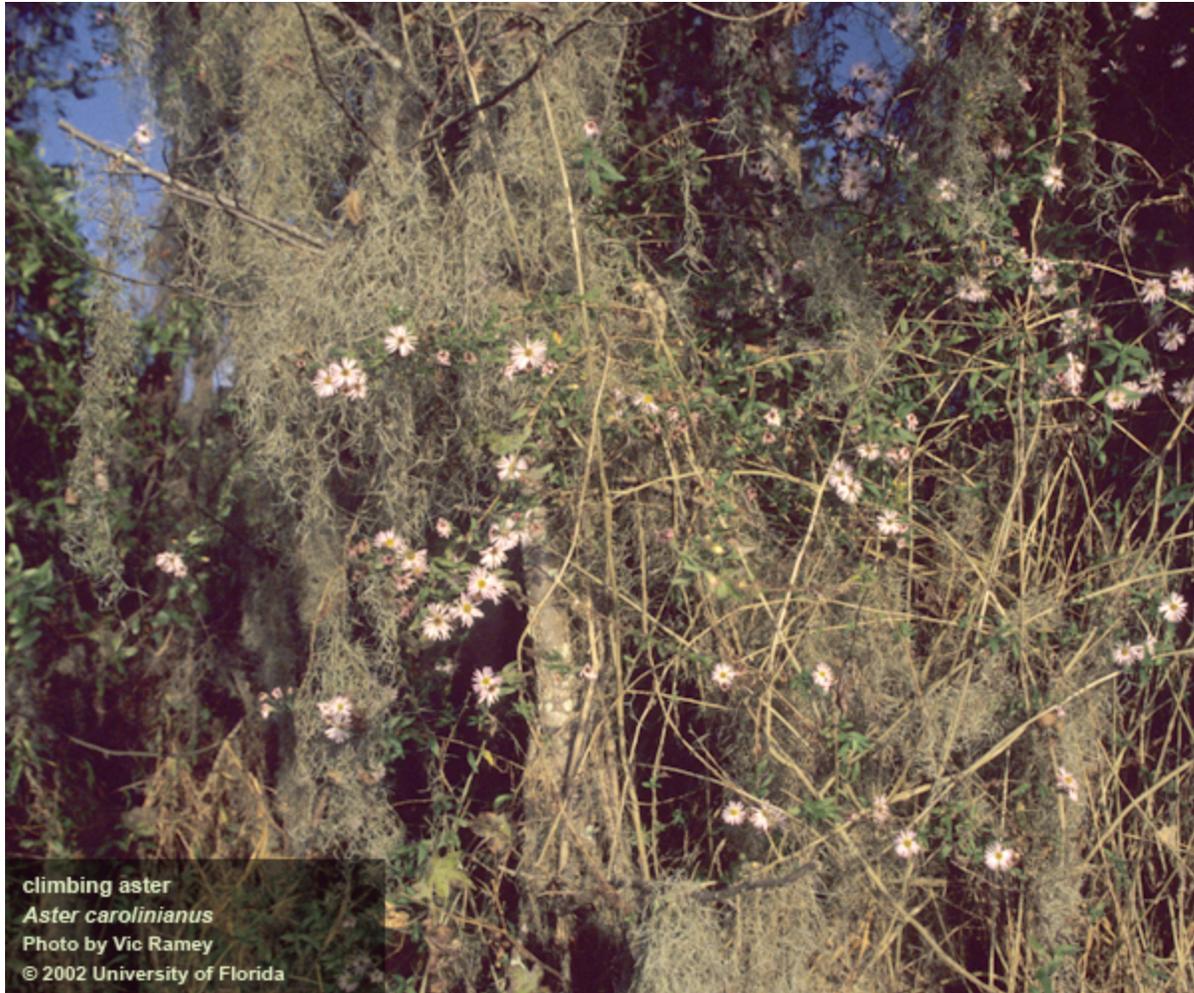
Native emergent vegetation included: bur-marigold, buttonbush, sawgrass, pennywort, maidencane, hempvine, yellow cow lily, pickerelweed, smartweed, duck potato, lizard's tail, bulrush, fire flag, and climbing aster.

Photo: Example of climbing aster.

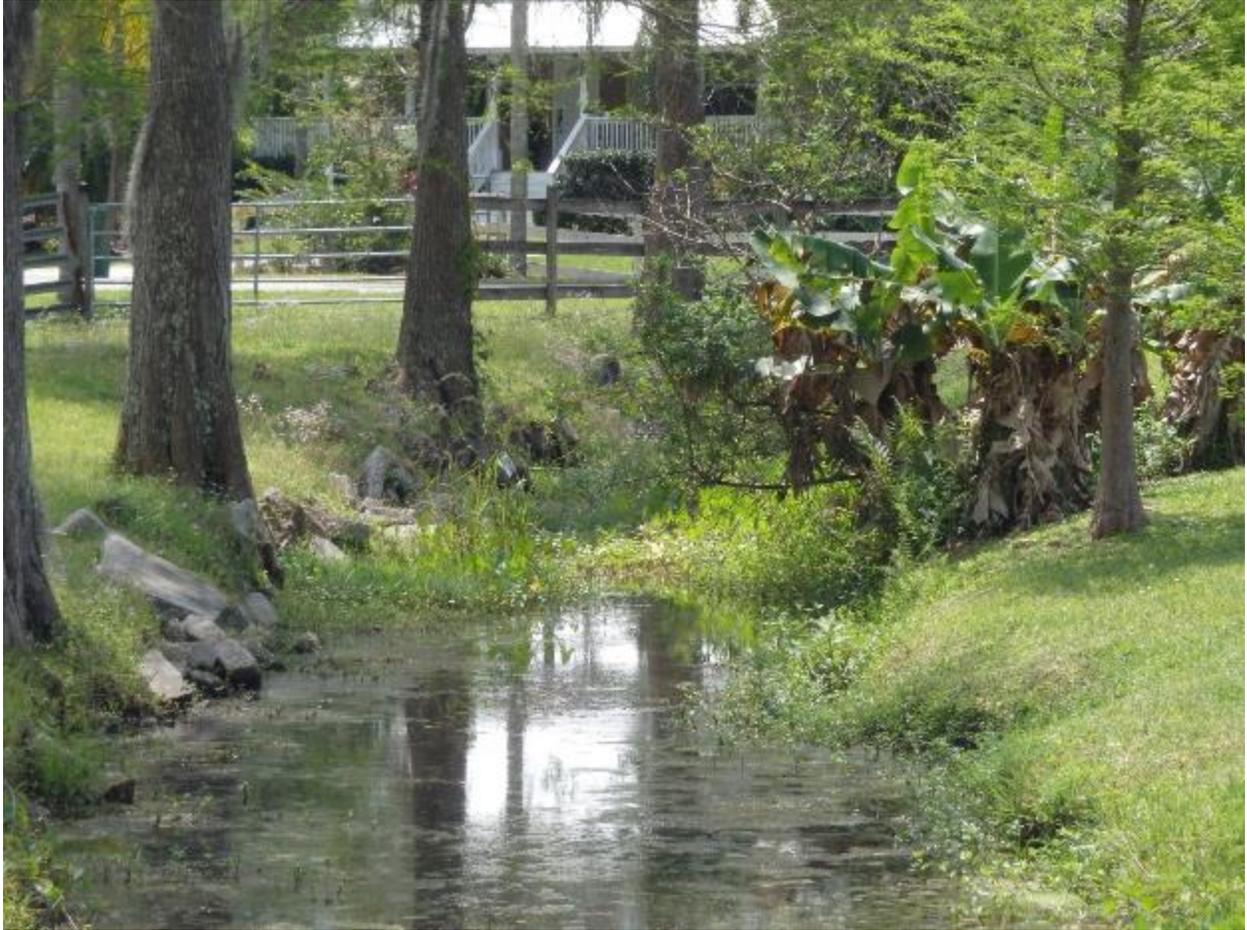
The eastern canal had a substantial amount of plant growth since the previous inspection. The species included: barnyard grass, torpedograss, pennywort, alligator weed and hydrilla. Water hyacinth was found in only a few patches around the lake and showed signs of the previous herbicide treatment. No hydrilla was found in the lake. The canal as well as Alligator weed and torpedograss will be targeted during the next herbicide treatment.

Photo: Eastern canal.

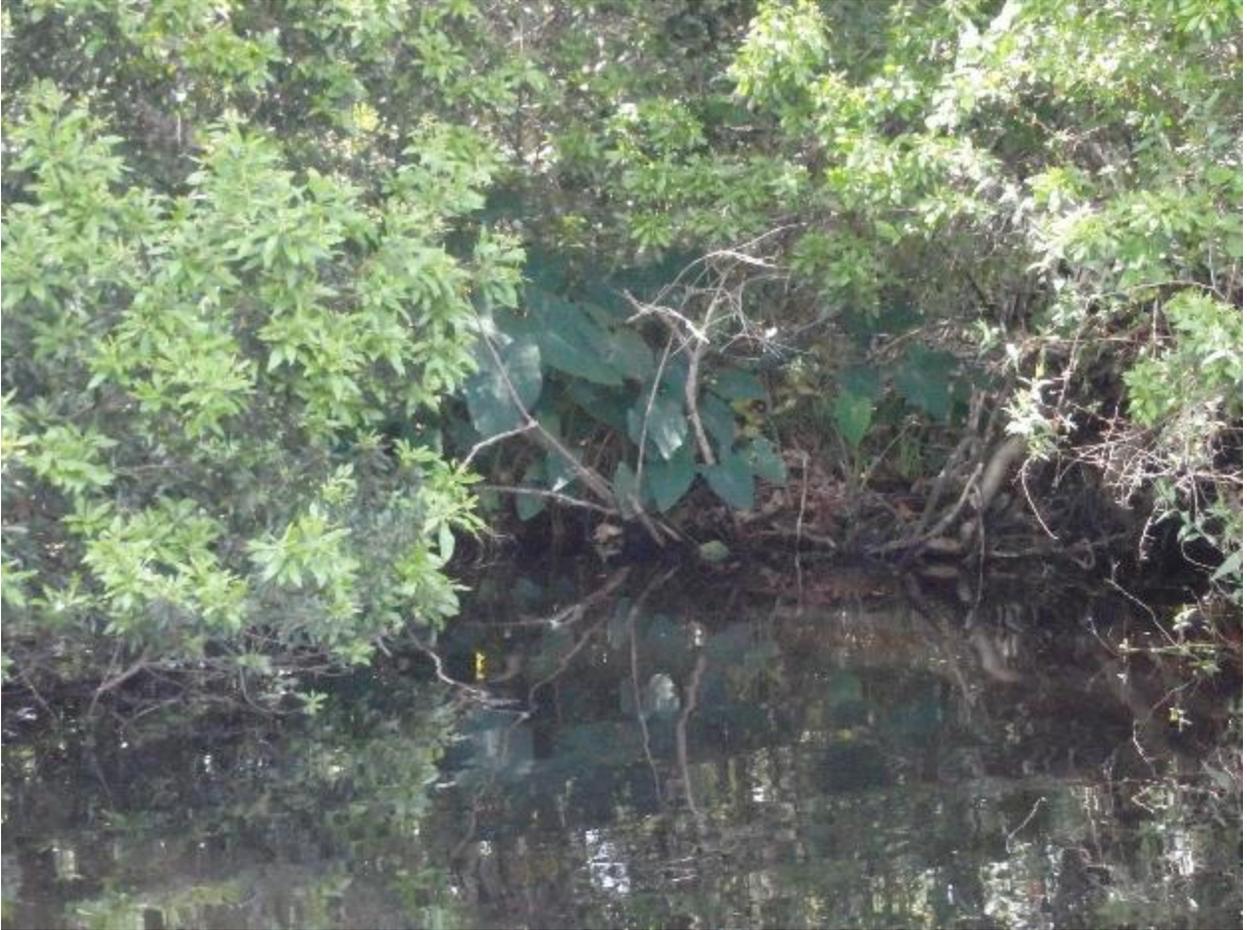
Invasive emergent species in the lake included: alligator weed, wild taro, primrose willow, torpedograss, salvinia, bur-head sedge, and a few patches of water hyacinth.

Photo: Elephant ear (invasive).

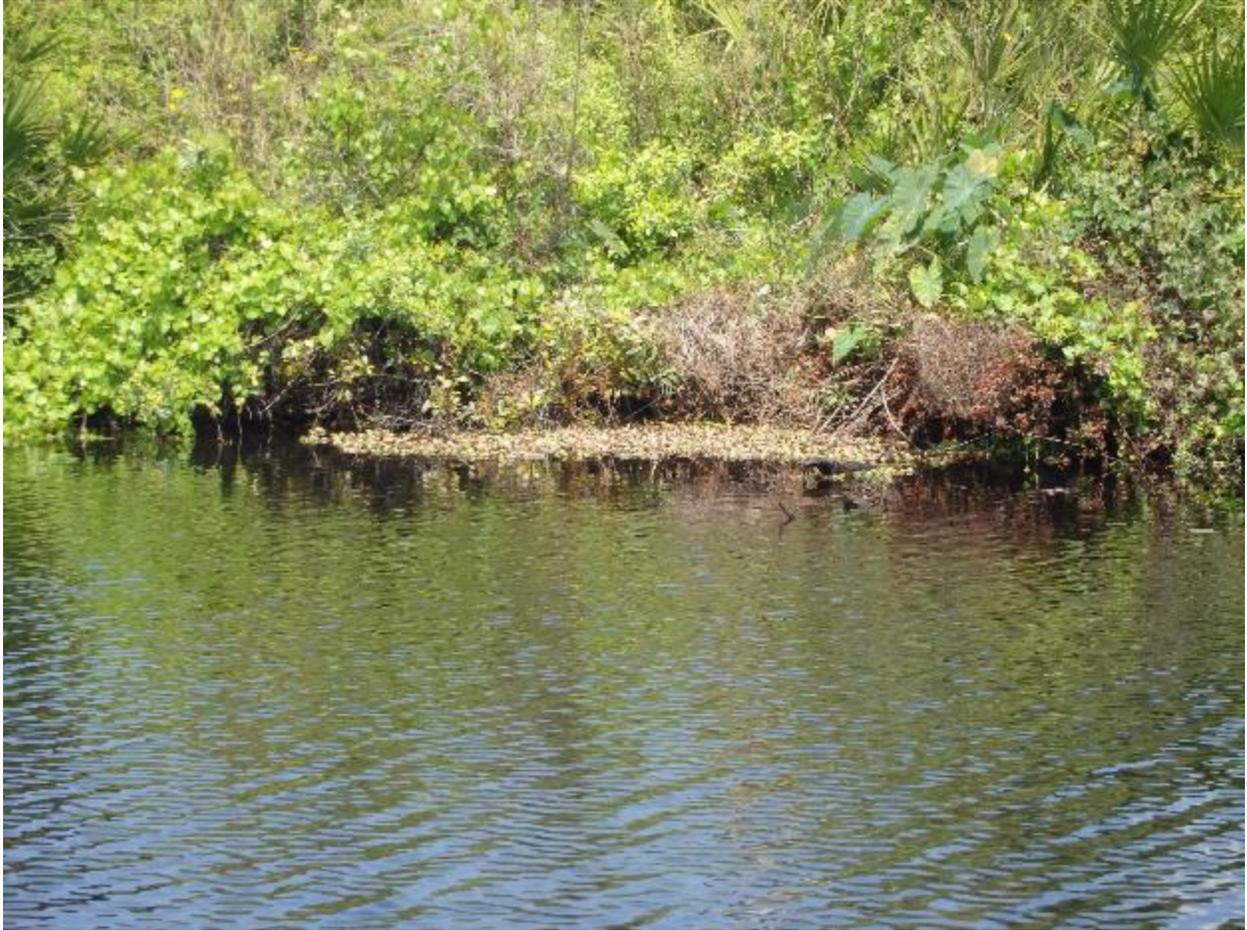
Photo: Treated water hyacinth.

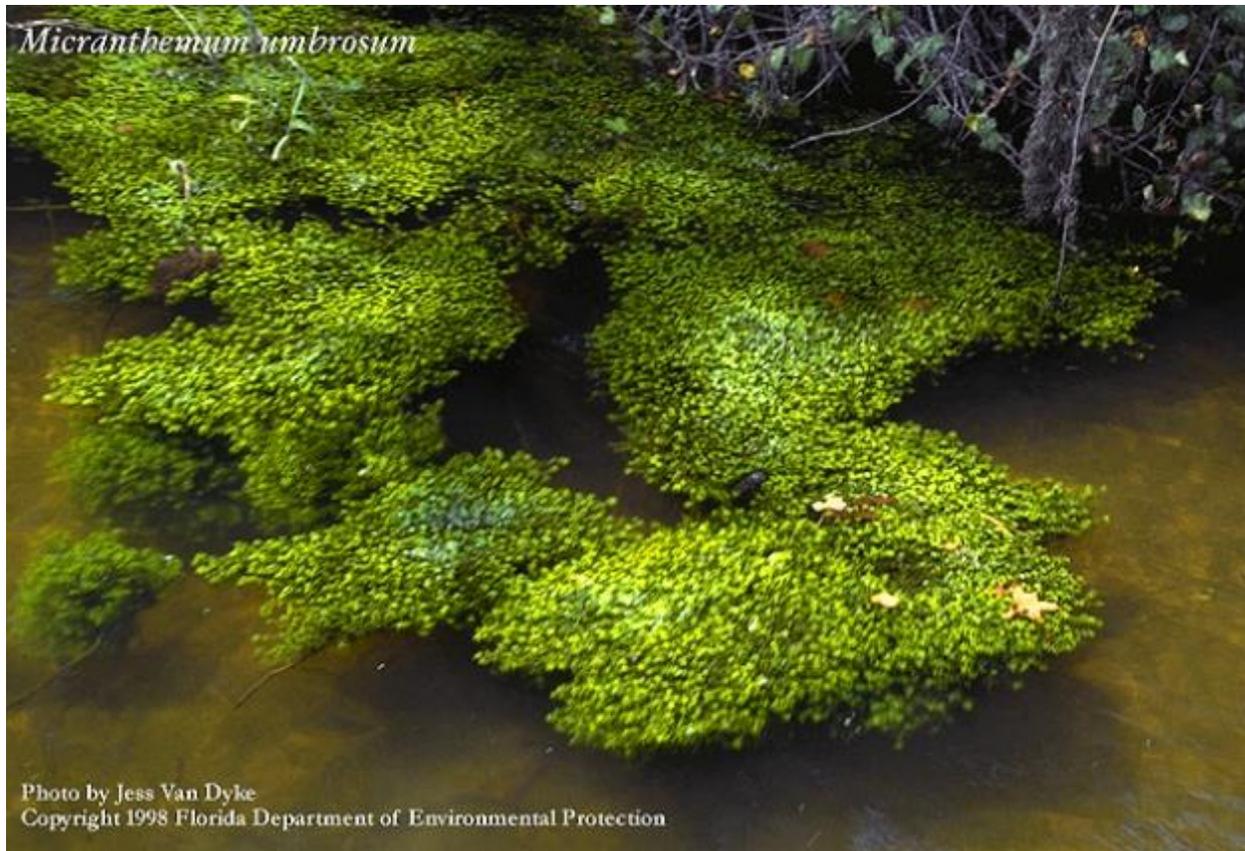
Observed native SAV in the lake included road grass and baby's tears. Both of these species were found in low quantities at a depth of 2 feet.

Photos: Example of baby's tears.

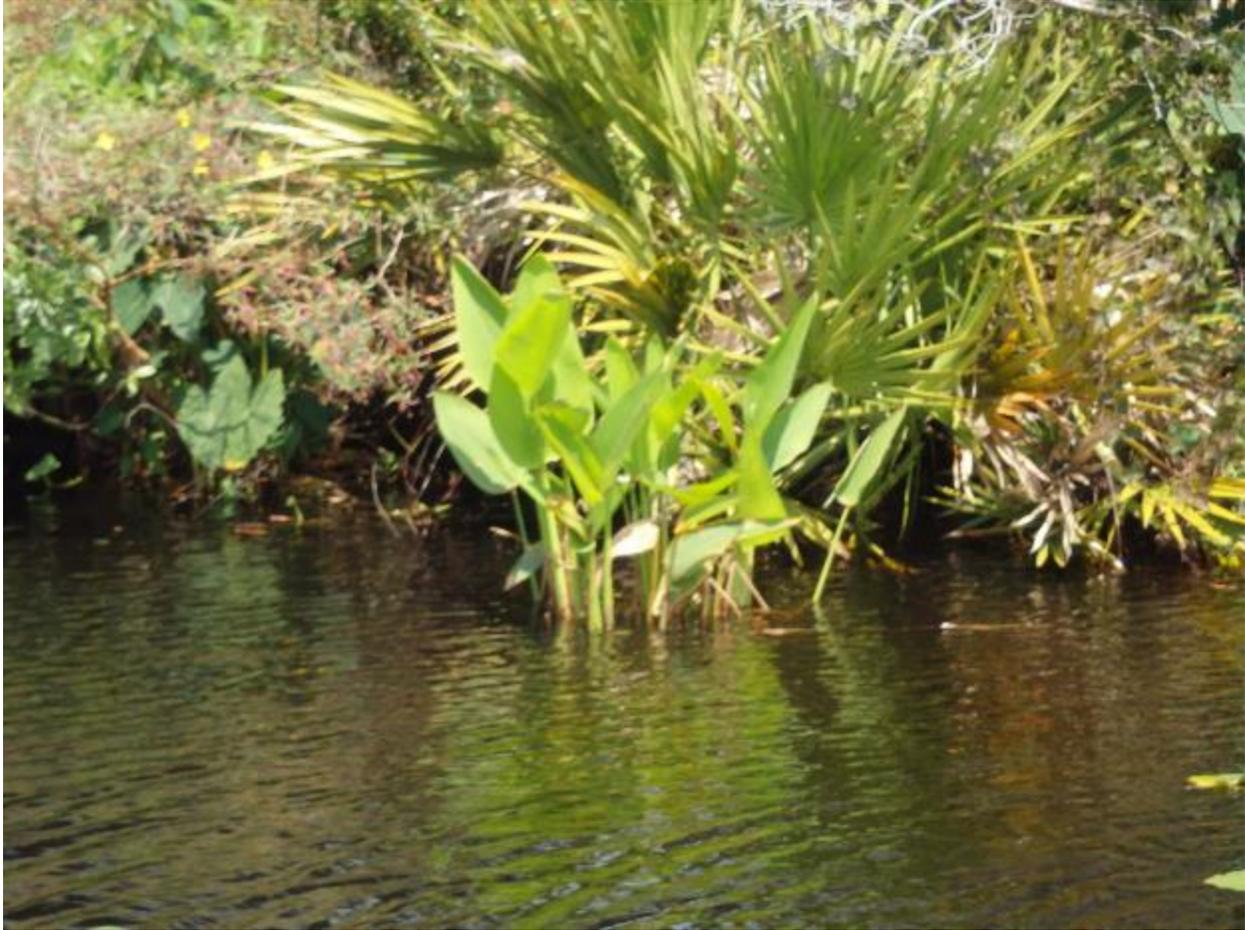
Observed native emergent vegetation in the lake included: bur-marigold, buttonbush, sawgrass, pennywort, maidencane, hempvine, yellow cow lily, pickerelweed, smartweed, duck potato, lizard's tail, bulrush, fire flag, and climbing aster. Pickerel weed, maidencane, duck potato and fire flag were showing spring growth and looked very healthy.

Photo: fire flag showing spring growth.
