Greetings Spring Lake Residents!

Please find the latest bioassessment of your lake below. Key highlights of this update include:

On **July 14<sup>th</sup>, 2016**, Seminole County Lake Management staff, Thomas Calhoun and Joey Cordell, surveyed the aquatic plants in **Spring Lake**.

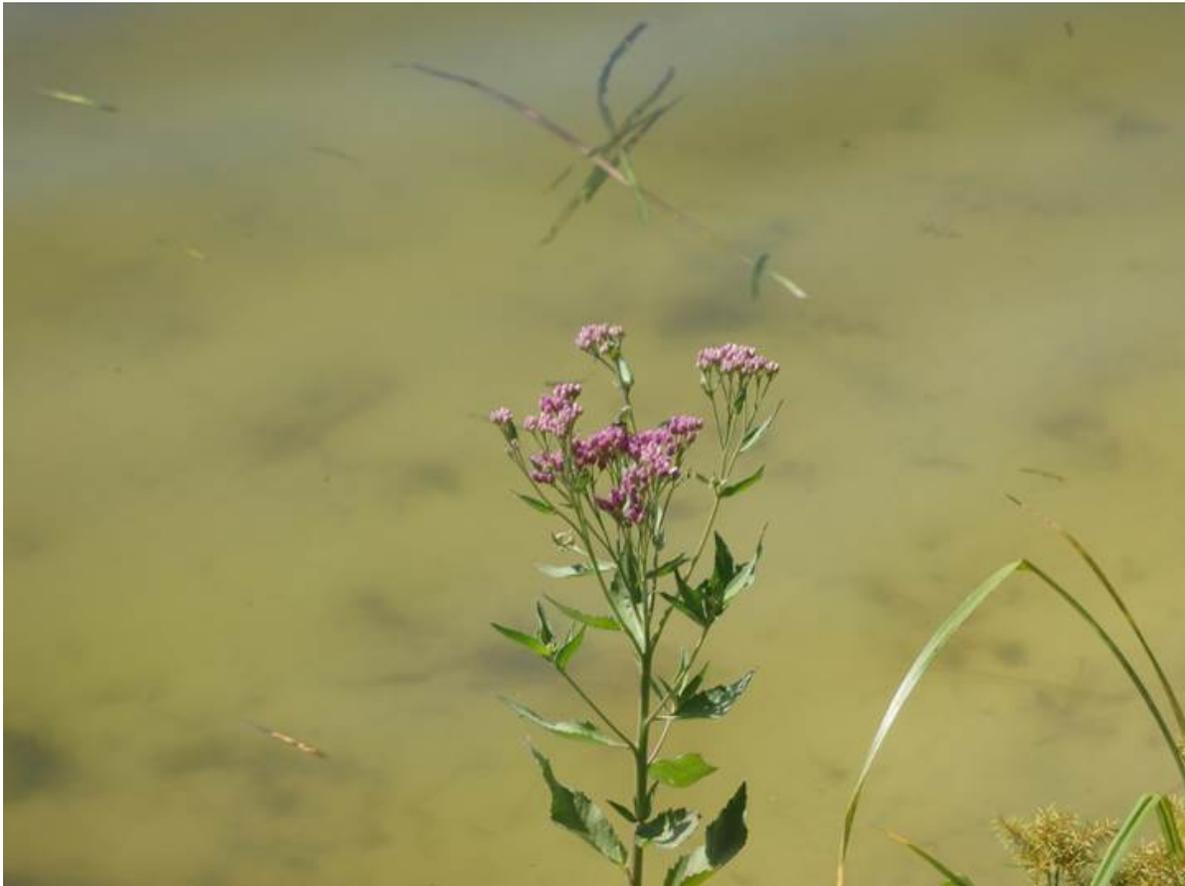
**Photo: Saltmarsh fleabane.**

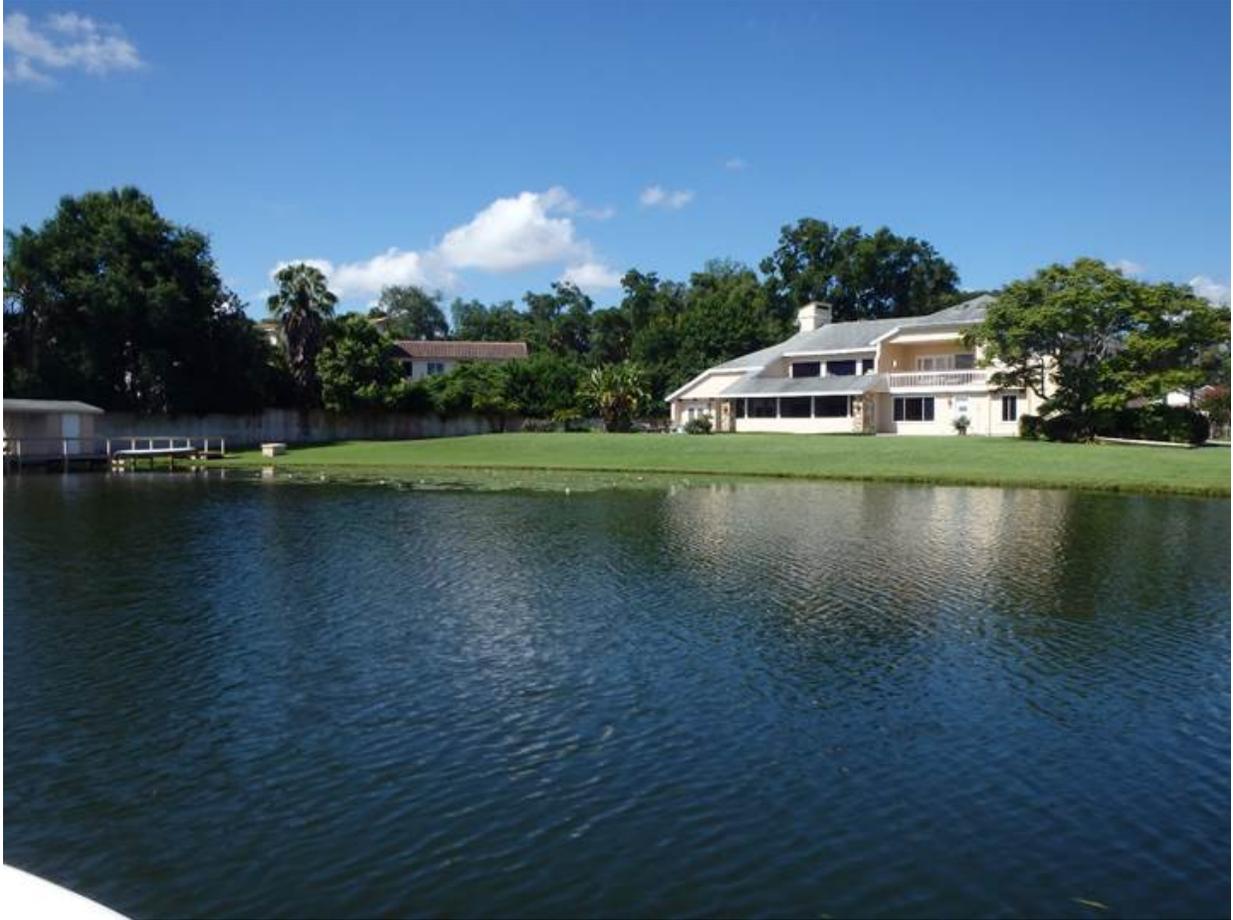
Native shoreline vegetation is very low on Spring Lake. Many shorelines have very little to no emergent vegetation. Native emergent vegetation is beneficial to your lake by; filtering run off, reducing erosion and providing habitat for aquatic species. Native emergent vegetation found during the inspection included: flatsedge, rush fuirena, pennywort, spatterdock, fragrant water lily, pickerelweed, duck potato, carolina willow, bulrush, and cattail.

**Photo: Non-vegetated shoreline.**

from this and other surveys. Continue to increase native aquatic plantings along the shoreline (such as pickerelweed, duck potato, and canna).

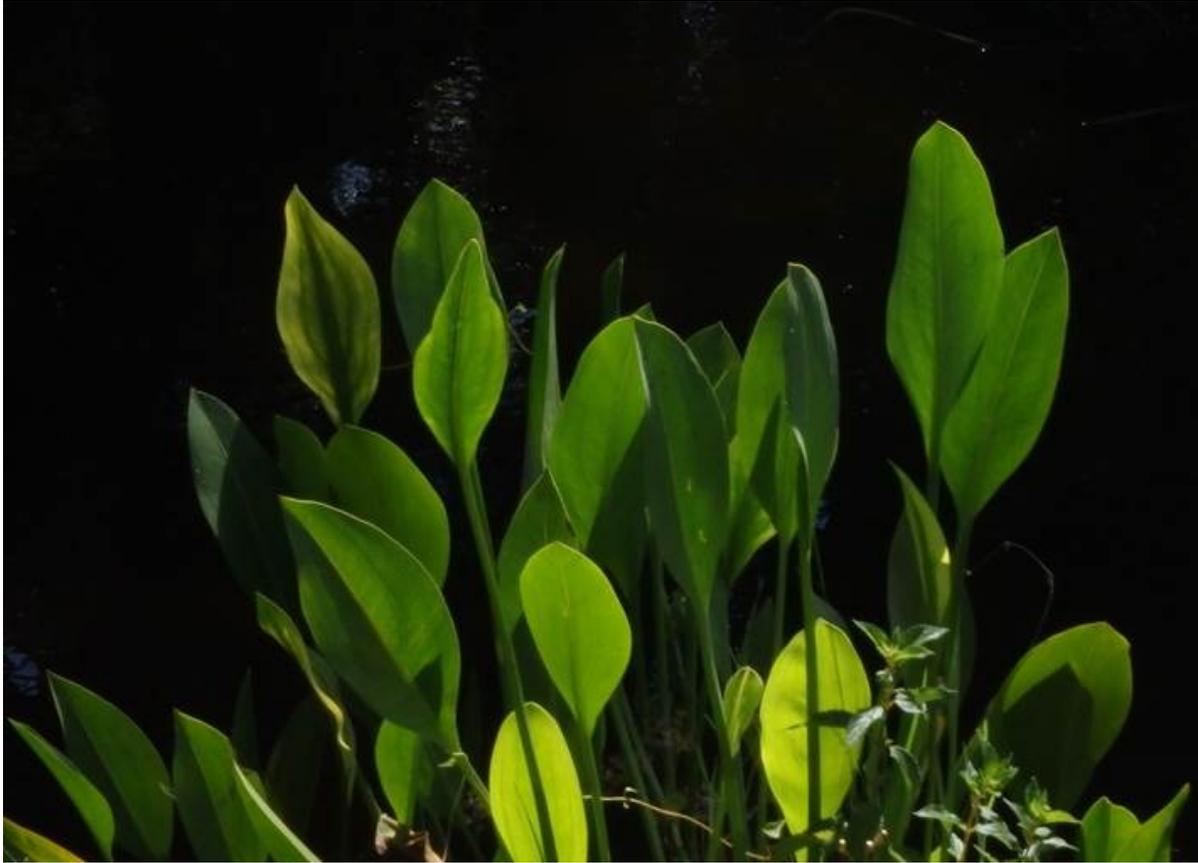
**Photo: Duck potato.**

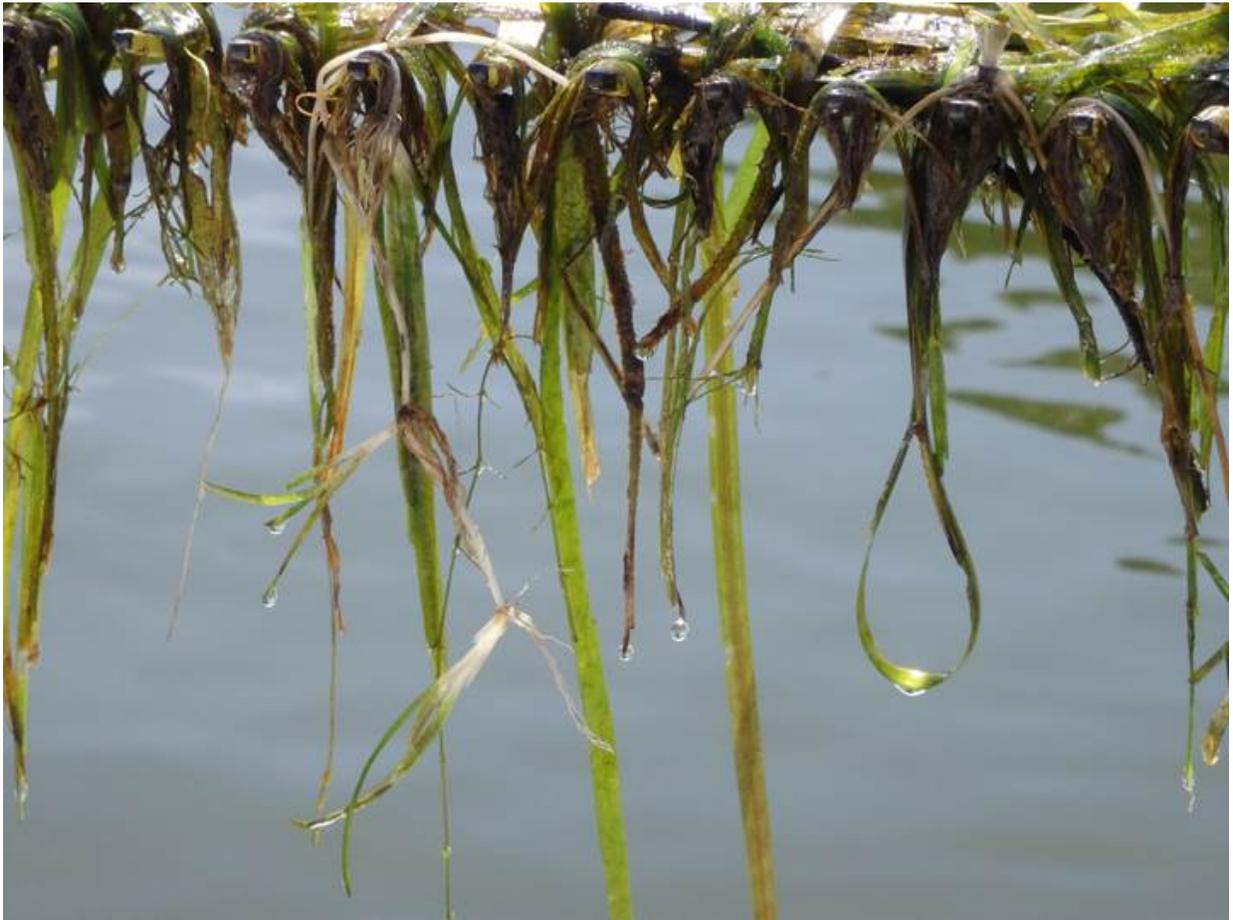
Four species of submersed aquatic vegetation (SAV) were observed during the inspection, including: water hyssop to 1 foot, southern naiad to 3, feet baby's tears to 1 foot, and eelgrass to 4 feet. The access corridors were open and in good shape. One sprig of hydrilla was seen during the inspection.

**Photo: Eelgrass mixed with southern naiad.**

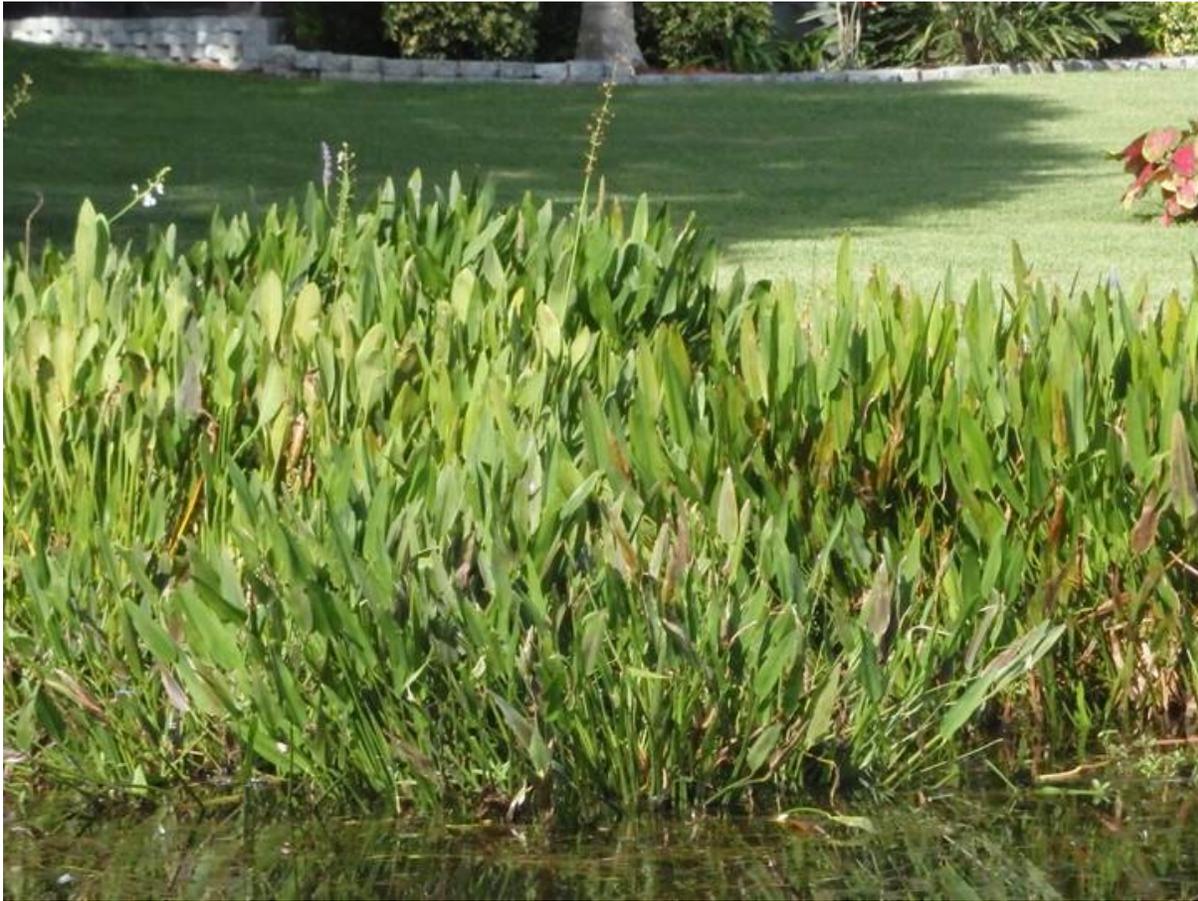
**Photo: Stand of native duck potato and pickerelweed.**

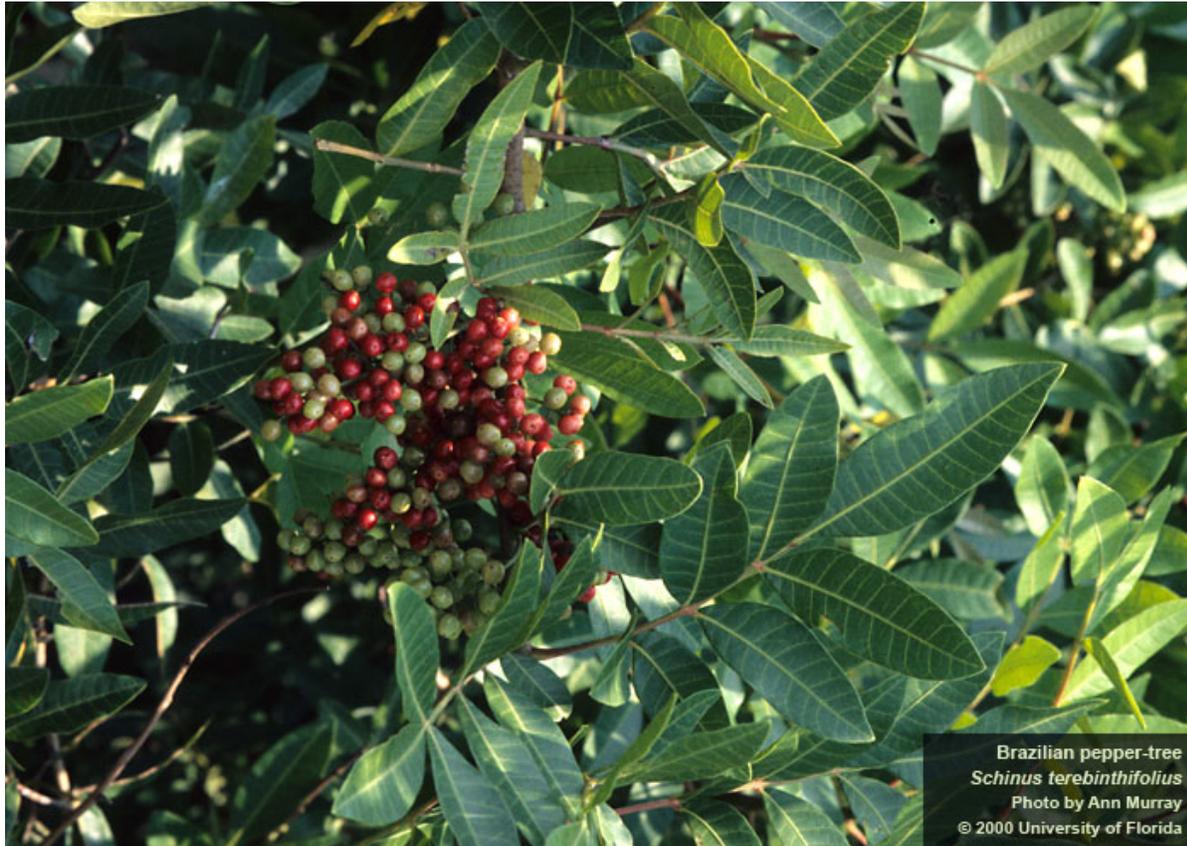
Invasive emergent vegetation found during the inspection included: alligator weed, para-grass, wild taro, umbrella sedge, water primrose, torpedograss, brazilian pepper tree, cogongrass and creeping oxeye.

**Photo: Brazilian Pepper tree invasive.**

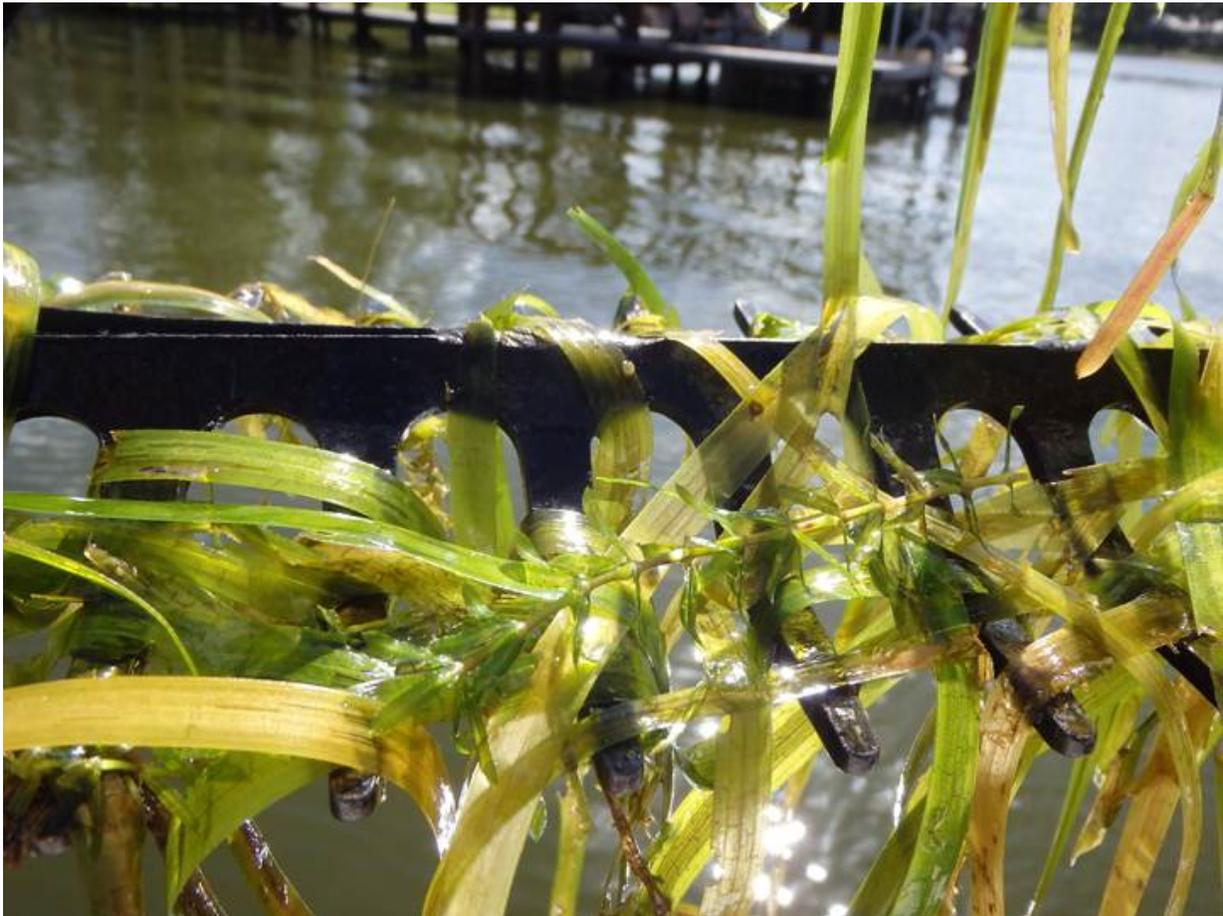
Four species of submersed aquatic vegetation (SAV) were observed during the inspection, including: stonewort to 4 feet, southern naiad to 4 feet baby's tears to 1 foot and eelgrass to 4 feet. The access corridors were open and in good shape. One sprig of hydrilla was found mixed in with eelgrass along the south eastern shore.

**Photo: Hydrilla found mixed in with eelgrass.**

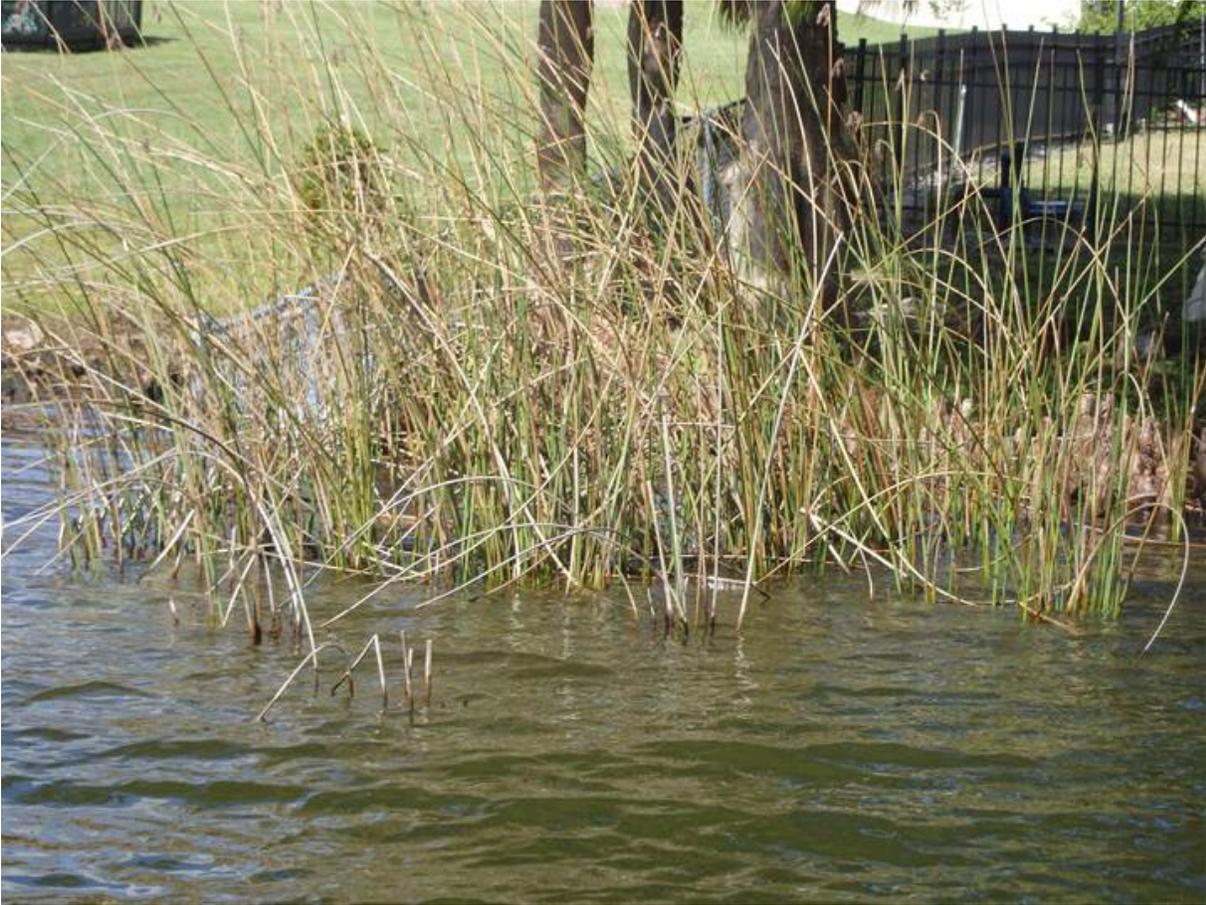
**Photo: Stand of native bul-rush.**

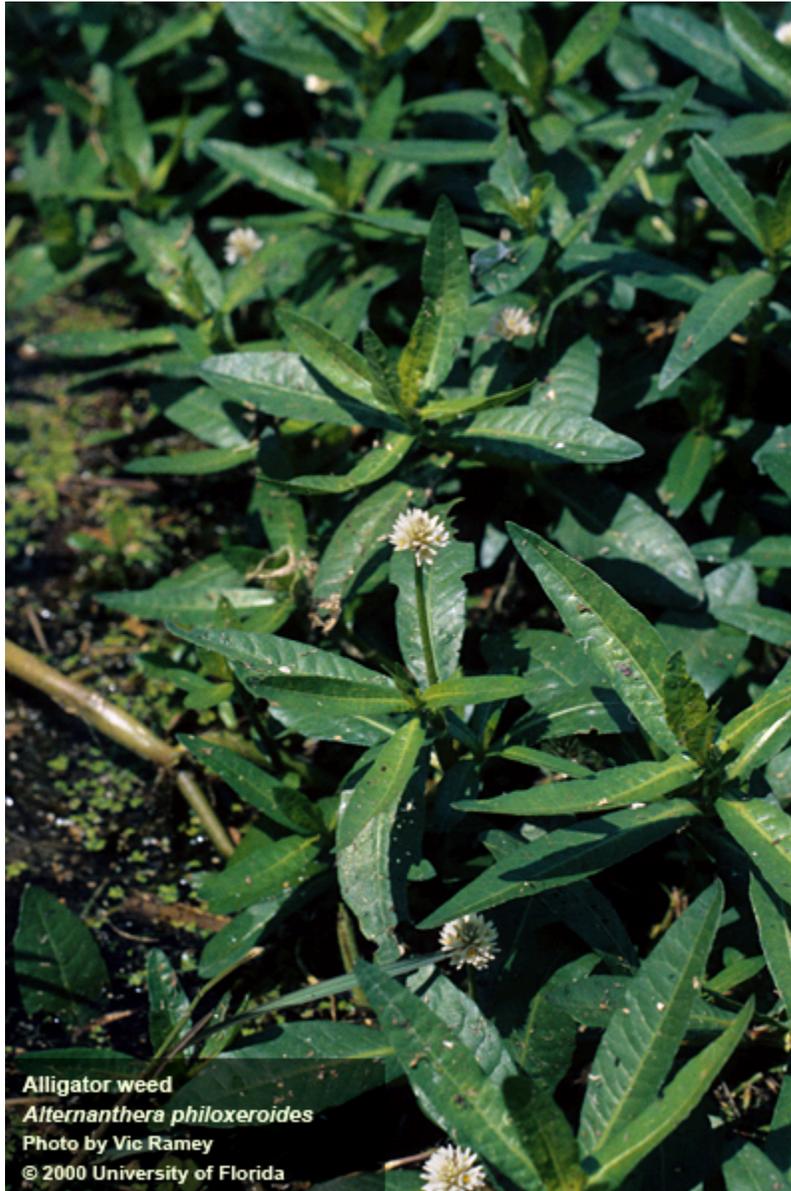
Invasive emergent vegetation found during the inspection included: alligator weed, para-grass, wild taro, umbrella sedge, water primrose, torpedograss, brazilian pepper tree, and creeping oxeye.

**Photo: Alligator weed invasive.**
