Greetings Lake Amory Residents!

Please find the latest bioassessment report for your lake below. Key highlights of this update include:

On **May 17th, 2016**, Seminole County Lake Management Program biologist, Thomas Calhoun surveyed the aquatic plants in **Lake Amory**.

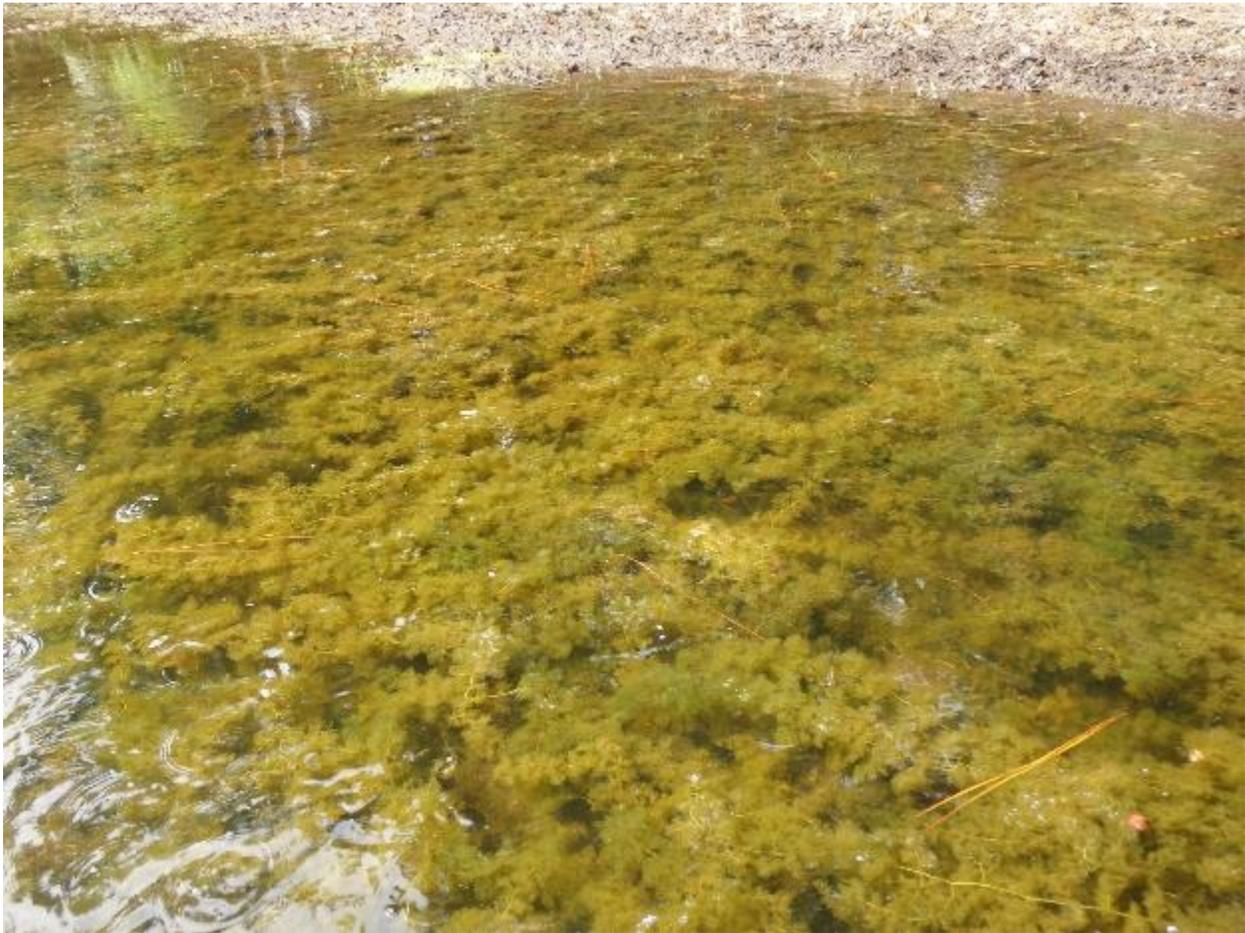
The water elevation was very low during the inspection. The bladderwort that was restricting access was targeted during this herbicide treatment. In areas where bladderwort was found topping out (reaching the surface), algae was growing on the decaying plant material.

Photo: Bladderwort found topping out in the Bird Island area.

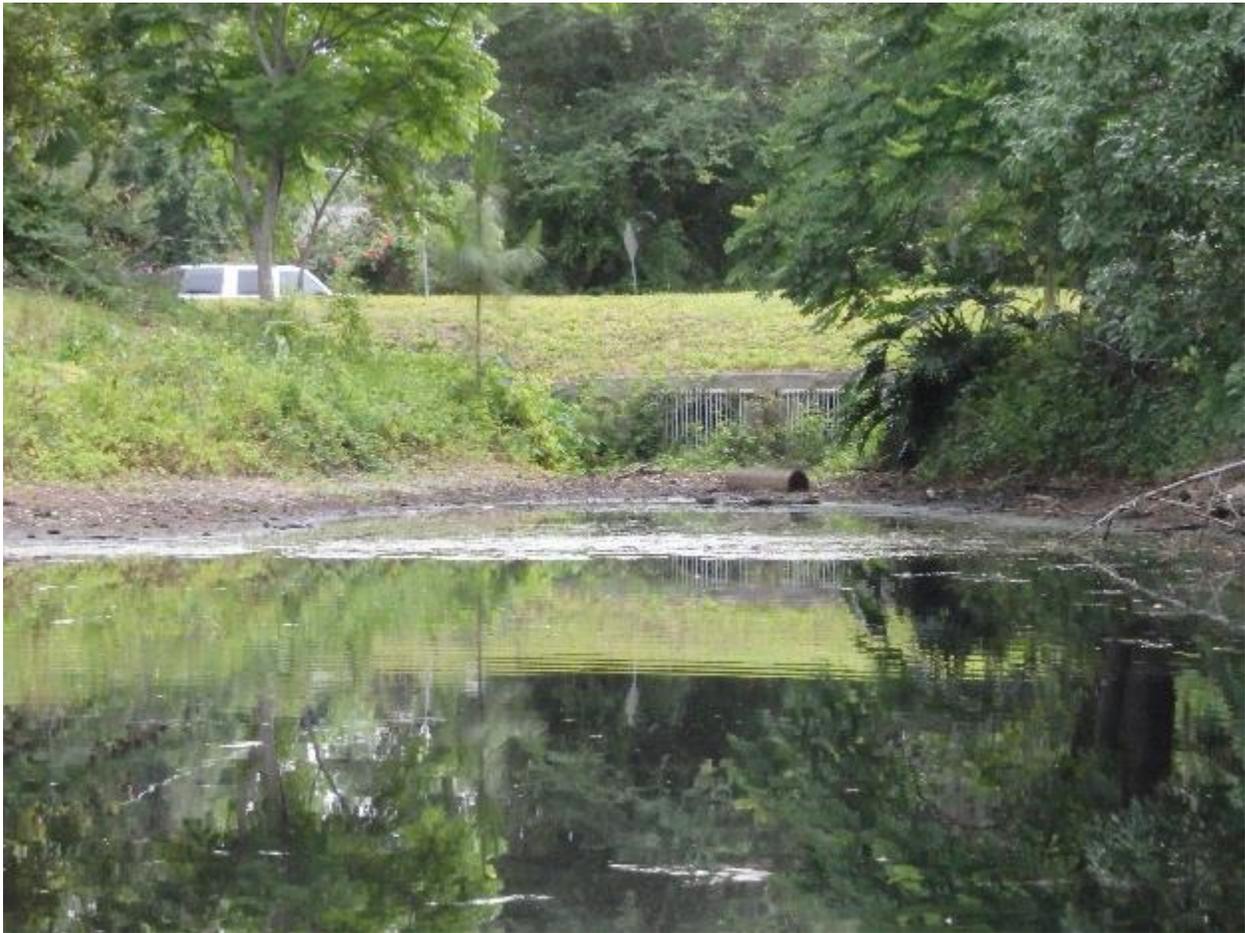
In the **Cactus Canal** and **Outfall Canal**, bladderwort was found topped out in areas less than 2 feet of water. Invasive emergent vegetation included: alligator weed, elephant ear, salvinia and torpedo grass. A small amount of algae was found in this area.

Photo: Outfall and carp barrier in the Outfall Canal.

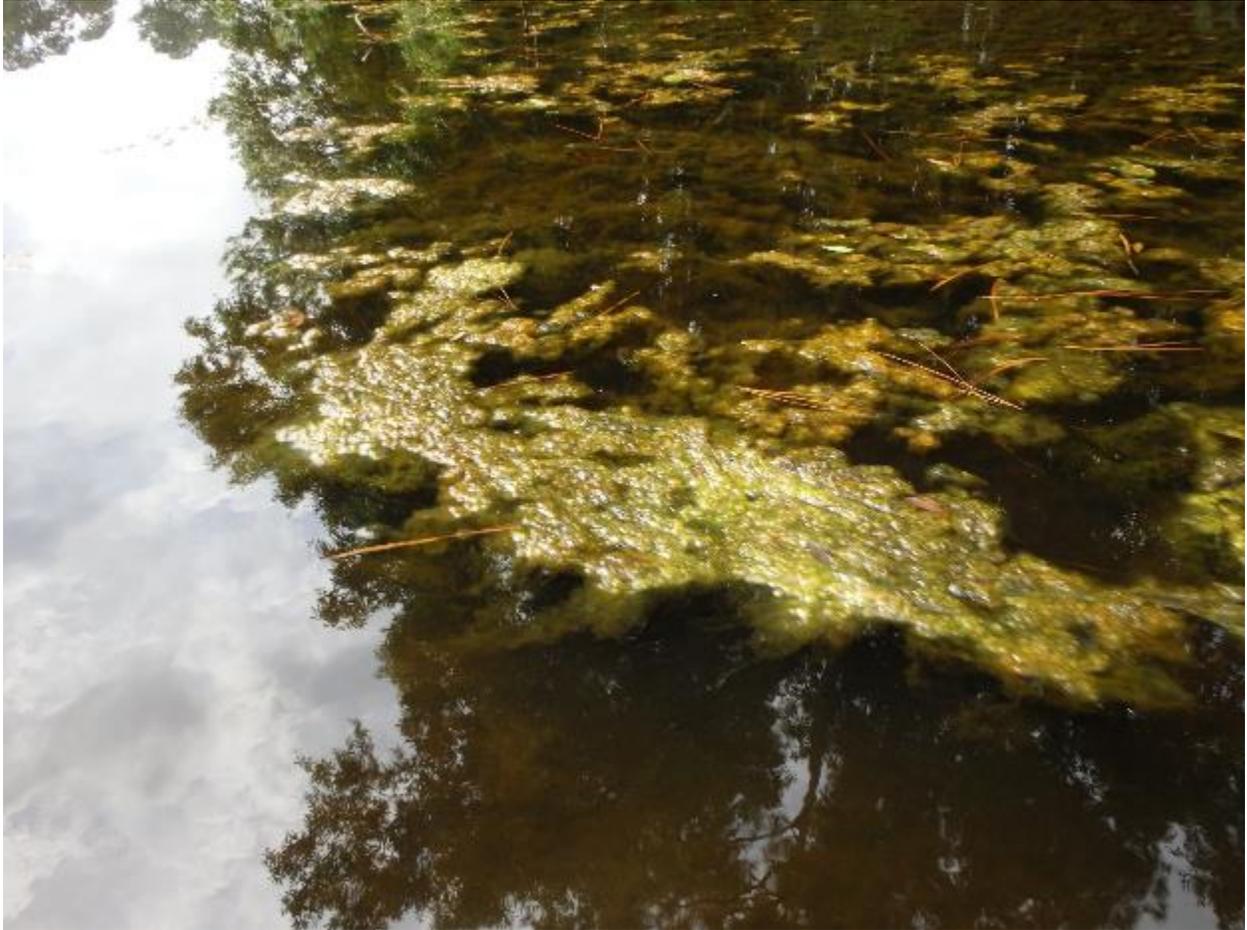
The **Bird Island** area was found to be in good condition. Native emergent vegetation, spike rush and duck potato, were doing very well. Many of the invasive species, such as barnyard grass and primrose willow, had died from previous herbicide treatments. Bladderwort was reaching the surface with an algae on top and will be treated during this month's herbicide treatment.

Photo: Algae present in Bird Island area.

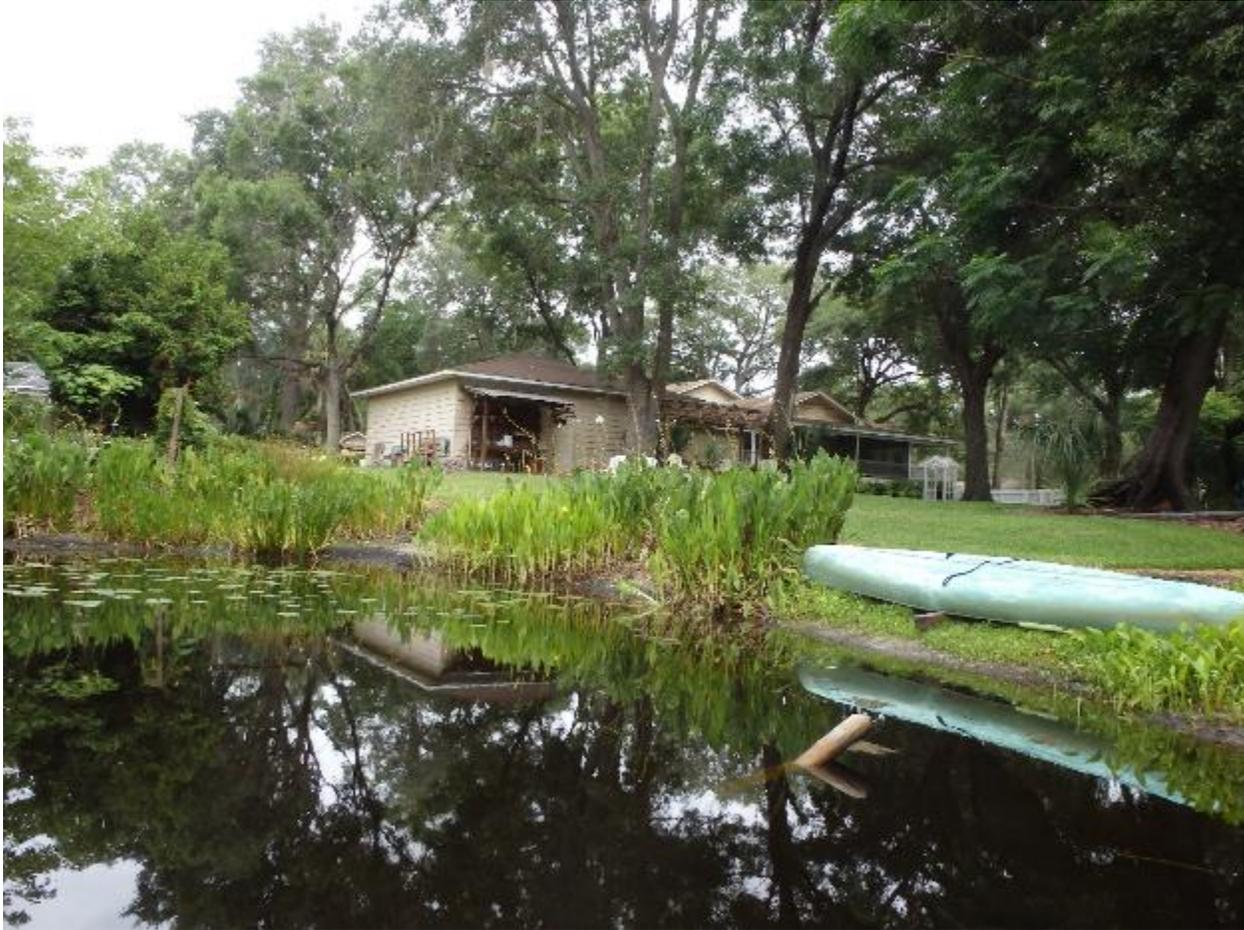
The Cove was found to be in great condition. Native emergent vegetation was in good condition with canna doing particularly well. Submersed aquatic vegetation in this area included roadgrass and bladderwort. A small amount of surface algae was present along the shoreline. Bladderwort treatment was not needed in The Cove at this time.

Photo: Native emergent vegetation, duck potato and canna.

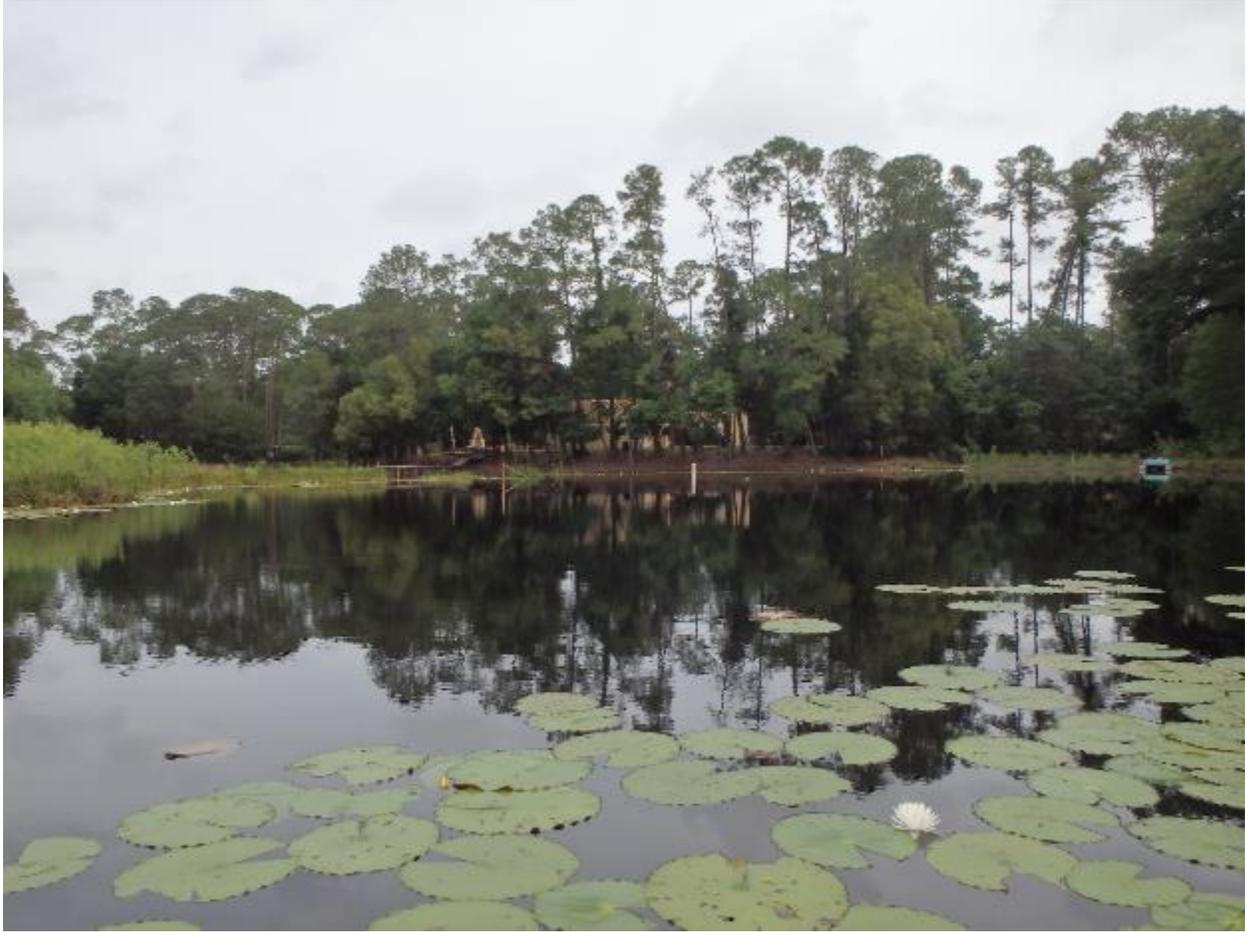
The **Lake Proper** area was found to be in good condition as well. Emergent vegetation included: canna, buttonbush, rush fuirena, pennywort, yellow cow lily, fragrant water lily, pickerelweed, duck potato, Carolina willow, and bulrush. Invasive species in this area included: alligator weed, elephant ear, torpedo grass and salvinia. Lily pads will be treated by the herbicide contractor to keep access areas open.

Photo: Lake Proper.

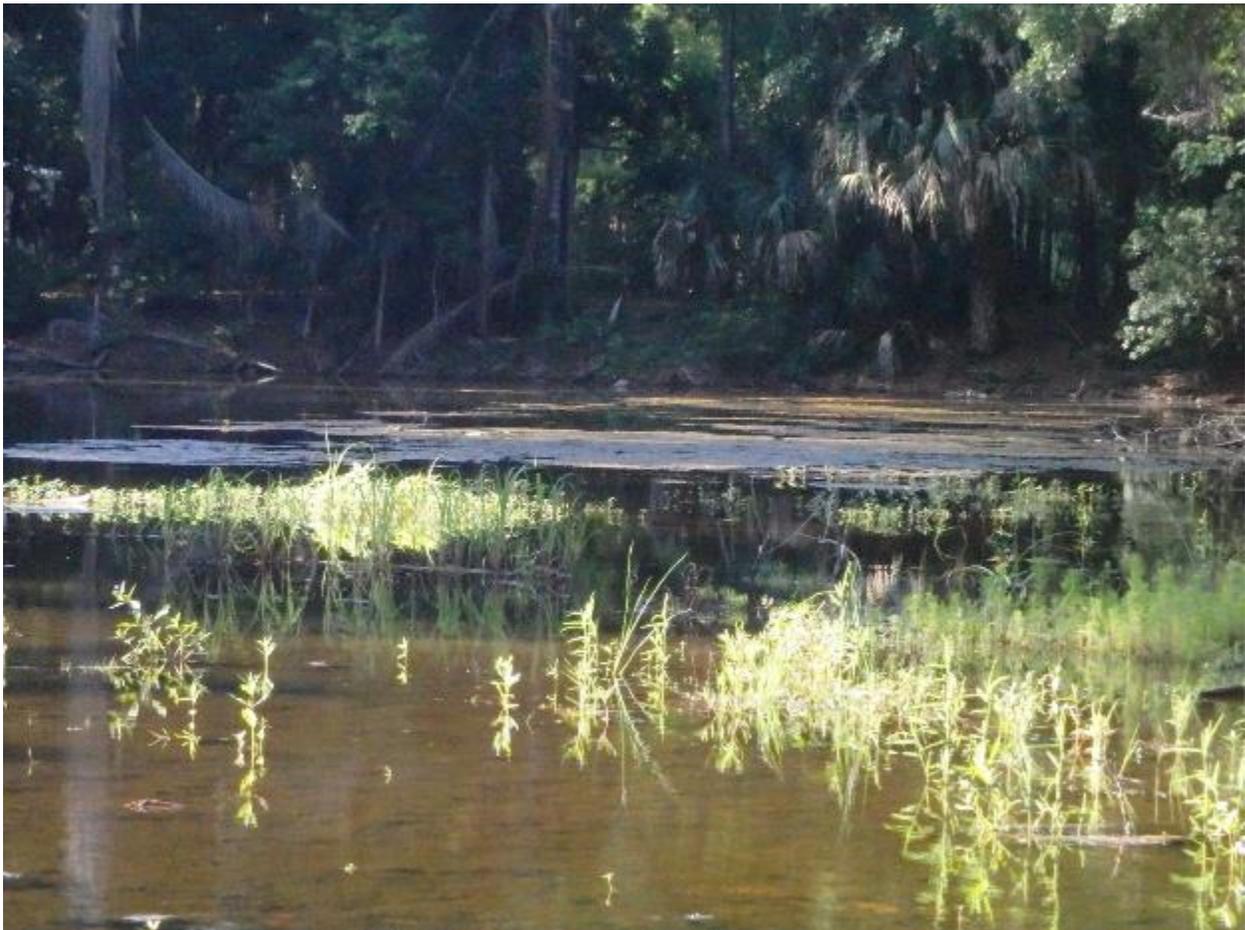
Cactus Canal and **Outfall Canal** were found to be in good condition. Invasive emergent vegetation included: alligator weed, elephant ear, salvinia and torpedo grass. Bladderwort was targeted in this area during the last herbicide treatment. Alligator weed and a sedge were noted as increasing in this area, and will be targeted during the next herbicide treatment.

Photo: Bladderwort “topped out” along the shoreline of Cactus Cove.

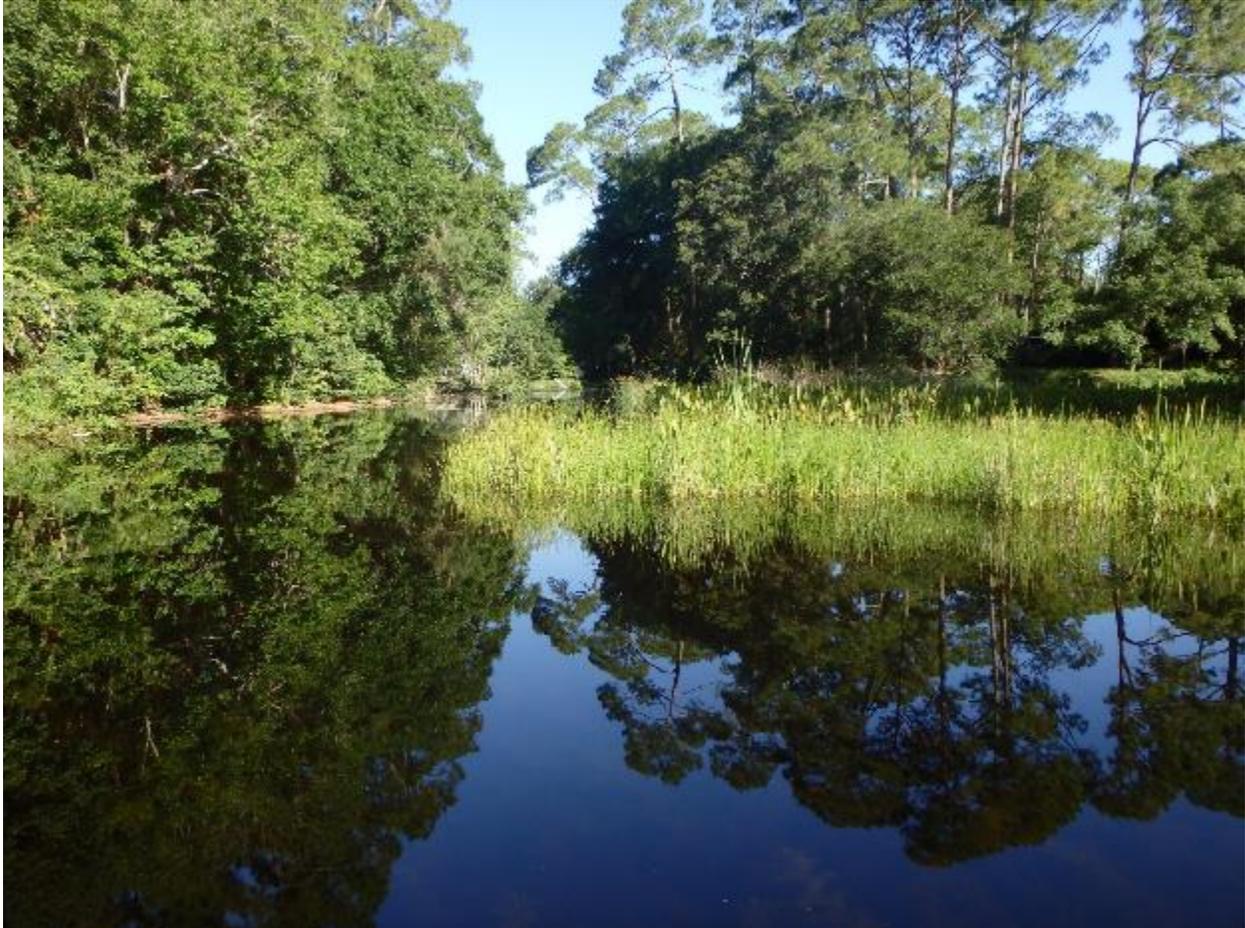
The **Bird Island** area was found to be in good condition. Spike rush and duck potato, native emergent vegetation, were doing very well. Invasive vegetation was minimal. Spike rush continues to expand in this area. Bladderwort was not reaching the surface and not blocking access during the inspection.

Photo: Spike rush expanding around Bird Island.

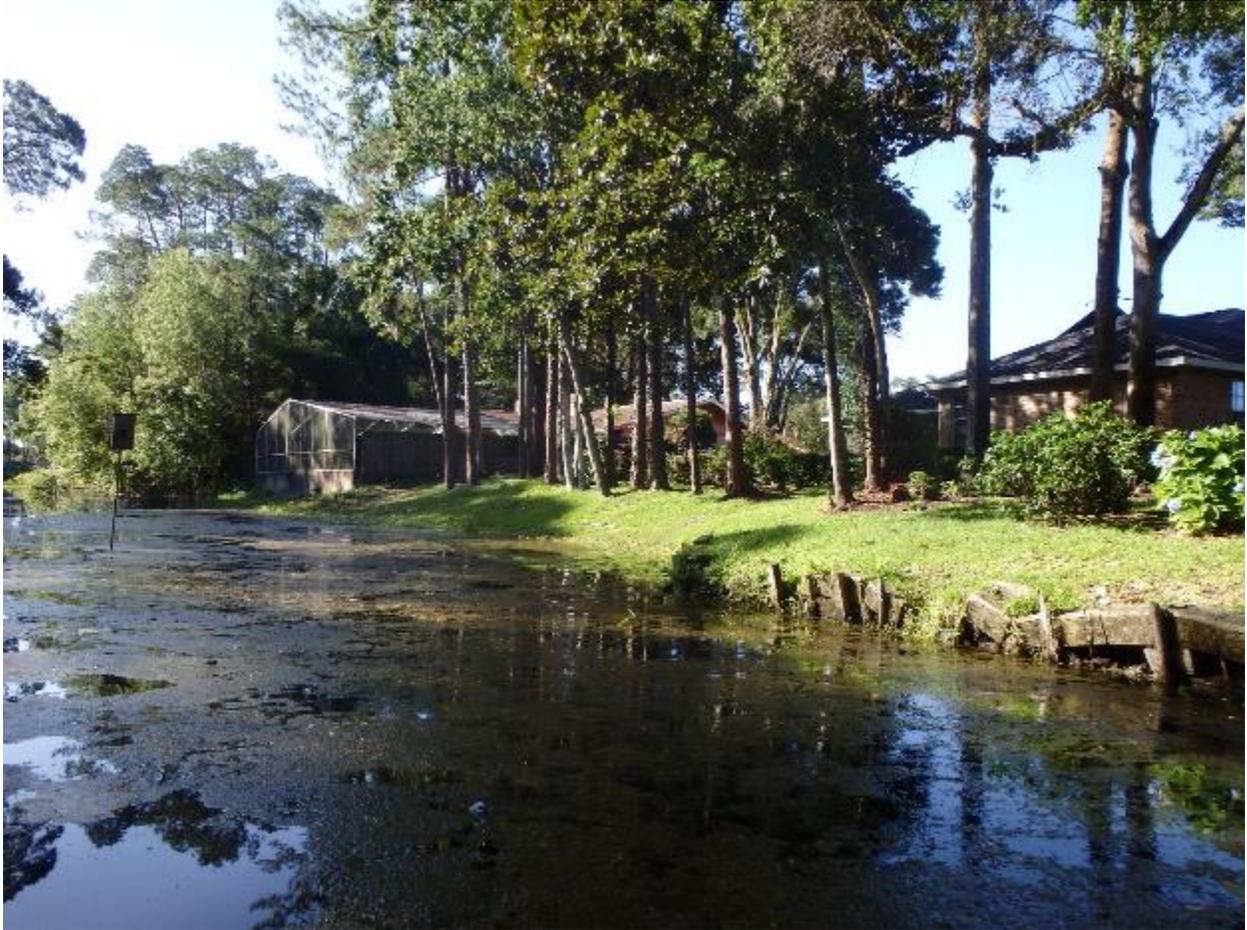
An algae bloom was present in **the Cove** during the inspection. Native emergent vegetation was doing well and minimal invasive vegetation was found. Submersed aquatic vegetation in the area included roadgrass and bladderwort. Invasive emergent species found in the Cove included: wild taro, alligator weed (alligator weed was noted as increasing). Topped out bladderwort was stimulating the growth of surface algae.

Photo: Algae found in the Cove area.

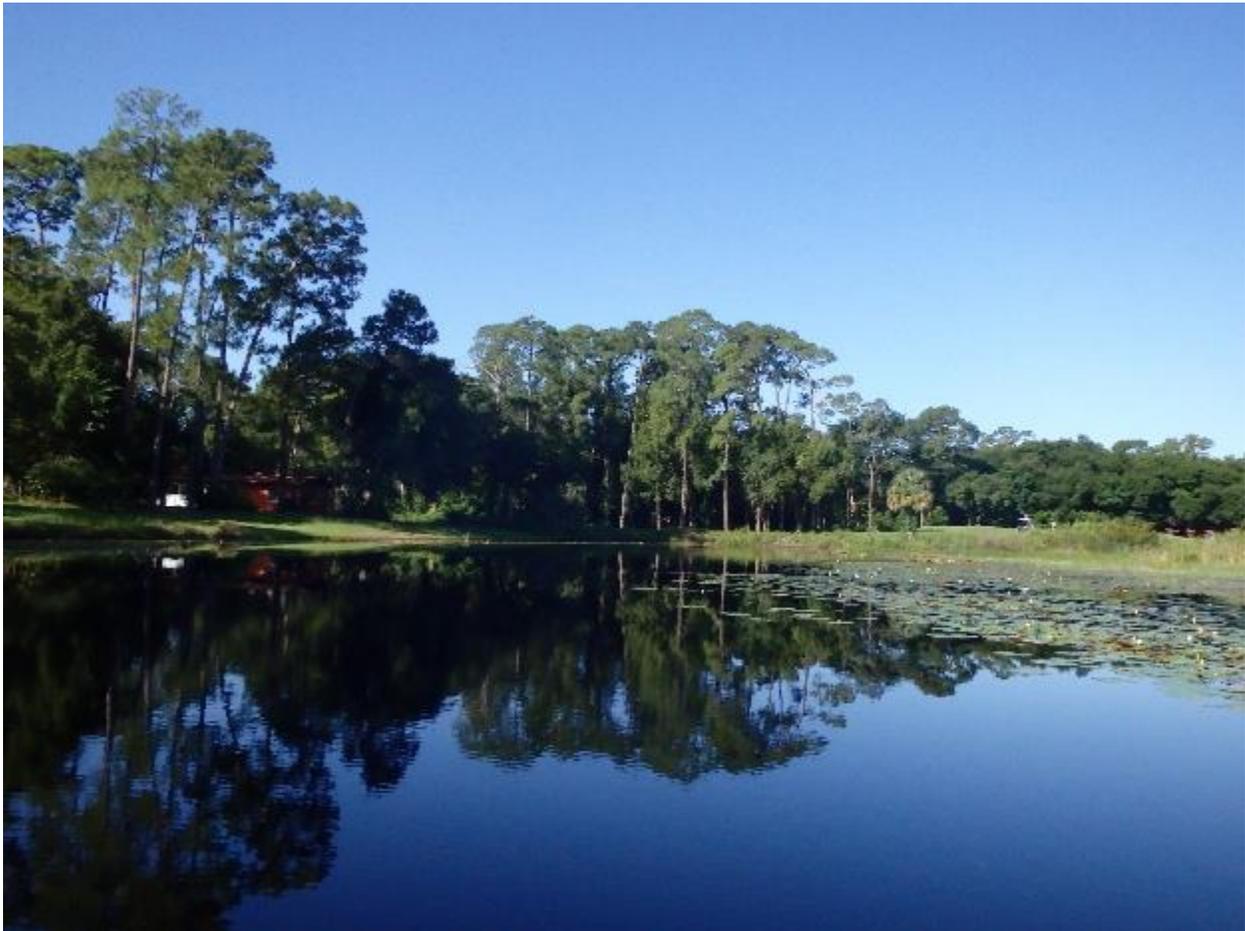
The **Lake Proper** area was found to be in good condition as well. The access corridors were open and accessible. Emergent vegetation included: canna, buttonbush, rush fuirena, pennywort, yellow cow lily, fragrant water lily, pickerelweed, duck potato, carolina willow, and bulrush. Invasive species found in this area included: alligator weed, elephant ear, torpedo grass and salvinia.

Photo: Lake Proper.
