Greetings Lakes Martha and Burkett Residents!

On **June 12th, 2017**, Seminole County Lake Management Program (SCLMP) staff, Thomas Calhoun and Joey Cordell, surveyed the aquatic plants in **Lakes Martha and Burkett**.

On **July 17th, 2017**, Seminole County Lake Management Program (SCLMP) staff, Joey Cordell and Alyssa Alers, surveyed the aquatic plants in **Lakes Martha and Burkett**.

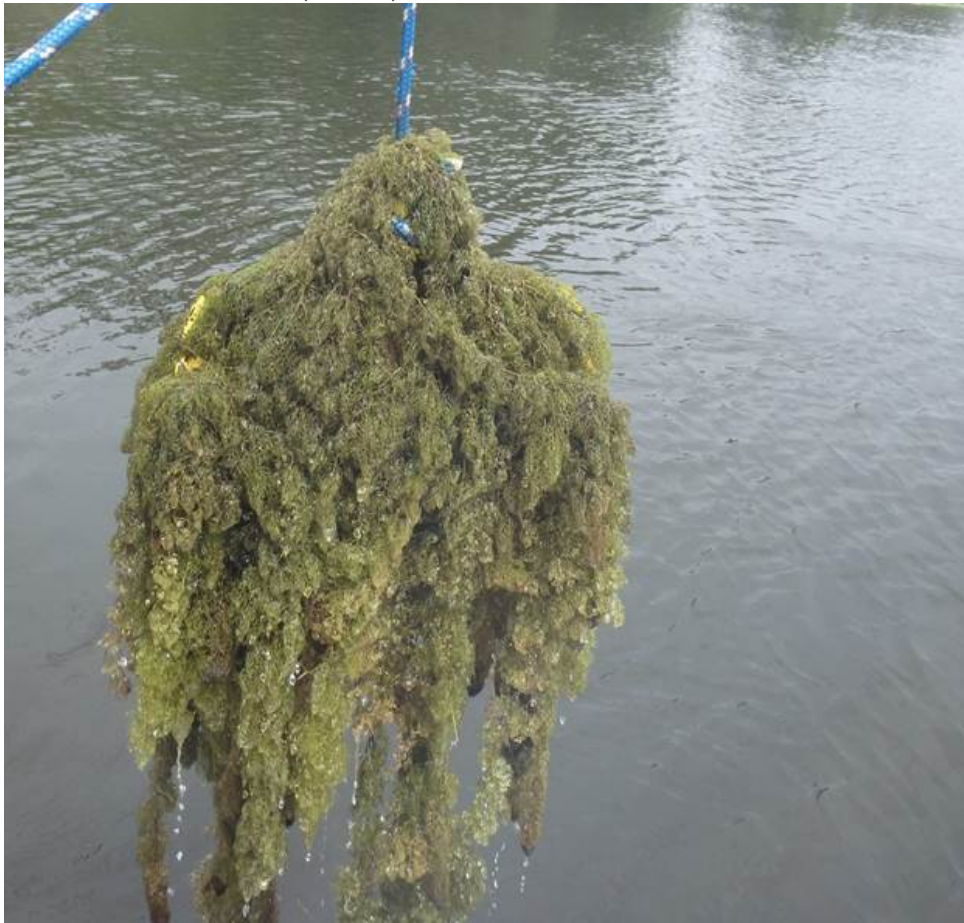
Four species of native submersed aquatic vegetation (SAV) were observed during the inspection including: lemon bacopa to 2 ft, loose watermilfoil to 3 ft, bladderwort to 6 ft, and eelgrass to 4 ft.

Photos: Bladderwort (native).

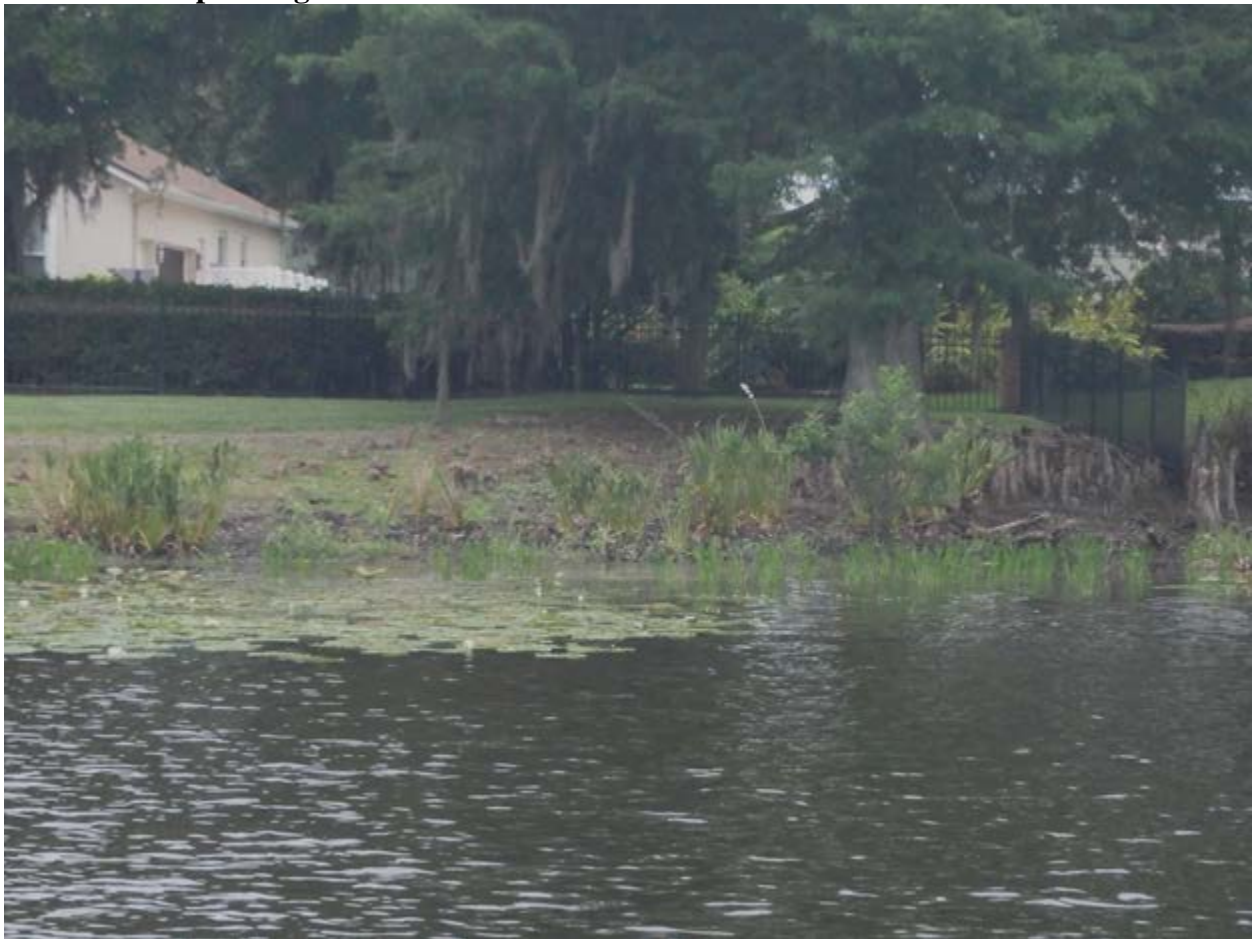
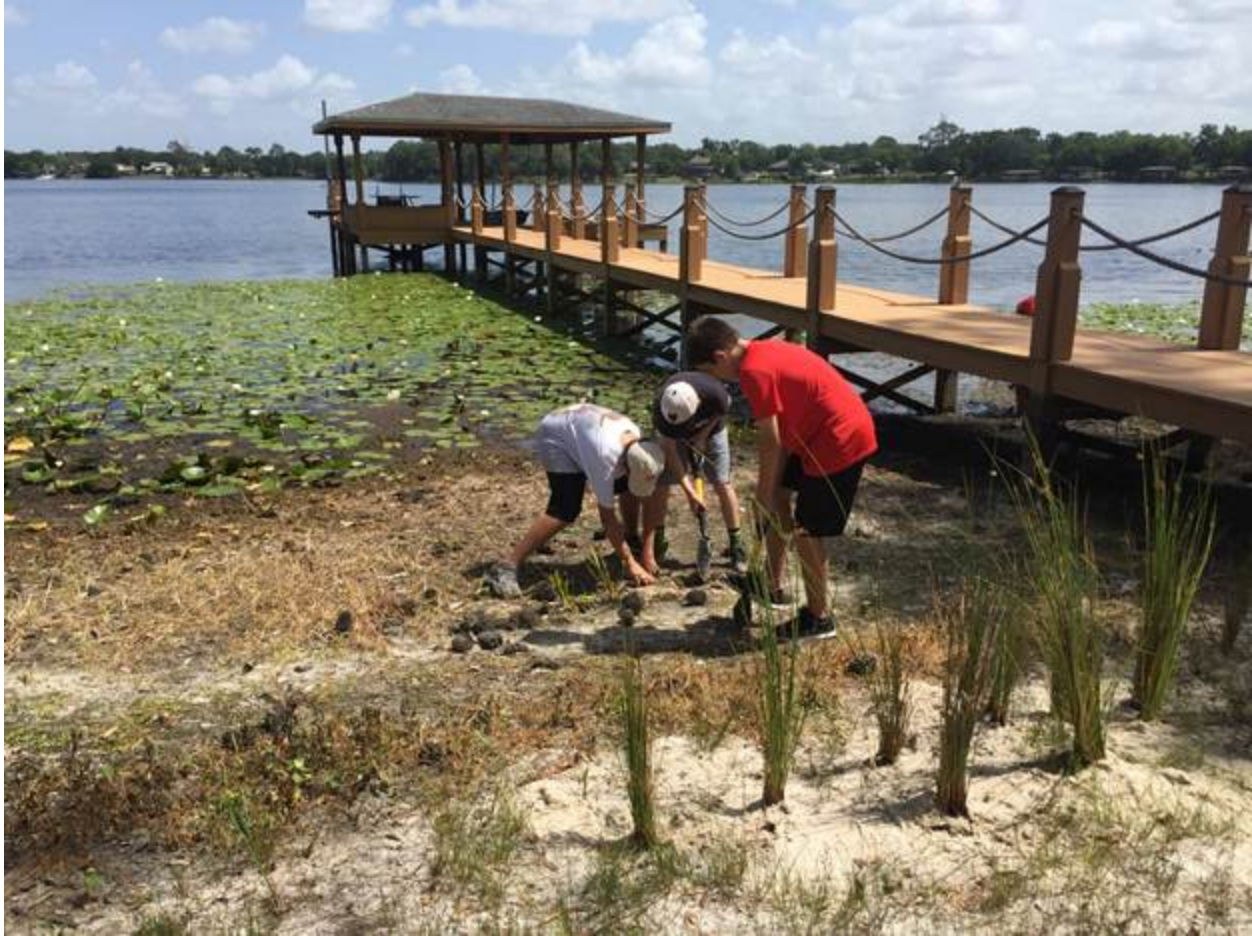
On May 20th, 2017, Seminole County's SERV Program, Orange County EPD, and Trinity Prep held another volunteer restoration event. During this even the volunteers planted 4,000 native shoreline plants at 5 sites. Species planted included: canna, duck potato, pickerelweed, sofrush, iris, and fire flag. The low water level at the time of the restoration event provided great conditions for the volunteers to plant deep in the soil. Most of the sites had a good survival rate.

Photo: SERV planting site.

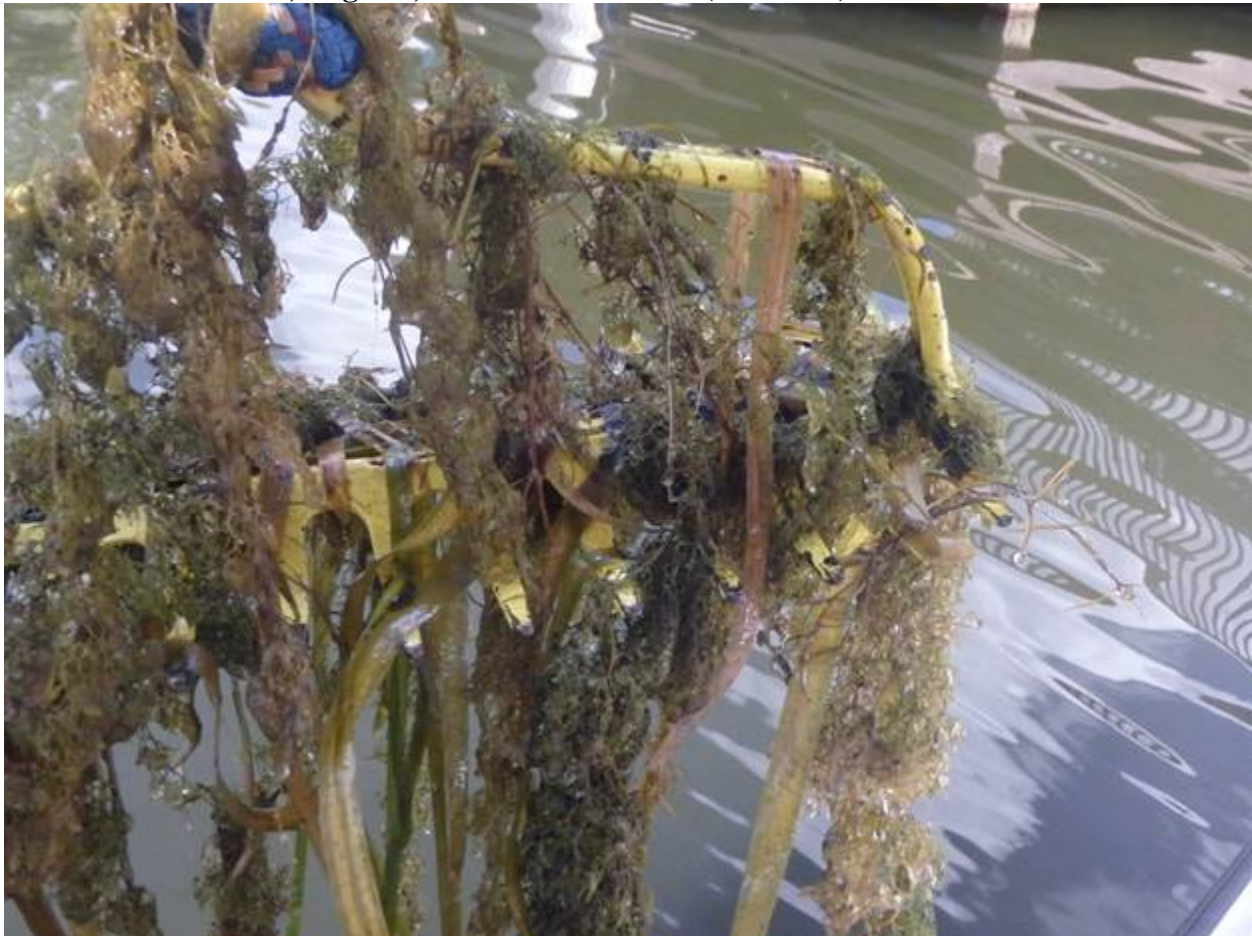
Eight species of native submersed aquatic vegetation (SAV) were observed during the inspection including: lemon bacopa, roadgrass, baby's tears to 1 ft, loose watermilfoil to 3 ft, southern naiad, eelgrass to 4 ft, and two species of bladderwort to 9 ft. These eight species provide a healthy level of biodiversity in the submersed plant communities. They also play an important role in the lakes ecosystem by reducing nutrients and providing habitat for aquatic wildlife.

Photos: Bladderwort, eelgrass, and southern naiad (all native).

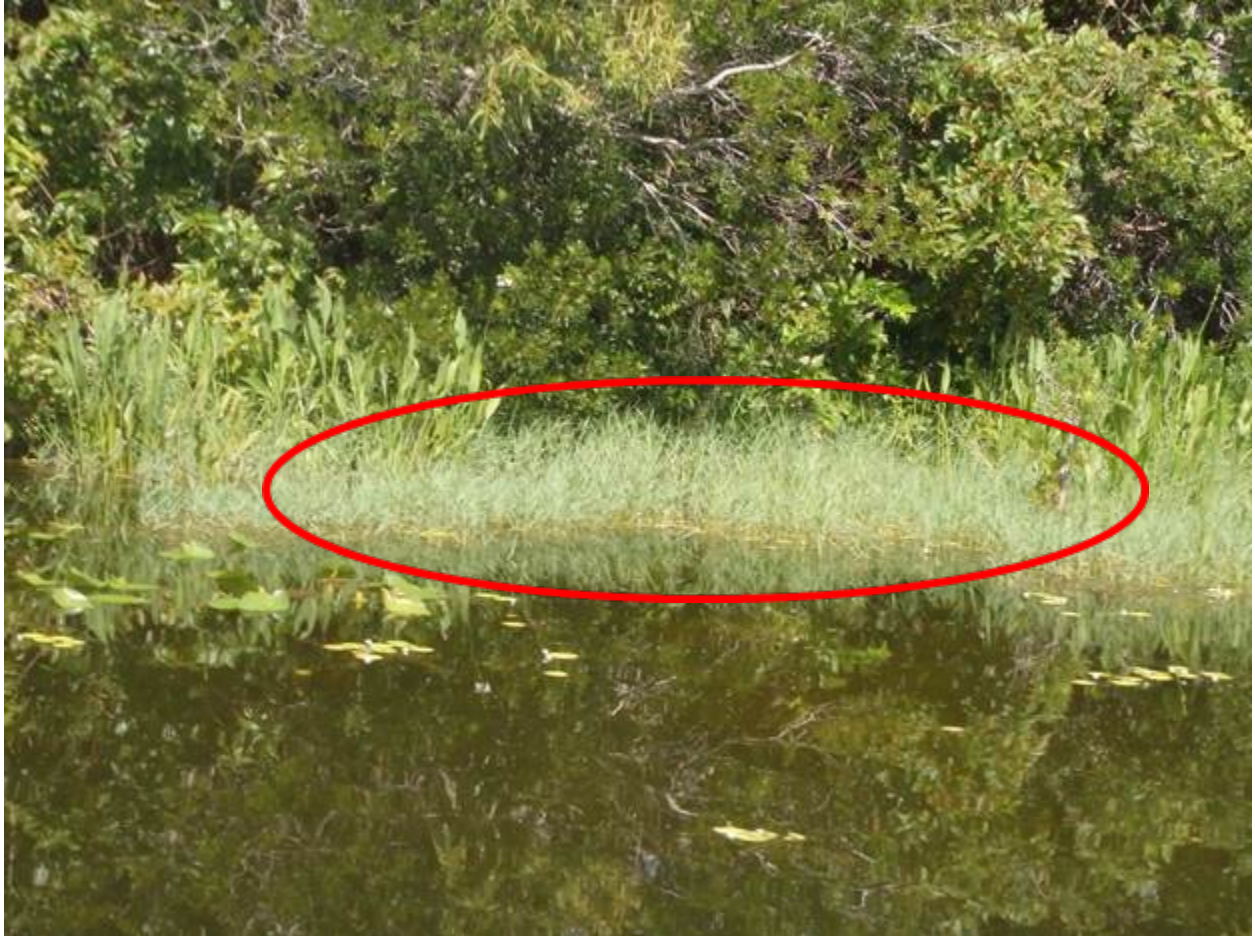
Exotic emergent vegetation observed during the inspection included: wild taro, dwarf papyrus, barnyard grass, primrose willow, torpedograss, cuban bur-head sedge, and creeping oxeye.

Photo: Torpedograss (invasive).

1 Work together or establish a lake association with other lakefront owners to control invasive plants and increase native aquatic plantings along shoreline (such as pickerelweed and duck potato). Have at least one annual lake association meeting, invite guest speakers (such as county or state biologists) and discuss lake specific issues.

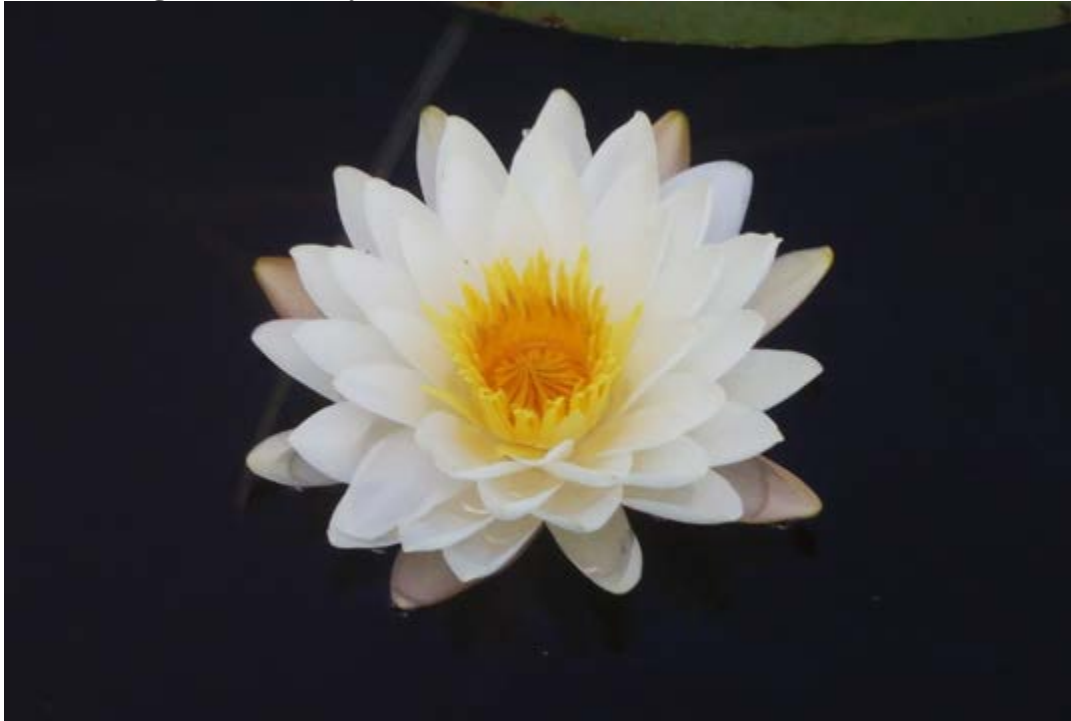
Native emergent vegetation included: canna, sawgrass, spikerush, rush furiana, pennywort, sofrush, spatterdock, fragrant water lily, banana lily, maidencane, pickerelweed, duck potato, carolina willow, bulrush, fire flag, cattail, and carolina redroot.

Photo: Fragrant water lily (native).
