Greetings Spring Lake Residents!

Bioassessments:

On **March 1st 2016**, Seminole County Lake Management staff, Thomas Calhoun and Joey Cordell, surveyed the aquatic plants in **Spring Lake**.

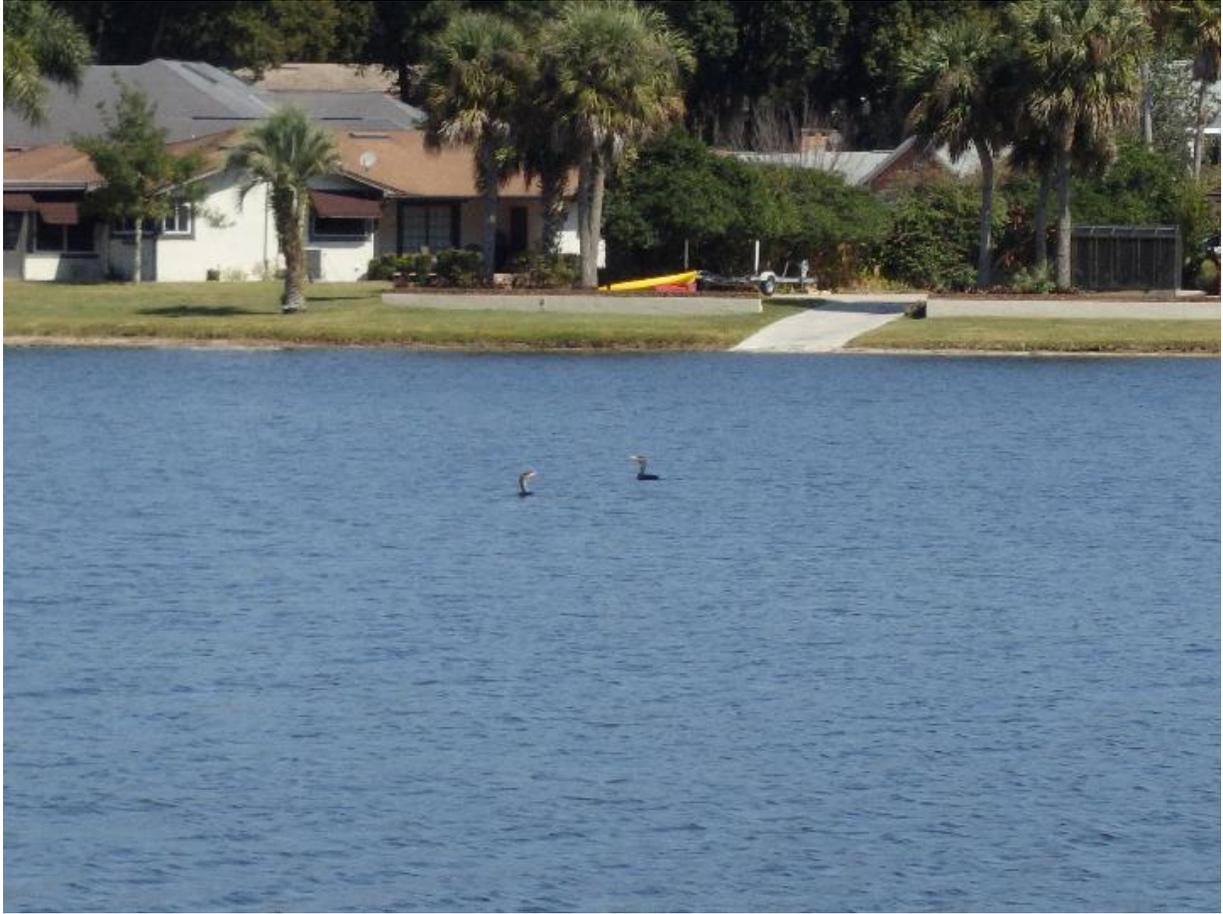
Native emergent vegetation found during the inspection included: pennywort, hempvine, yellow cow lily, fragrant water lily, pickerelweed, duck potato, bulrush, cordgrass, fire flag, cattail, and iris. Many of the shorelines in Spring Lake have little to no emergent aquatic vegetation. Emergent vegetation is important to lake systems as it acts as a filter for nutrient runoff from surrounding yards. Planting native vegetation is an easy and effective way to improve the water quality of the lake. It is also effective at reducing shoreline erosion.

Photo: Example of shoreline without vegetation.

1. Work together with other lakefront owners. Have *at least* one annual lake association meeting, invite guest speakers (such as county or state biologists), and discuss lake specific issues, especially nutrients/lake management recommendations. SCLMP staff will be glad to present our findings from this and other surveys. Continue to increase native aquatic plantings along shorelines (such as pickerelweed, duck potato, and canna).

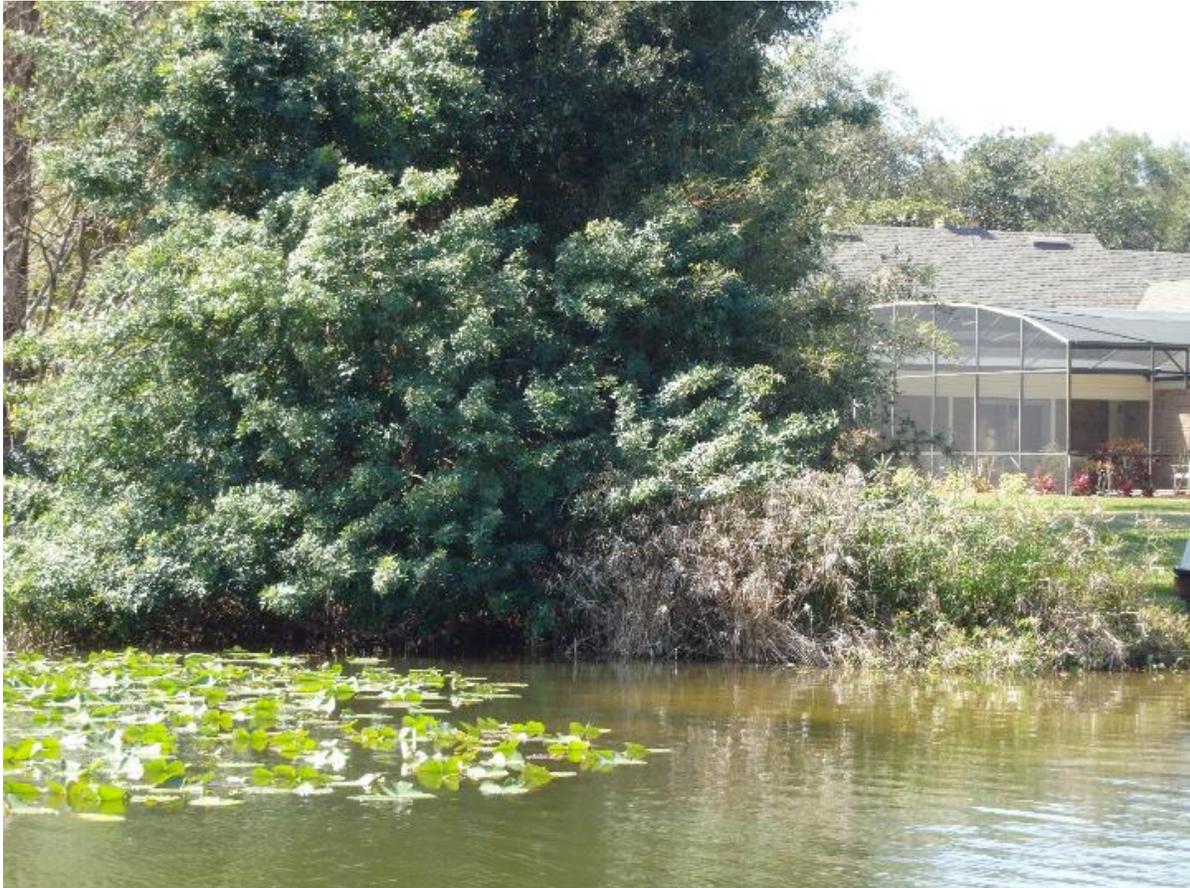
A minimal amount of invasive emergent vegetation was found during the inspection. Invasive emergent species observed during the inspection included: alligator weed, wild taro, primrose willow, Chinese tallow, Brazilian pepper tree, and creeping oxeye.

Photo: The invasive Brazilian pepper tree.

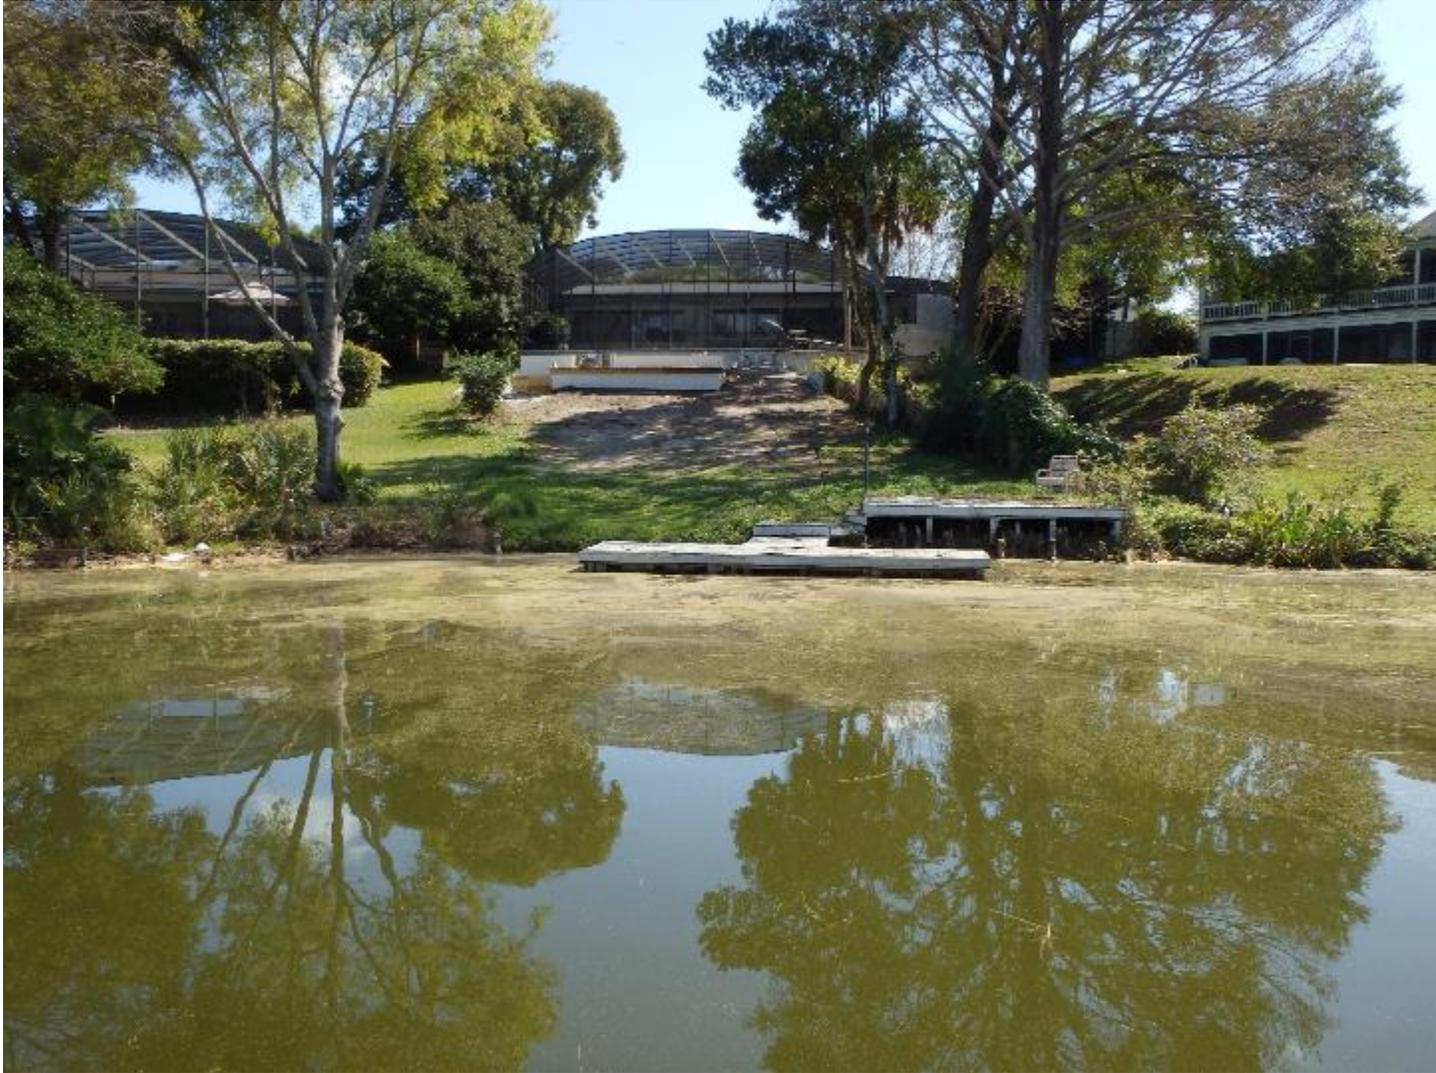
The water elevation at the time of the inspection was 63.07 feet above sea level. The secchi reading (measurement for water clarity) was 3.9 feet in a total depth of 12.0 feet. Two grass triploid (sterile) carp fish were observed during this inspection. An algae bloom was also present on the south east side of the lake.

Photo: Algae bloom.

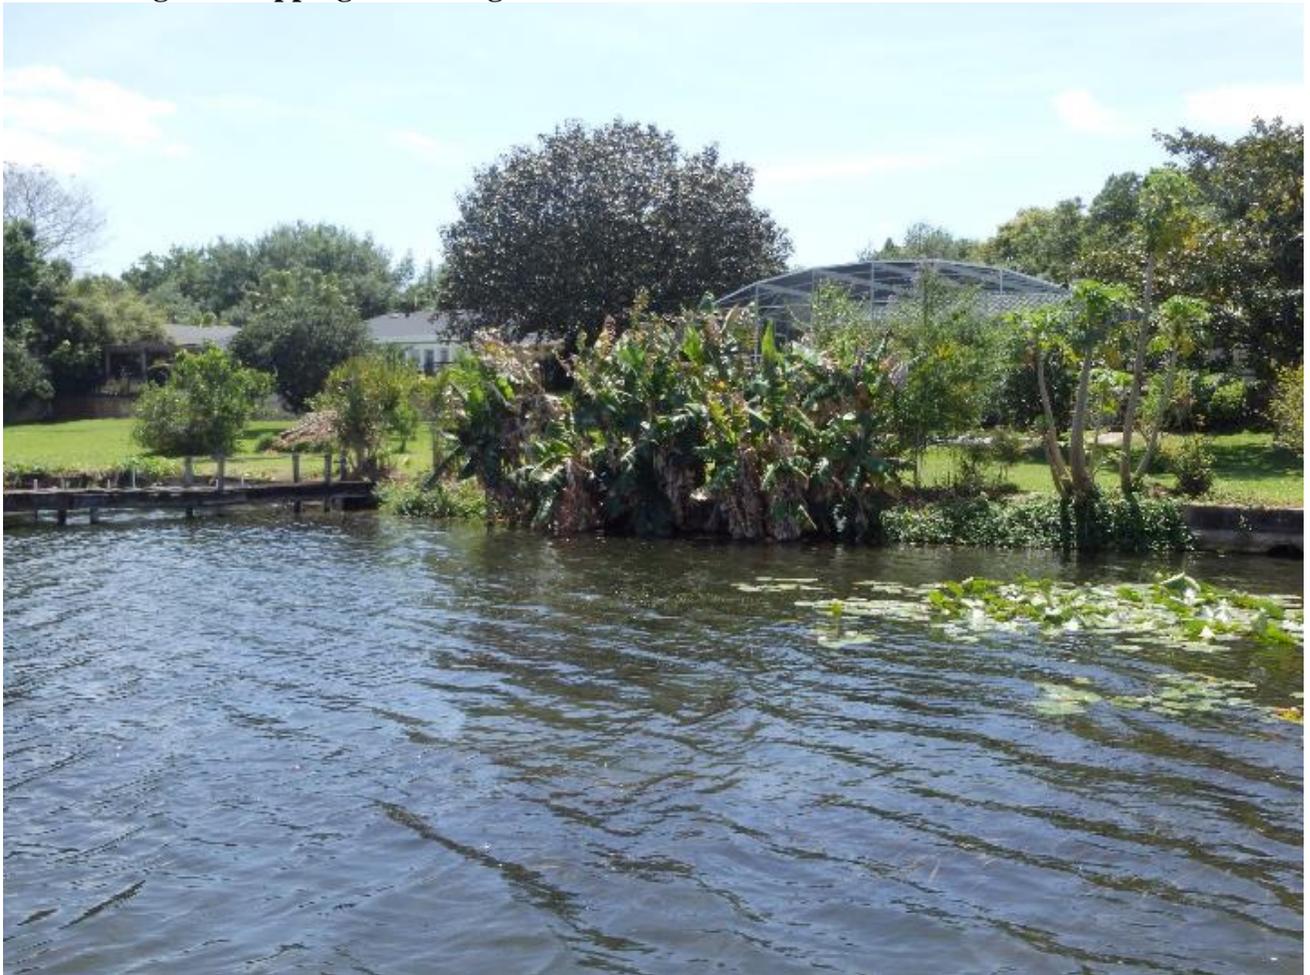
Eelgrass was the dominant SAV and was found to a maximum depth of 4.0 feet; this species was found “topping out” (reaching the surface) in depths less 1.5 feet. This was an increase in depth of 3.5 feet from the previous inspection. Southern naiad was not found during this inspection. Access corridors were open and in good shape. No hydrilla was observed during the inspection.

Photo: Eelgrass “topping out” along the shoreline.

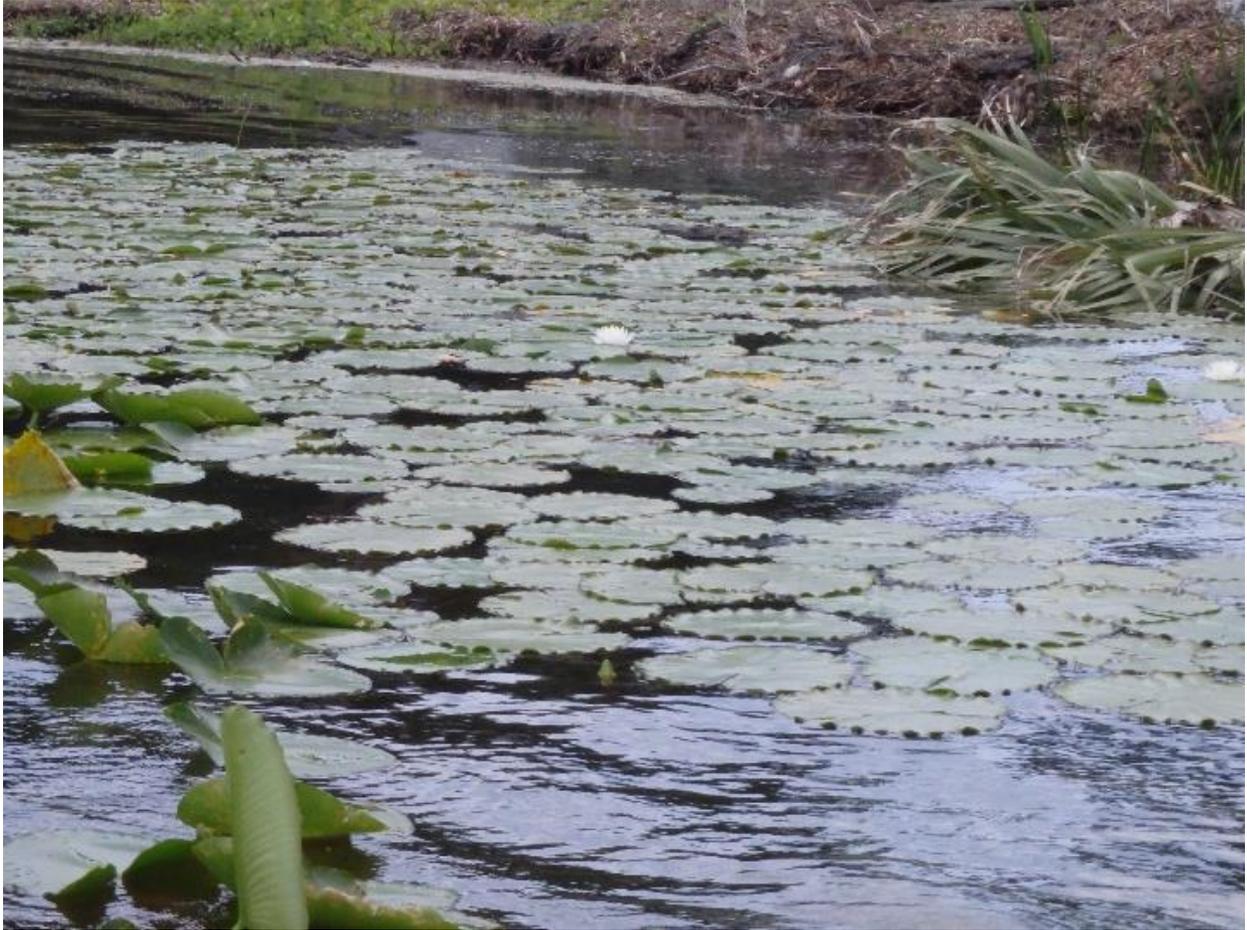
Photo: Fragrant water lily.

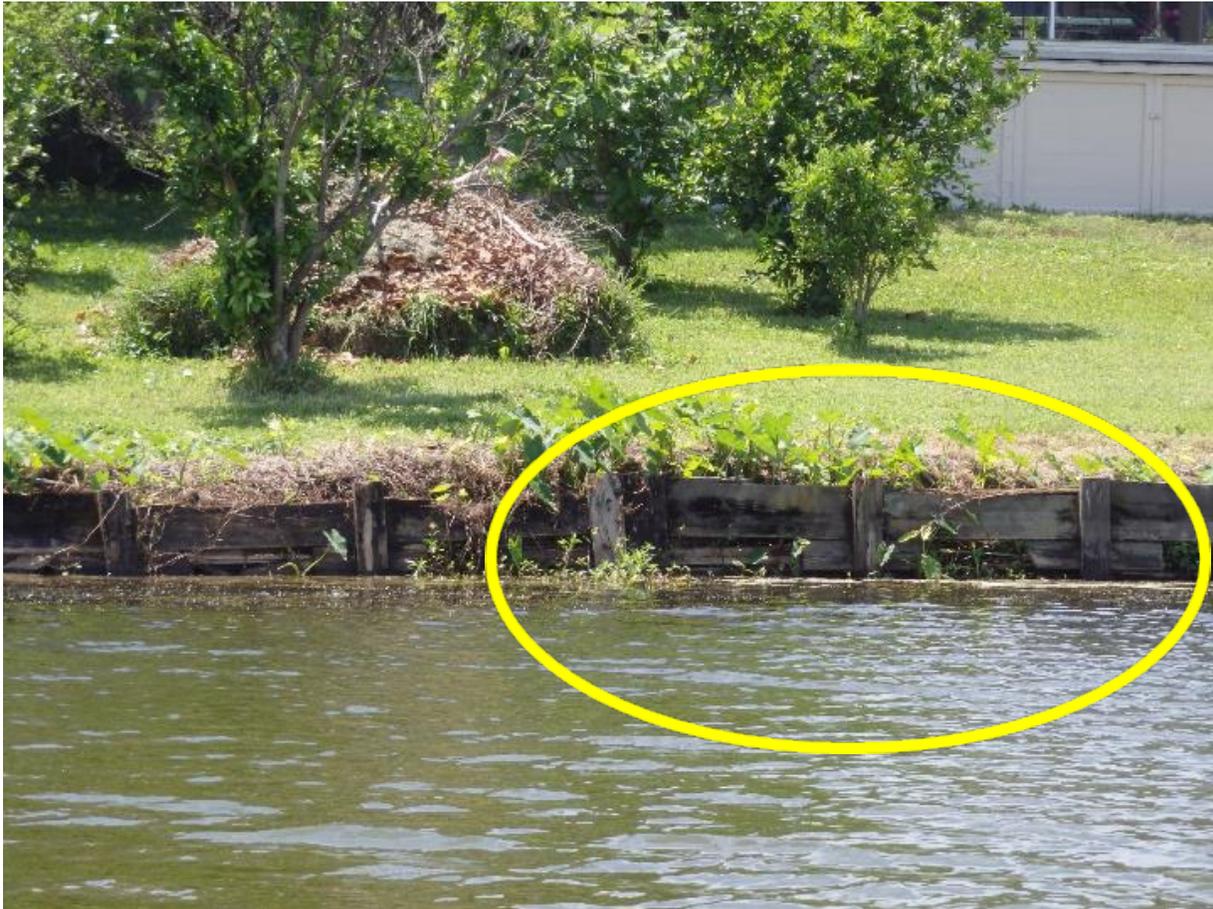
A minimal amount of invasive emergent vegetation was again found during this inspection; this was a positive effect of the MSBU-funded herbicide maintenance program. Invasive emergent vegetation observed during the inspection included: alligator weed, wild taro, primrose willow, torpedo grass, Chinese tallow, Brazilian pepper tree, and creeping oxeye.

Photo: Invasive emergent vegetation wild taro.

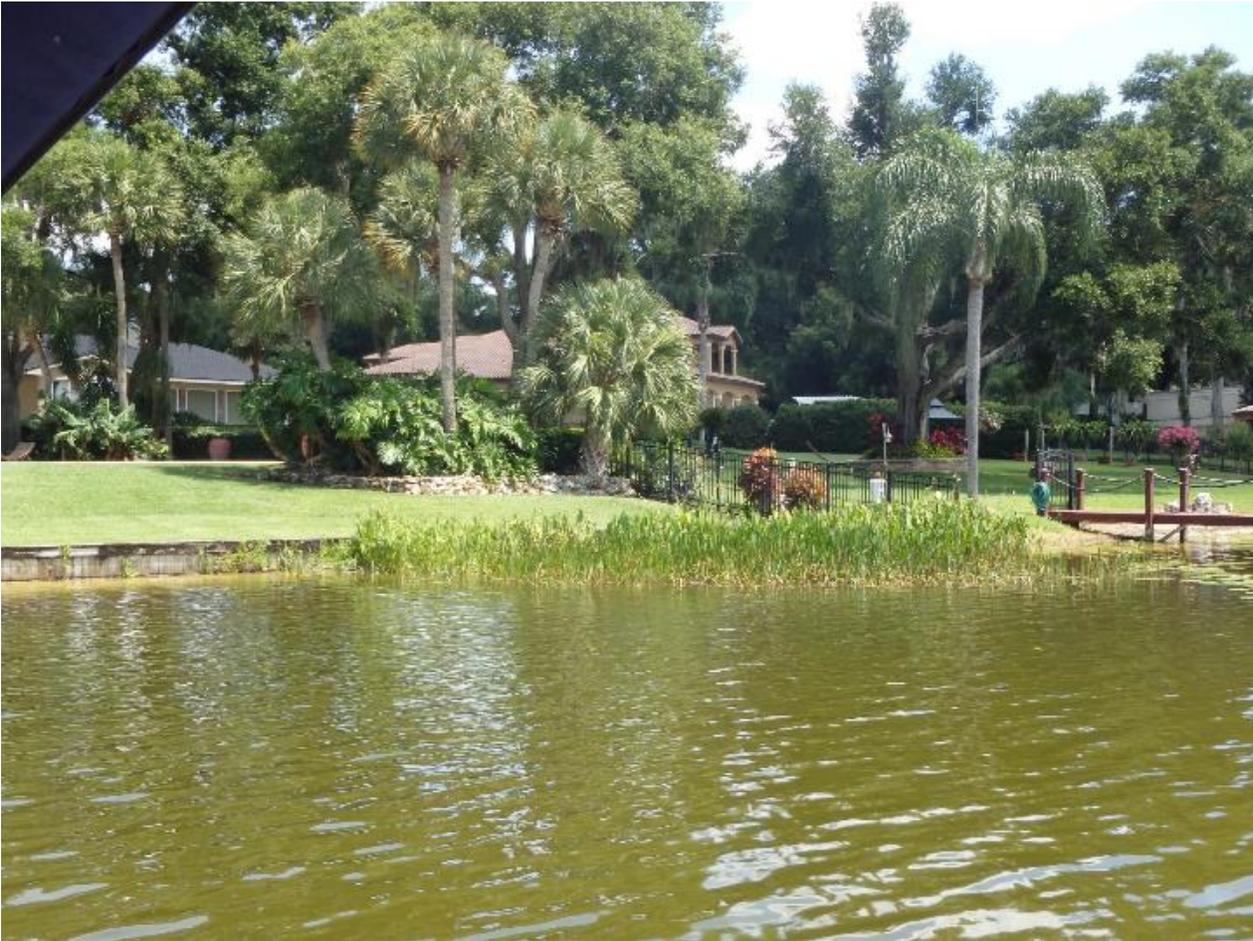
Photo: Stand of native emergent duck potato and pickerel weed.

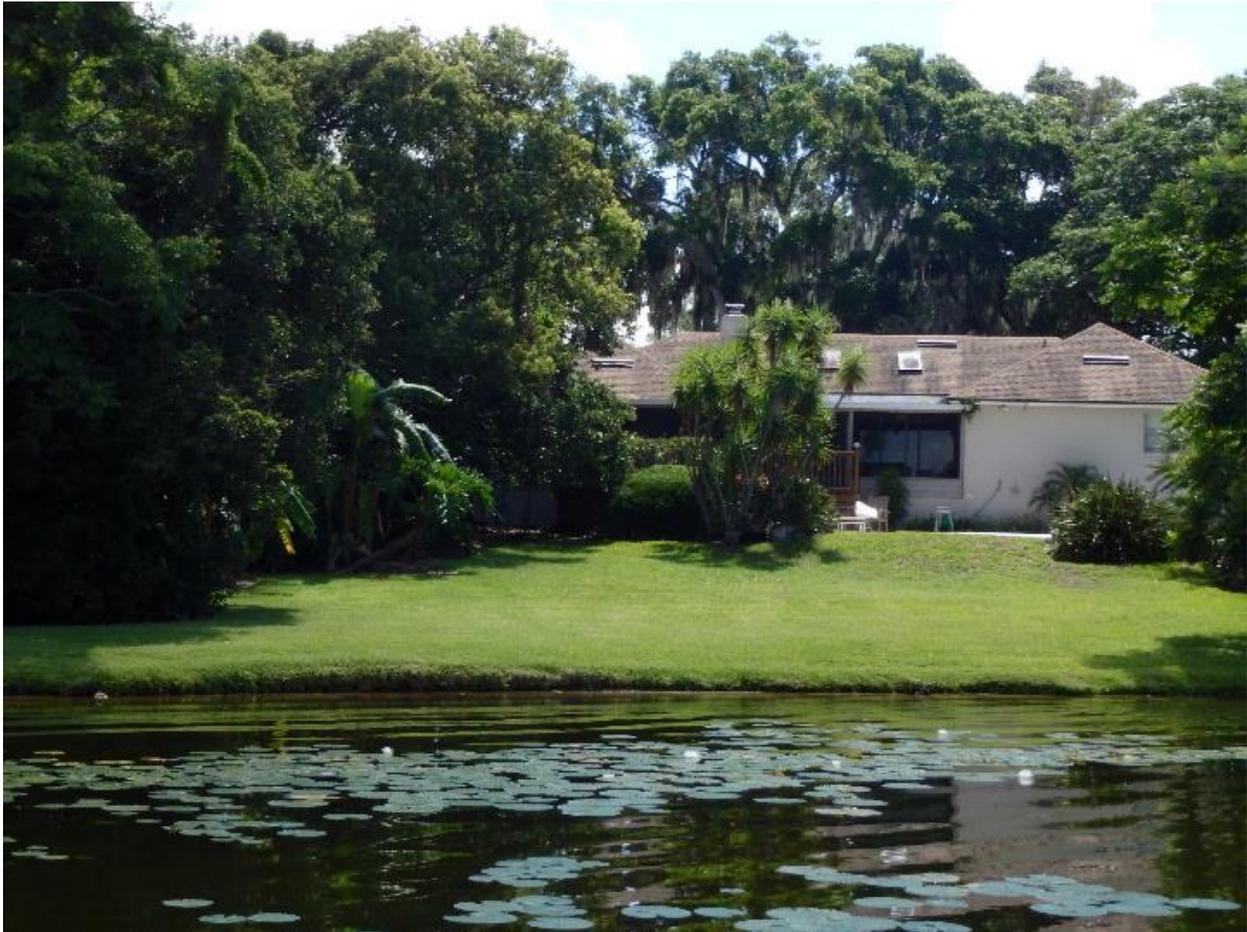
Native emergent vegetation found during the inspection included: pennywort, yellow cow lily, fragrant water lily, pickerelweed, duck potato, bulrush, cordgrass, fire flag, cattail, rush-fuirena and iris. Many of the shorelines in Spring Lake have little to no emergent aquatic vegetation. Emergent vegetation is important to lake systems as it acts as a filter for nutrient runoff from surrounding yards. Planting native vegetation is an easy and effective way to improve the water quality of the lake. It is also effective at reducing shoreline erosion.

Photo: Example of shoreline without emergent vegetation.
