**SPRINGWOOD WATERWAY**  
**DECEMBER 2014 & MARCH 2015 - LAKE BIOASSESSMENT**

On **December 2<sup>nd</sup>, 2014**, Seminole County Lake Management Program (SCLMP) staff (Thomas Calhoun, Marie Lackey and Sophia Pengra) surveyed the aquatic plants of **Springwood Waterway**.

On **March 16<sup>th</sup>, 2015**, Seminole County Lake Management Program (SCLMP) staff, Thomas Calhoun and Beth Stephens, surveyed the aquatic plants of **Springwood Waterway**.

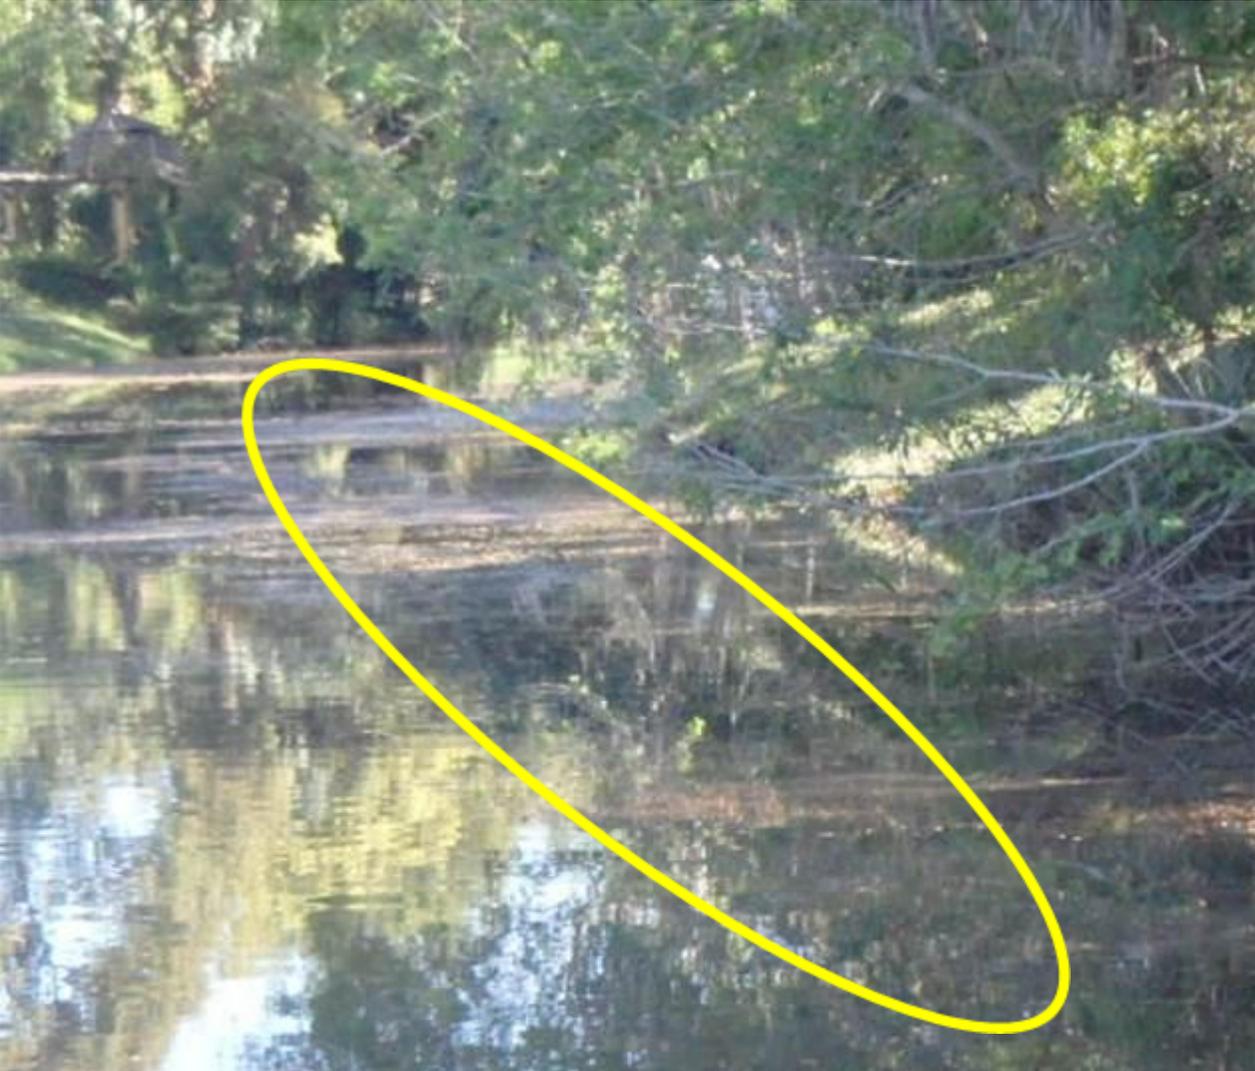
Native SAV, lemon bacopa, continues to expand along the majority of the banks within the waterway and is reaching the surface in many areas. Native SAV found included: roadgrass, stonewort, southern naiad, and 2 types of bladderwort. Southern naiad is covering the back half of the canal creating competition for space with hydrilla. The water elevation was noted as high. Harvesting is not necessary at this time as access was open and navigable.

**Photo: Lemon bacopa in canal.**

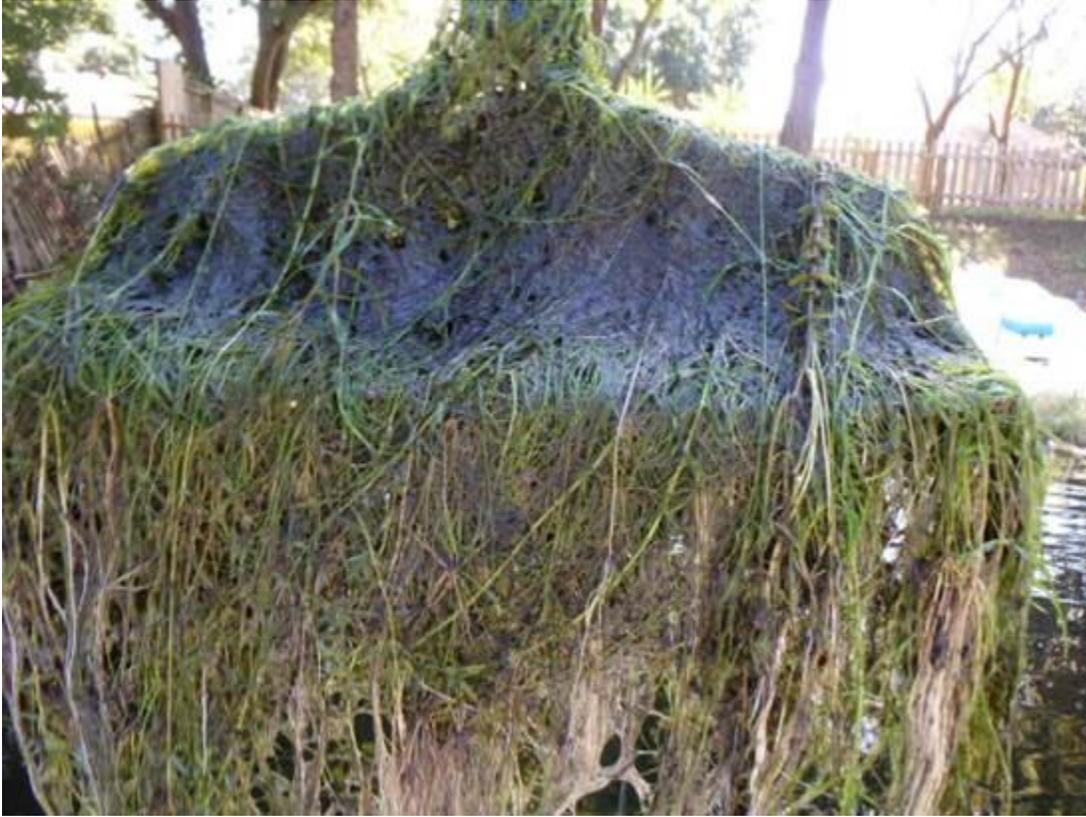
**Photo: Close up of southern naiad.**

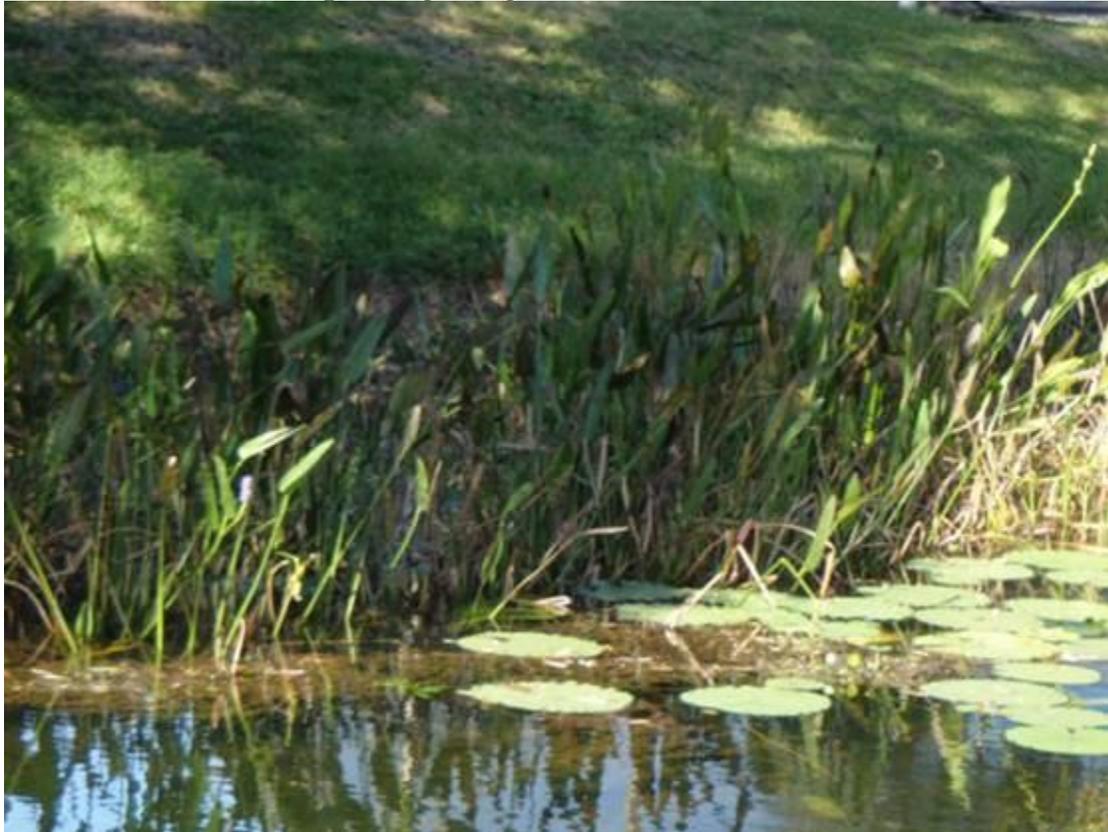
Native emergent vegetation continues to be found in good condition, and expanding. Less torpedo grass was found than in the previous months.

**Photo: Pickerelweed expanding along the shoreline.**

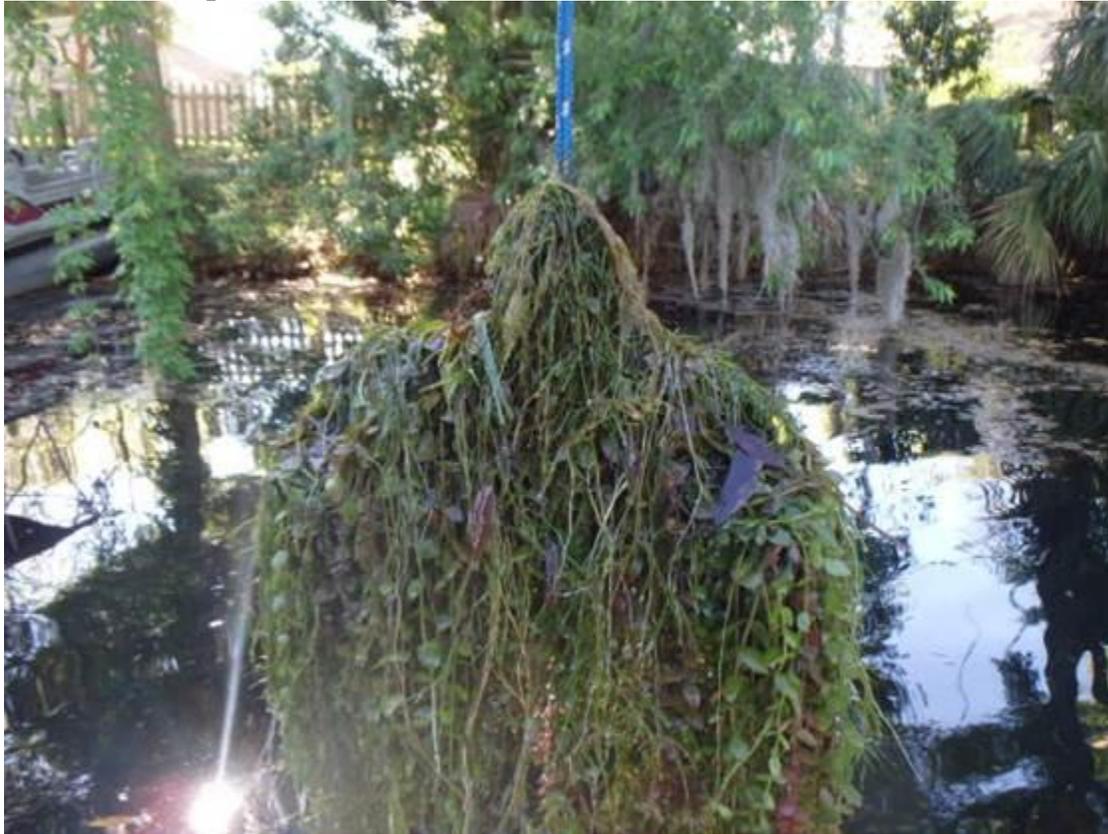
Lemon bacopa, a beneficial native plant, continues to expand along the majority of the banks within the waterway and is reaching the surface in many area of the canal. Homeowners are encouraged to remove lemon bacopa if blocking their access to the canal. Native SAV found included: lemon bacopa, roadgrass, stonewort, southern naiad, and 2 types of bladderwort. The water elevation was observed as high. Mechanical harvesting is not necessary at this time.

**Photo: Close up lemon bacopa.**

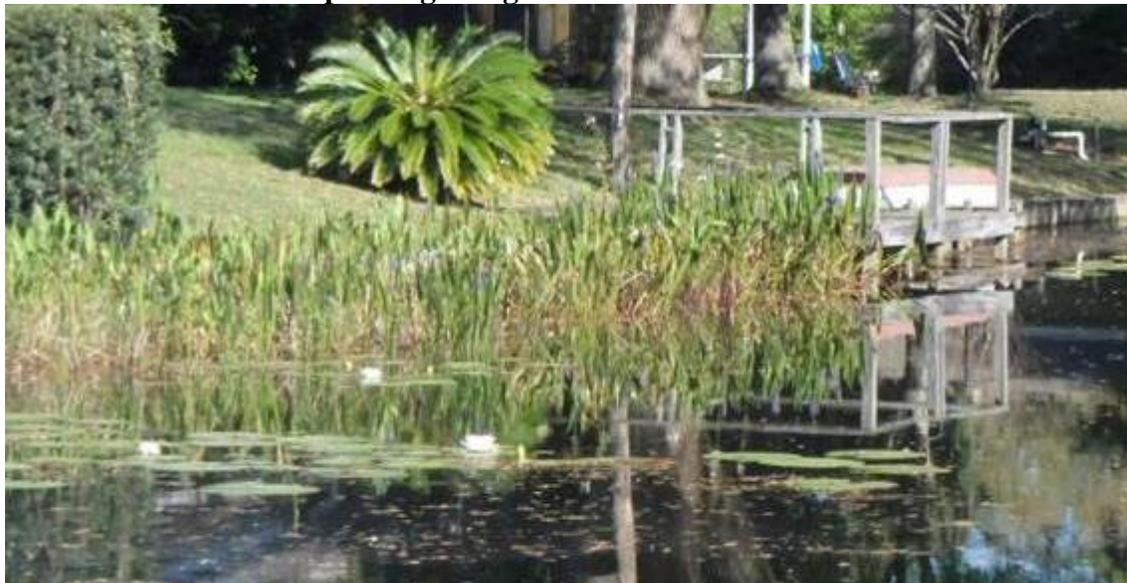
Native emergent vegetation continues to be found in good condition, and expanding. Less torpedo grass was found than in the previous months.

**Photo: Pickerelweed expanding along the shoreline.**

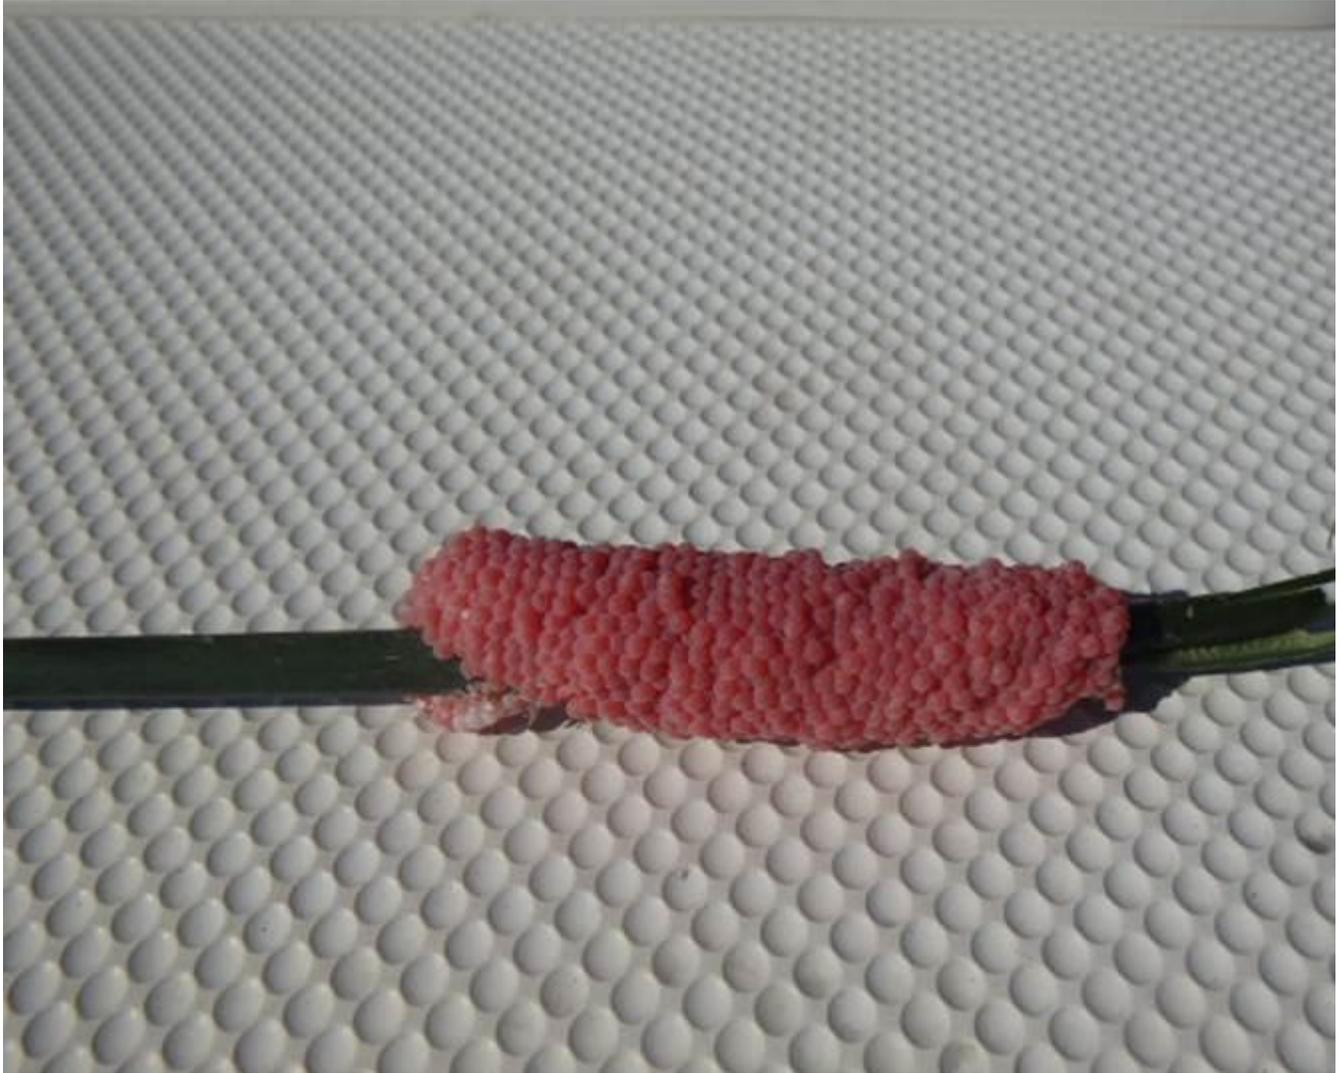
An increasing amount of exotic apple snail eggs are being found within the waterway. It is recommended that the eggs are crushed and allowed to fall in the water.

**Photo: Close up of exotic apple snail eggs.**
