HORSESHOE LAKE BIOASSESSMENT
OCTOBER 2014

On **October 14th, 2014**, Seminole County Lake Management Program and Water Quality Program personnel, Marianne Pluchino and Gloria Eby, surveyed the aquatic plants in Horseshoe Lake North.

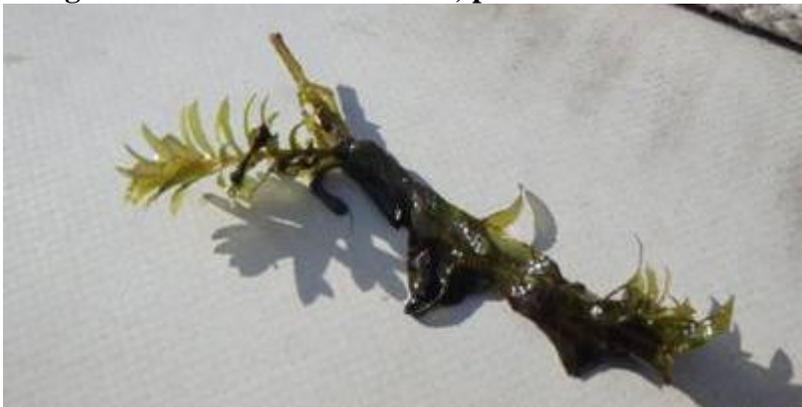
One sprig of the invasive SAV **hydrilla** was found in less than 1 foot of water along the northeast shoreline during this inspection. Hydrilla reproduces from stem fragments, buds, and tubers (potato like seeds). Tubers and turions are deposited by the plant into the sediment and are used to perennialize the plant as a means of propagation (re-growth). Tubers and turions can remain viable for many years; one square meter of hydrilla can produce 5,000 tubers. We will continue to monitor the inshore areas of the lake to enable rapid response to new hydrilla growth.

Photo: Hydrilla found along the north eastern shoreline; plant was hand removed from lake.

There are many ways to manage hydrilla. These include: chemical treatment, grass carp fish, mechanical removal, water draw down, and hand removal. The current amount of hydrilla only warrants hand removal. Hydrilla sprigs, when found, should be pulled out by hand, ensuring you get the root crown and entire stalk without breakage. Currently we have carefully hand removed the sprigs we have personally observed. More information on hydrilla can be found at: <http://plants.ifas.ufl.edu/node/183>.

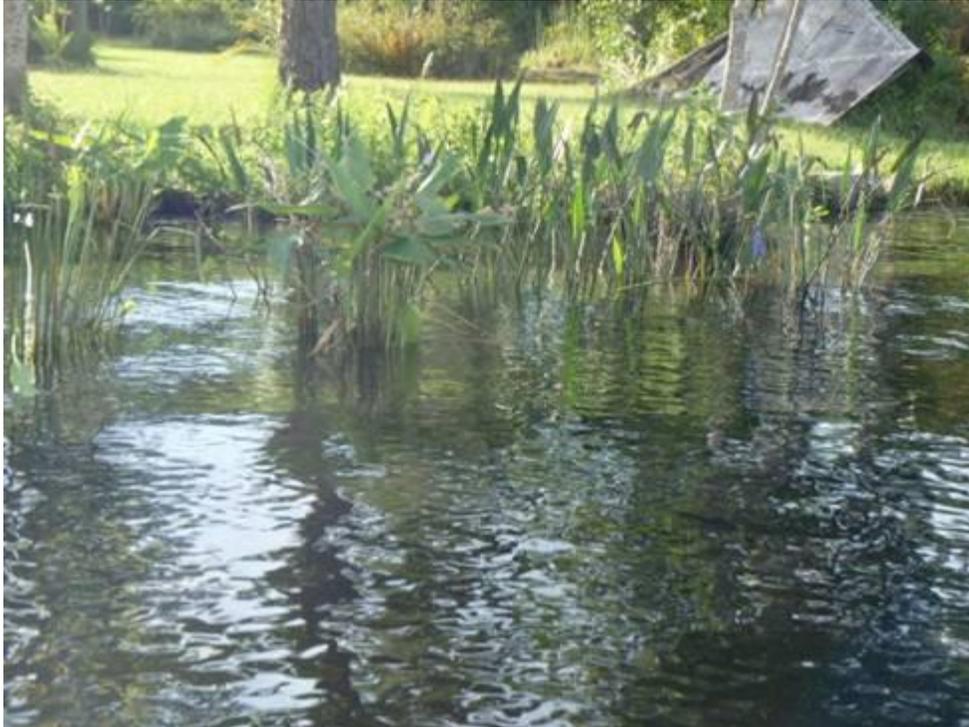
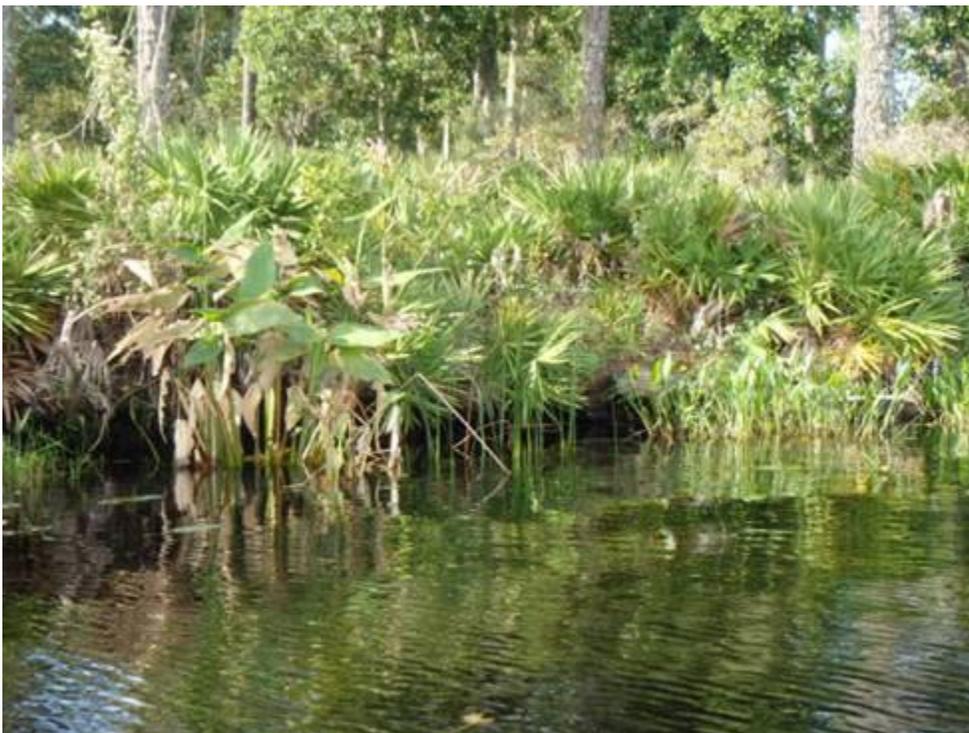
Baby's tears, a beneficial SAV species, was found to a depth of 2 feet. A small patch of eelgrass was observed in 1 foot of water. Native emergent vegetation observed during the inspection included: button bush, sawgrass, flat sedge, pickerelweed, canna, fire flag, duck potato, bulrush, lizard tail, and maidencane. The planted maidencane and pickerelweed from the August 16th restoration event is establishing well around the lake. A complete loss of plants has occurred at one site location, likely due to wind/wave action as these plants were planted in deeper water.

Photos: Planting locations performing well!

2 Continue to establish a beneficial native shoreline for Horseshoe Lake North, especially in locations that are devoid of emergent aquatic plants. Given that some plants are stressed, or did not survive from the previous planting session, the planting of native species should continue until successful establishment is achieved. SCLMP recommends planting in new locations that are shallower and have more sunlight.

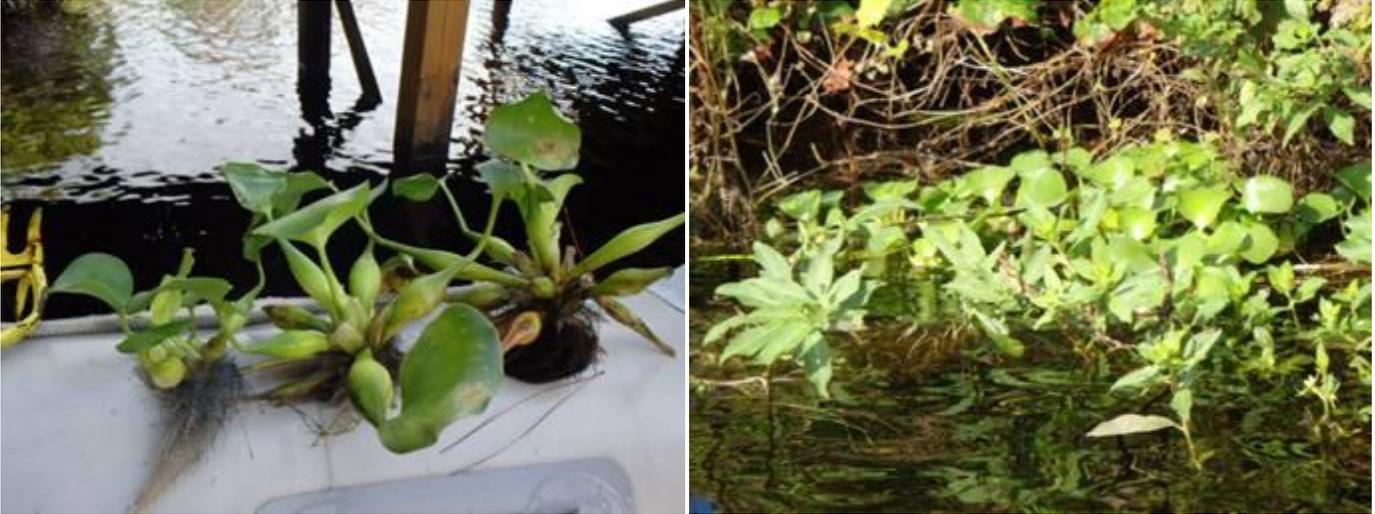
Water hyacinth, now coined one of the worst floating weeds in Florida, was noted mainly along the west shoreline of the lake of which was targeted the October treatment. A new publication on this plant can be found at: <http://edis.ifas.ufl.edu/pdffiles/AG/AG38500.pdf>.

Photo: Water Hyacinth (with daughter plants).

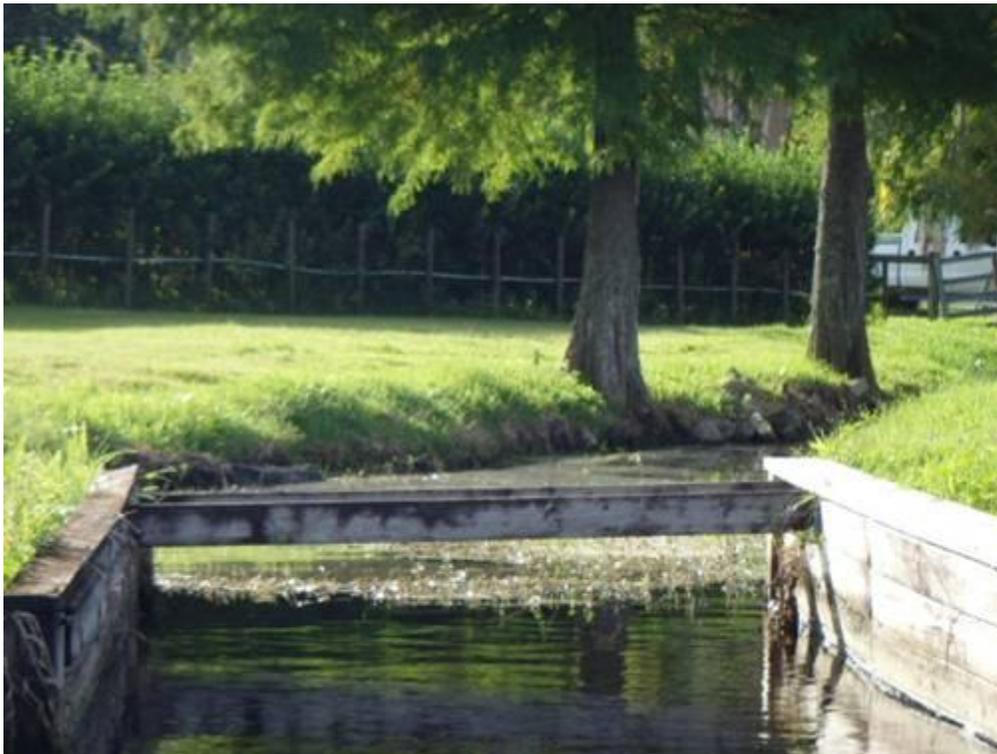
The 8th Street Canal continues to be routinely treated for alligatorweed, torpedo grass, and salvinia.

Photo: 8th Street Canal.
