Greetings Mirror Lake Residents,

Please find the latest bioassessment report for your lake below. Key highlights of this update include:

On **March 16th, 2016**, Seminole County Lake Management staff, Thomas Calhoun and Joey Cordell, surveyed the aquatic plants in **Mirror Lake**.

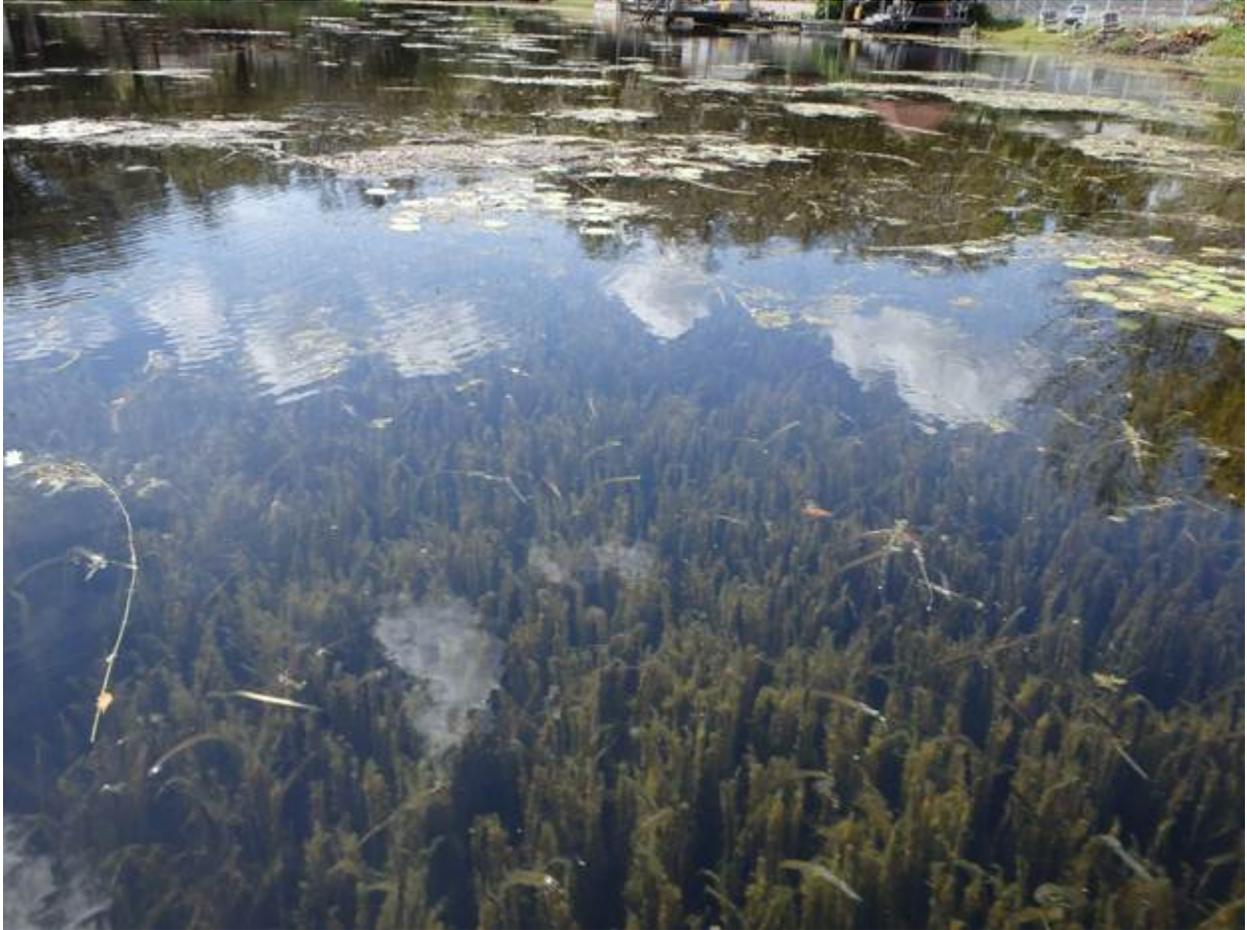
Five species of native submersed aquatic vegetation (SAV) were found during the inspection. These native species included: lemon bacopa to 3 feet, eelgrass to 4 feet, and three species of bladderwort to 7 feet. Eelgrass has increased around the boat ramp and the canal. Also lemon bacopa was noted as expanding in the shallow areas around the lake. In the southern lobe of the lake bladderwort is returning from last year's treatment. Access corridors remain open. We will continue to monitor to see if any submersed treatments will be needed in this area.

Photo: Eelgrass.

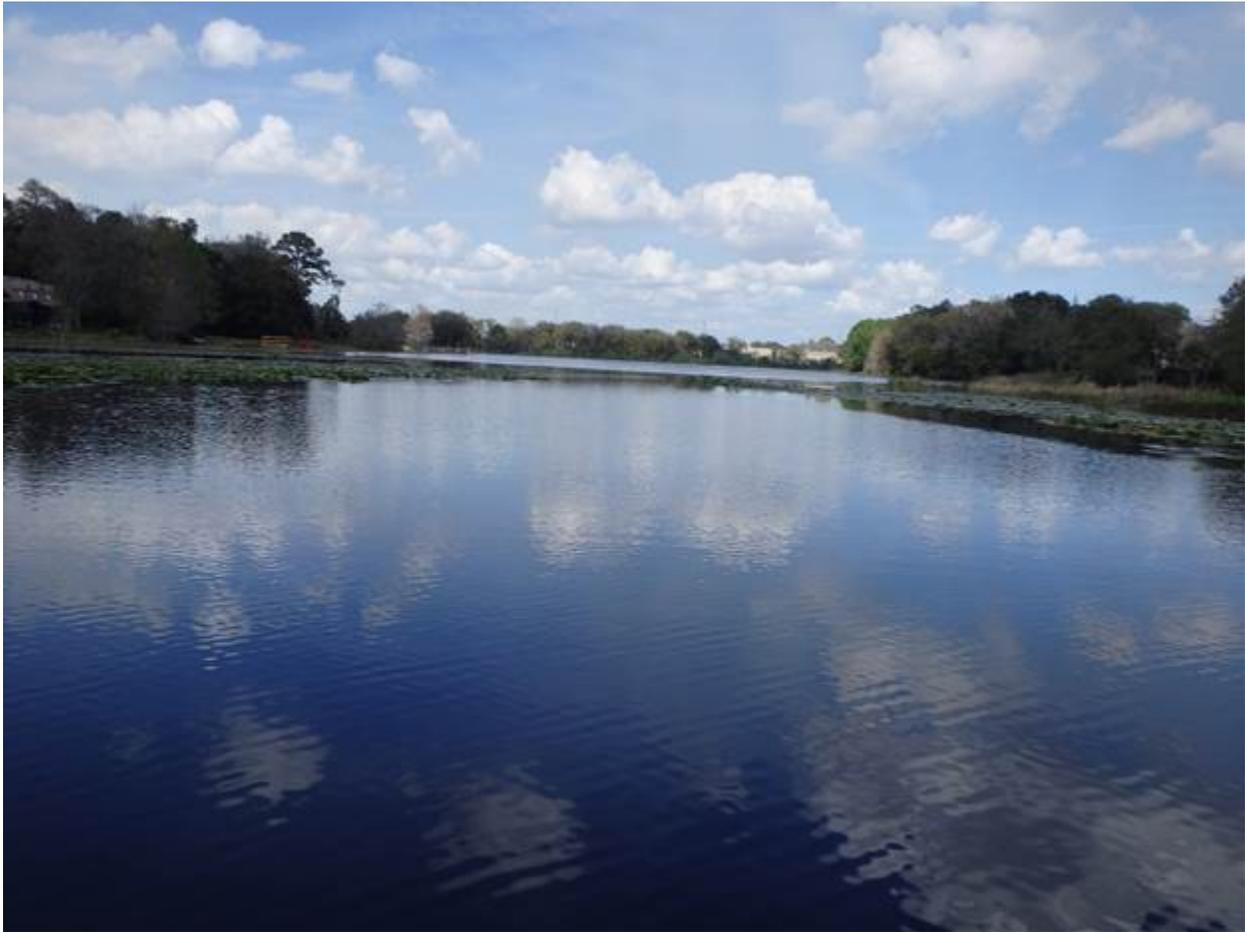
Invasive emergent vegetation included: alligator weed, wild taro, primrose willow, torpedo grass, brazilian pepper tree, cuban bur-head sedge, and creeping oxeye.

Photo: Southeast corridor.

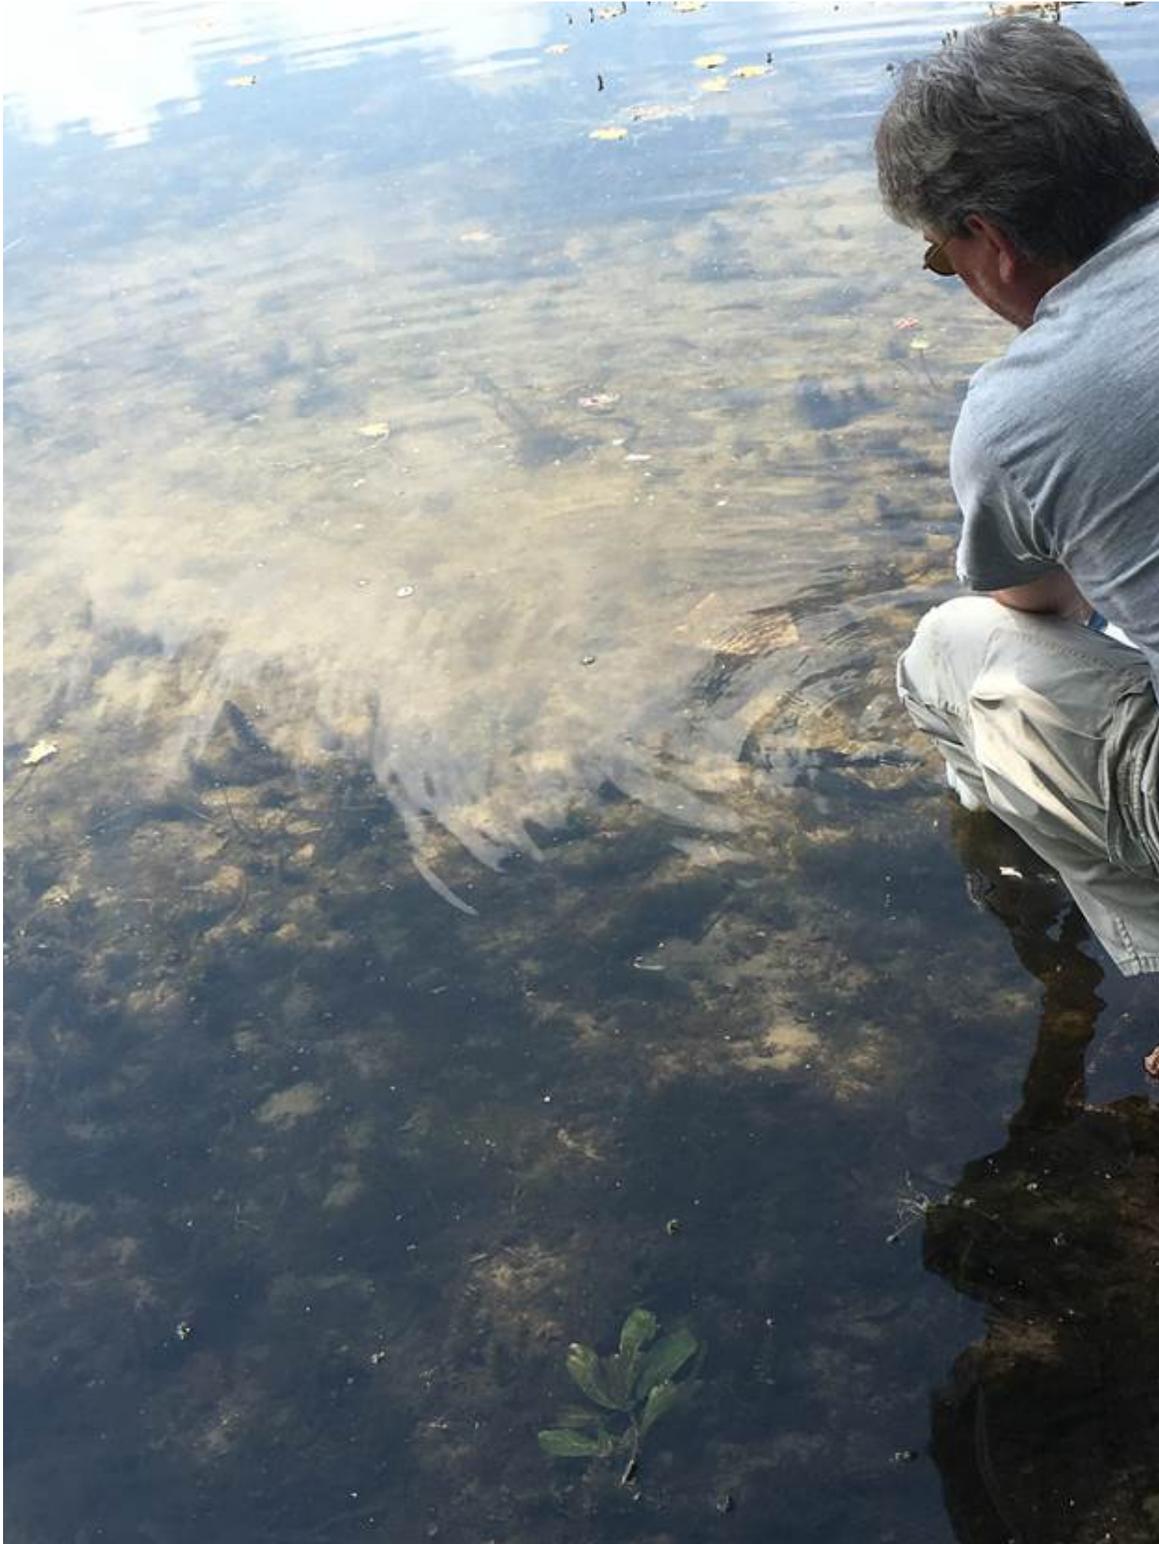
Hydrilla was found at the community boat ramp in small amounts during the survey. Triploid (sterile) grass carp were stocked April 14th.

Photo: Triploid (Sterile) grass carp being released into Mirror Lake.

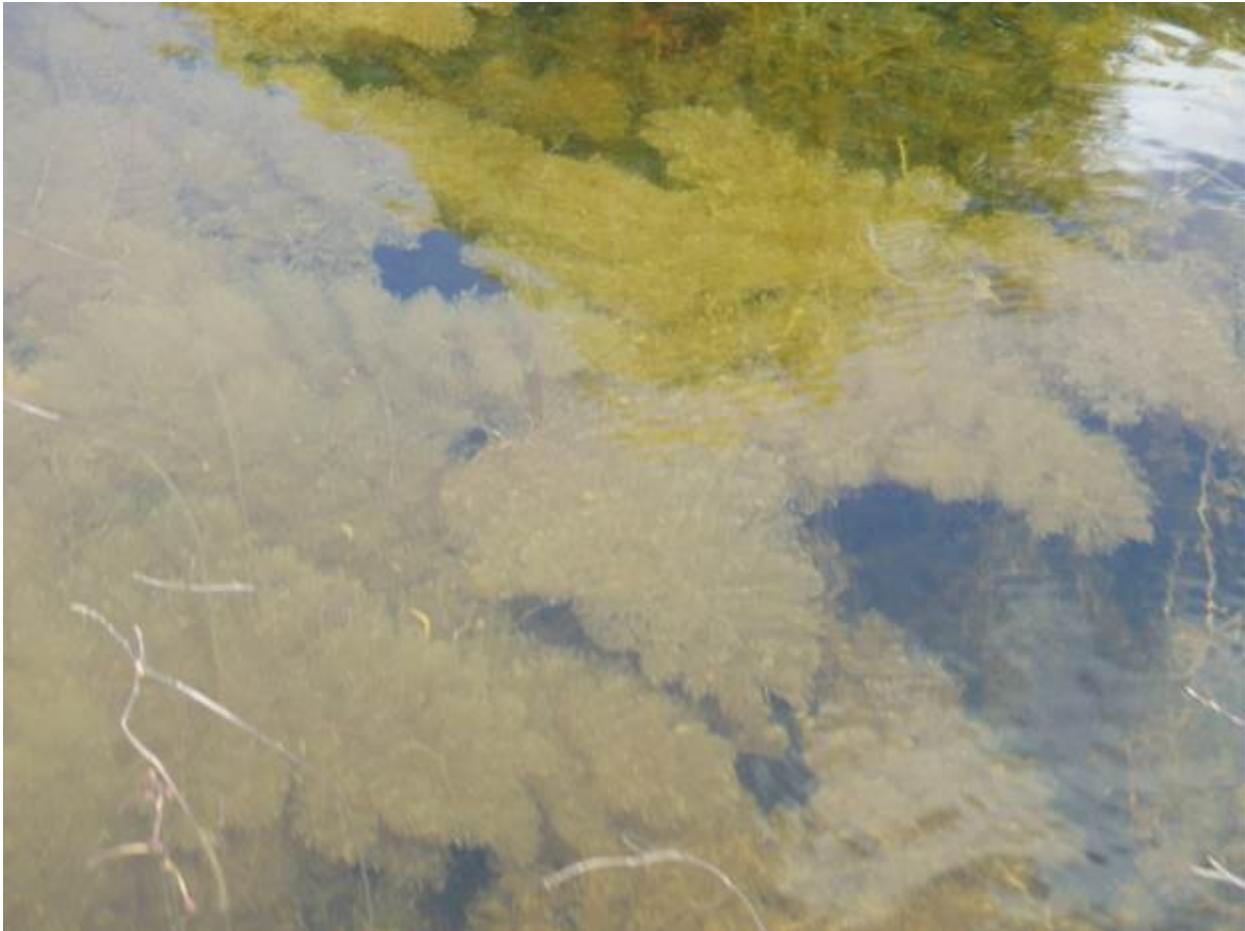
Native species of submersed aquatic vegetation (SAV) have increased around the lake. Eight species of (SAV) were found during the inspection. These native species included: lemon bacopa to 3 feet, stone wort to 6 feet, southern naiad to 6 feet, road grass to 2 feet, eelgrass to 4 feet, and three species of bladderwort to 9 feet. The recent stocking of grass carp will help manage the expansion of these species. Herbicide treatments for SAV in the access corridors will be used as needed.

Photo: Bladderwort.

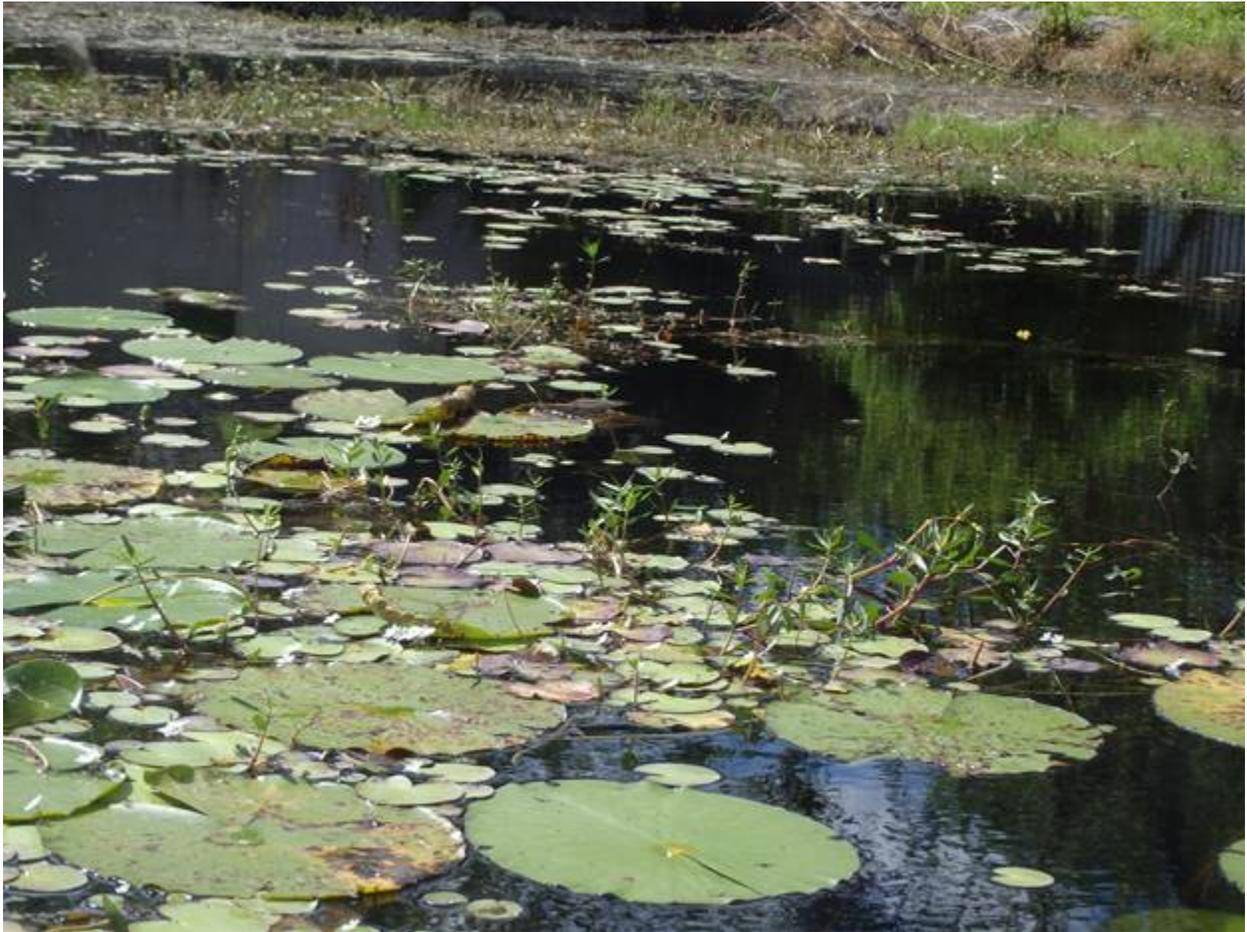
Native emergent vegetation found during the survey included: golden canna, spike-rush, yellow cow lily, fragrant water lily, American lotus, banana lily, maidencane, pickerelweed, duck potato, carolina willow, cordgrass, fire flag, cattail, and climbing aster. The water lilies are expanding in the shallow areas of the lake. Water lilies will be targeted during the next herbicide treatment to keep access corridors open.

Invasive emergent vegetation included: alligator weed, wild taro, primrose willow, torpedo grass, brazilian pepper tree, cuban bur-head sedge, and creeping oxeye. Alligator weed was found expanding in the southern lobe of the lake. This species will also be targeted during the next herbicide treatment.

Photo: Water lilies and alligator weed expanding in the southern lobe.
