# SEMINOLE COUNTY TRAILS & GREENWAYS SAFETY IMPROVEMENT PLAN

SEMINOLE COUNTY, FL

May 2022

Prepared by:  
**Kittelson & Associates, Inc.**  
225 East Robinson Street, Suite 355  
Orlando, FL 32801  
407.540.0555

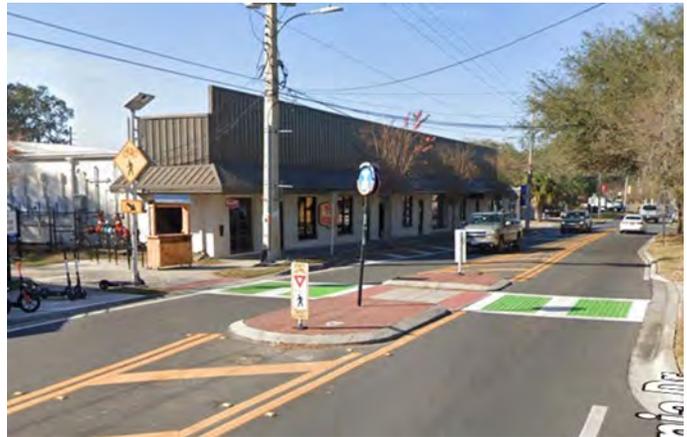
Figure 1 Dinky Line Intersection

- The City does use a series of bollards, flexposts, and slow zones for shared micro-mobility for traffic calming, but there are no established guidelines.
- The Dinky Line Trail in Orlando exhibits organized wayfinding signage and infrastructure that could be aspirational to Seminole County. One such piece of equipment is improved bike bars at major intersections.
- The Dinky Line Trail also provides bulbouts on certain streets in combination with RRFBs to stop traffic when actuated.
- The City has implemented high-visibility crosswalks in certain areas/trail crossings to highlight the crossing area, seen in Figure 1.

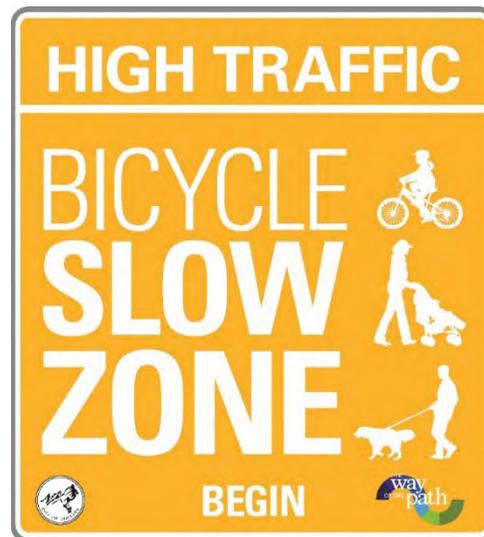
Figure 2 Boulder Trail Sign

- The City relies primarily on peer enforcement to ensure those using the trail are complying with the rules. Named *The Way of the Path*, these rules are expressed in a series of wayfinding signs- seen in Figure 2.
- The City does not have a codified standard for trail design, but they do adhere to certain design standards:
  - Splitting walk and bike modes at major intersections and activity centers;
  - Rectangular Rapid Flashing Beacons (RRFBs) for all mid-block crossings;
  - Soft-scaping and hardscaping color differentiation;
  - Differing standards for residential vs. commercial areas; and
  - Dismount zones for skateboarders and cyclists.
- It was also emphasized that the effectiveness of communication should be center to any signage used (i.e. stating what to do vs. what not to do)

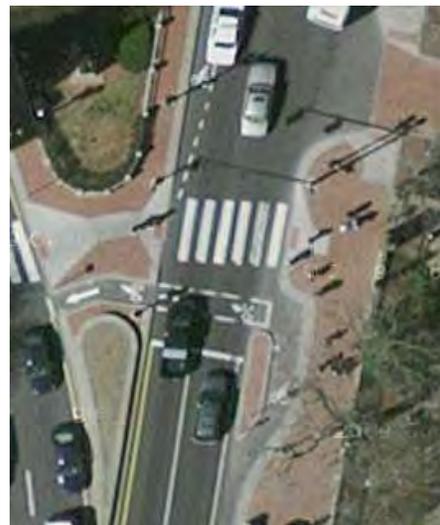
Figure 3 Jug Handle Intersection

- Jug Handle intersections have been piloted in the City to divert trail traffic at intersection corners to avoid crowding and improve cyclist movements. The example in is in Figure 3 from Cambridge, MA;

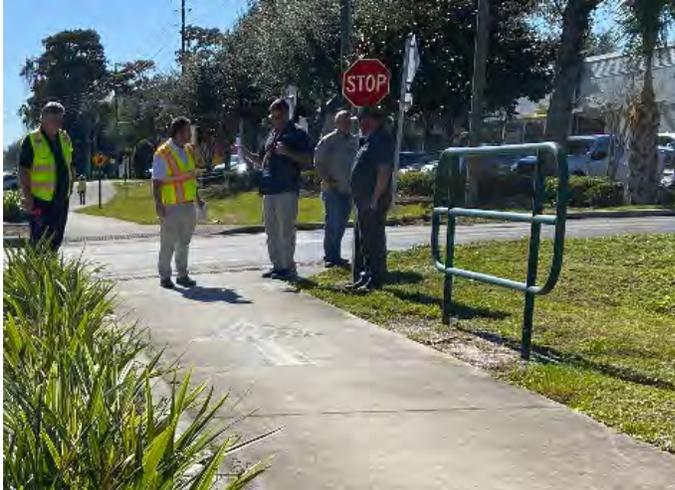
Figure 6 Bike Bar for Cyclists near Stop Sign

At certain locations, trail users are expected to stop at the stop bar located at the trail stop sign prior to entering into an intersection. A bike bar, featured in Figure 6, is provided to encourage cyclists to stop without dismounting, using the bike bar as support.

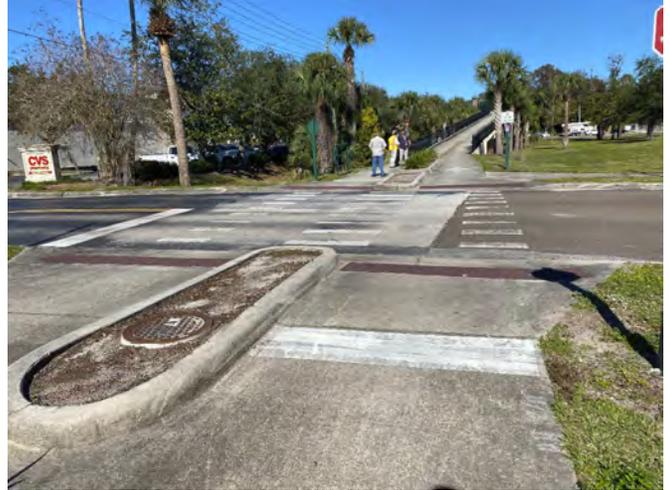
Figure 5 Trail Conditions at Bridge Terminus

User speed at this location was of particular concern as cyclists will naturally gain speed as they exit the bridge ramp. **Error! Reference source not found.** is illustrative of the stopping distance the user must react to when approaching the stop bar. Based on trail counts provided by the County, usage on this portion of the trail is higher compared to other areas.

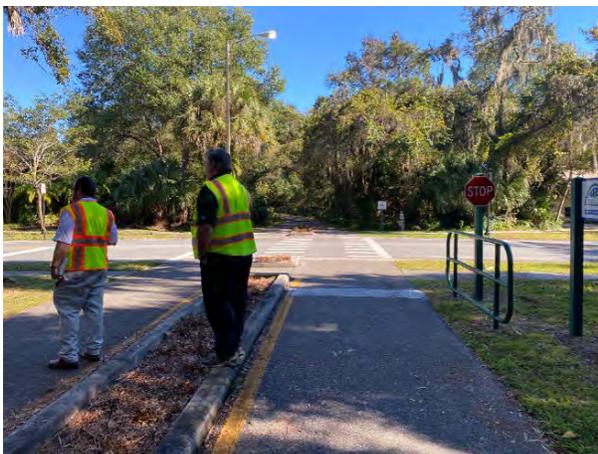
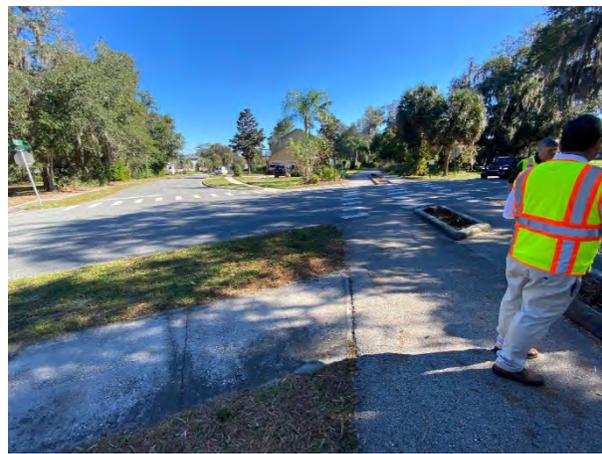
Figure 7 A Pair of Trail Crossings at Tuscora (left) and Lake Jessup (right)

The remaining intersections in this category cross at heavily used residential streets where the primary safety concerns are visibility of the trail crossing to motorists and stop compliance among trail users. Conditions at these intersections are shown in Figure 3.

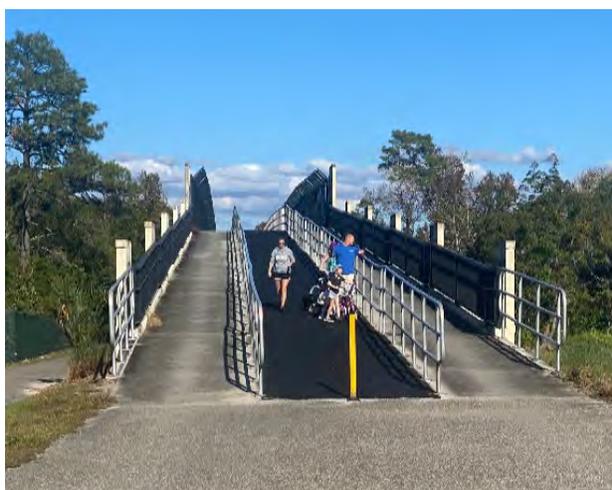
Figure 9 SR 434 Bridge Section

The pedestrian bridge exhibits unique conditions due to the placement of an equestrian segment through the center of the platform, effectively separating horseback traffic from other users. However, due to lack of demand, those walking along the trail often use this center portion of the bridge deck while others tend to use the outside sections for riding a bike. A cross-section photo of this bridge is provided in Figure 9.

Severe and fatal crashes have occurred at this location with speed and the configuration of the bridge and its deck infrastructure being significant factors. While in the field it was discovered that the tiling in the center portion of trail is in disrepair and present tripping hazards. It was noted by Seminole County staff that they are amenable to phasing out the equestrian use of the trail, possibly removing the railings. The railings were noted as direct contributors to a cyclist fatality.

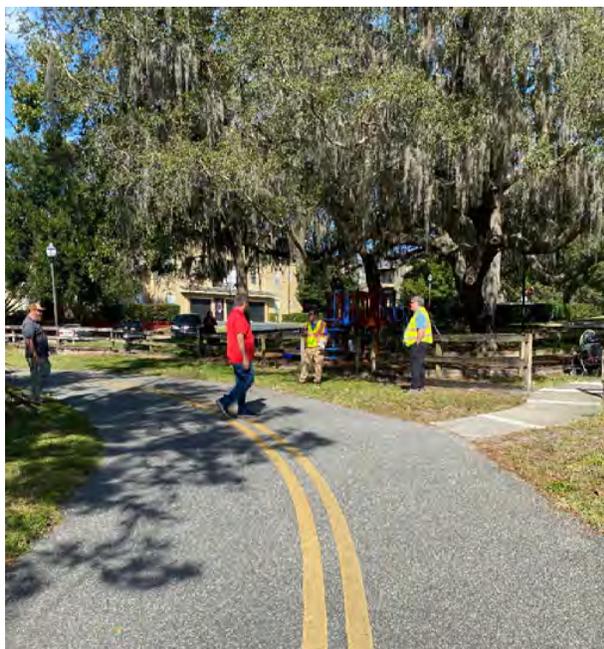
Figure 11 Blind Corner South of Lake Mary Boulevard

South of Lake Mary Boulevard on the Seminole Wekiva Trail, conditions that contribute to undesirable biking speed and operation were found to be due to the topography and curvature of the trail (a slight slope, but enough to gain speed), seen in Figures 6 and 7. Compounding these issues is the overgrowth of shrubbery from the adjacent residential areas that obscures sight lines around the curves.

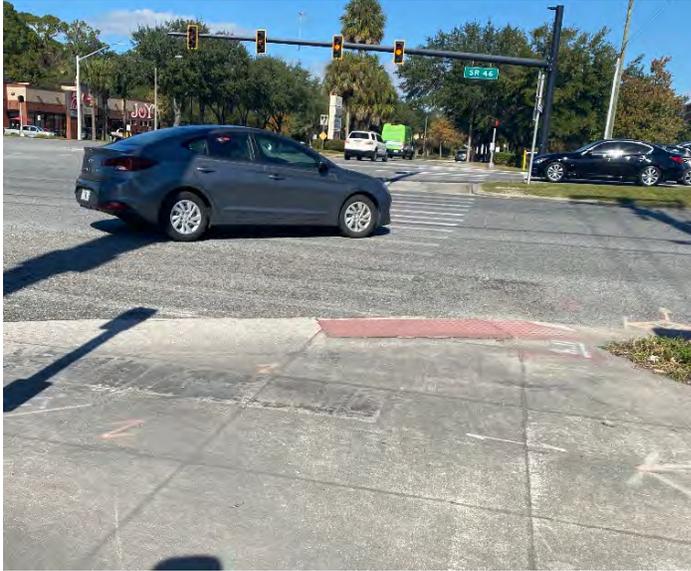
Figure 13 Intersection of SR 46 and Rinehart Road

The SR 46 and Rinehart Road intersection has a lengthy crossing distance across SR 46 (roughly 160ft) from the southeast corner to the northeast corner where the trail continues. Traffic is also heavy along both roadways, with SR 46 experiencing an AADT of 35,000 and Rinehart Road at 18,000.<sup>8</sup> Noise, truck traffic, and speed experienced firsthand at this intersection make it difficult to cross without the aid of the pedestrian phase. Notably, the median nose on SR 46 is extended to provide refuge for crossing trail users (Figure 13).

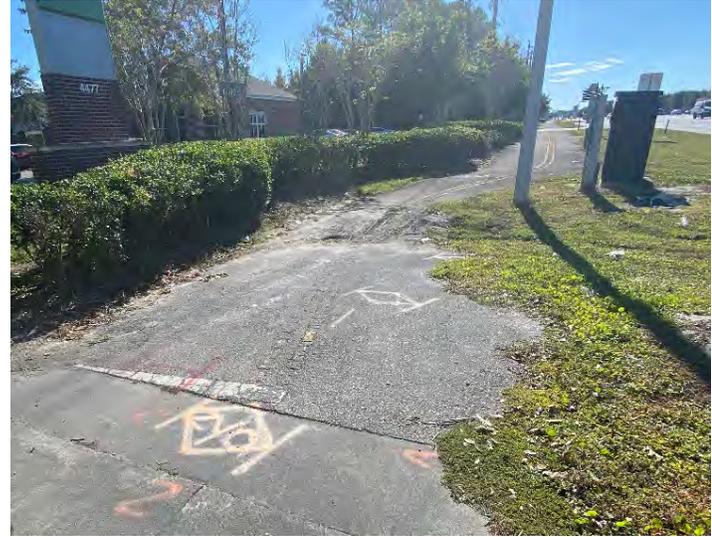
Figure 12 Conditions Approaching the Intersection

The area of the trail leading up to the intersection was noted to have water and debris from drainage, creating a slipping hazard for those approaching the intersection. Additionally, it is not apparent to the trail user that the continuation of the trail is across the intersection as signage and visual cues are limited to reinforce the trail continuity.

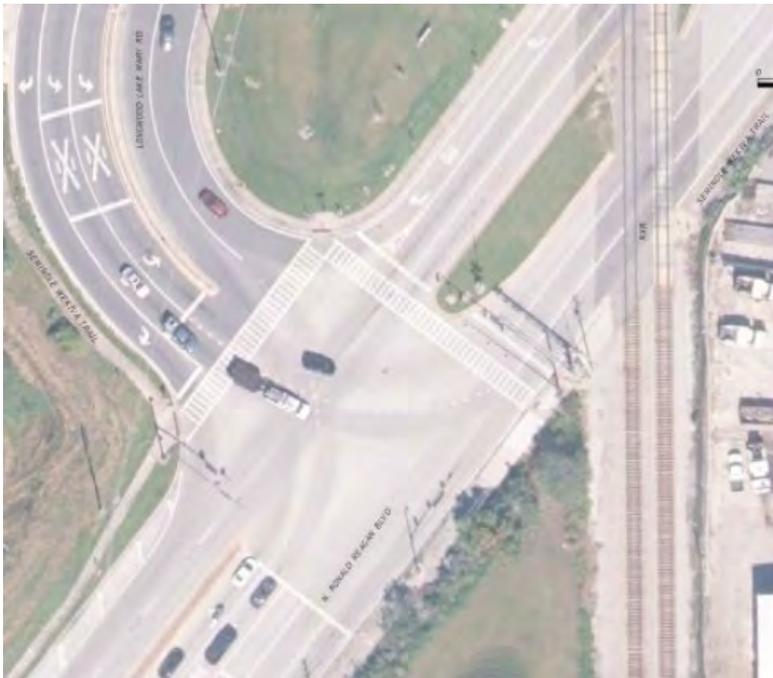
Figure 14 LM Boulevard Intersection

At the Longwood Lake Mary (LLM) Road intersection, conditions and conflicts were due to a lack of wayfinding, which would determine the safest path to cross the intersection and on which legs. In the aerial shown in Figure 14, trail users are meant to cross where there are marked crosswalks.

In the field it was observed that those using the trail chose their own path when approaching the intersection. One cyclist took the full outside left lane to reach the northeast corner where the trail

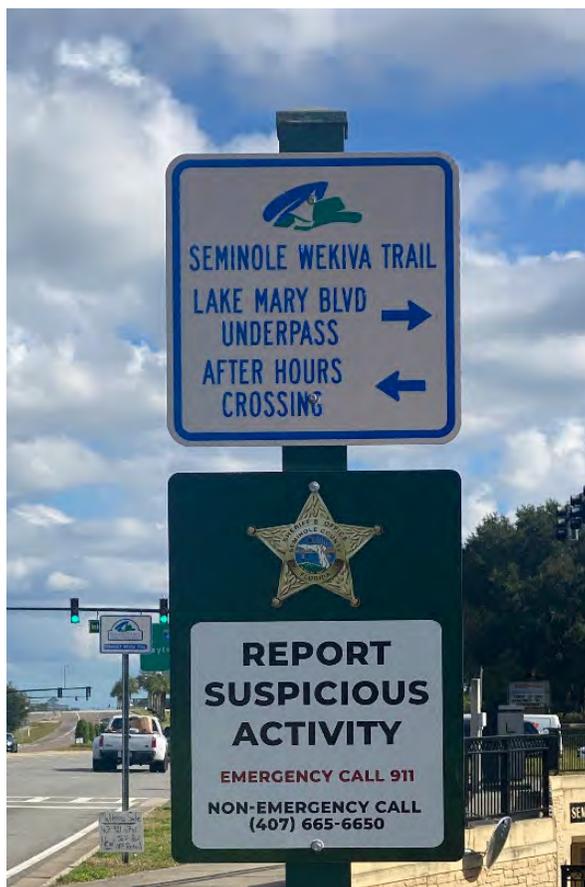
Figure 15 Lake Mary Boulevard and Seminole Wekiva Trail

Wayfinding on the trail was present at most trail heads and major intersections, but often failed the attention of the user or the motorist. However, recently added wayfinding has been updated with appropriate safety information and directions.

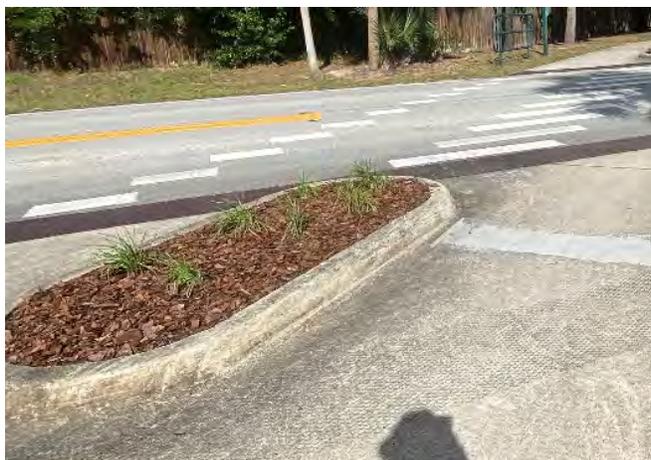
Figure 17 Medians at Tuscora Intersection

Additionally, there are underutilized pieces of infrastructure in the residential sections that once housed shrubs or plants that have been since paved over or perished due to climate conditions. These medians were still effective at splitting directional traffic and providing an area for cyclists to rest a foot without needing to dismount.

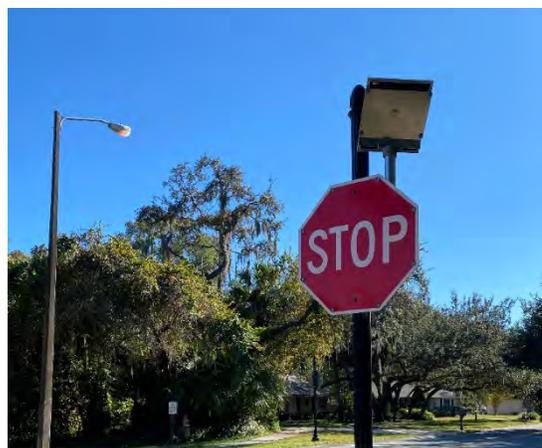
Figure 16 Illuminated Stop Sign

Finally, areas of the trail that are in established neighborhoods have added safety features at the request of the residents. Seen in **Error! Reference source not found.**, solar powered lights around the stop sign at the Tuscora Drive intersection to provide added awareness at the crossing.

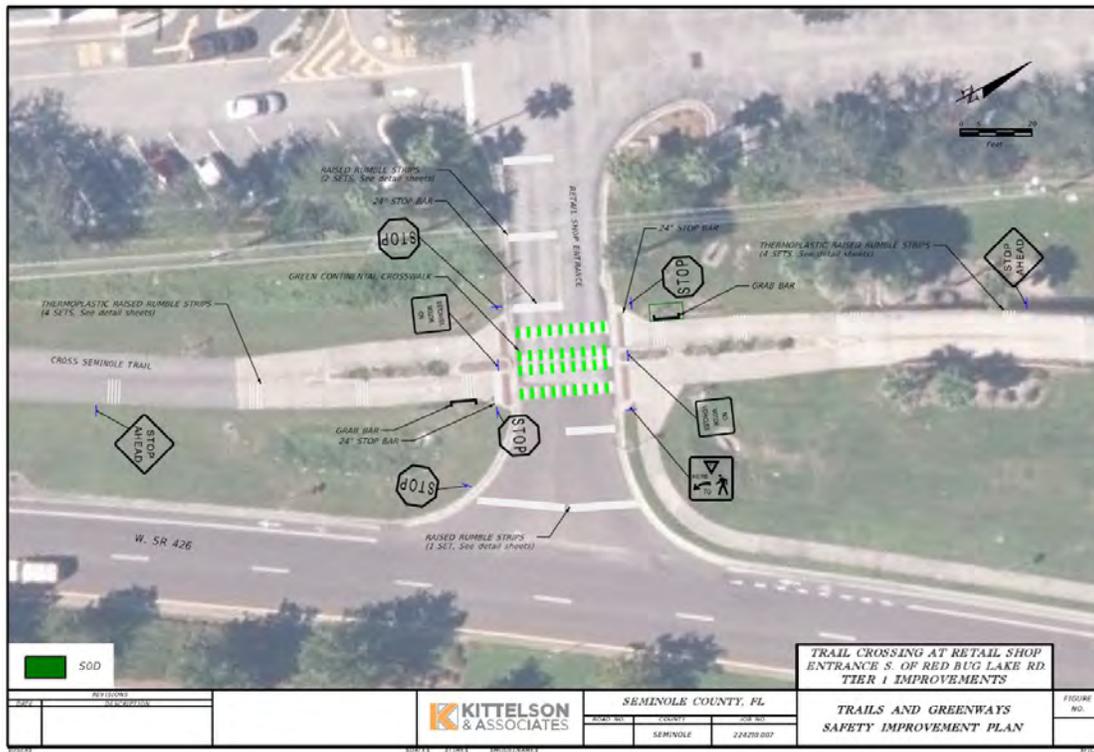
Figure 18 Tier I Improvements at Red Bug Lake Road Retail Center

This Tier of recommendations should be deployed swiftly to mitigate the current safety conflicts observed and discussed. Treatments such as, high visibility crossings, wayfinding signage, and rumble strips. This first Tier is intended to be the starting point of the suggested solutions. An example is shown in Figure 14, with the full planset for all location with a comprehensive visualization of elements is located in the Appendix.

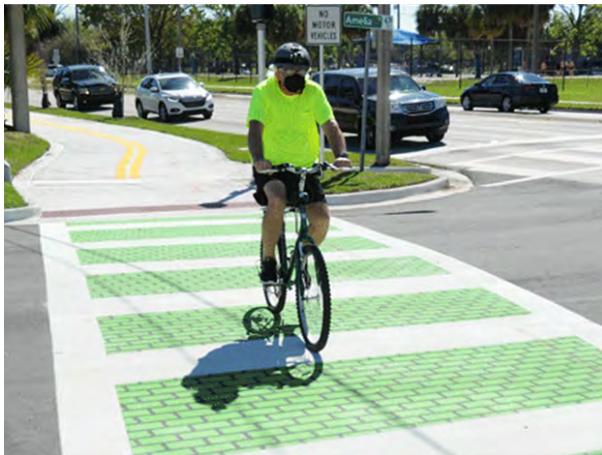
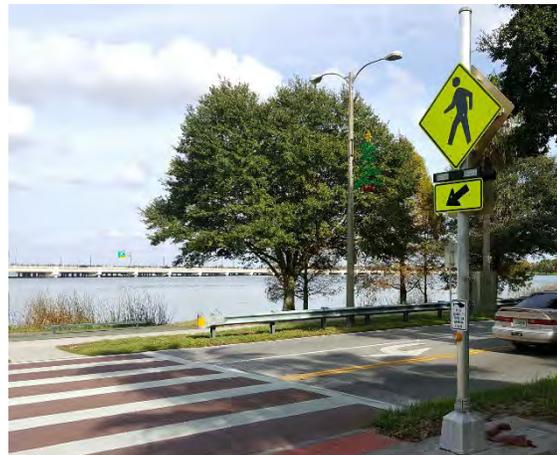
advance into the crossing area. This conflict mitigation is meant to be accomplished primarily through high visibility crosswalks and RRFBs at the crossing, seen in Figure 21 and Figure 20. These elements are particularly important at the Longwood Lake Mary Road intersection in addition to unsignalized crossings throughout the trail system.

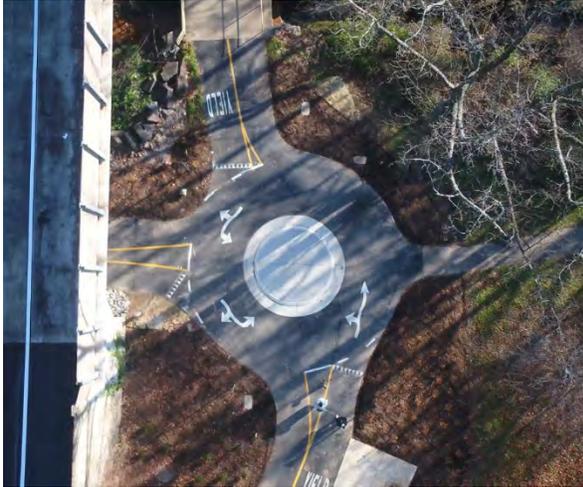
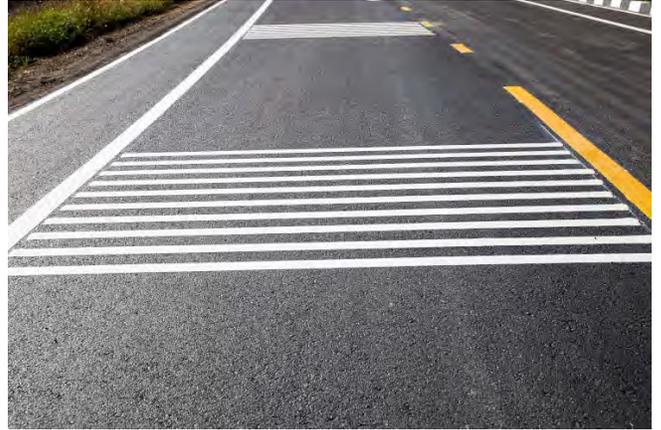
This element is poignant in reviewing the conditions at the SR 434 trail bridge and the Aloma Avenue & Red Bug Lake Road retail entrance. The purpose of these treatments is to slow all users down to achieve a desired and safe travel speed and to grab their attention for potential conflicts ahead. In Tier I, these elements include a proposed mini-roundabout for trail users (particularly at the bottom of the SR 434 bridge) to terminate the vista as users look ahead and allow them to slow down before reaching unsafe travel speeds. This element is seen in Figure 23. Also included as the base for this tier are rumble strips for both the trail users and motorists to be used as audible and tactile cues to increase awareness and slow down as they approach a conflict point, shown in Figure 22. Similar in effect to roadway rumble strips, trail strips are thinner and constructed out of multiple strips of thermoplastic striping to remain bike and rollerblade-friendly.

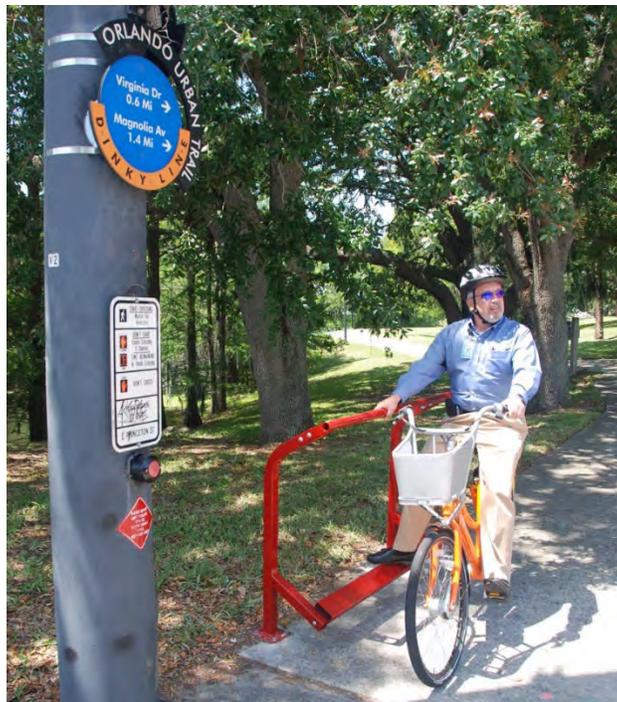
Figure 24 Example of Grab Bar

Amenities such as park benches and bicycle parking are often considered indicators for trail users that an approaching context is changing or there is opportunity or necessity to dismount or stop from their bike or PEV (if applicable). Standard for all intersections where the trail user will be required to stop are improved Bike Grab bars so the cyclist may stop without dismounting and grab onto the bar for balance, shown in Figure 24. The positioning and styling would replace the existing grab bars on the trail system.

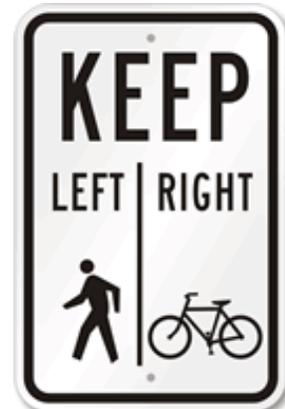
Figure 26 Mode Split Sign Example

Across all locations, signage and wayfinding remained standard across all field site locations unless a major change to the trail configuration necessitated a change in signage or user travel needed to be directed to a specific direction. Instances where modes needed to be separated between bicycle/PEVs and pedestrians, trail signs were recommended to alert the trail user to navigate to the portion of the segment appropriate for their mode of travel, seen in Figure 26. A concurrent study of wayfinding is being conducted for Seminole County Leisure Services; this effort has coordinated with that study team and the focus of this study remains signage that is more regulatory in nature.

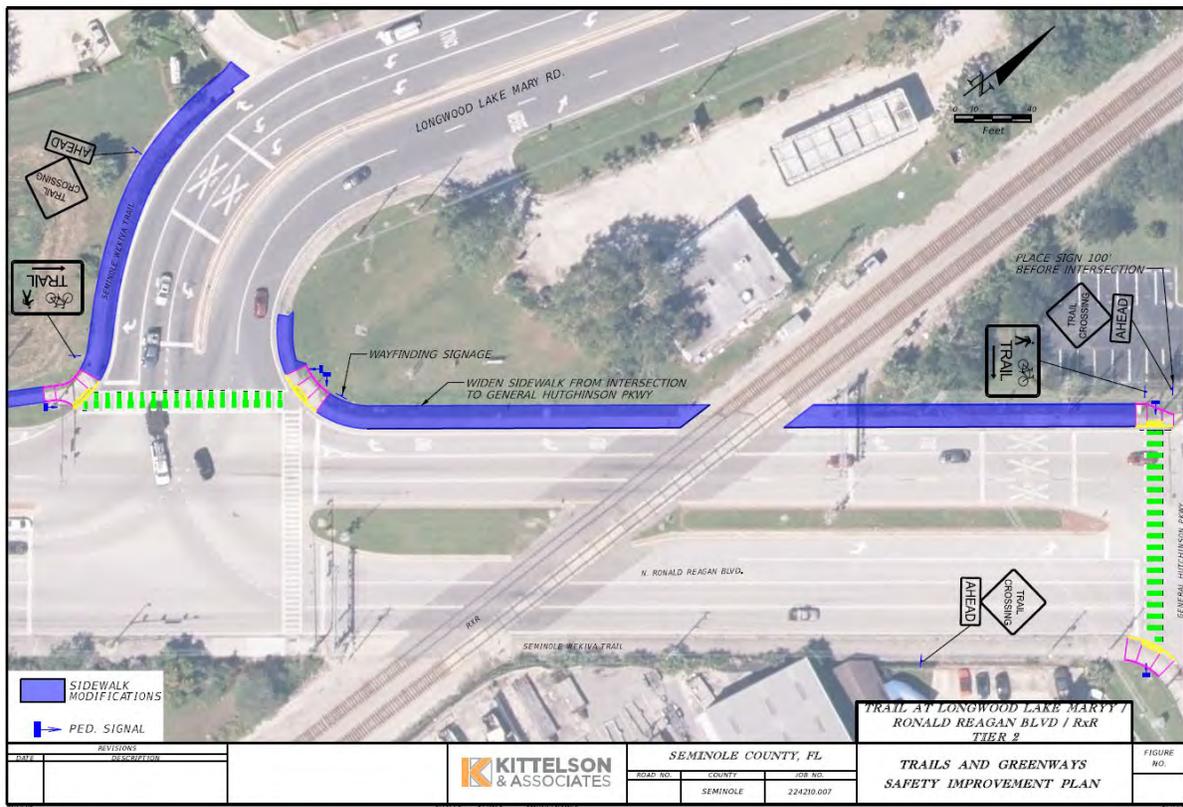
Figure 27 Longwood Lake Mary Road Intersection

Ronald Reagan Boulevard at General Hutchinson Parkway, as shown in Figure 27. Larger scale advanced warning signals in the form of an actuated or thermal detection pedestrian signal that stops motorist traffic when a trail user approaches the crossing is also recommended in this Tier. Example is show in Figure 28.

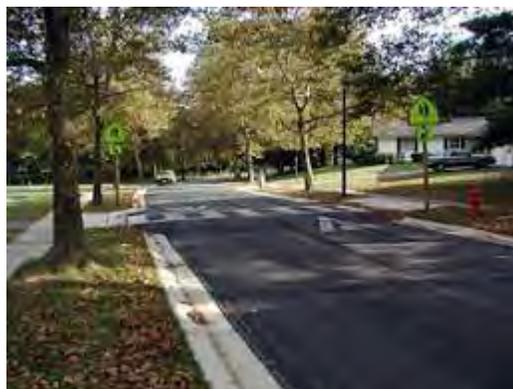
Figure 29 Raised Crosswalk Example

The primary change in traffic calming from Tier I to Tier II is the addition of hardscaping to various elements, particularly at intersections. Raised crosswalks are being recommended at most intersections to slow the travel in the approach and through the intersection, in combination with high visibility striping. Trail users would also need to traverse over the raised crosswalk to ensure they are also slowing down as they enter the intersection. An example from Safe Routes to School is illustrated in Figure 29. Equally, where splitting modes is recommended, the addition of plastic delineators are suggested for additional reinforcement to travel in the appropriate lane and at a reasonable speed. The recommended traffic delineators are also easy to install and remove as needed.

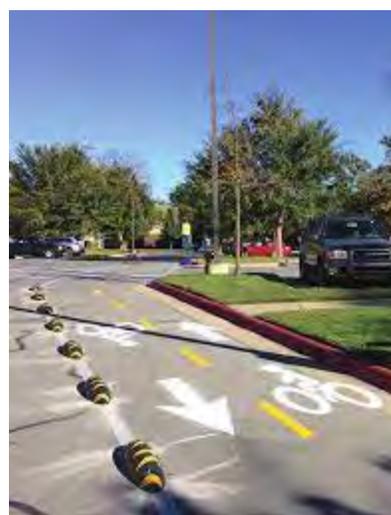
Figure 30 Example of Mode Delineators

While Seminole County staff did not indicate the desire to bar any PEV or specific user-type from the trails, it is also recommended in this study to establish a desirable speed as user trends change. As indicated in the peer agency interviews, many agencies have established areas where all PEV users and cyclists must dismount, and have established specific, enforceable rules to ensure that mixed traffic is safe and efficient. While this document is not making specific policy recommendations related to this, it does encourage that a broader, blanket policy related to the planning for future needs is considered in the future.

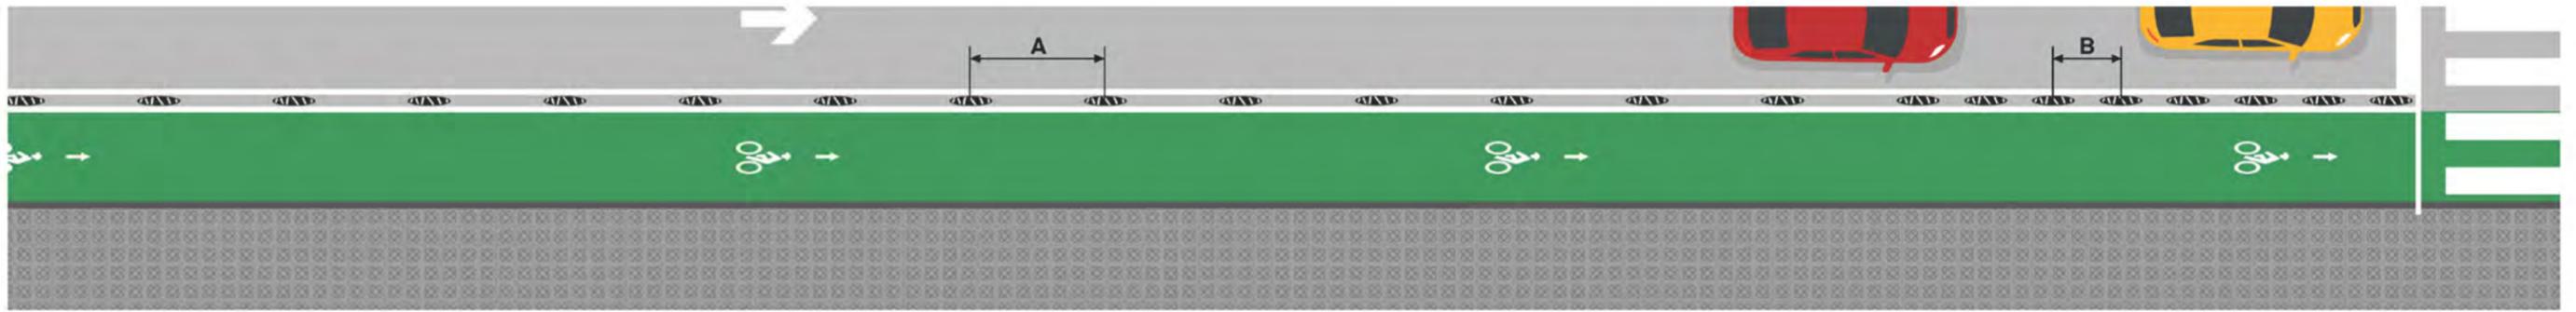
### PARALLEL CONFIGURATION

**A: 8ft 6 23/64 in** (middle of the road). **B: 4ft 3 3/16 in** (near the intersection).

ZICLA CYCLE LANE SEPARATOR DETAIL

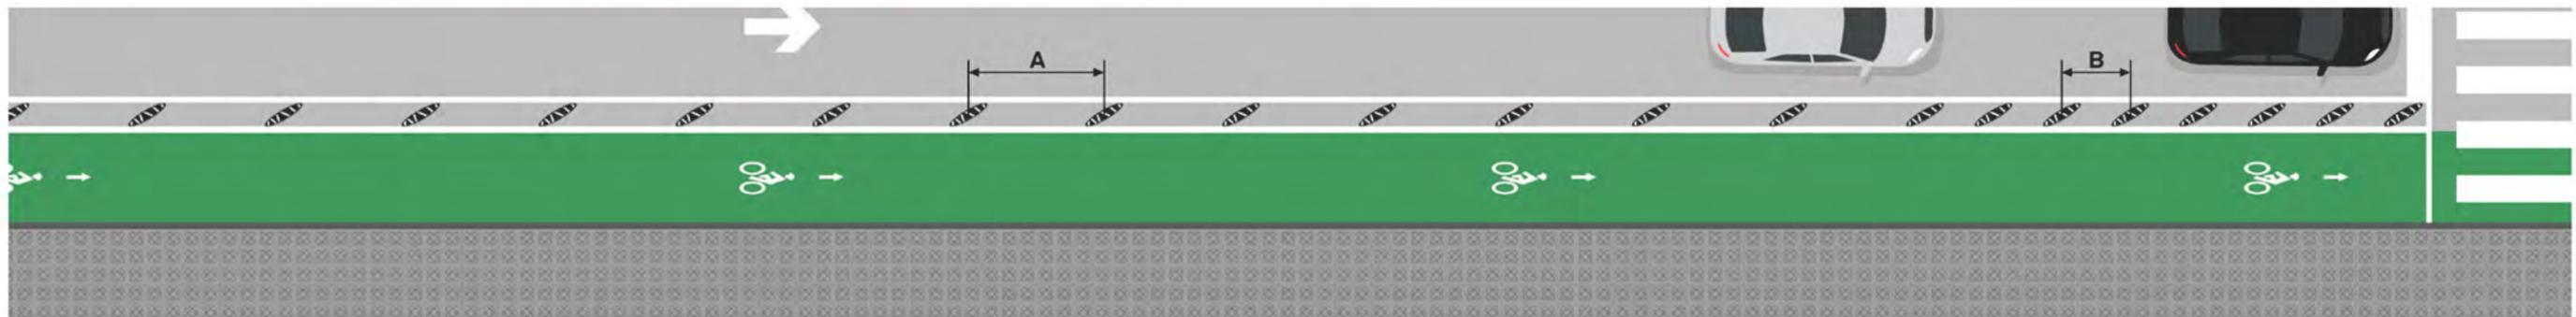
### OBLIQUE CONFIGURATION

**A: 8ft 6 23/64 in** (middle of the road). **B: 4ft 3 3/16 in** (near the intersection).

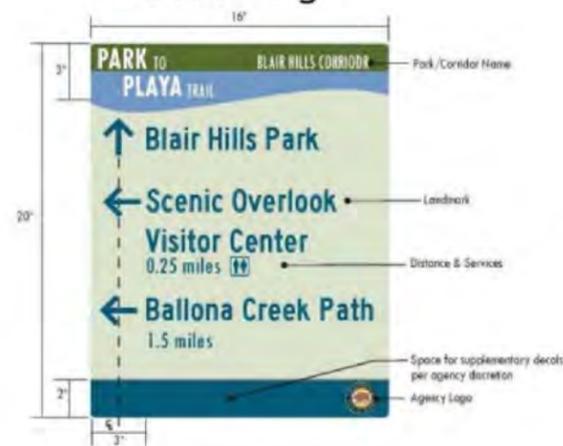
#### Direction Sign

WAYFINDING SIGN EXAMPLE
