PROPERTY CONDITION ASSESSMENT

SUMMARY REPORT

1096 Merritt St, Altamonte Springs, FL 32701

July 31, 2019

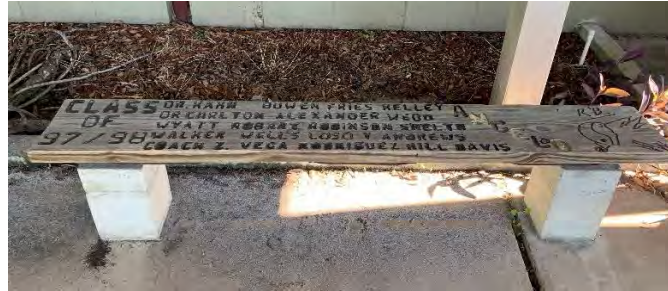
Fig 4.9.1.B Memorial Bench

The benches are constructed of concrete, wood or wood with concrete masonry unit (CMU) supports. The concrete benches may be reused but should be pressure washed to remove the buildup of dirt and mold. The wood benches are in disrepair and unsafe. The wood benches with CMU supports are memorial benches. The memorial bench wood material is in good condition and could be salvaged for incorporation into an alternate type of memorial.

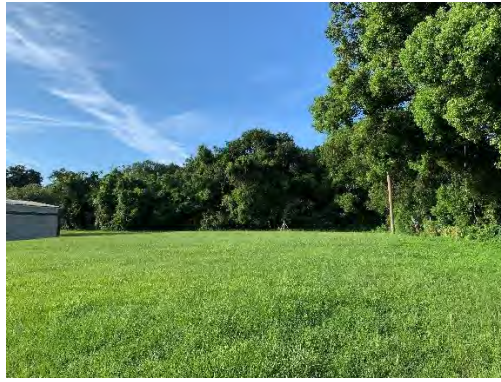
Fig. 4.9.1.D Open Field

The purpose of and use of an open area on the western portion of the site is not known. It is presumed that the area may have been used as a multipurpose field. The area drains predominately northward, has good ground cover and appears to be free draining. There are flat areas in the southwest and western portions of the field that are relatively flat and have softer conditions. Future development of the area should take into consideration of what the area has been used for in the past.

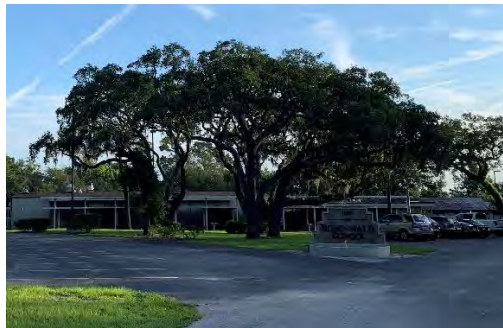
Fig. 4.9.2 Parking Lot Oak Trees

In general, the landscaping material is what is anticipated of a facility that has not been utilized for eight years. The site appears to have some minimal level of regular maintenance including grass cutting. Lawn area are in good condition with fair to good coverage. The plant material within beds or planters has either died or is overgrown. Large oak trees are located throughout the site and appeared to be in good health. Landscape islands and beds adjacent to vehicular use areas are void of protective curb. Nor are landscape areas adjacent to parking protected by wheel stops. Rectangular concrete blocks are located along the edges of the south/front parking facility presumably to prevent vehicular traffic from parking in or traversing through landscape material.

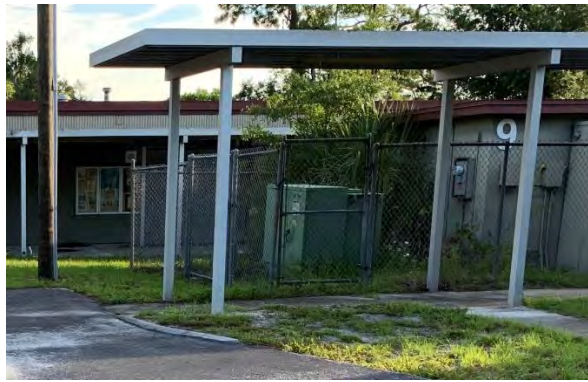
Fig. 4.9.8.C – Primary Point of Service

A pole mounted transformer is located at the southwest corner of the property. Overhead power lines run northward along the westerly property line to an apparent service drop on the west of Building 9. The power meter is located on the exterior west wall of Building 9. Secondary power lines extend from Building 2 and Building 5 to a pole south of the greenhouse. Power service requirement will need to be addressed for any new uses. Communication may also be on the same poles. The clear height of the lowest utilities is of concern. These overhead lines are easily accessible as they drop below the adjacent sidewalk canopy.

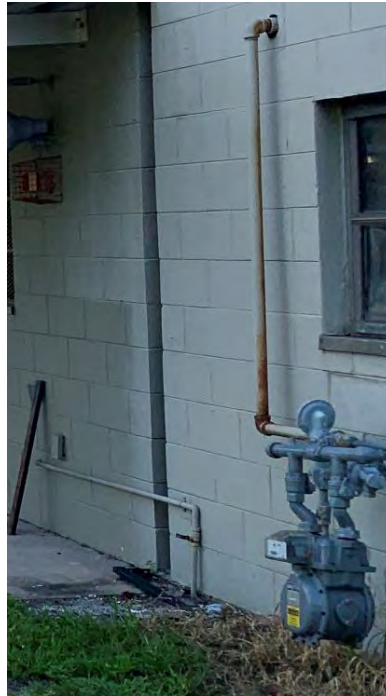
Fig. 4.9.9.E

TECO Peoples gas provides service. Service connection is on the west side of Building 1. The condition of the underground service line is not known. Coordination with TECO is required and existing line is to be marked in accordance with State law prior to any excavation.

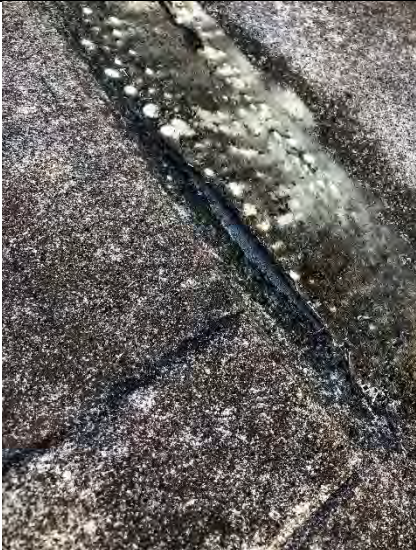
<p>REPORT SECTION: ROOF</p> <p>PHOTO: ROOF – BUILDING 1</p> <p>PHOTO DESCRIPTION: OPEN SEAM</p>

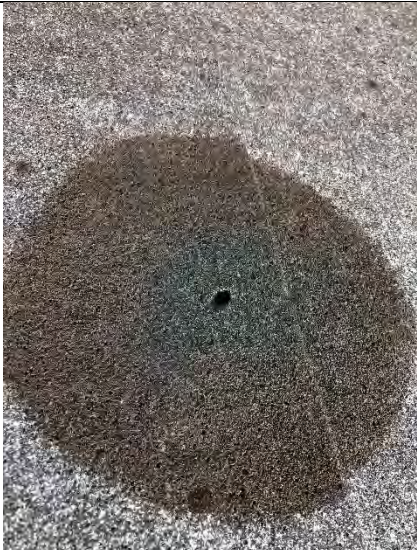
<p>REPORT SECTION: ROOF</p> <p>PHOTO: ROOF – BUILDING 1</p> <p>PHOTO DESCRIPTION: HOLES IN MEMBRANE</p>
17.

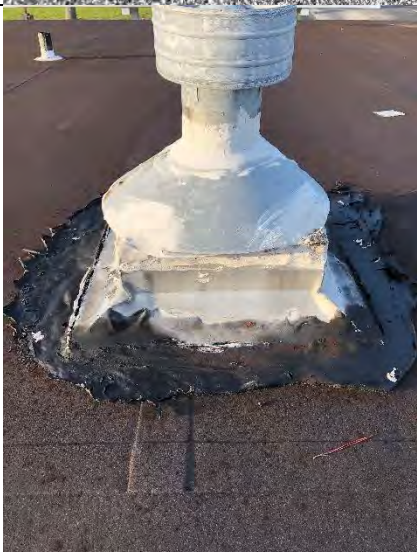
<p>REPORT SECTION: ROOF</p> <p>PHOTO: ROOF – BUILDING 1</p> <p>PHOTO DESCRIPTION: STRIP FLASHING AROUND FAN CURLED</p>

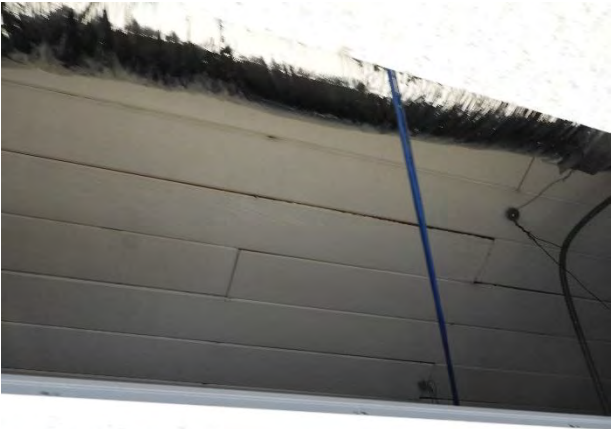
56.

A photograph showing a close-up of a roof structure. The main surface is covered in light-colored, horizontally-oriented painted wood paneling. Above this paneling, a dark, fibrous material, likely insulation, is visible. A blue vertical pipe or rod runs through the center of the paneling. The lighting is bright, suggesting an outdoor or well-lit indoor environment.	<p>REPORT SECTION: ROOF</p> <p>PHOTO: BUILDING 5 - WOOD PANELING</p> <p>PHOTO DESCRIPTION: PAINTED WOOD PANELING ABOVE ACT</p>

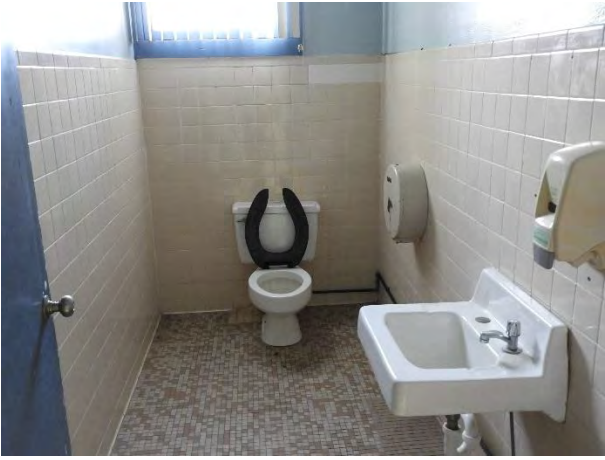
58.

A photograph showing the overall view of a bathroom. The walls are covered in light-colored, square tiles. A white toilet is positioned against the back wall. To the right, there is a white pedestal sink with a chrome faucet. A paper towel dispenser is mounted on the wall above the sink. A window with blue curtains is visible at the top of the frame. The floor is covered in a patterned tile.	<p>REPORT SECTION: INTERIOR FINISH</p> <p>PHOTO: BUILDING 5 - BATHROOM</p> <p>PHOTO DESCRIPTION: OVERALL OF BATHROOM</p>

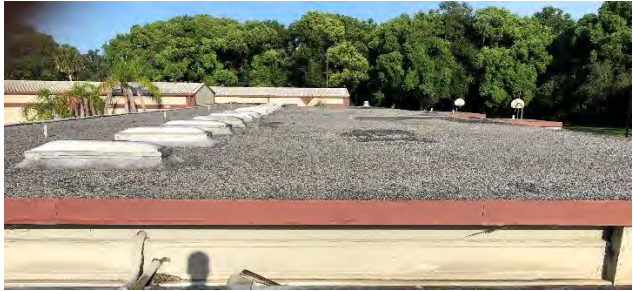
69.

<p>REPORT SECTION: ROOF</p> <p>PHOTO: BUILDING 6 – ROOF 1</p> <p>PHOTO DESCRIPTION: OVERALL OF BUILDING 6 ROOF</p>

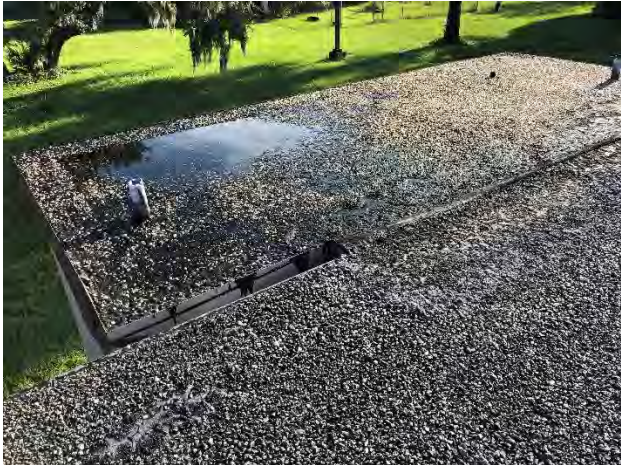
70.

An aerial photograph of a flat roof covered in gravel. A large, irregularly shaped pond of water is visible in the upper left quadrant of the roof. The surrounding area is a green lawn with trees.	<p>REPORT SECTION: ROOF</p> <p>PHOTO: BUILDING 6 – ROOF 2</p> <p>PHOTO DESCRIPTION: PONDING AT ROOF</p>

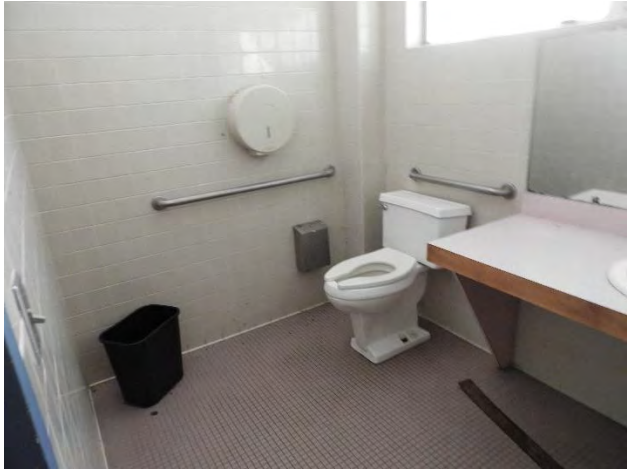
77.

<p>REPORT SECTION: INTERIOR FINISH</p> <p>PHOTO: BATHROOM – BUILDING 7</p> <p>PHOTO DESCRIPTION: OVERALL OF BUILDING 7 BATHROOM</p>

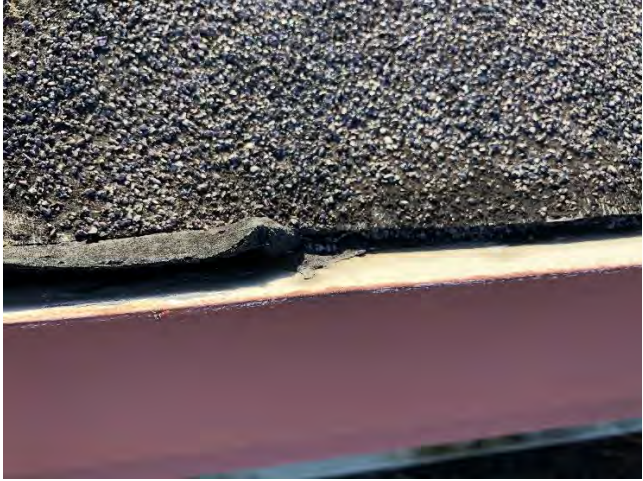
A close-up photograph of a roof edge. The top part shows a dark, granular surface, possibly gravel or a membrane. Below it, a dark, curved object is visible, and the bottom part shows a reddish-brown surface, likely a metal roof edge or a different material.	<p>REPORT SECTION: ROOF</p> <p>PHOTO: BUILDING 7 - ROOF</p> <p>PHOTO DESCRIPTION: OPEN MEMBRANE EDGE</p>

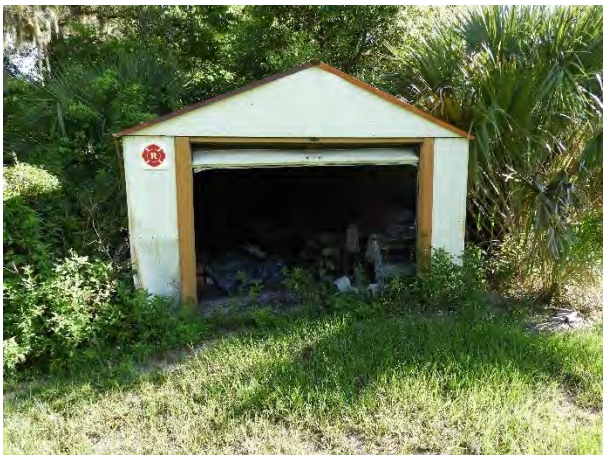
<p>91.</p>

<p>REPORT SECTION: EXTERIOR</p> <p>PHOTO: SIDING - BUILDING 12</p> <p>PHOTO DESCRIPTION: FRONT VIEW OF BUILDING 12</p>
<p>92.</p>

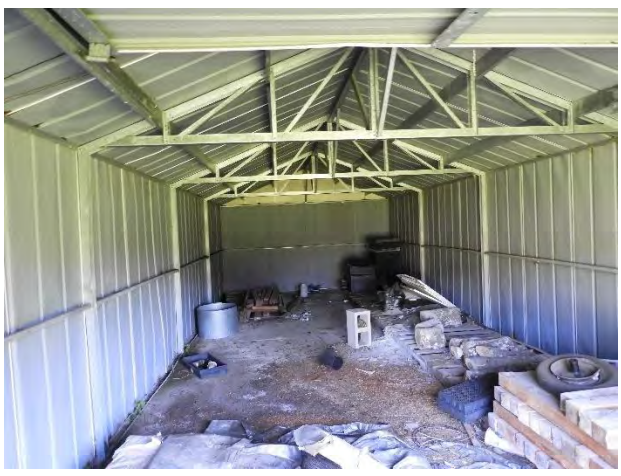
<p>REPORT SECTION: INTERIOR FINISH</p> <p>PHOTO: INTERIOR – BUILDING 12</p> <p>PHOTO DESCRIPTION: OVERALL INTERIOR VIEW OF BUILDING 12</p>

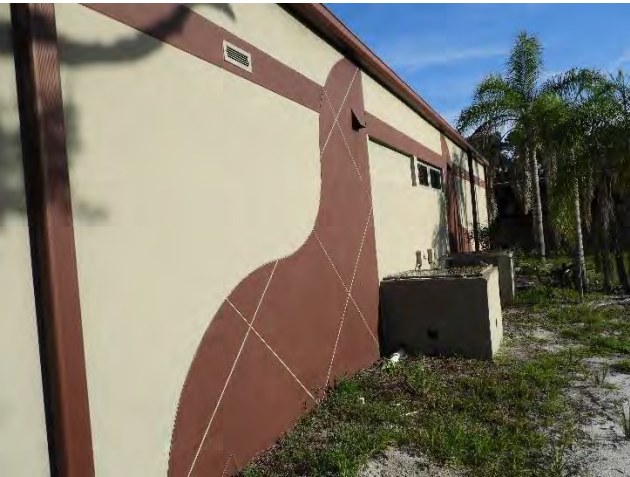
REPORT SECTION: EXTERIOR PHOTO: BACK ELEV. BUILDING 13 PHOTO DESCRIPTION: BUILDING 13 BACK ELEVATION

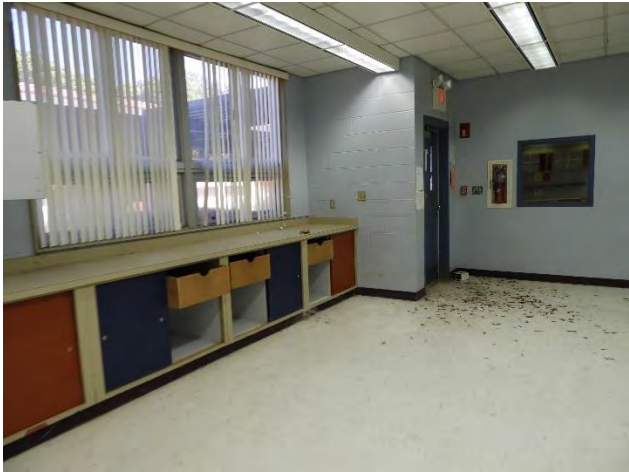
<p>97.</p>

<p>REPORT SECTION: INTERIOR FINISH</p> <p>PHOTO: CLASSROOM – BUILDING 13</p> <p>PHOTO DESCRIPTION: PARTIAL VIEW OF CLASSROOM IN BUILDING 13</p>
<p>98.</p>

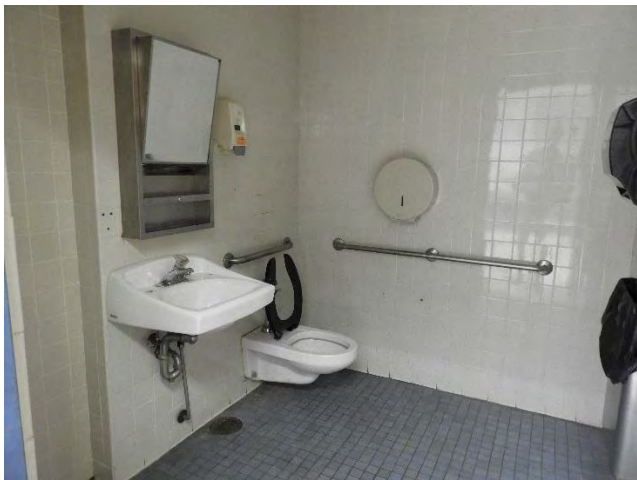
<p>REPORT SECTION: INTERIOR FINISH</p> <p>PHOTO: BUILDING 13 - BATHROOM</p> <p>PHOTO DESCRIPTION: OVERALL OF BATHROOM IN BUILDING 13</p>
<p>99.</p>

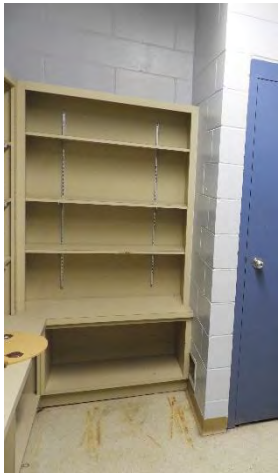
<p>REPORT SECTION: INTERIOR FINISH</p> <p>PHOTO: VCT STAINS – BUILDING 13</p> <p>PHOTO DESCRIPTION: STAINING ON VCT IN ELECTRICAL ROOM</p>

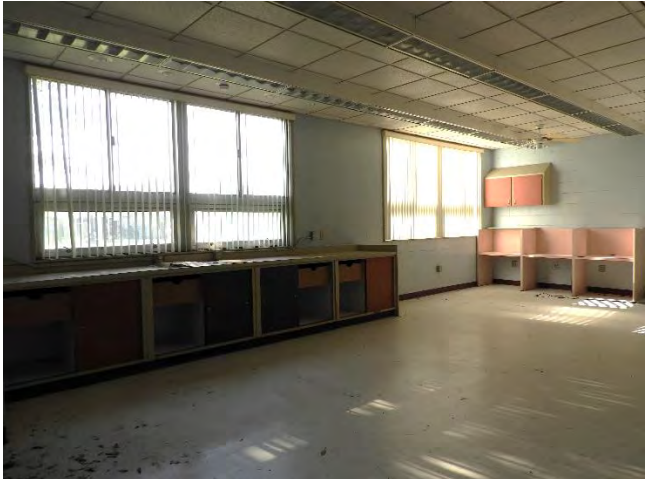
106.

A photograph of the interior of a classroom in Building 14. The room has a drop ceiling with recessed lighting. There are large windows on the left side with vertical blinds. The walls are a light color. There are wooden desks and chairs arranged in the room. The floor is a light-colored tile or linoleum.	<p>REPORT SECTION: INTERIOR FINISH</p> <p>PHOTO: CLASSROOM – BUILDING 14</p> <p>PHOTO DESCRIPTION: OVERALL CLASSROOM – BUILDING 14</p>

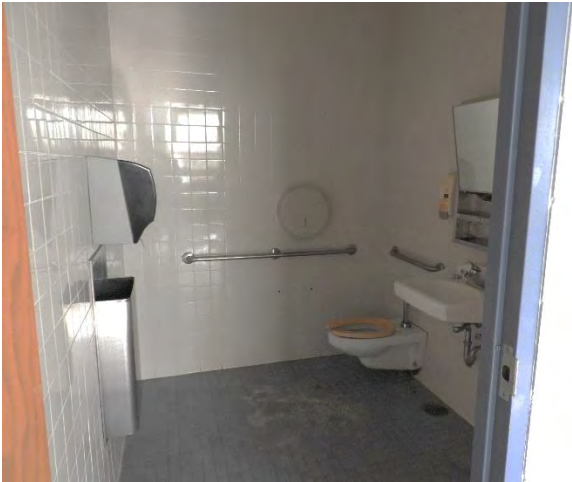
107.

<p>REPORT SECTION: INTERIOR FINISH</p> <p>PHOTO: BUILDING 14 - BATHROOM</p> <p>PHOTO DESCRIPTION: OVERALL OF TYPICAL BATHROOM</p>
108.

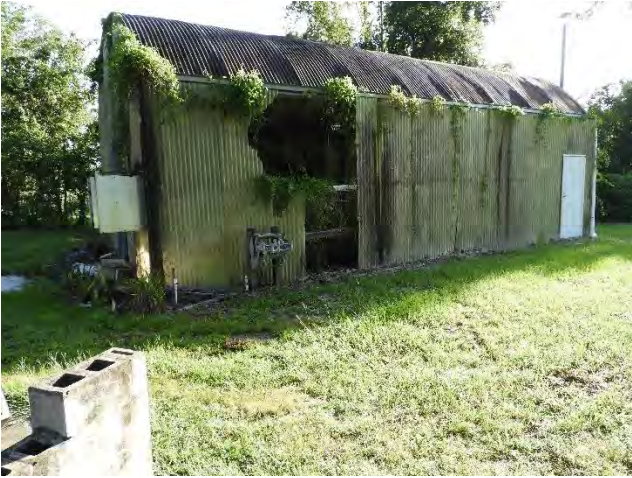
114.

A photograph showing the exterior of Building 15, a long, narrow structure with a corrugated metal roof and walls. The building is heavily overgrown with green vines and other vegetation. It is situated on a grassy area with trees in the background. A concrete block wall is visible in the foreground on the left.	REPORT SECTION: EXTERIOR PHOTO: PERSPECTIVE – BUILDING 15 PHOTO DESCRIPTION: OVERALL VIEW OF BUILDING 15
115.

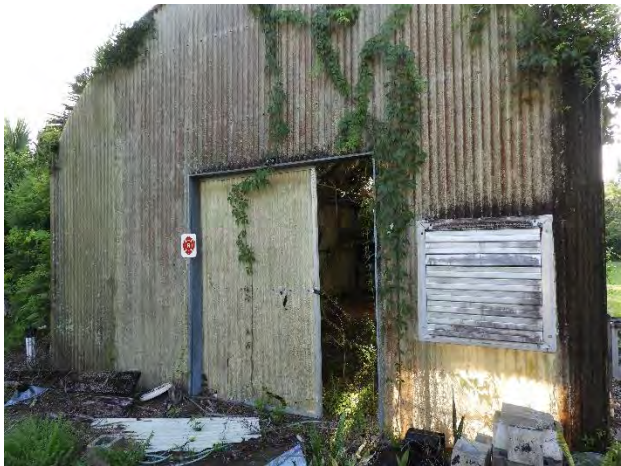
A close-up photograph of the sliding entry door of Building 15. The door is made of corrugated metal and is partially open, revealing the interior. The surrounding walls are also made of corrugated metal and are covered in green vines. A window with horizontal slats is visible to the right of the door.	REPORT SECTION: DOOR PHOTO: SLIDING ENTRY DOOR PHOTO DESCRIPTION: SLIDING DOOR AT BUILDING 15

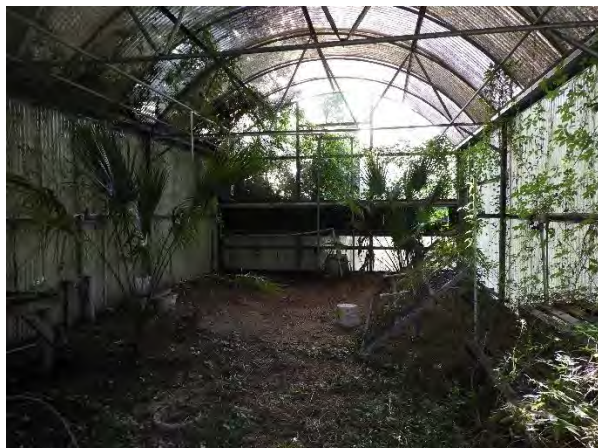
116.

PHOTO: BUILDING 15 - INTERIOR

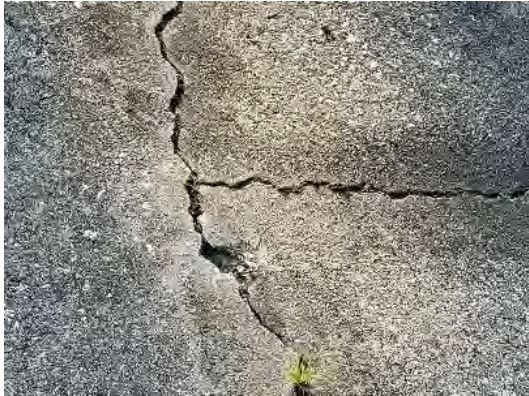
<p>231.</p>

A photograph showing a close-up of a dark asphalt surface with a prominent, irregular crack running vertically and then horizontally across the frame. The crack is deep and appears to be a joint or a significant structural failure.	<p>REPORT SECTION: SITE – BASKETBALL COURT</p>
<p>232.</p>

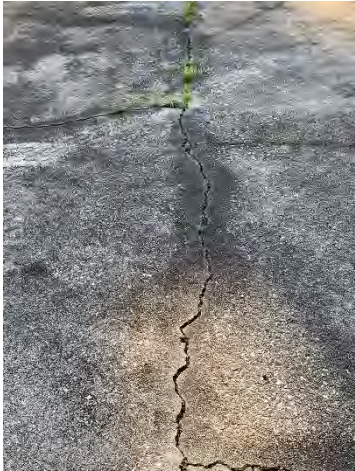
A photograph showing a close-up of a dark asphalt surface with a vertical crack. A small patch of green weeds is growing from the crack. The surface shows some texture and wear.	<p>REPORT SECTION: SITE – BASKETBALL COURT</p>

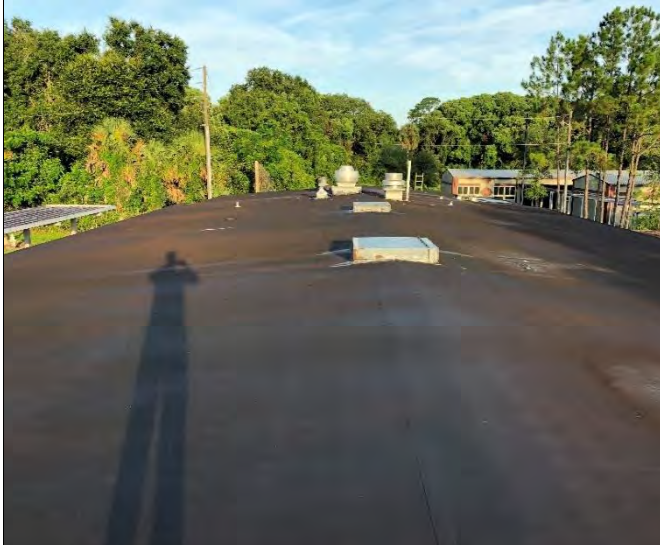
PHOTO: M4

PHOTO DESCRIPTION:
Building #1; rooftop fans.

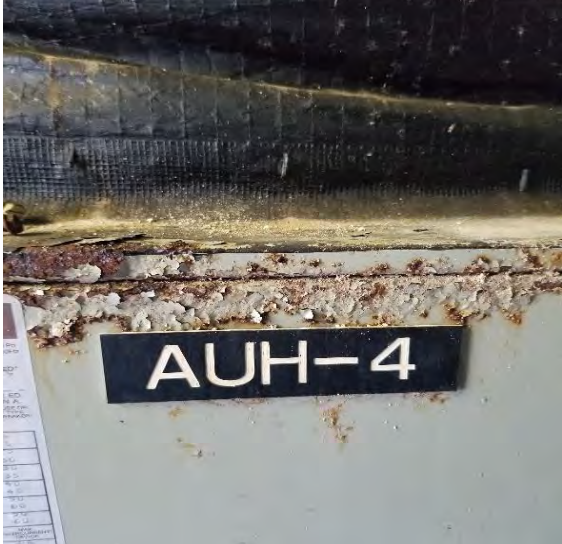
<p>REPORT SECTION: 4.5.1</p> <p>PHOTO: M7</p> <p>PHOTO DESCRIPTION: Building #1, Room 01-001G; AHU-4-1.</p>
375.

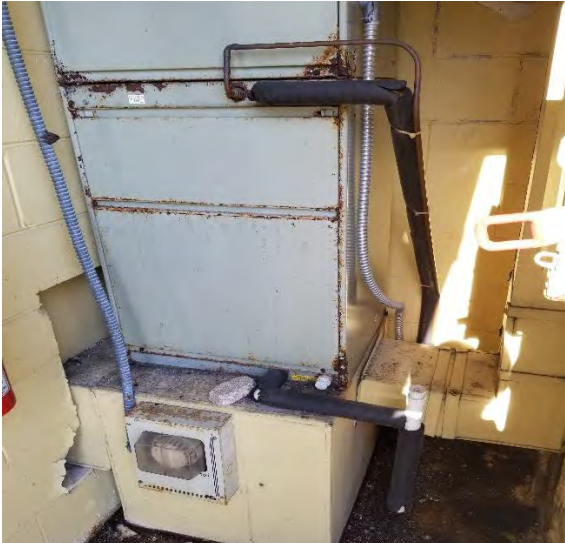
<p>REPORT SECTION: 4.5.1</p> <p>PHOTO: M8</p> <p>PHOTO DESCRIPTION: Building #3, Room 03-002E; AHU-10-3.</p>
376.

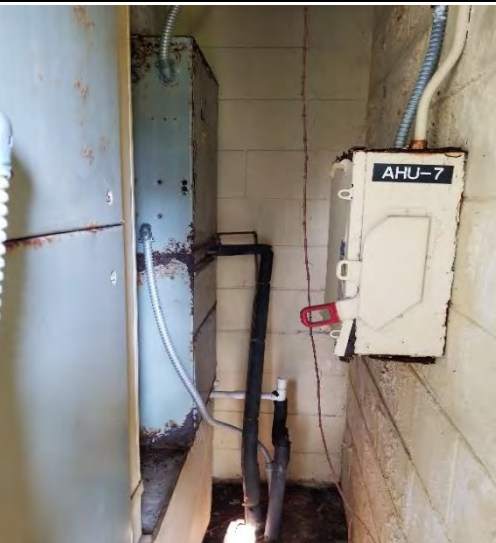
<p>REPORT SECTION: 4.5.1</p> <p>PHOTO: M9</p> <p>PHOTO DESCRIPTION: Building #4, Rom 04-006E; AHU-7-4.</p>

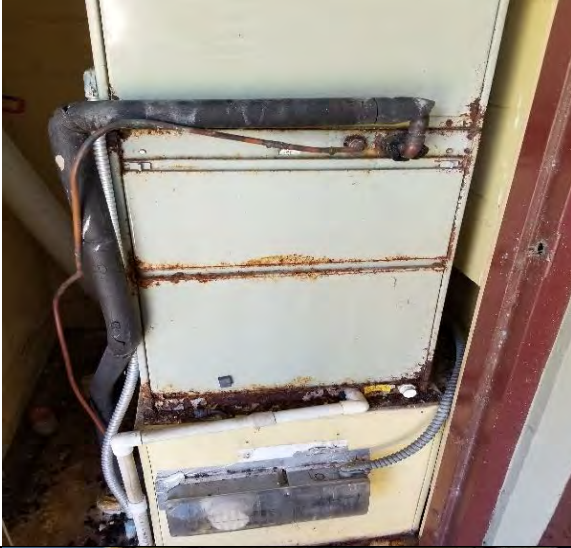
<p>REPORT SECTION: 4.5.1</p> <p>PHOTO: M10</p> <p>PHOTO DESCRIPTION: Building #7, Room 07-002C; AHU-X1-7.</p>
378.

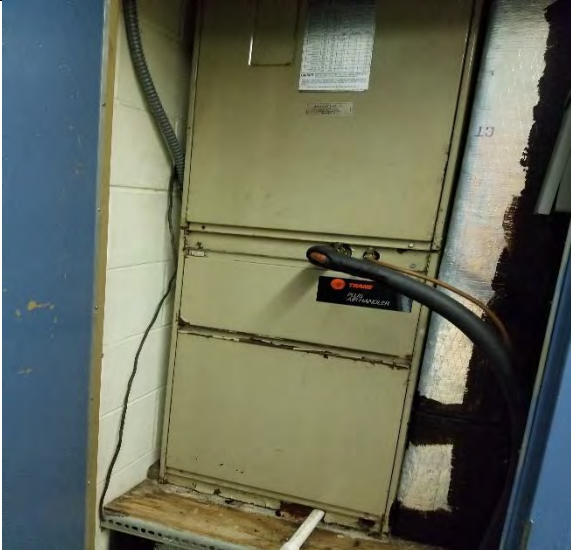
<p>REPORT SECTION: 4.5.1</p> <p>PHOTO: M11</p> <p>PHOTO DESCRIPTION: Building #13, Room 13-001B; AHU-X2-13.</p>
379.

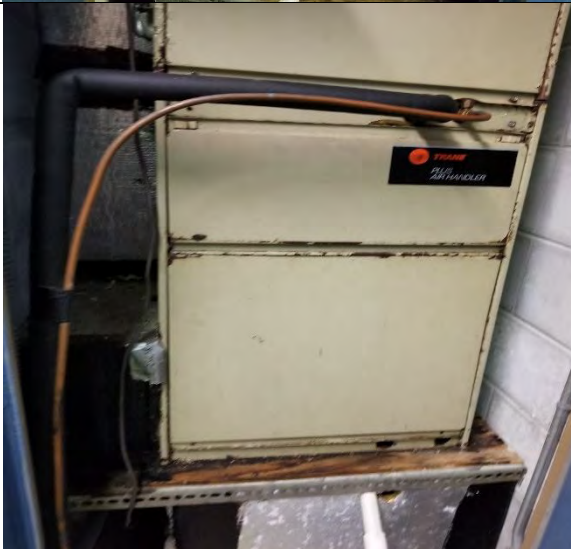
<p>REPORT SECTION: 4.5.1</p> <p>PHOTO: M12</p> <p>PHOTO DESCRIPTION: Building #14, Room 14-001B; AHU-X1-14.</p>

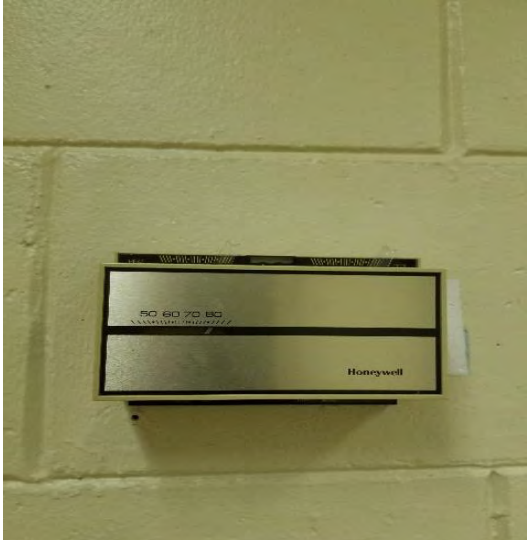
<p>REPORT SECTION: 4.5.1</p> <p>PHOTO: M13</p> <p>PHOTO DESCRIPTION: Mechanical thermostat, Building #1.</p>
381.

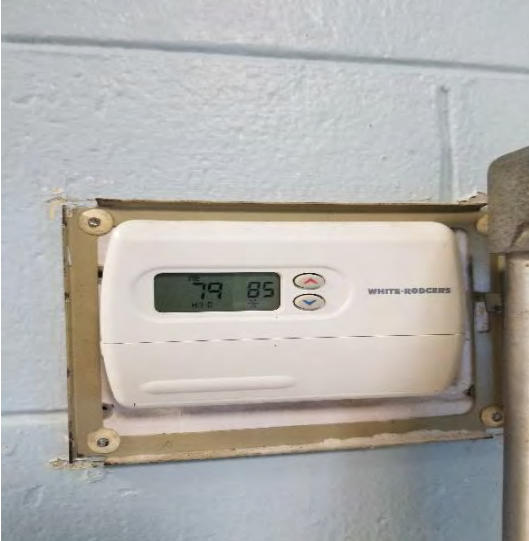
<p>REPORT SECTION: 4.5.1</p> <p>PHOTO: M14</p> <p>PHOTO DESCRIPTION: Digital thermostat, Building #1.</p>
382.

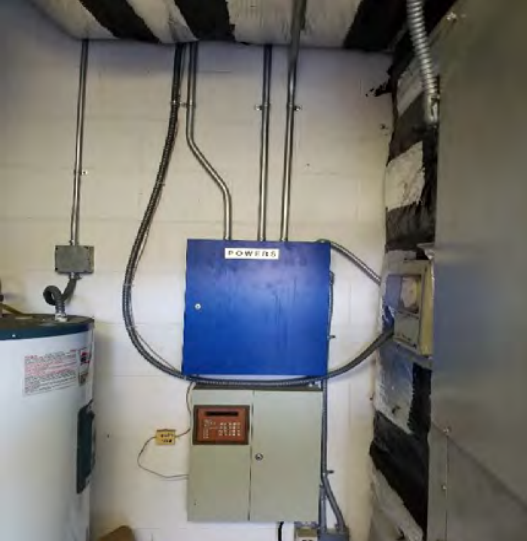
<p>REPORT SECTION: 4.5.1</p> <p>PHOTO: M15</p> <p>PHOTO DESCRIPTION: Appears to be an existing controls cabinet.</p>

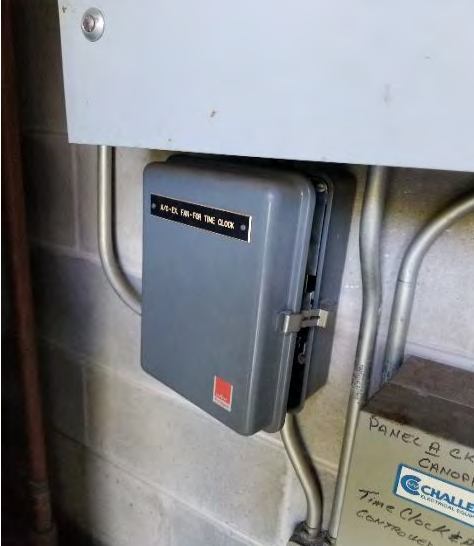
<p>REPORT SECTION: 4.5.1</p> <p>PHOTO: M16</p> <p>PHOTO DESCRIPTION: HVAC timeclock for control of HVAC equipment.</p>
384.

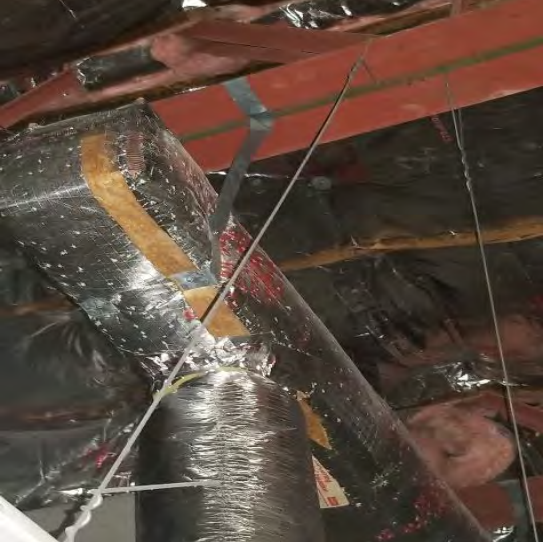
<p>REPORT SECTION: 4.5.2</p> <p>PHOTO: M18</p> <p>PHOTO DESCRIPTION: Building #1; Ductwork above the ceiling with aluminum tape duct insulation sealer.</p>

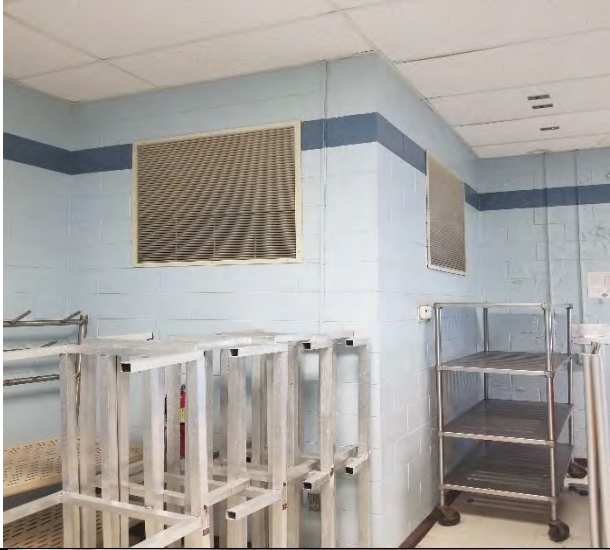
<p>REPORT SECTION: 4.5.2</p> <p>PHOTO: M19</p> <p>PHOTO DESCRIPTION: Building #1; High return air grilles.</p>
387.

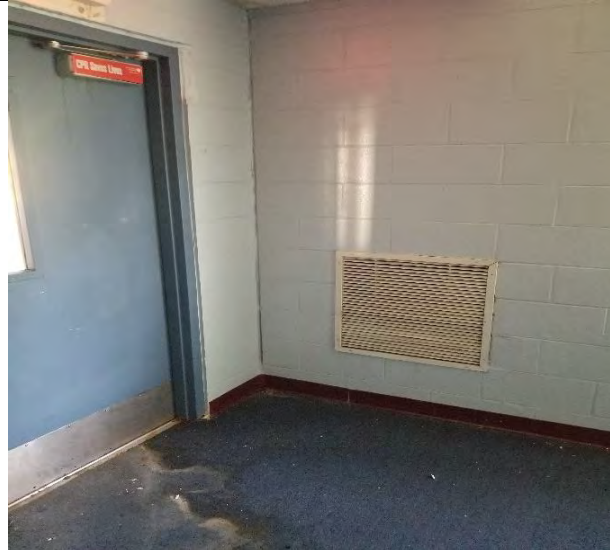
<p>REPORT SECTION: 4.5.2</p> <p>PHOTO: M20</p> <p>PHOTO DESCRIPTION: Building #4; Low return air grille.</p>
388.

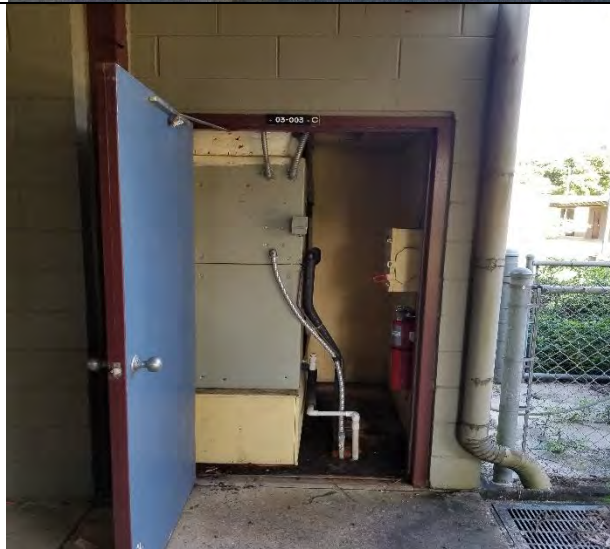
<p>REPORT SECTION: 4.5.3</p> <p>PHOTO: M21</p> <p>PHOTO DESCRIPTION: Building #3; Mechanical room.</p>

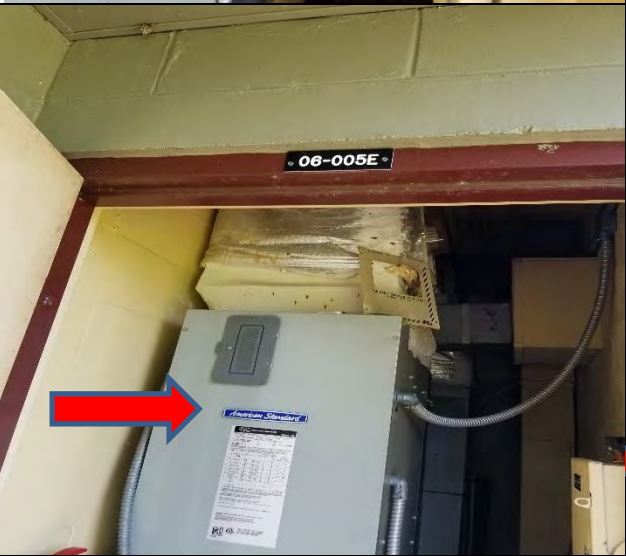
<p>REPORT SECTION: 4.5.3</p> <p>PHOTO: M23</p> <p>PHOTO DESCRIPTION: Building #6; Mechanical Room.</p>
<p>391.</p>

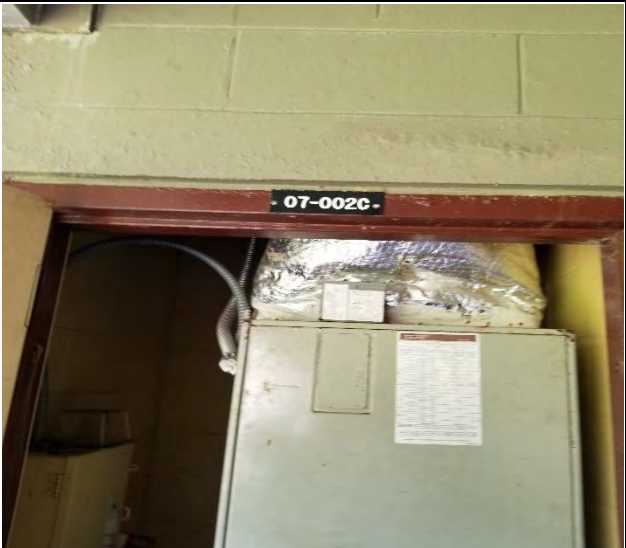
<p>REPORT SECTION: 4.5.3</p> <p>PHOTO: M24</p> <p>PHOTO DESCRIPTION: Building #7; Mechanical Room.</p>

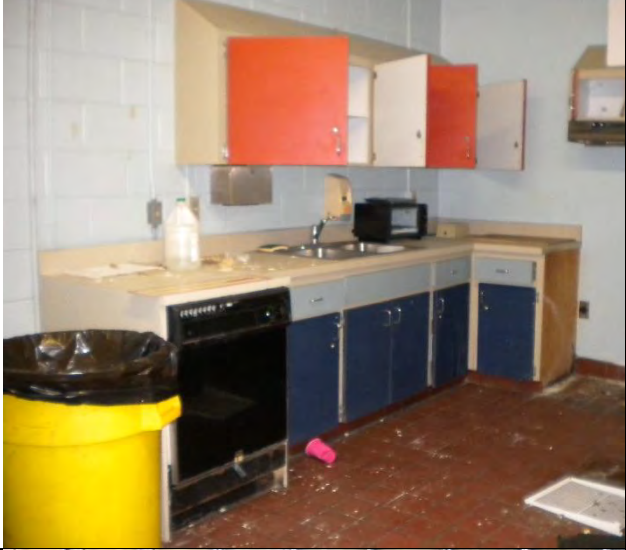
REPORT SECTION: 4.6 PHOTO: P4 PHOTO DESCRIPTION: Building #1; kitchen
399.

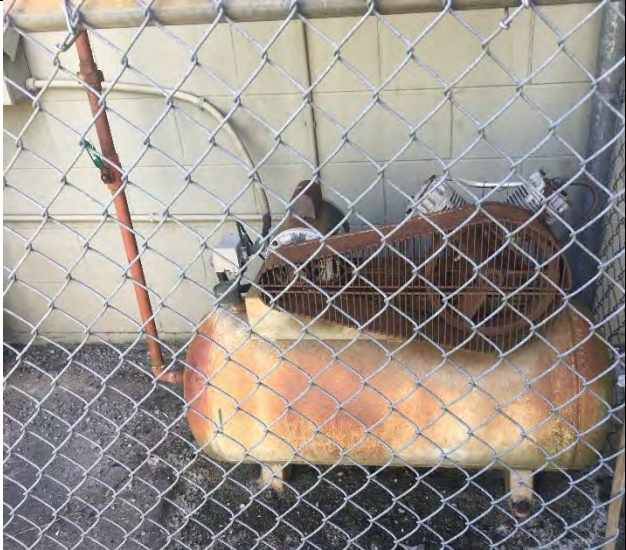
REPORT SECTION: 4.6 PHOTO: P5 PHOTO DESCRIPTION: Building #6; air compressor
400.

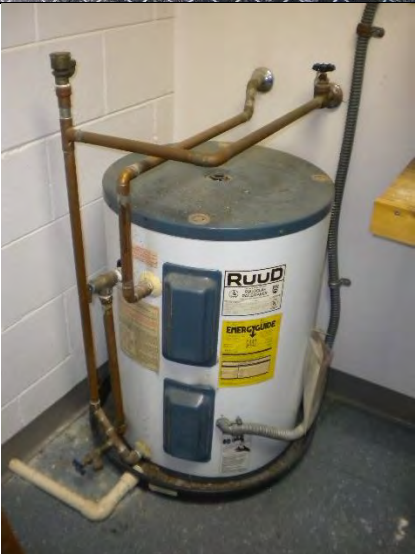
REPORT SECTION: 4.6 PHOTO: P6 PHOTO DESCRIPTION: Building #3; electric water heater

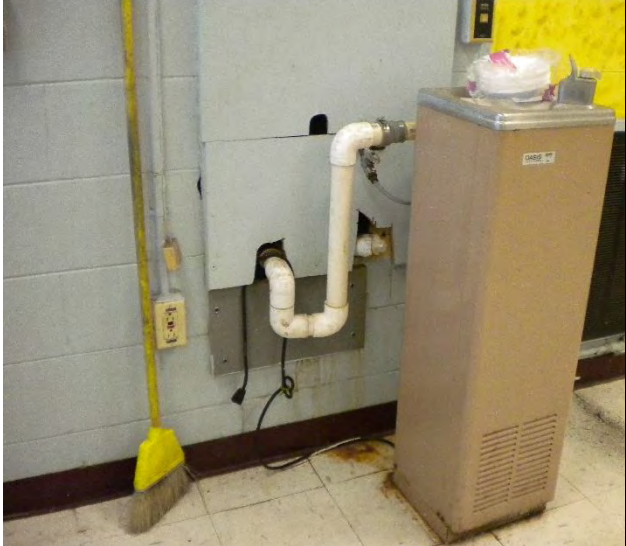
REPORT SECTION: 4.6 PHOTO: P7 PHOTO DESCRIPTION: Building #1; electric water cooler
402.

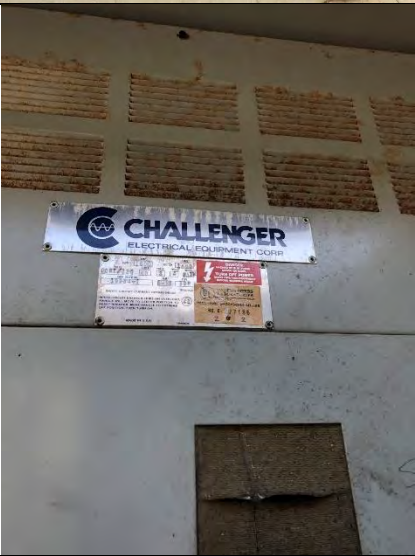
REPORT SECTION: 4.8.1 PHOTO: E1 PHOTO DESCRIPTION: Building #9; Main Switchboard
403.

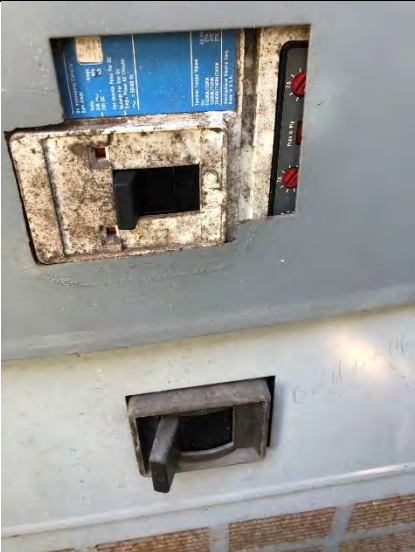
REPORT SECTION: 4.8.1 PHOTO: E2 PHOTO DESCRIPTION: Building #9; Main Switchboard

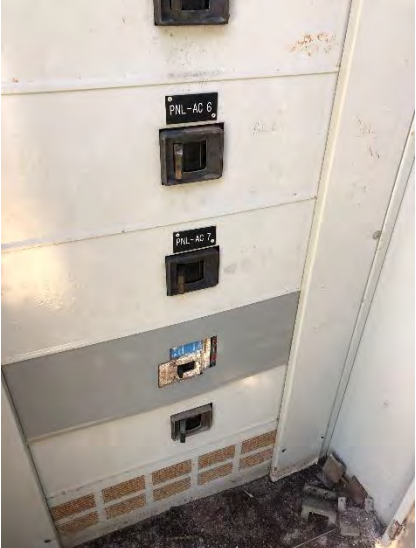
<p>REPORT SECTION: 4.8.1</p> <p>PHOTO: E3</p> <p>PHOTO DESCRIPTION: Building #9; Main Switchboard</p>
405.

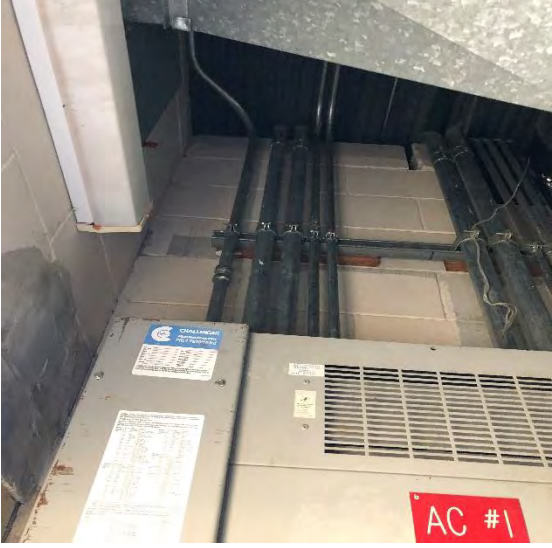
<p>REPORT SECTION: 4.8.1</p> <p>PHOTO: E4</p> <p>PHOTO DESCRIPTION: Building #1; Panelboard AC#1</p>
406.

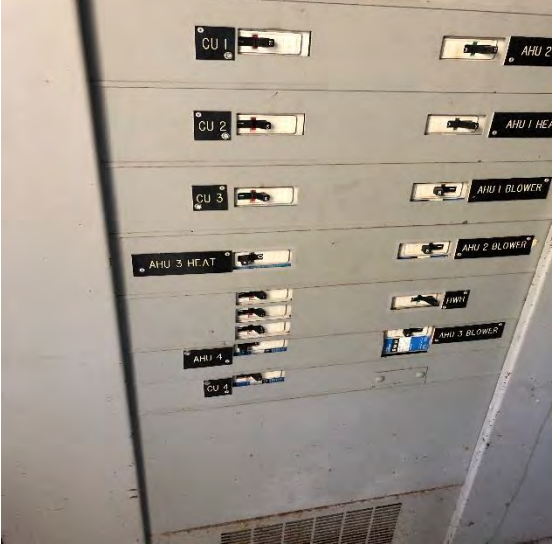
<p>REPORT SECTION: 4.8.1</p> <p>PHOTO: E5</p> <p>PHOTO DESCRIPTION: Building #1; Panelboard AC#1</p>

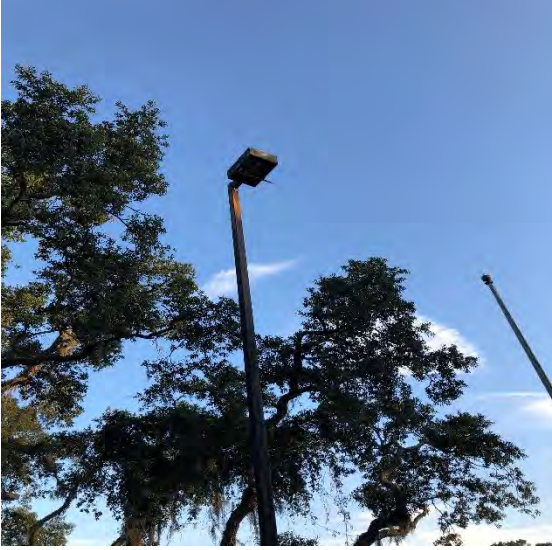
<p>REPORT SECTION: 4.8.2</p> <p>PHOTO: E6</p> <p>PHOTO DESCRIPTION: Site Lighting</p>
408.

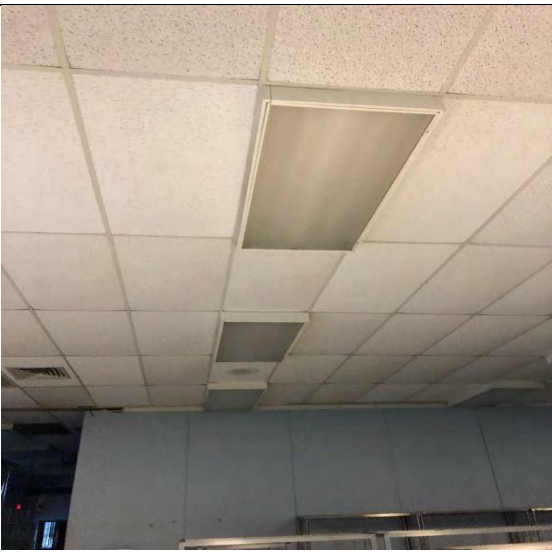
<p>REPORT SECTION: 4.8.2</p> <p>PHOTO: E7</p> <p>PHOTO DESCRIPTION: Canopy Lighting – Through out.</p>
409.

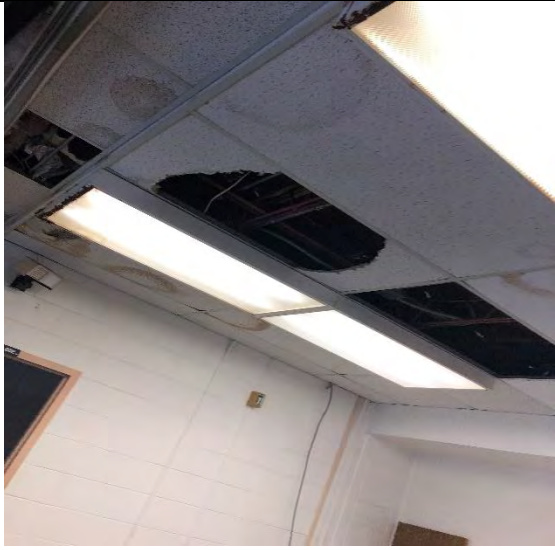
<p>REPORT SECTION: 4.8.2</p> <p>PHOTO: E8</p> <p>PHOTO DESCRIPTION: Interior Lighting – Building #1</p>

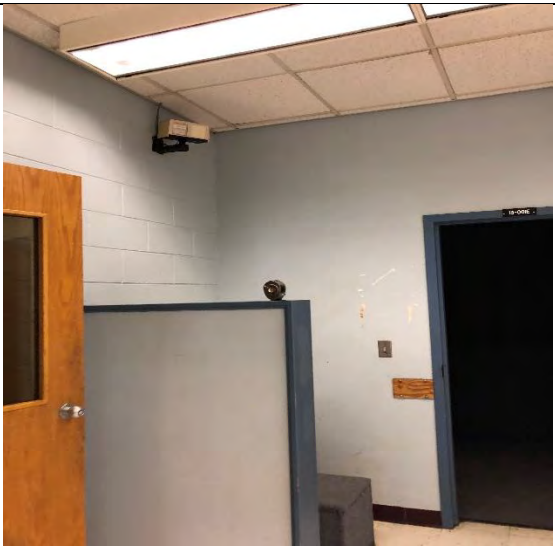
<p>REPORT SECTION: 4.8.2</p> <p>PHOTO: E9</p> <p>PHOTO DESCRIPTION: Interior Lighting</p>
411.

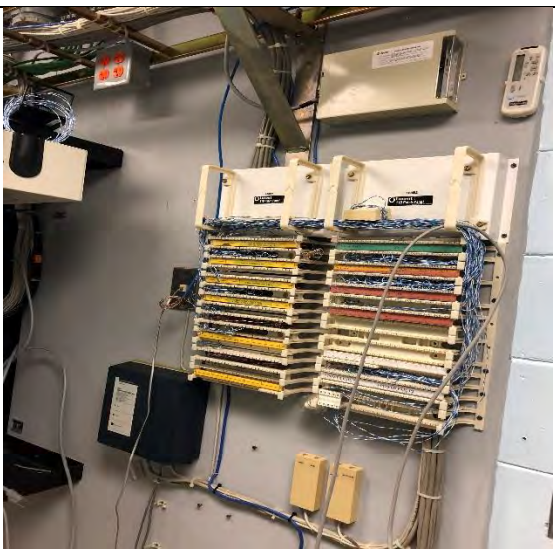
<p>REPORT SECTION: 4.8.3</p> <p>PHOTO: E10</p> <p>PHOTO DESCRIPTION: Intrusion system</p>
412.

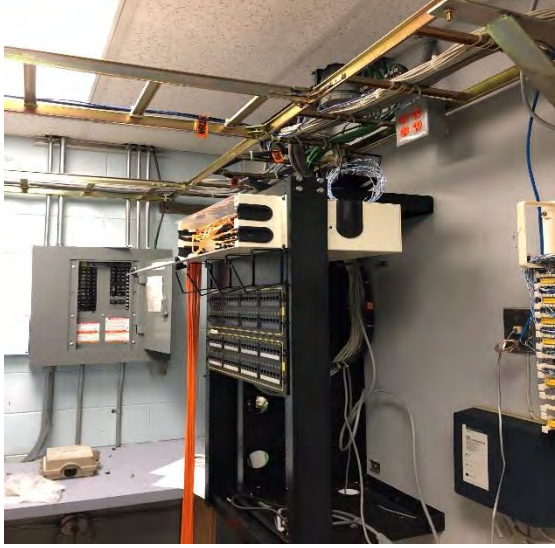
<p>REPORT SECTION: 4.8.4</p> <p>PHOTO: E11</p> <p>PHOTO DESCRIPTION: Telephone Terminal Board (TTB) at Building #1.</p>

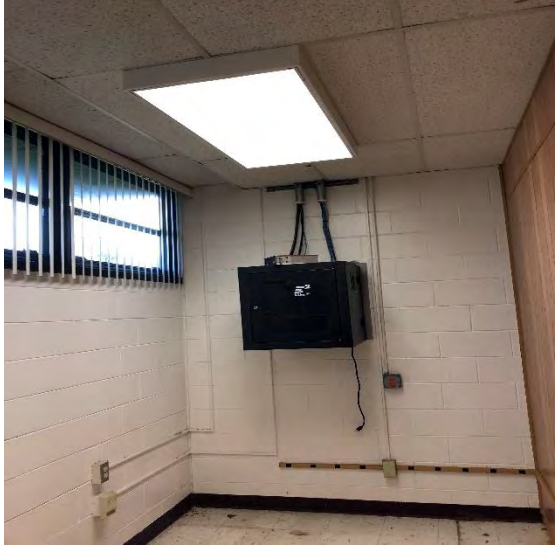
A photograph of a data rack in Building #1. The rack is filled with various electronic components, including what appears to be a switch or router. Cables are organized and run along the top of the rack. The surrounding environment includes a desk with some equipment and a wall-mounted electrical panel.	<p>REPORT SECTION: 4.8.4</p> <p>PHOTO: E12</p> <p>PHOTO DESCRIPTION: Building #1 Data Rack</p>

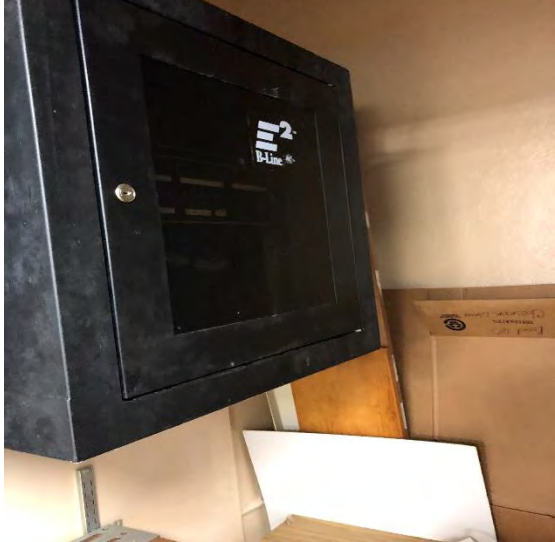
A photograph of a data rack in Building #2. The rack is a black, wall-mounted unit. It is located in a room with white brick walls and a window with blue blinds. The rack is connected to the wall with cables.	<p>REPORT SECTION: 4.8.4</p> <p>PHOTO: E13</p> <p>PHOTO DESCRIPTION: Building #2 Data Rack</p>

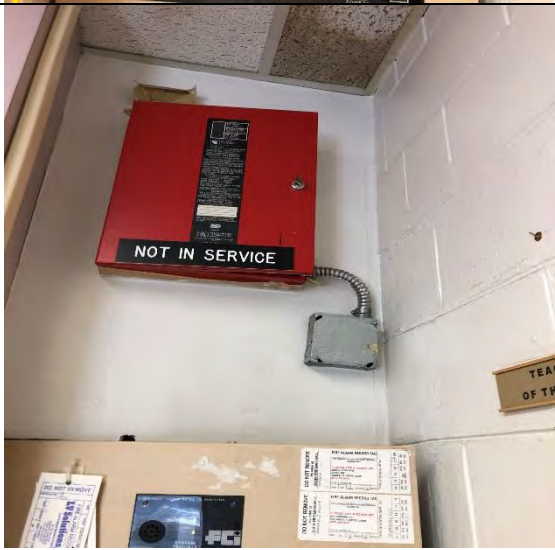
<p>REPORT SECTION: 4.8.5</p> <p>PHOTO: E15</p> <p>PHOTO DESCRIPTION: Building #2 Fire Alarm Control Panel.</p>
<p>417.</p>
